Report of the investigation
of the grounding of
ARCO ARUN
off Broadness Point, River Thames
on 13 October 1998

FILE: MAIB 1/6/106

SYNOPSIS (all times are UTC)

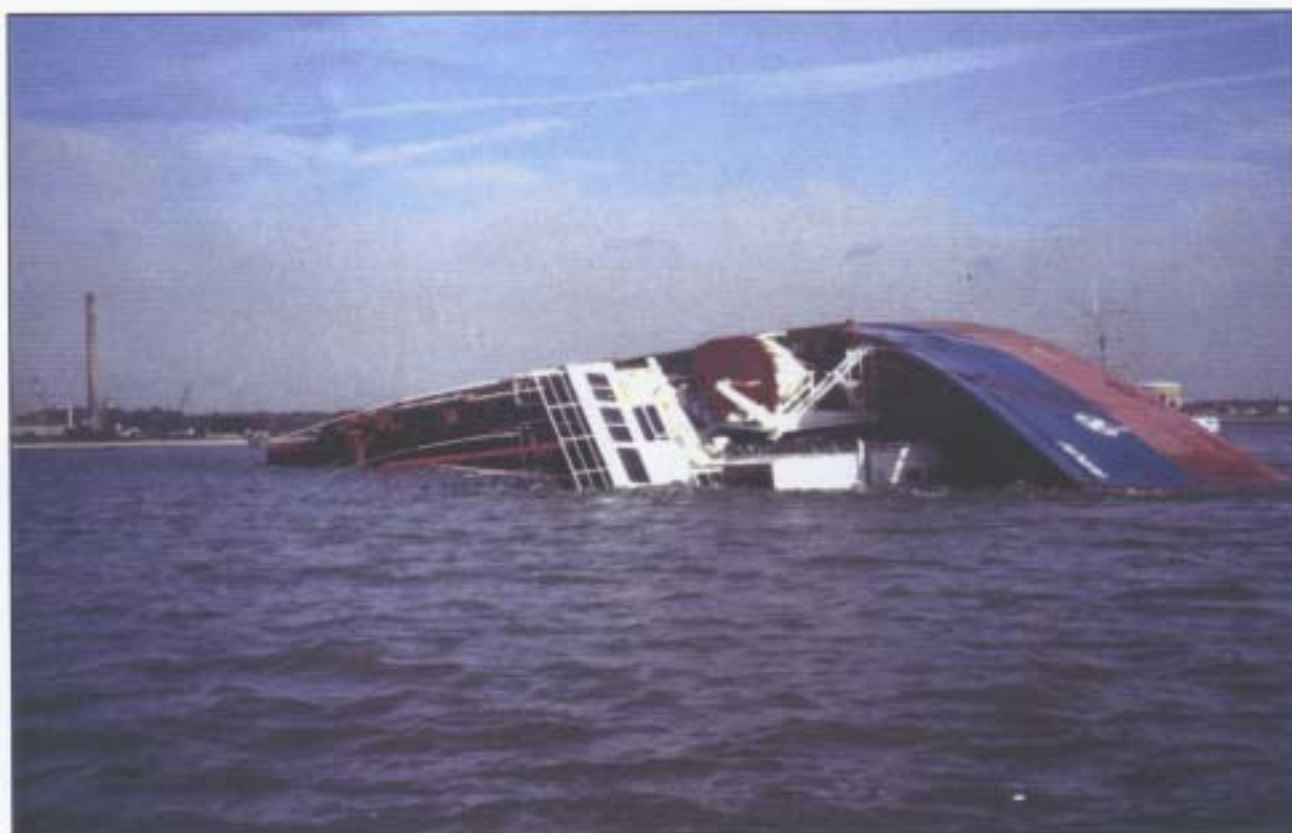
Despite salvage attempts, *Arco Arun* capsized at about 0830 on 15 October, 42½ hours after she had first grounded (**see Photograph 2**).

Arco Arun - capsized

into the aft machinery space. The flooding caused the vessel's list to progressively increase; which culminated in her capsizing on the morning of 15 October. Salvage attempts were hampered because the volumetric capacities of void and machinery spaces were not known.

Progressive flooding from forward to aft caused the vessel first to list and finally to capsize. The flooding occurred mainly through watertight doors that were designed principally to limit progressive flooding from aft to forward. The vessel capsized after the flooding had reached the aft engine room.

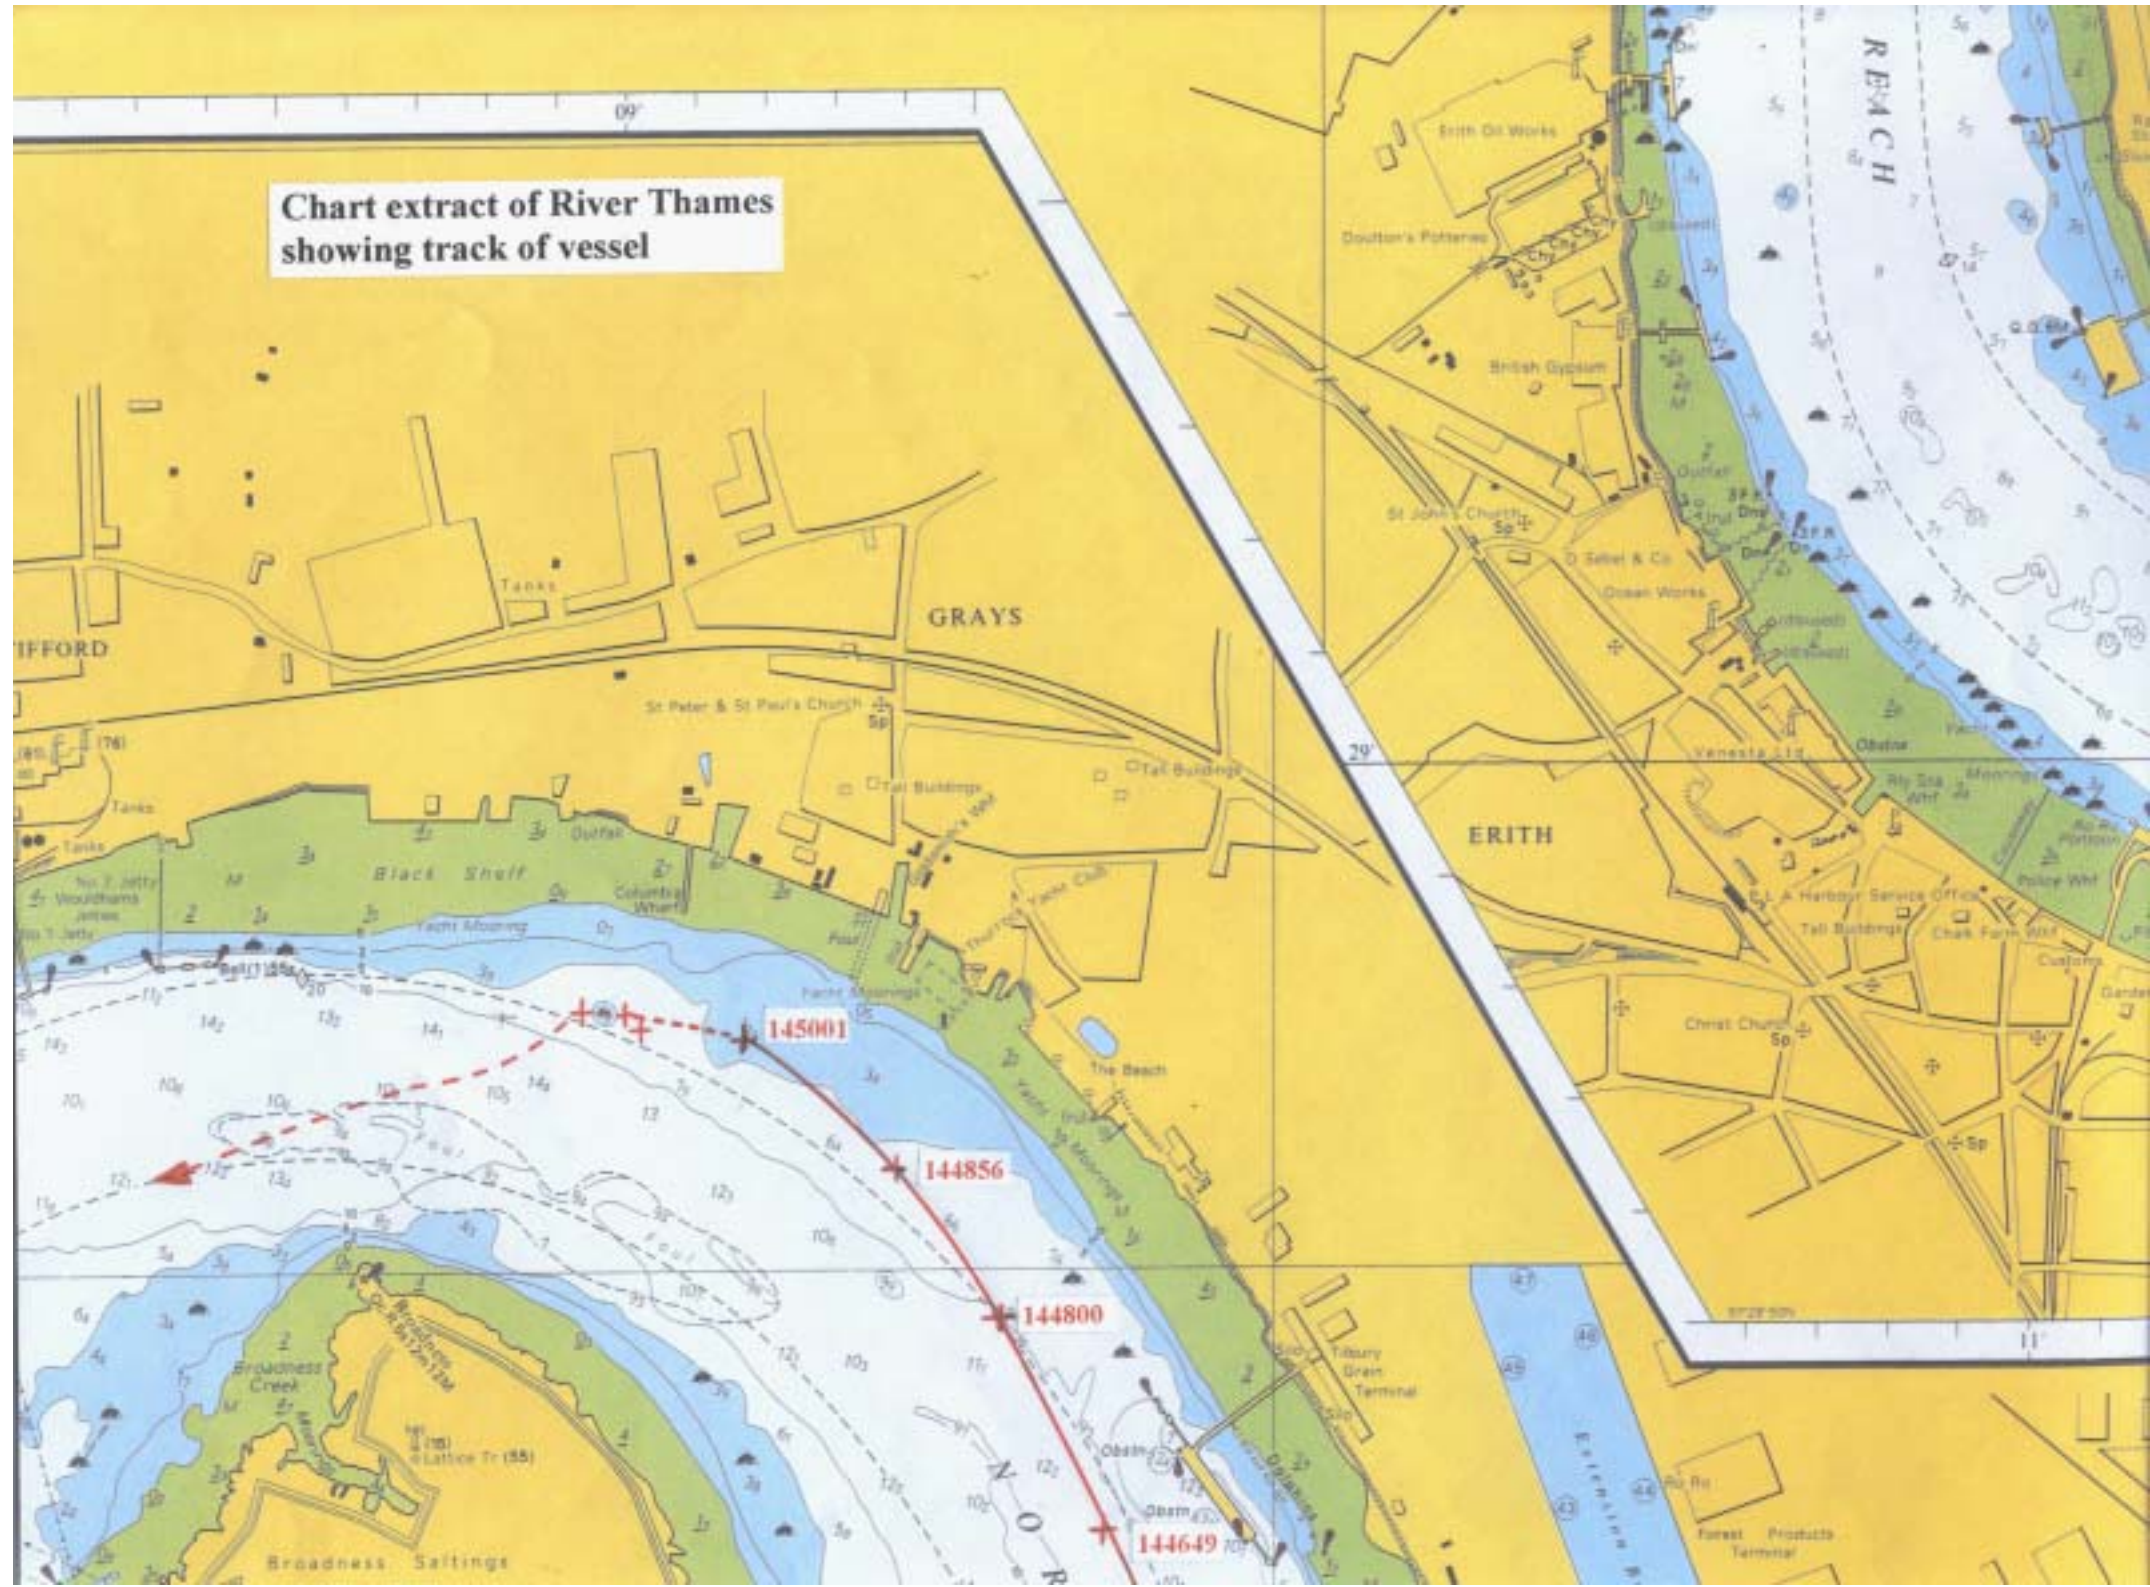
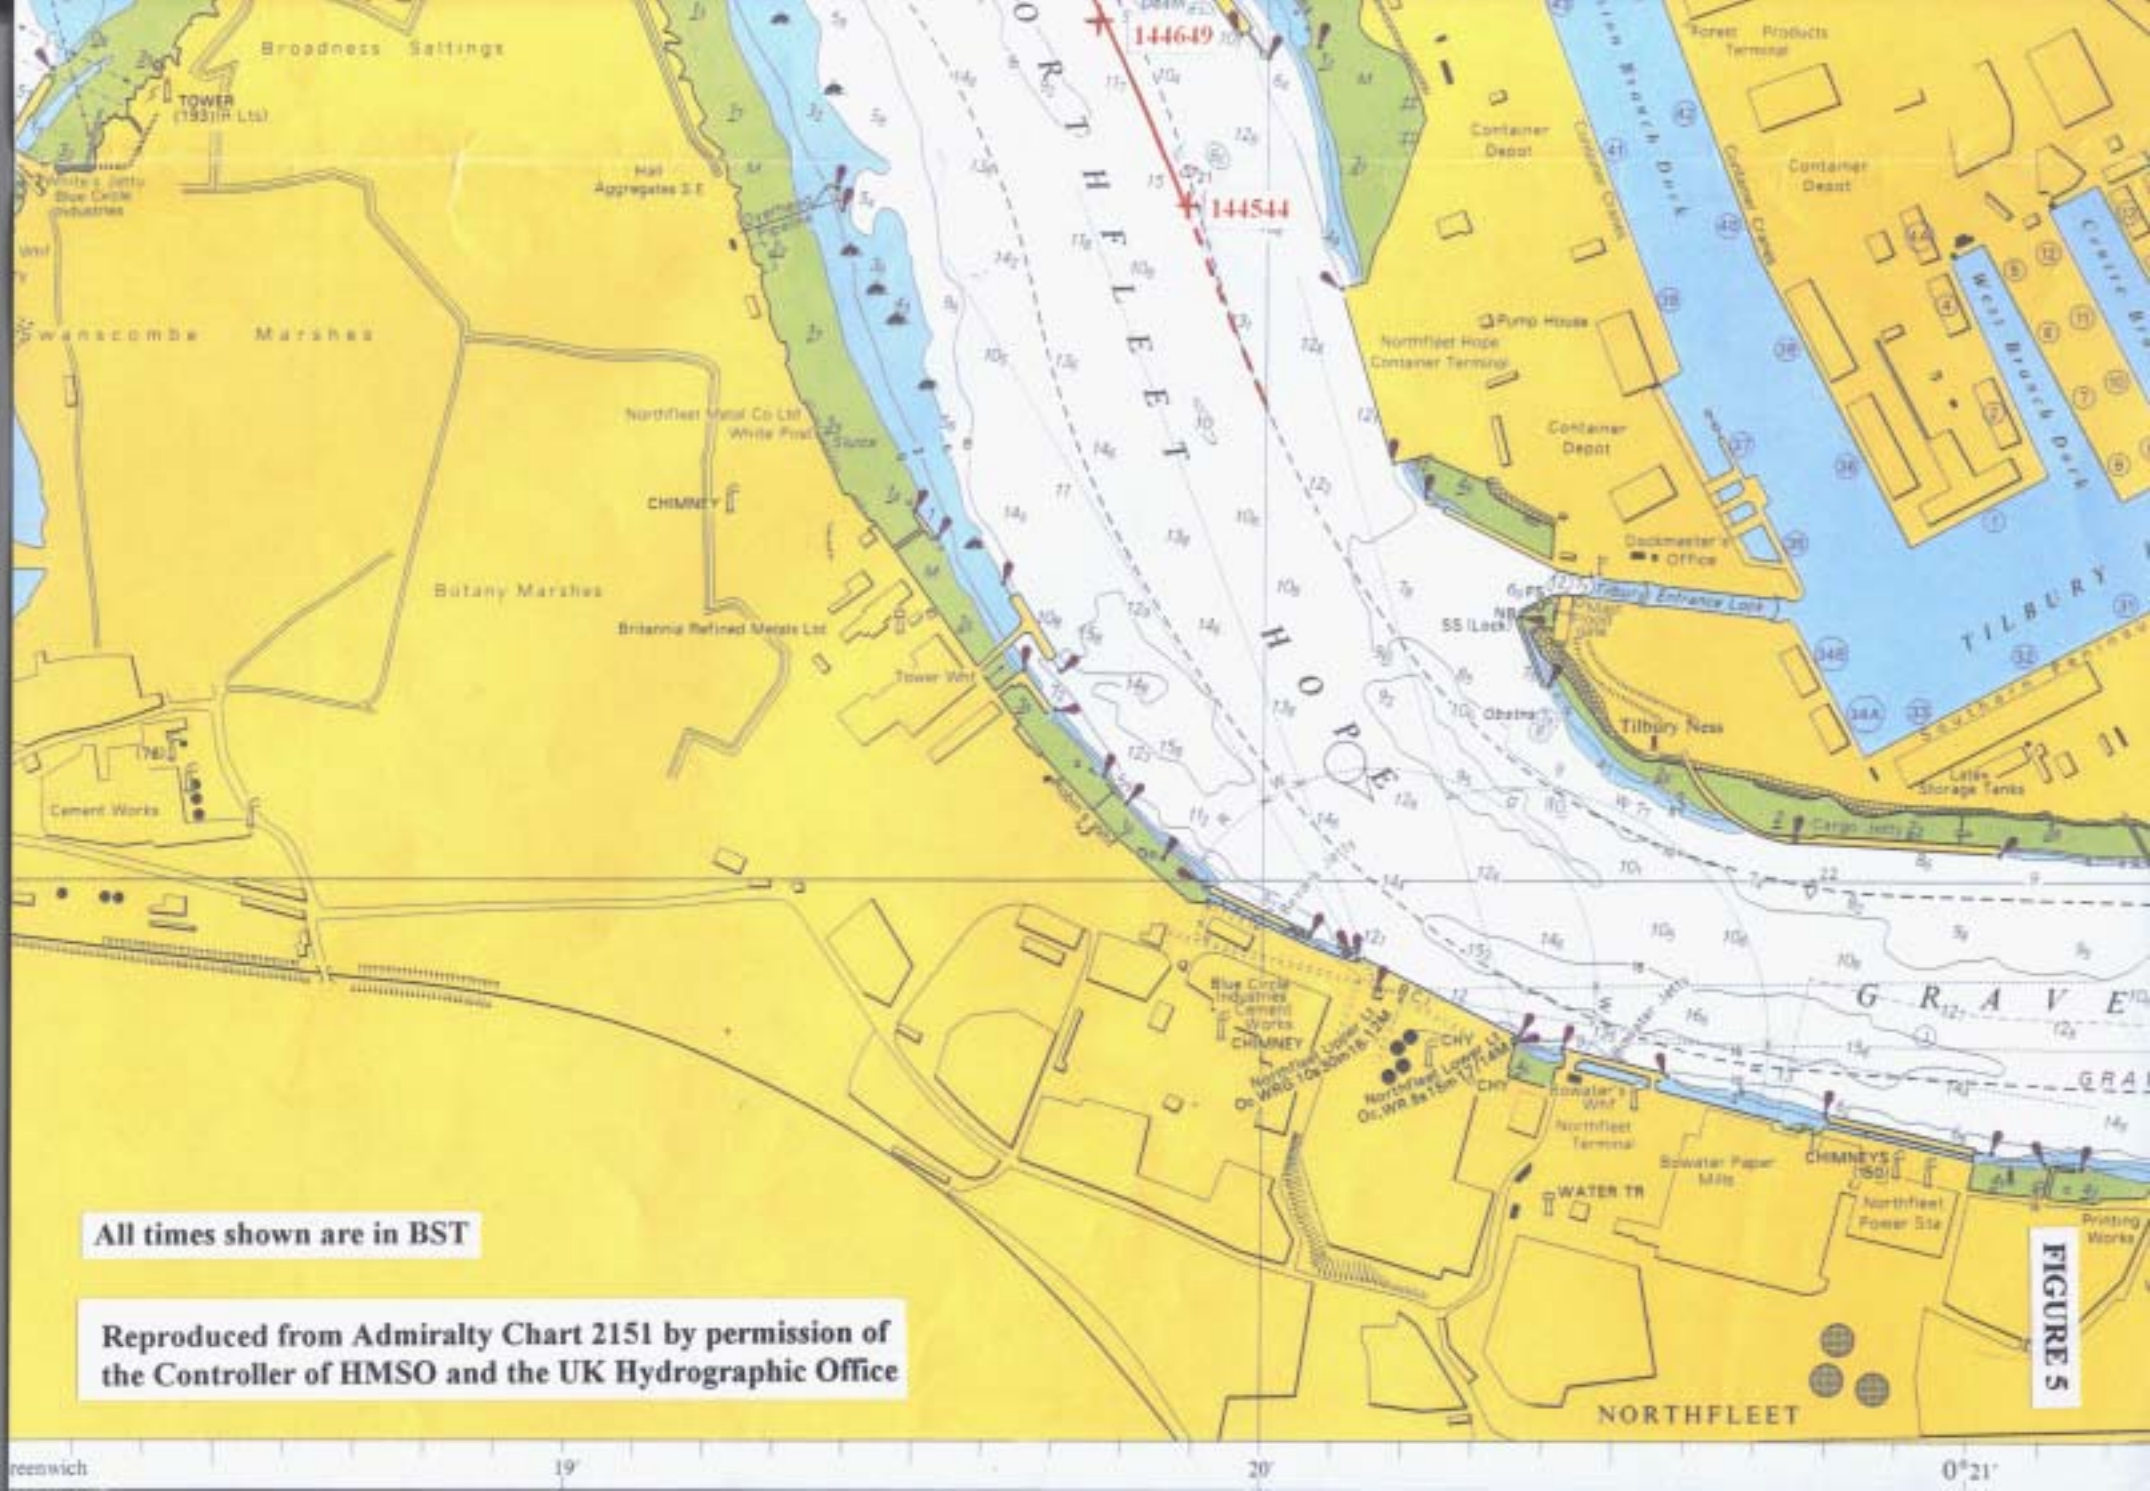
Chart extract of River Thames
showing track of vessel

The accident was caused by a navigational error which went undetected by the bridge team. [2.3, 2.4, 2.5]

6. At a draught of 6.6m and with a tide 1½ hours after low water, *Arco Arum* was constrained to navigate within an unmarked fairway. The hazards posed by this fact do not appear to have been fully appreciated by either those on *Arco Arum* or those in PCL. [2.3, 2.8]

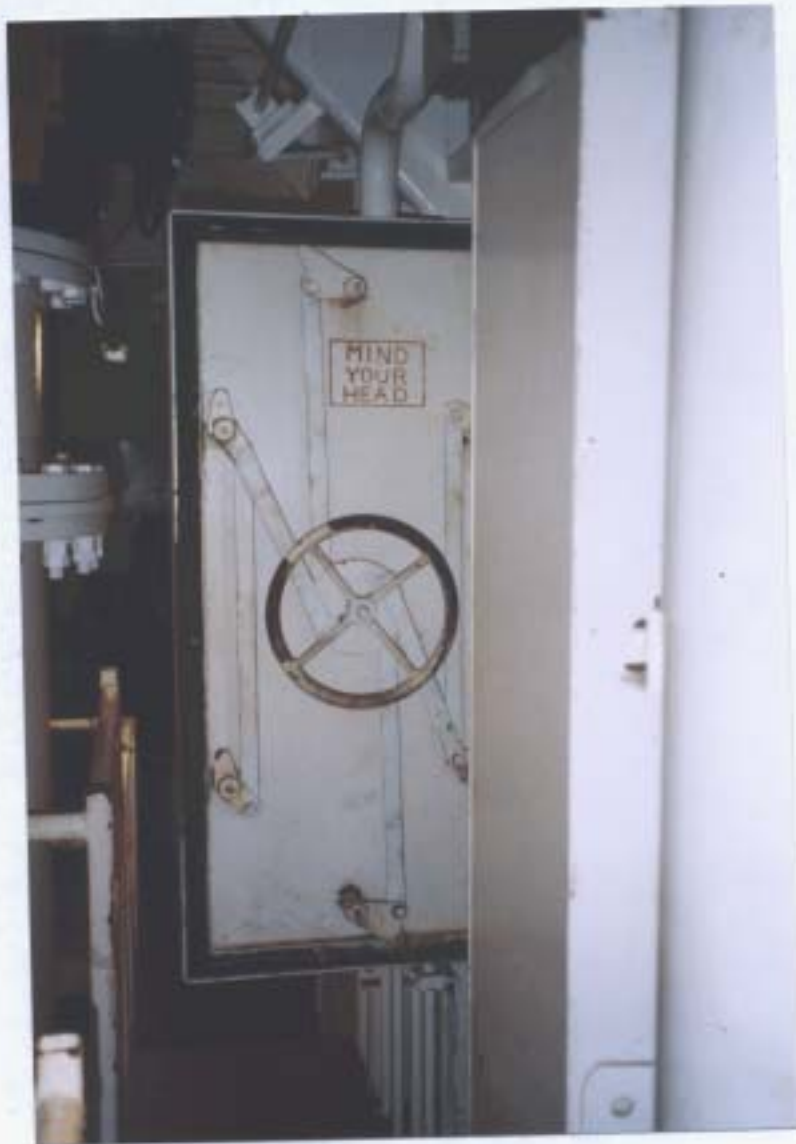
PHOTOGRAPH 3

It can be seen from the general arrangement drawing (**Figure 2 - general arrangement**) that the watertight doors on *Arco Arum* were all hinged to open aft. This arrangement gives greater protection against progressive flooding from aft to forward, when hydrostatic pressure would act to press the door closed against its rubber seals. On this occasion the hydrostatic pressure acted in the other direction, causing the seals to be less effective. The doors allowed water to pass and progressive flooding to occur.

Watertight Door

4. The watertight doors between the forward machinery space and the forward void space are in the process of being replaced with hydraulic sliding doors fitted with alarms on all vessels of the class.
