**A report on the investigation of the capsize and
foundering of the workboat/tug
Trijnie
with the loss of one life
in the approach channel to Milford Docks,
Milford Haven, on 8 September 1998**

Marine Accident Investigation Branch
First Floor Carlton House
Carlton Place
Southampton
SO15 2DZ

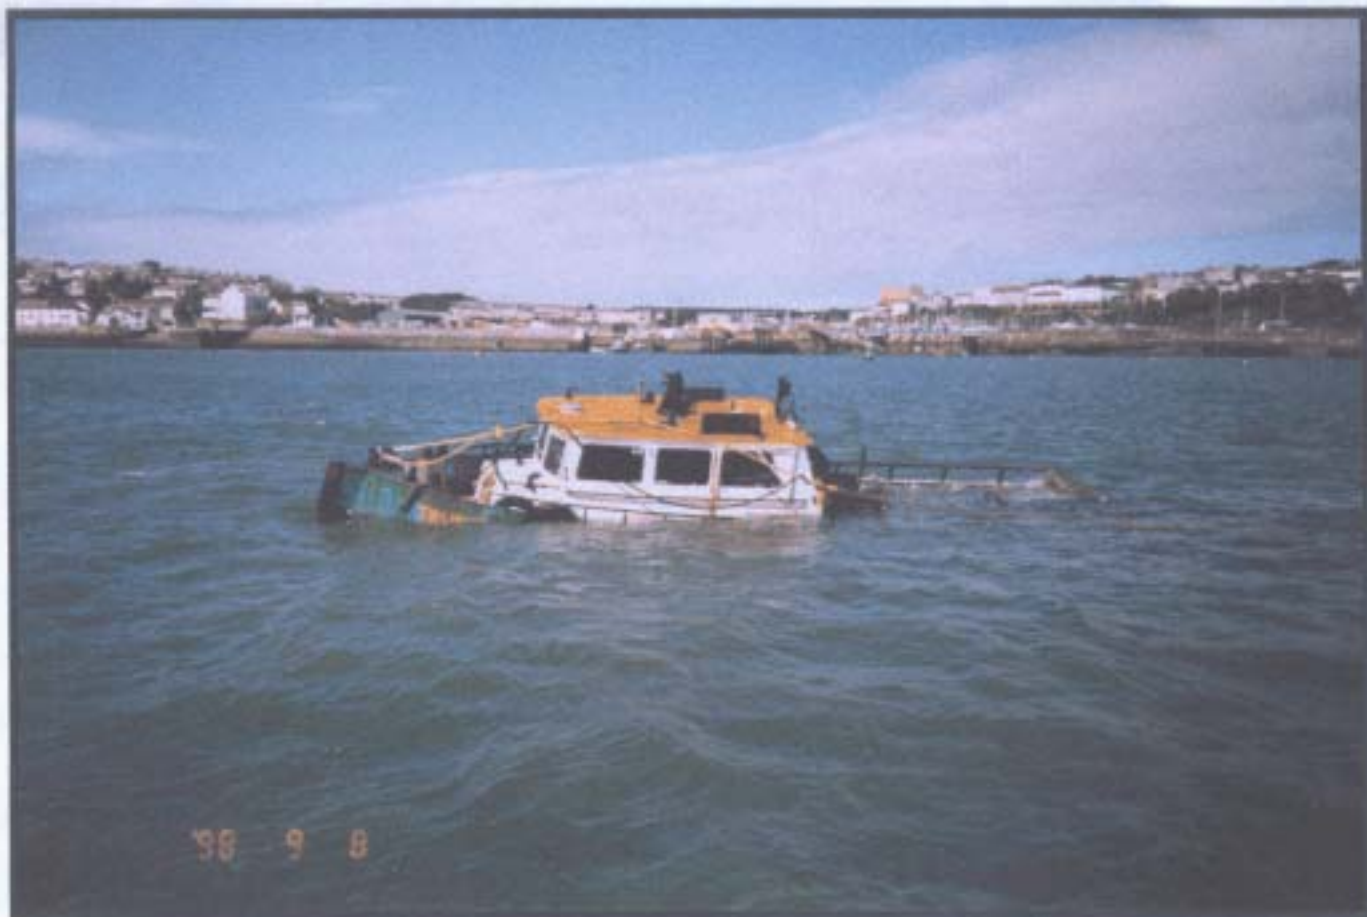
Trijnie partially submerged at low water, prior to her salvage

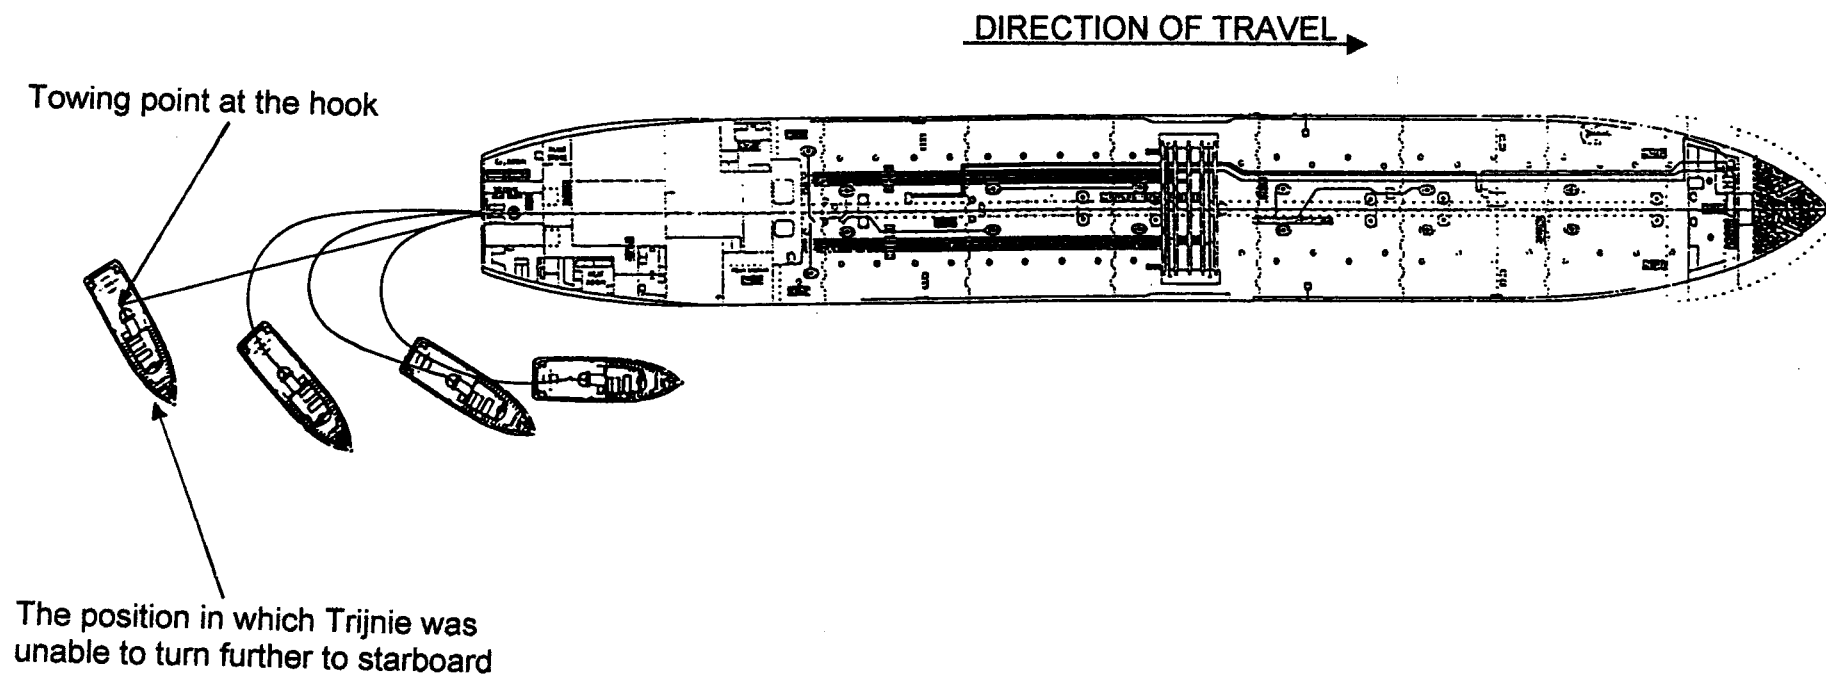
When the tug had peeled-off to a point where her heading was between 60° and 90° from the ship's, the coxswain found she would not turn any further. With the tow line taking the weight on the port beam *Trijnie* began heeling to port (**Figure 2**). The coxswain initially retained his rudder angle and engine movements but soon afterwards, water began to flow over the after bulwarks. He reversed the engines and helm to bring the tug back to port but as soon as he had done so, he saw water starting to pour into the wheelhouse. He left the helm position, went to the aft door where his crewman was standing and told him to abandon the tug. The coxswain then climbed over the starboard side and jumped into the water.

Trijnie making her peel-off manoeuvre to starboard without a gog rope
(Tug and ship to scale)

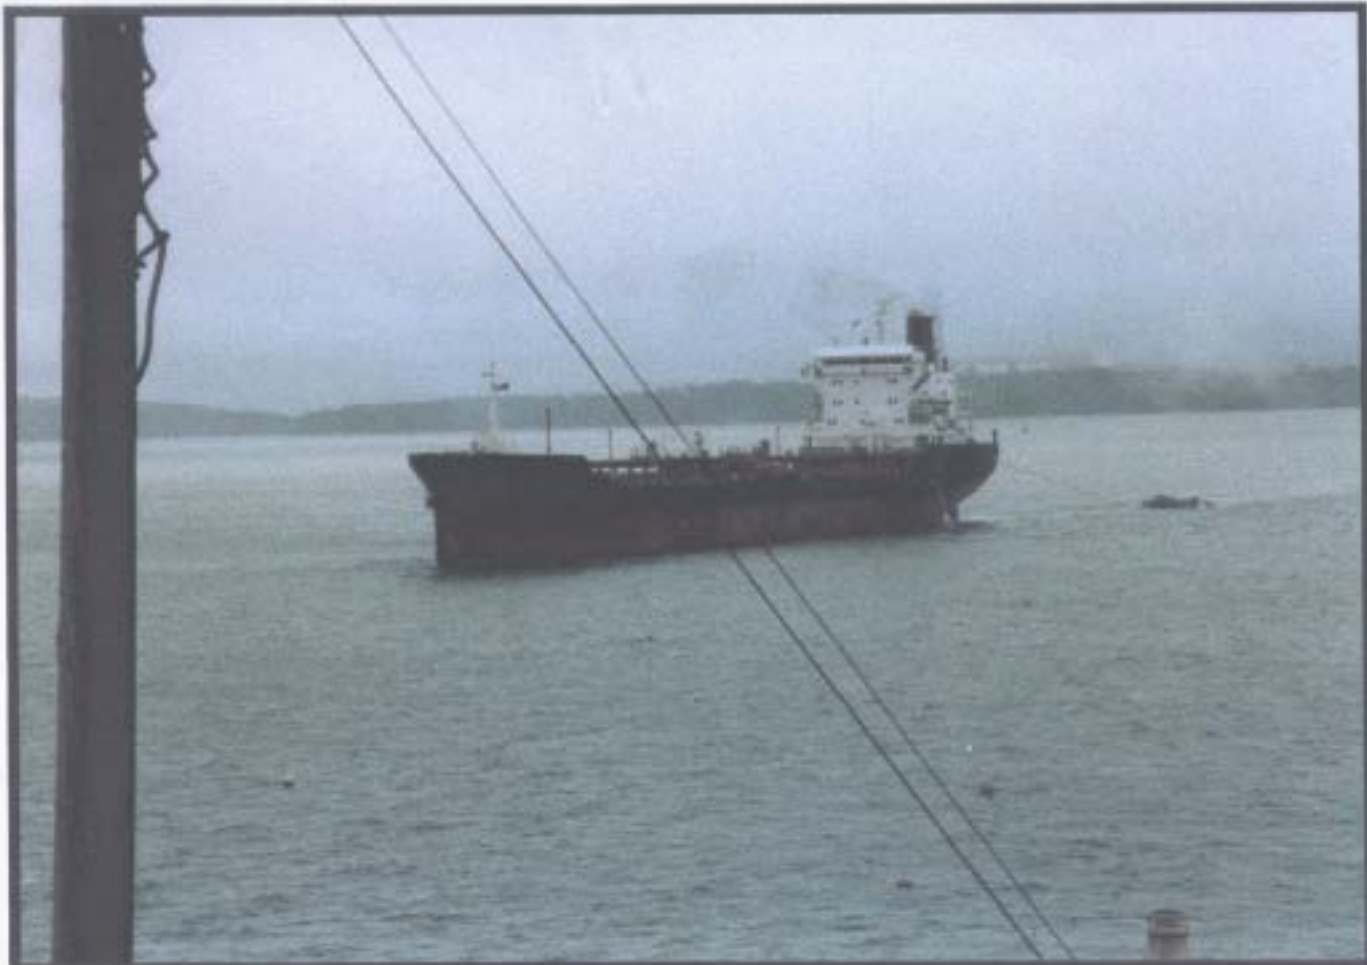
1. *Tjilerman* and *Trijnie*, with the latter in the capsized position

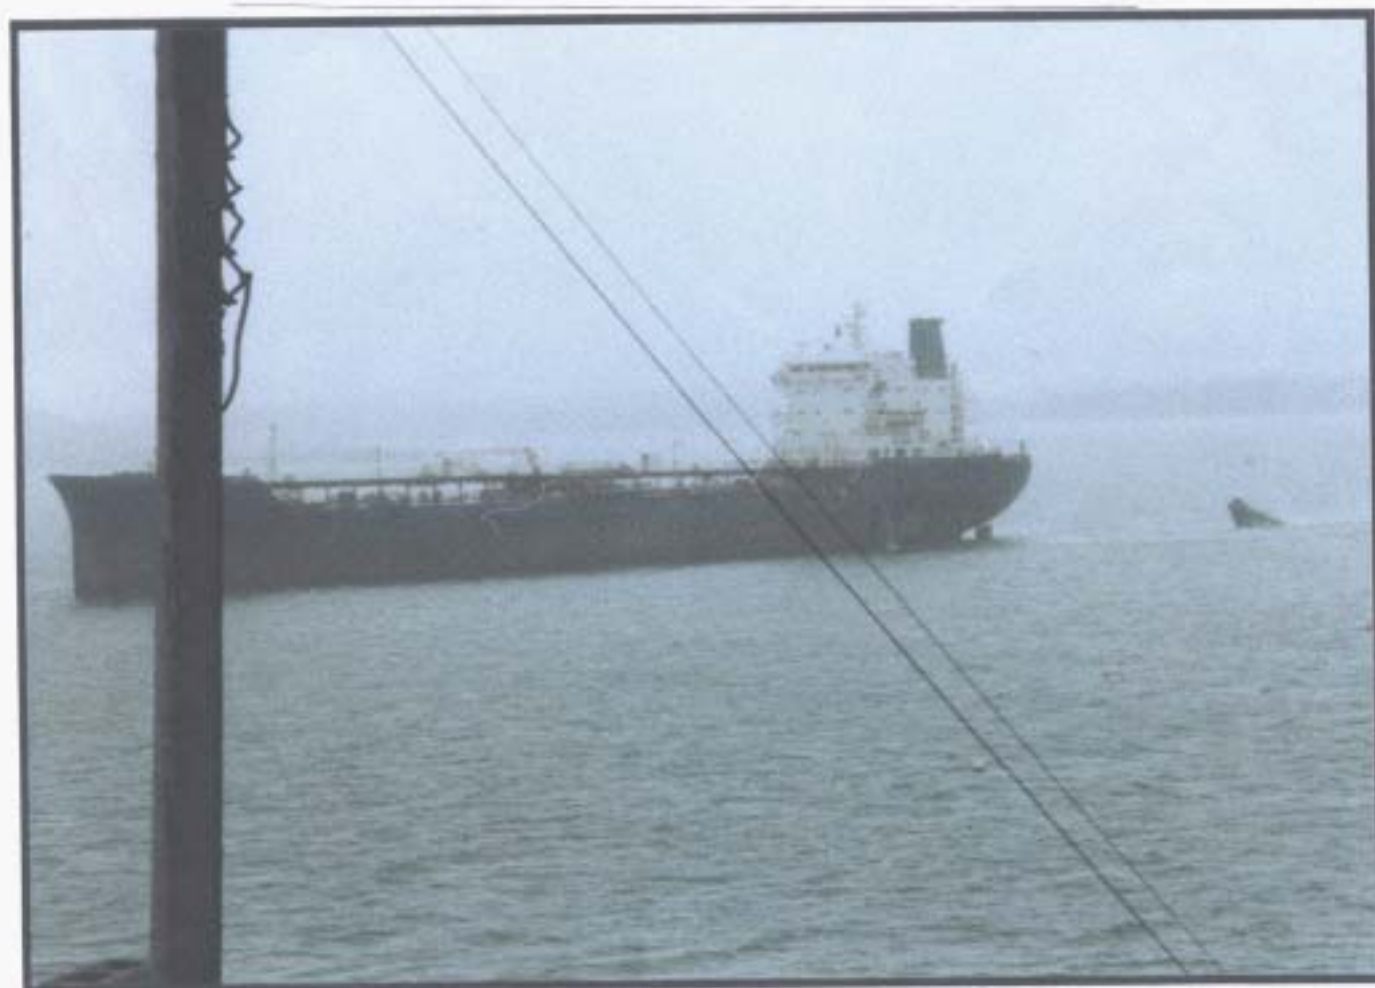
Following her capsize, *Trijnle* had taken up an inverted bows-up attitude. The mooring line, on which there was a lot of weight, was still attached to the ship (**Figure 3 and Photographs 1 and 2**). The pilot and Port Control discussed the implication of letting go the mooring line and whether the tug would sink. By this time fire brigade divers had been called to the scene to search the tug for the missing crewman. It was then suggested that *Anglegarth* could take over from *Tillerman* to keep *Trijnle*'s bow above water pending the arrival of the divers.

2. *Trijnie* in the inverted bows-up position

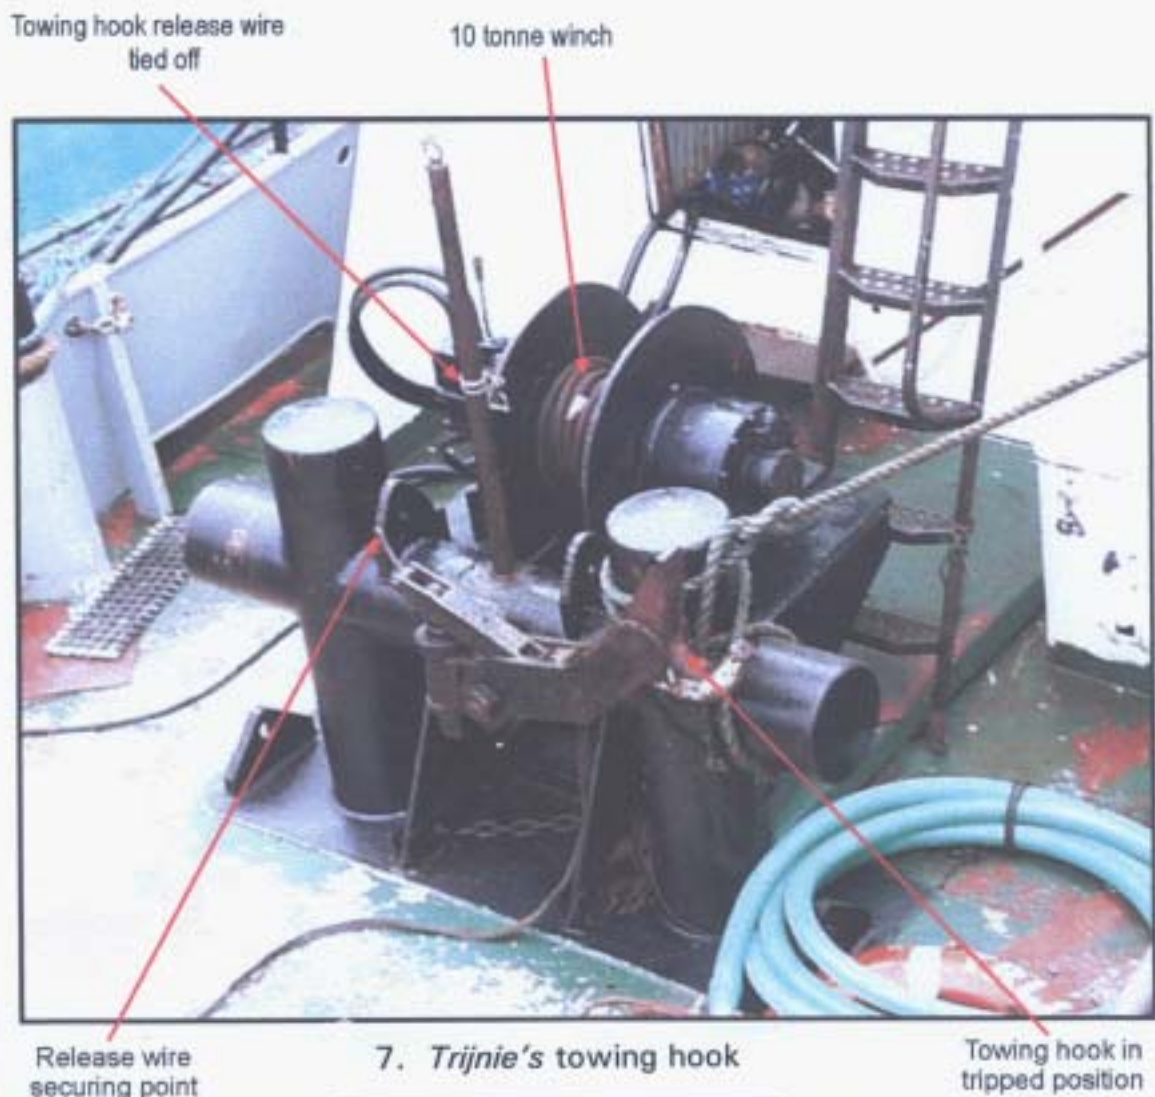
When *Trijnie* was raised following the accident, it was found that the tow hook release wire **was** not secured to the hook but tied **off** on the vertical stanchion (**Photograph 7**). It was confirmed that none of the divers had touched the wire at any time. The investigation revealed that the wire had been tied **off** when working at the Texaco berths. The crews found heaving lines fell on the release wire when being thrown from ships and tripped the hook, which was inconvenient when running mooring lines.

After the accident, the release wire was untied from the stanchion and secured to the hook. In attempting to trip the hook from the helm position, the system would not work. However the hook was found to be have been displaced to about 30° above the horizontal, and probably occurred during the incident. During later tests, the hook was found to release satisfactorily when using the wire.

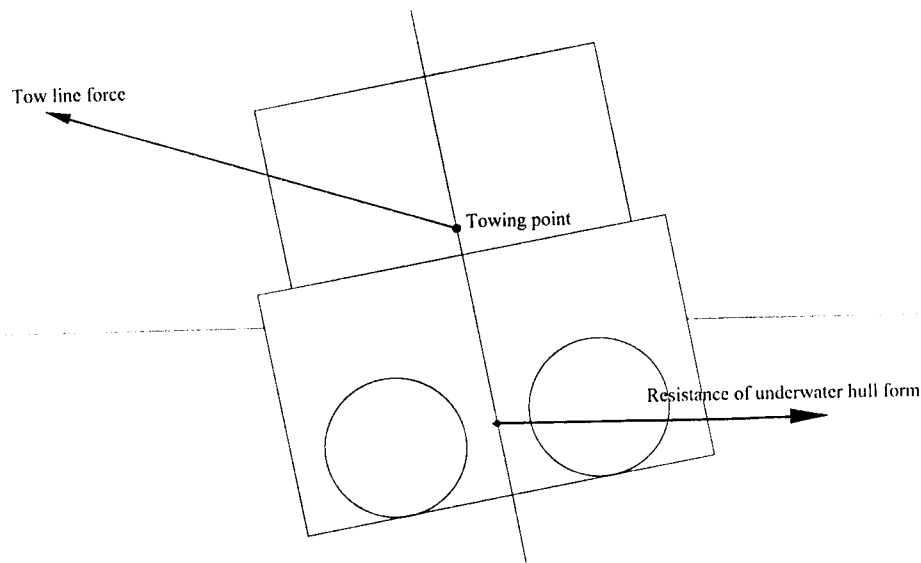
Figure 4 - A sketch showing the opposing forces on a tug in the girting position

Another effect is that a heeling moment is created by the vertical distance between the towing point and the point of resistance to movement on the tug's hull form, together with the magnitude of the opposing forces. This is known as girting and can cause a tug to capsize (**Figure 4**).

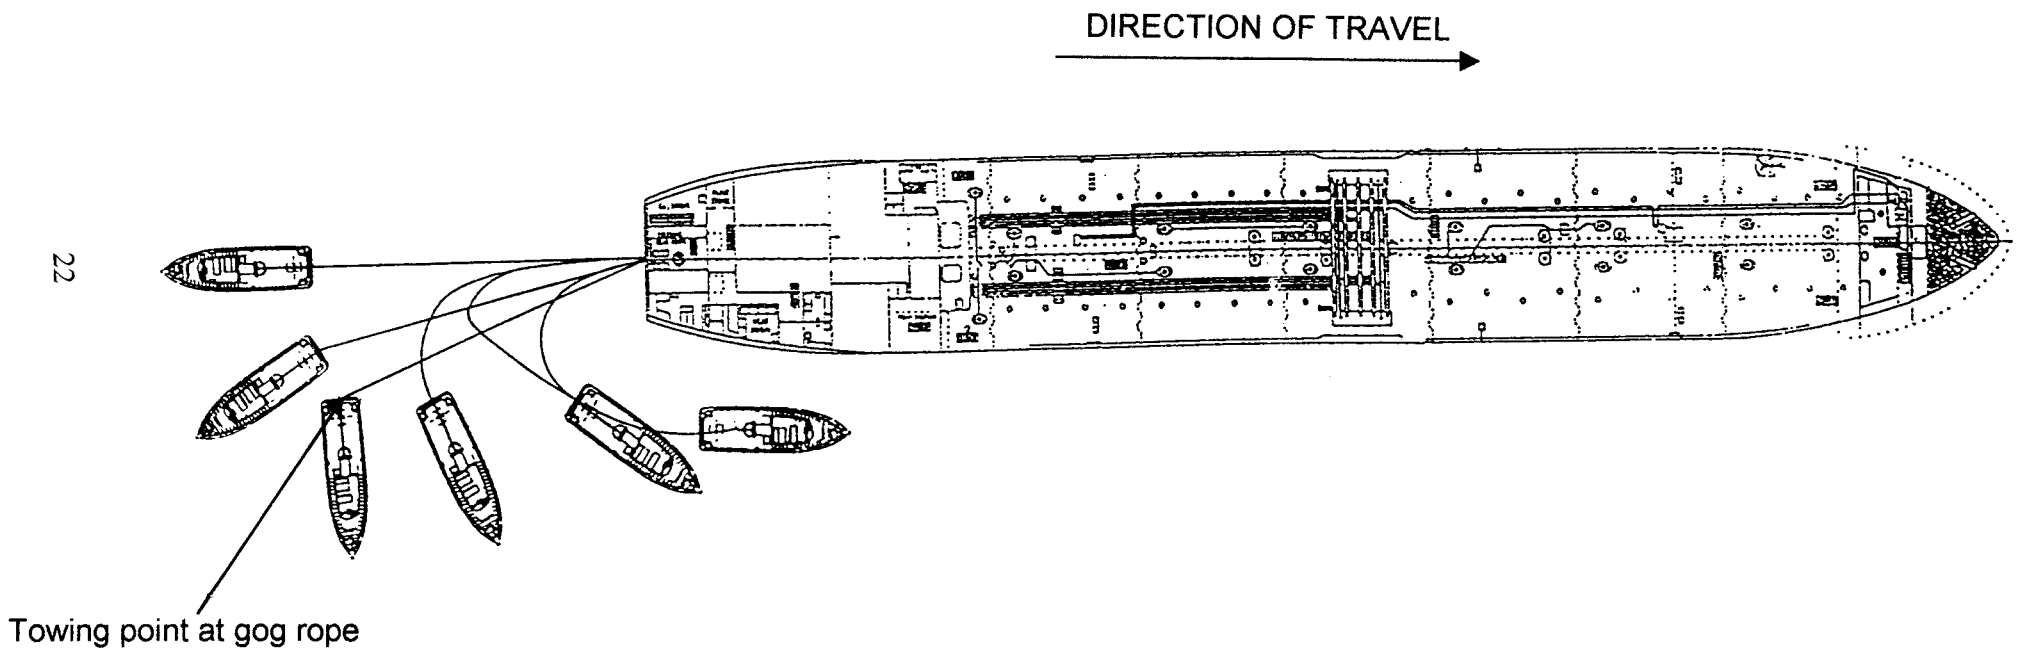
The peel-off manoeuvre using a gog rope
(Tug and ship to scale)

By using a gog rope, the horizontal distance between the towing point and the centre of pressure is increased, which increases the horizontal turning moment. This enhances the tug's ability to steer. Being able to manoeuvre out of a beam-on situation means that the tow line can be brought into the fore and aft centreline of the tug and dangerous heeling moments can be prevented (**Figure 5**).

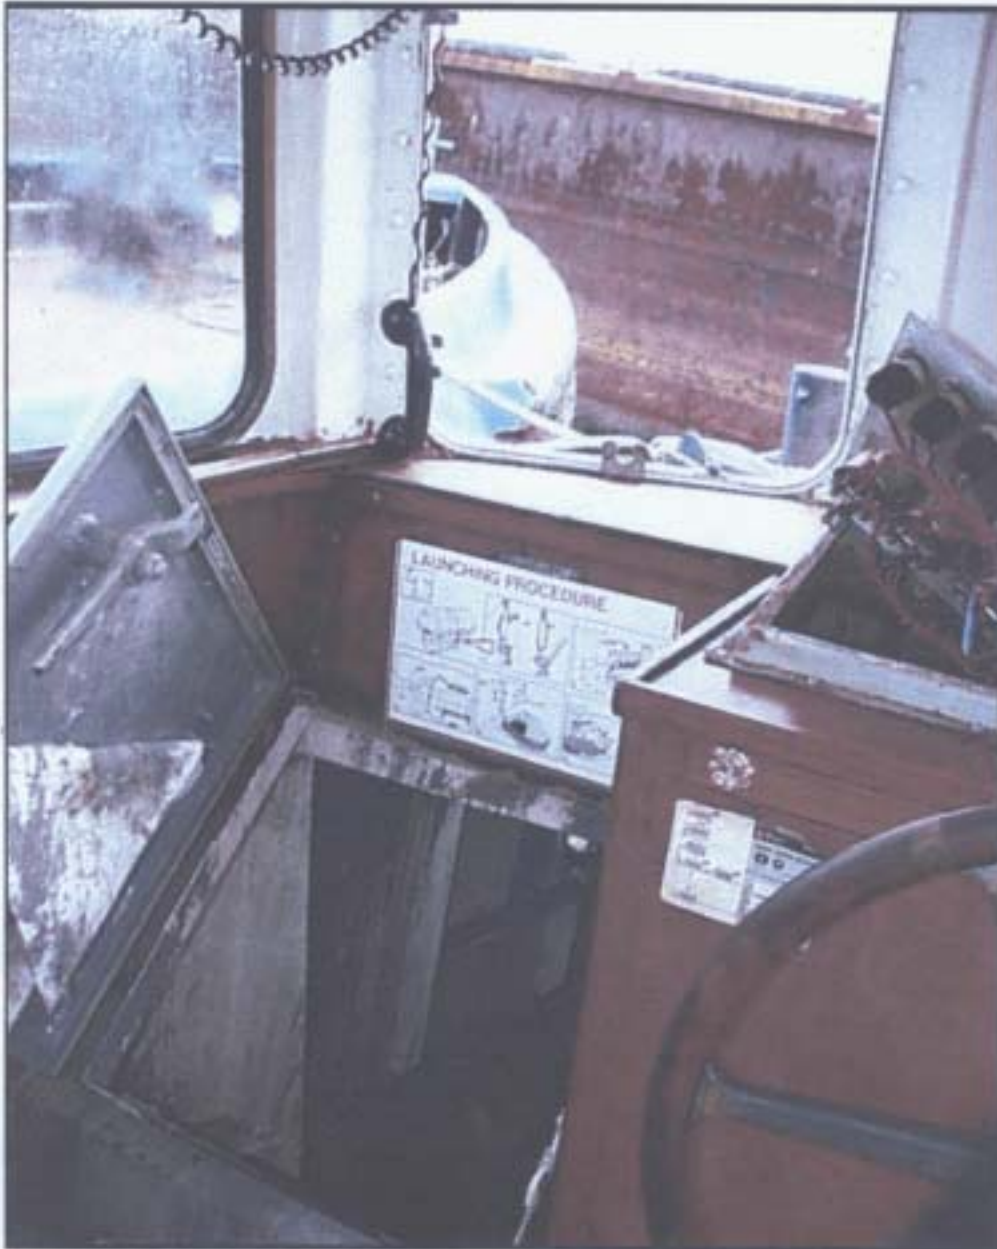
10. This access hatch to the lower deck was closed during the incident
