**Report of an Investigation**  
**into a switchboard explosion on**  
***m.v. Pride of Le Havre***  
**on 27 July 1998**  
**off the Port of Le Havre, France.**

The explosion is considered to have been caused by a direct connection being made between two phases of the 660volt incoming supply. Contributory causes include the use of non-company issue test equipment and entangled test leads.

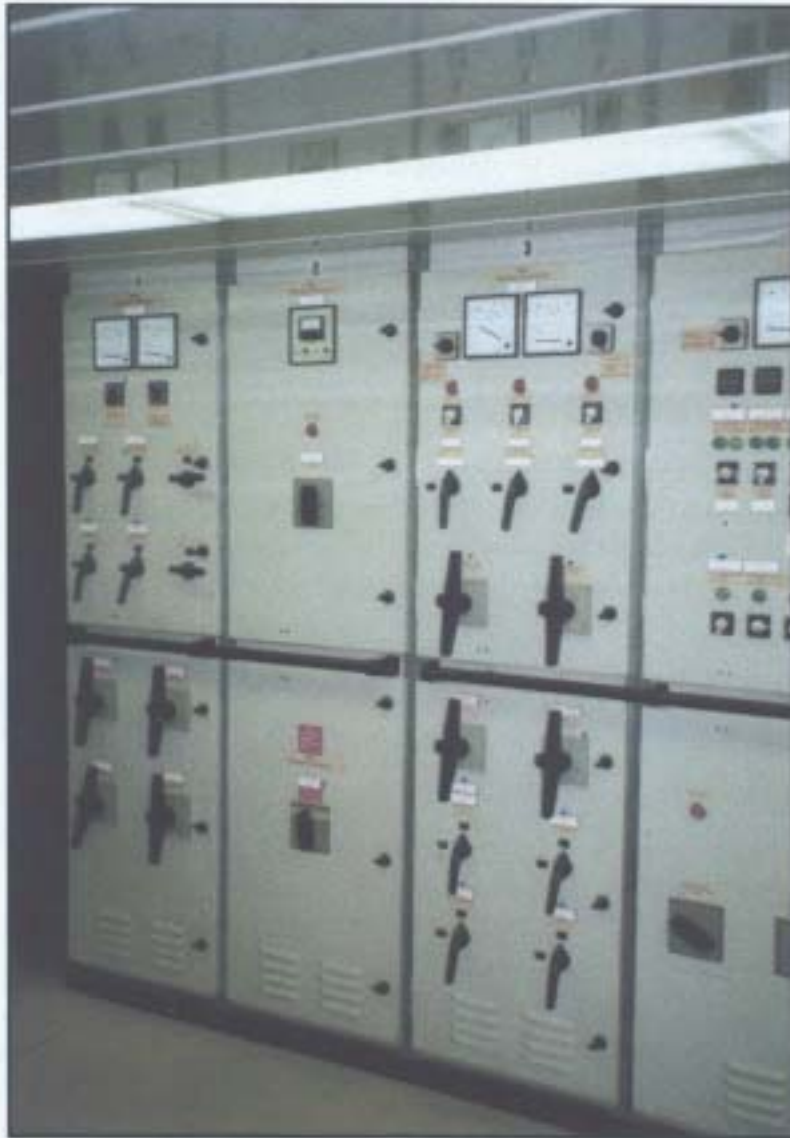
*Main Switchboard (Port Side) Panels 1, 2 & 3*

The switchboard is well lit from the front with all panels and controls in apparent good order. The original German name plates, together with their English equivalent, are attached to the panel front, next to the appropriate switch. No 2 panel contains the breakers for the main supply to vehicle deck fans, drencher pump, and No 2 non-essential services. No 3 panel contains the actual group controls for the fans, various auxiliary engine room machinery, deck and car deck hydraulics and a galley transformer. No 1 panel contains the controls for reefer sockets and the air conditioning plant. Details of panels No 2 and 3 are shown in annex 1.

*The initial inspection indicated that core damage was concentrated in section No 2 with secondary damage to section No's 1 & 3. The switchboard was blacked out and then split between section No's 6 & 7 to enable repairs to continue in safe conditions.*

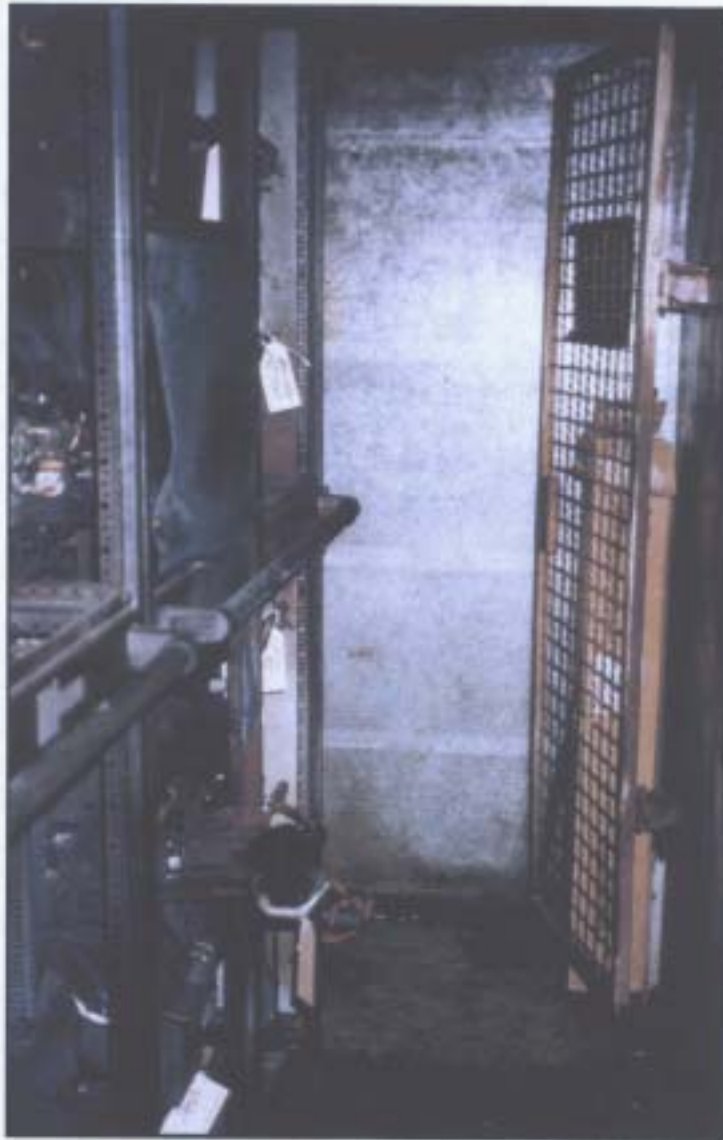
*Port side entrance to rear of Main Switchboard.  
Note open Fuse Switch for Car Deck Ventilation Fans*

The arc chutes fitted to the fuse switch were found to have been removed. This not only gave easier access to the power connections but also allowed any arc to develop unimpeded.

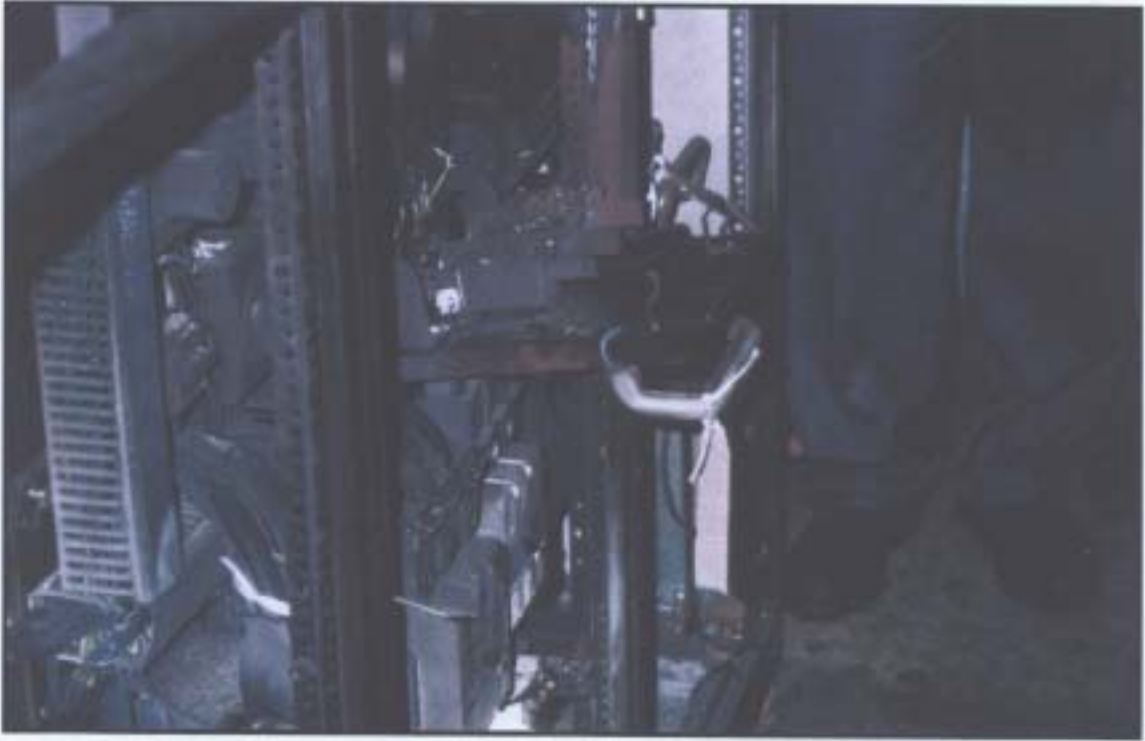
*Open Fuse Switch for Car Deck Ventilation with Fuse in situ*

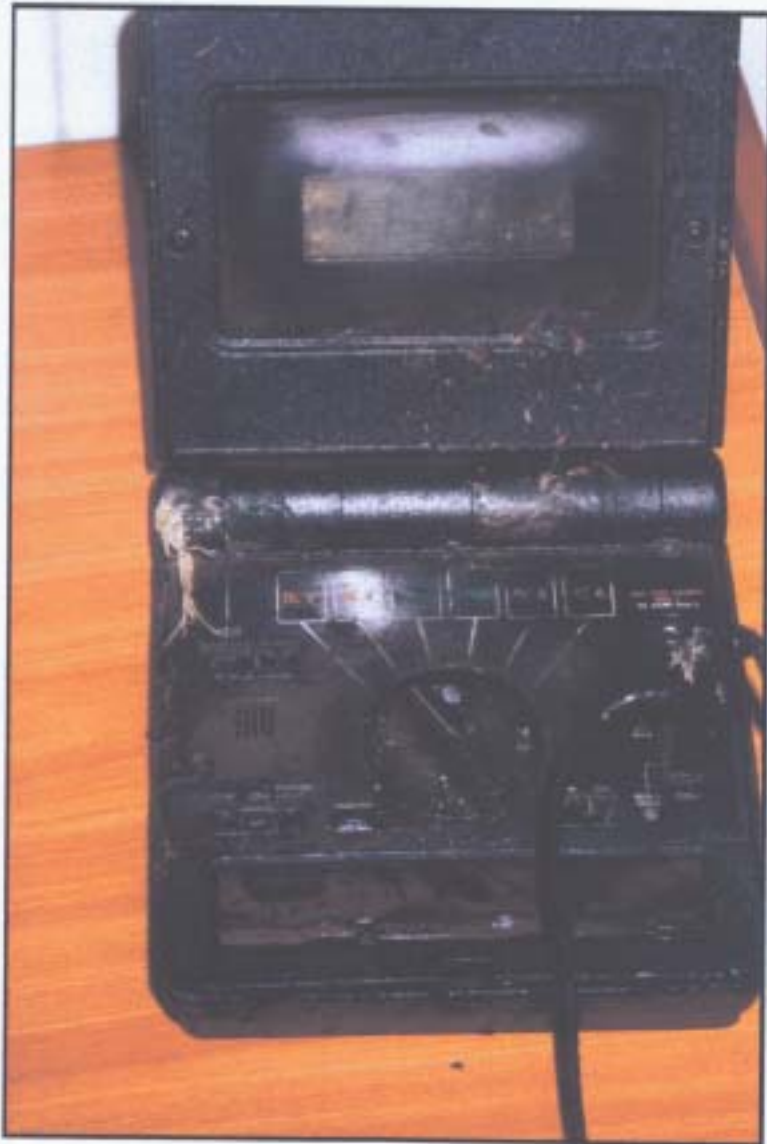
*"Micronta" Multi-Meter condition after explosion.  
Note test lead in closed loop with meter set to measure Volts.*

*The meter had suffered external heat damage and was partially covered in a soot like deposit. The meter selector switches were set to read ac volts and the on/off switch was in the on position. The digital readout was not showing a display when initially seen, but when a new set of batteries were installed the display read 0000. The rear case was removed and the internal circuitry was found to be clean and it did not exhibit any signs of damage which could have been caused by an internal electrical fault. The printed circuit board was broken beneath the test terminal marked “+”, apparently due to excessive pressure on the terminal. This damage appeared to have disconnected this terminal from the rest of the circuit board. Plugged into the “COM” and “+” terminals was a test lead. This lead had black coloured insulation and was fitted with male 4mm plugs on both ends. The insulation of this lead had suffered damage of a type usually caused by heat. The lead was unfused. Connected in this way this lead shorted out the two terminals which are used in voltage measurements. There was a third test terminal on the instrument which is used in conjunction with the “COM” terminal for current measurement. The metalwork within this terminal was slightly discoloured indicating that no plug had been inserted into this terminal when the fault occurred which caused damage to the rest of the exterior of the meter. The test lead was unplugged from the test terminals and the male plugs and the metalwork of the sockets was found to be bright, indicating that both the plugs and sockets had been protected at the time of the fault which caused the damage to the rest of the meter.*

*In a recess in the multi-meter case were two test probes. These were covered by a layer of soot like material, but it was possible to see that the plastic moulding of one of the probes had red coloured plastic insulation. The metalwork of these probes was undamaged. Also with the meter was an instruction leaflet. This had a section in various foreign languages, but not in English. Examination of the leaflet showed that whilst the meter was rated for use up to 2000 volts dc, it was only rated for 500volts RMS ac.*

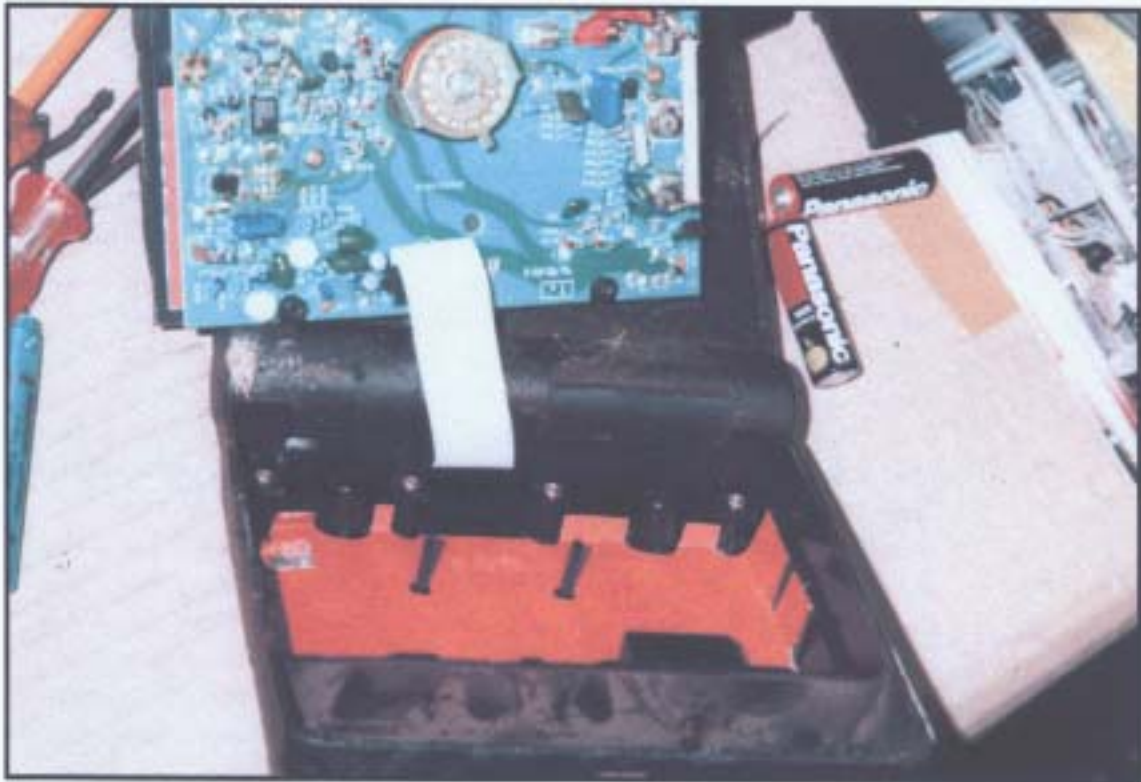
*Internals of "Micronta" Multi-Meter.  
Note lack of damage showing that meter was not in circuit at time of explosion.*

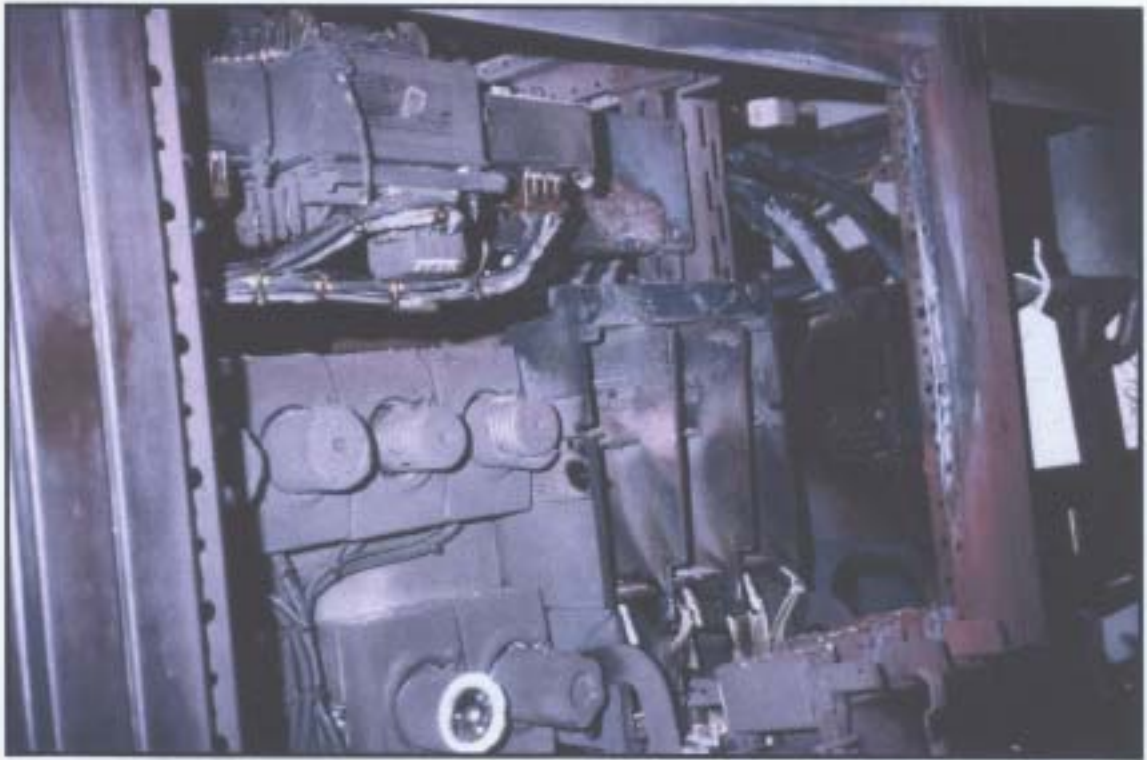
*a) An AEG 250amp fuse switch. The arc chutes had been removed from the switch and had suffered sooting only, indicating that they had not been in place on the switch at the time of the fault. The outgoing terminals of the switch were also relatively undamaged. The incoming bus-bar side terminals of this switch had been destroyed in the fault. Tests showed that the three 160amp fuses, though physically damaged, had not ruptured.*

*On board the Pride of Le Havre, I was shown the main switchboard in the engine control room. Access to the rear of the switchboard was controlled by gates which were locked when first seen. A permit to work had been issued to authorise access and one gate was unlocked. Mr Jackson, who had carried out repairs following the accident, described the work that he had carried out. Various new pieces of equipment were evident in the section containing the switchgear for the ventilating fans and the drencher pump. Both the essential and non-essential service bars could be seen within the switchboard. The connections between the ventilation fan fuse and the non-essential service bars were seen to be cables to the top of the fuse switch. The contactor for the fans was mounted directly below the fuse switch and was clearly visible, as were the bare copper connections between the two. The outgoing cables to the fans were below the contactor. There was a small area of heat damage to the metal framework of the switchboard in the area of the ventilating fan fuse switch, with a small amount of erosion of the metal.*

*Car Deck Ventilation Fan Fuse Switch.  
Note arcing damage to top of Fuse Switch (incoming power).*

The probable sequence of events was that when the two leads were applied, the direct phase-to-phase connection gave a short circuit. The resultant arc flashed over and upwards to the drencher pump connections and ultimately to the non-essential circuit breaker. The 800amp fuses supplying the non-essential bus-bars ruptured with the resultant voltage depression on the main bus-bars causing the arc across the three phases of the drencher pump switchgear to be extinguished.

*AFT - Fuse switch burnt beyond repair, new ships spare fitted. Supply cables from busbars cut back and re-terminated.*
