Report on the investigation of  
the collision between the German container ship

***Merkur***

and the United Kingdom fishing vessel

***Silvery Sea***

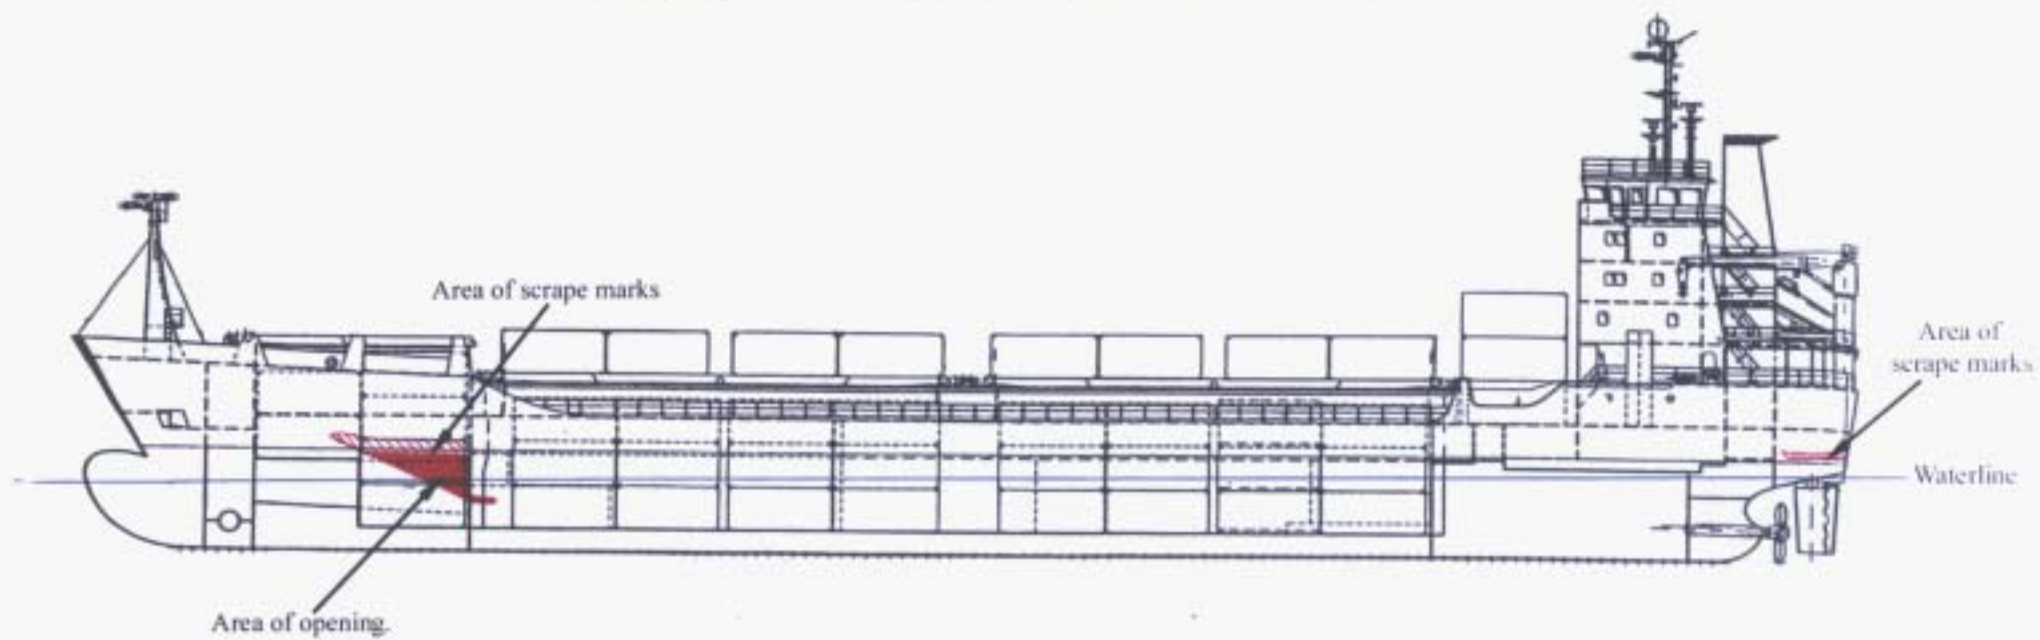
Diagram 1 - Profile of *Merkur* showing damage on port side

During the search, the crew of *Merkur*'s lifeboat were able to see the damage to their own ship and told the master that there was a hole in the ship's port side plating at the after end of No 1 hold. Although no flooding was initially reported or noticed, this had changed by the time the search ended. At 1430, the flooding into both Nos 1 and 2 holds was so great that the master declared an emergency and requested pumps. These were forthcoming from a number of vessels during the rest of the day and, by

*Silvery Sea*'s bow made a large hole measuring about 2.5m high by about 3m long on the port side at the after end of *Merkur*'s No 1 hold. There were a number of scrape marks forward and above the damage. The opening stopped at the transverse bulkhead dividing numbers 1 and 2 holds. This bulkhead was split. There were further smaller and lower gashes, which ran aft of the transverse bulkhead for about 2.5m. There were also longitudinal scrape marks on the port quarter (see **Diagram 1 and Photograph 9**).

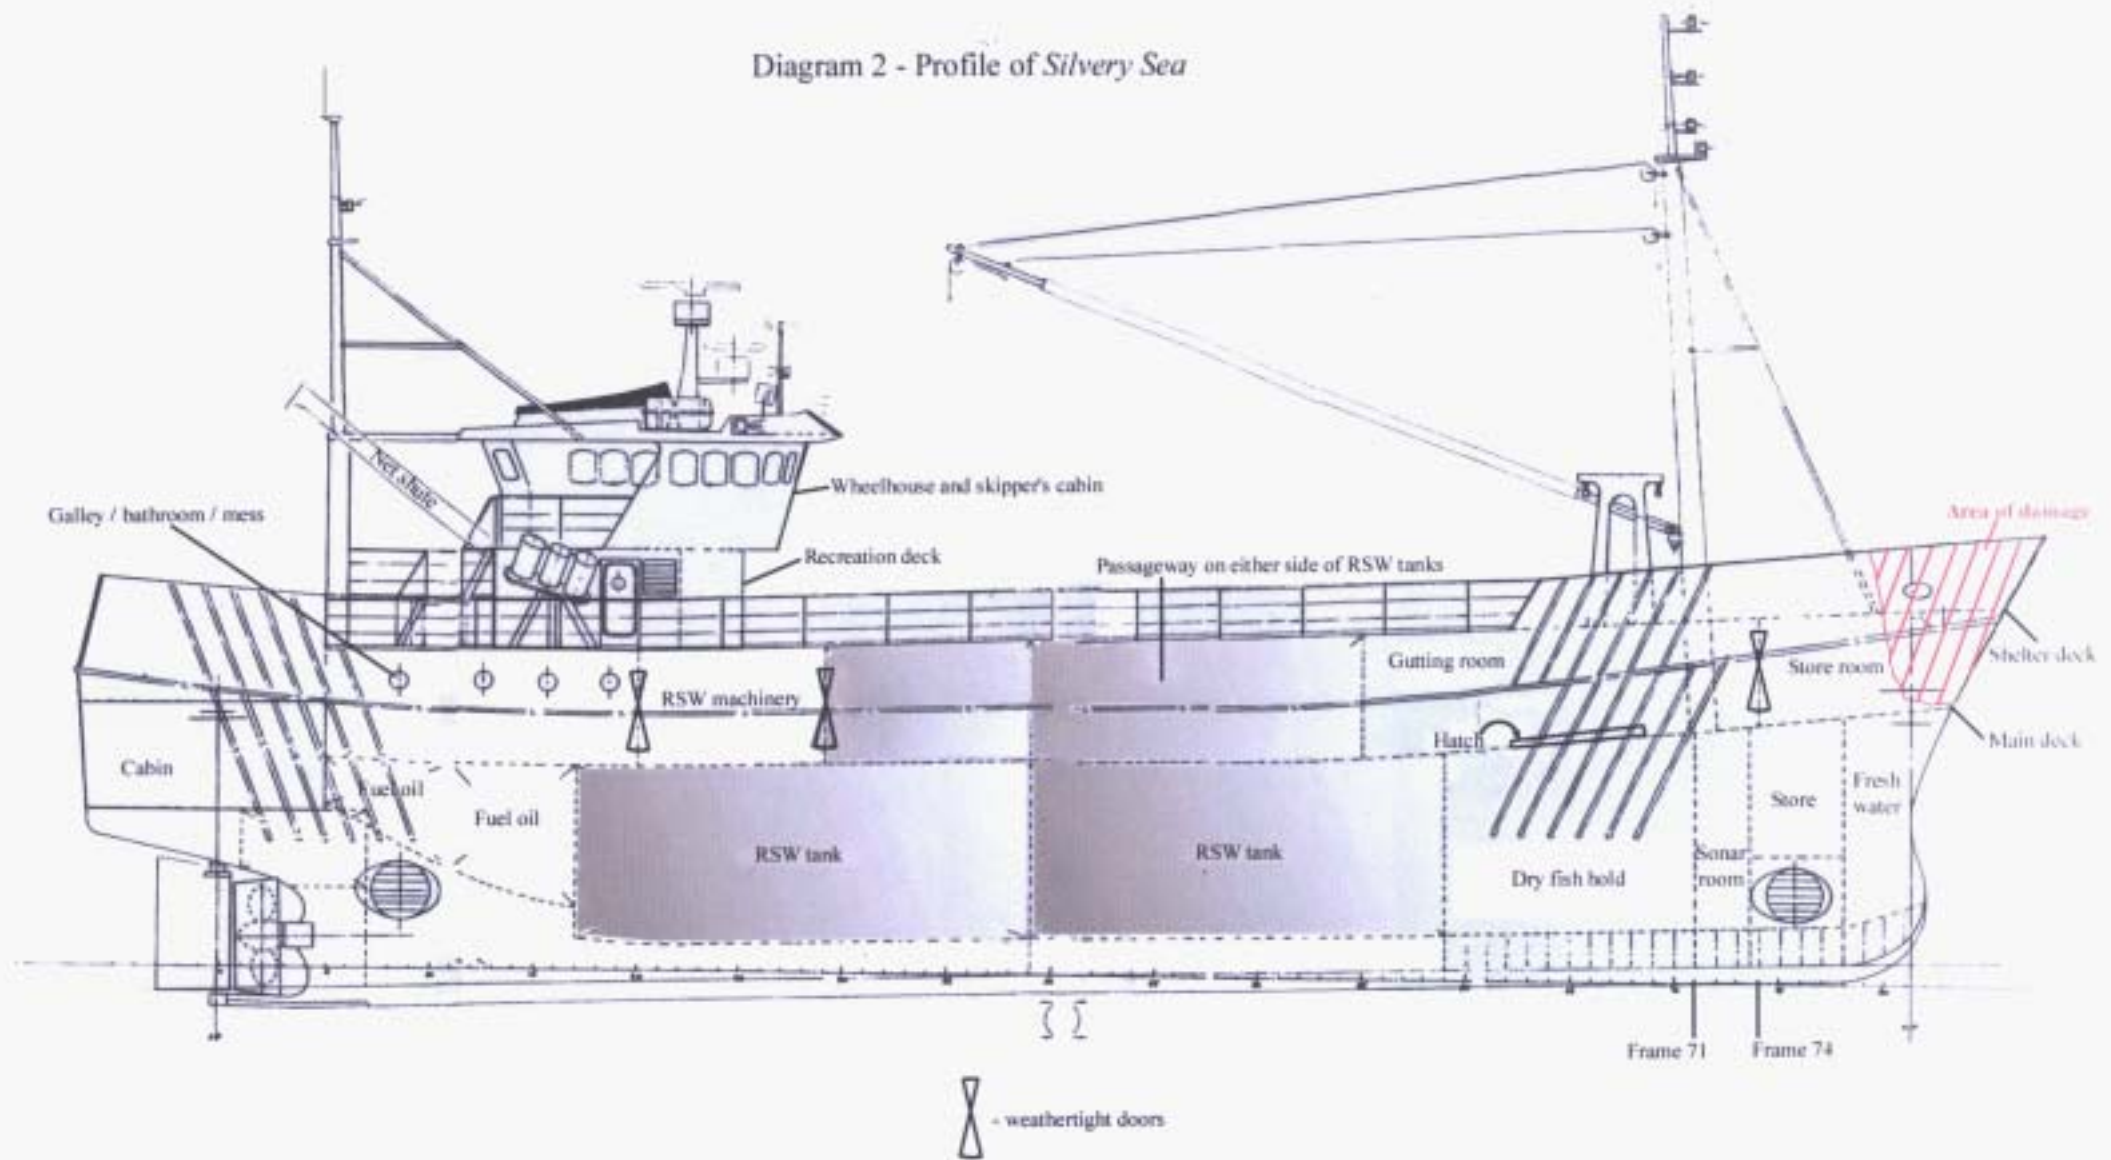
Diagram 2 - Profile of *Silvery Sea*

The major impact damage was to the stem of the fishing vessel. In this area, above the main deck, the structure was crumpled and had been pushed back by about 2.5m, or as far as the forestays of the foremast. The uppermost deck had been pushed down and the forward end of the store space had been opened up. There was no damage below the main deck or evidence of pressure damage to the hull (see **Diagram 2 and Photograph 8**).

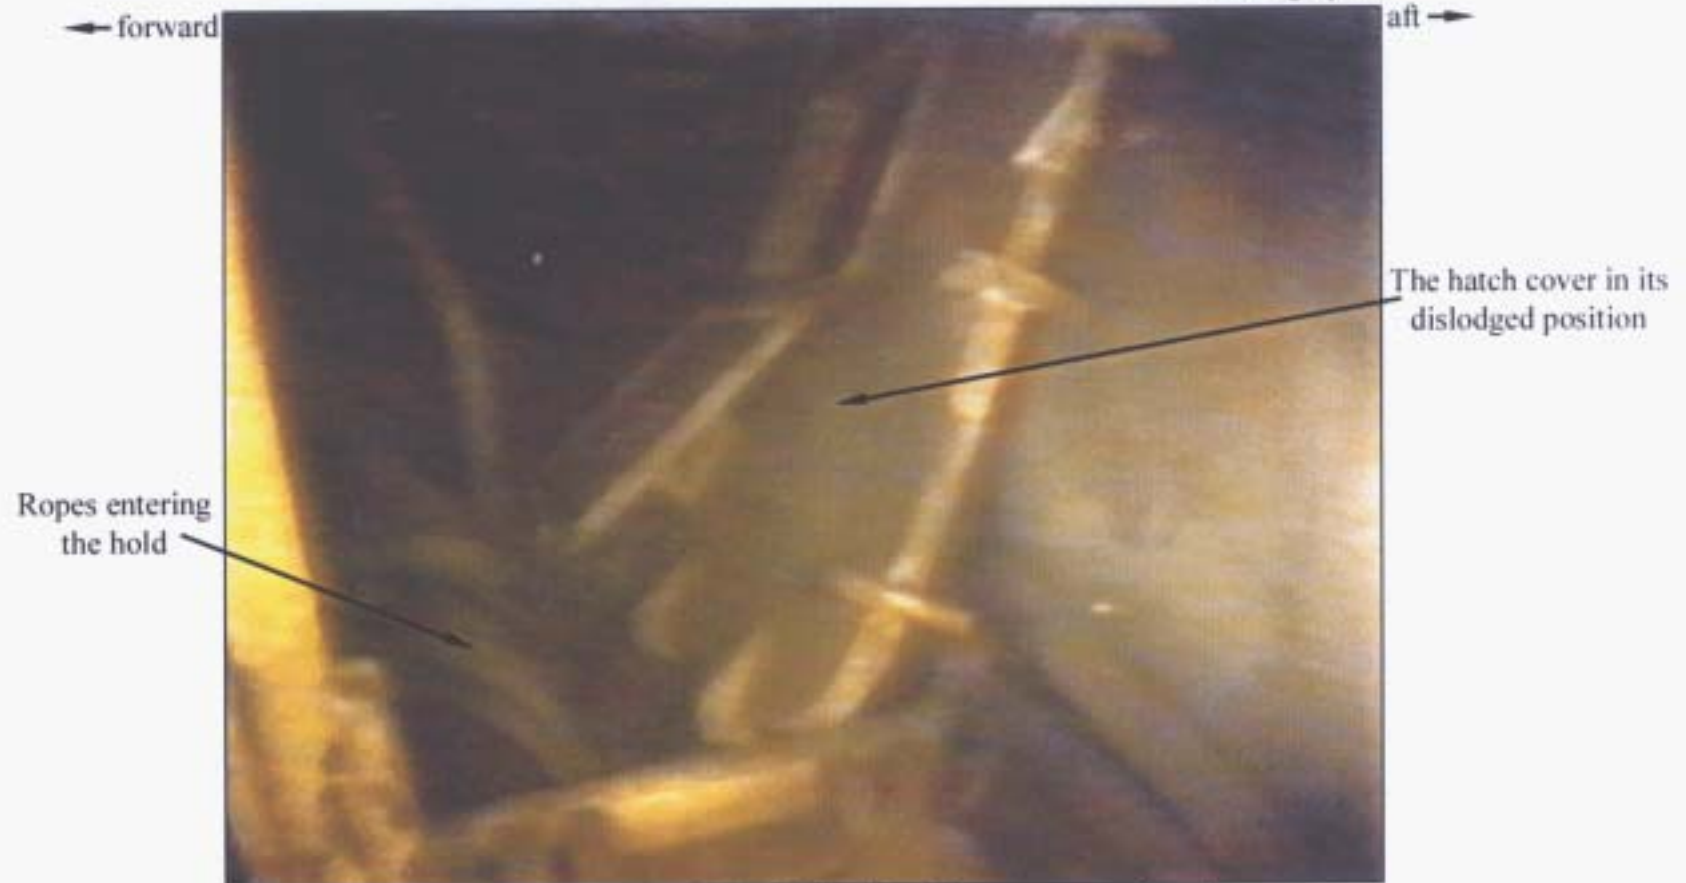
Photograph 4

View of the hatch to dry fish hold (looking from port to starboard)

Floodwater would have passed through the door into the gutting room and then into the passageways on either side of the RSW tanks. The hatchcover to the dry fish hold was found dislodged and this would have allowed water into this space. Therefore, most of the spaces forward of the accommodation would have filled rapidly and increased the vessel's draught forward so that she would have trimmed very quickly by the head. When *Merkur*'s master arrived on the bridge, the only part of *Silvery Sea* still visible was her stern. The rest of the hull was underwater. As she started to go down, the engine room would have flooded. Its door was found open which would have increased the rate of sinking.

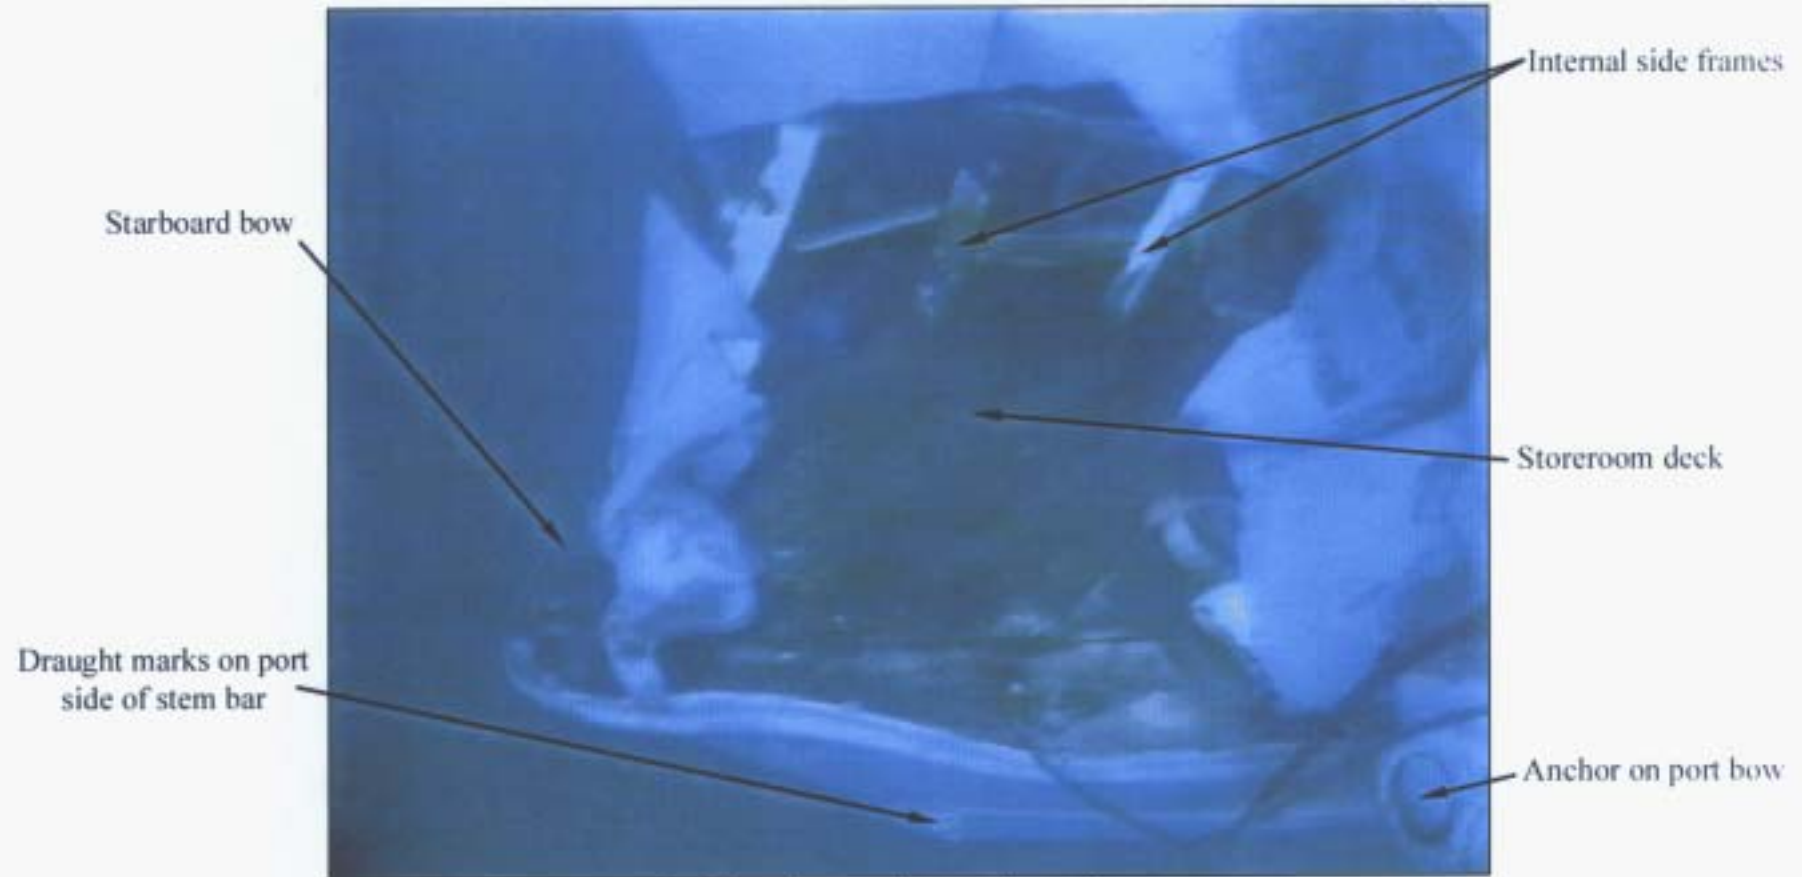
Photograph 8

Looking down on the opening to the stem

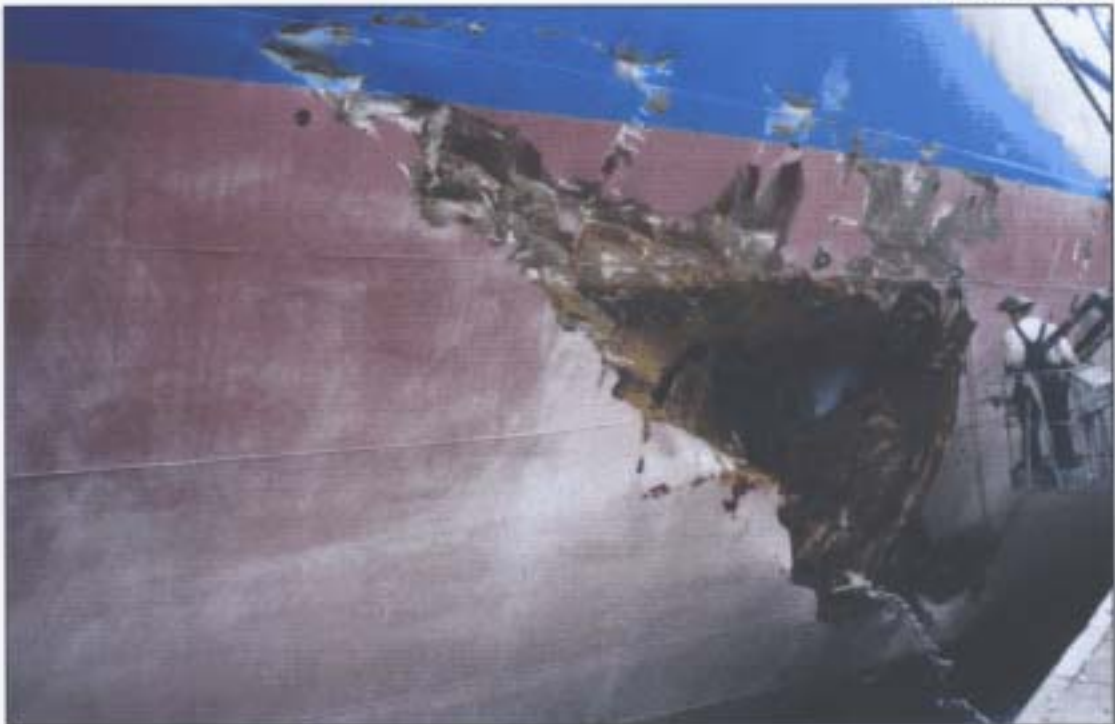
Photograph 9

View of the forward damage to Merkur

The damage to *Silvery Sea* shows a bias to the port bow while the scrape marks on *Merkur* indicate that the fishing vessel impacted at an angle in excess of 90°. If *Merkur* had altered course to starboard earlier, the angle between them would have been less. Therefore, *Merkur* must have only just started to turn when the collision occurred.

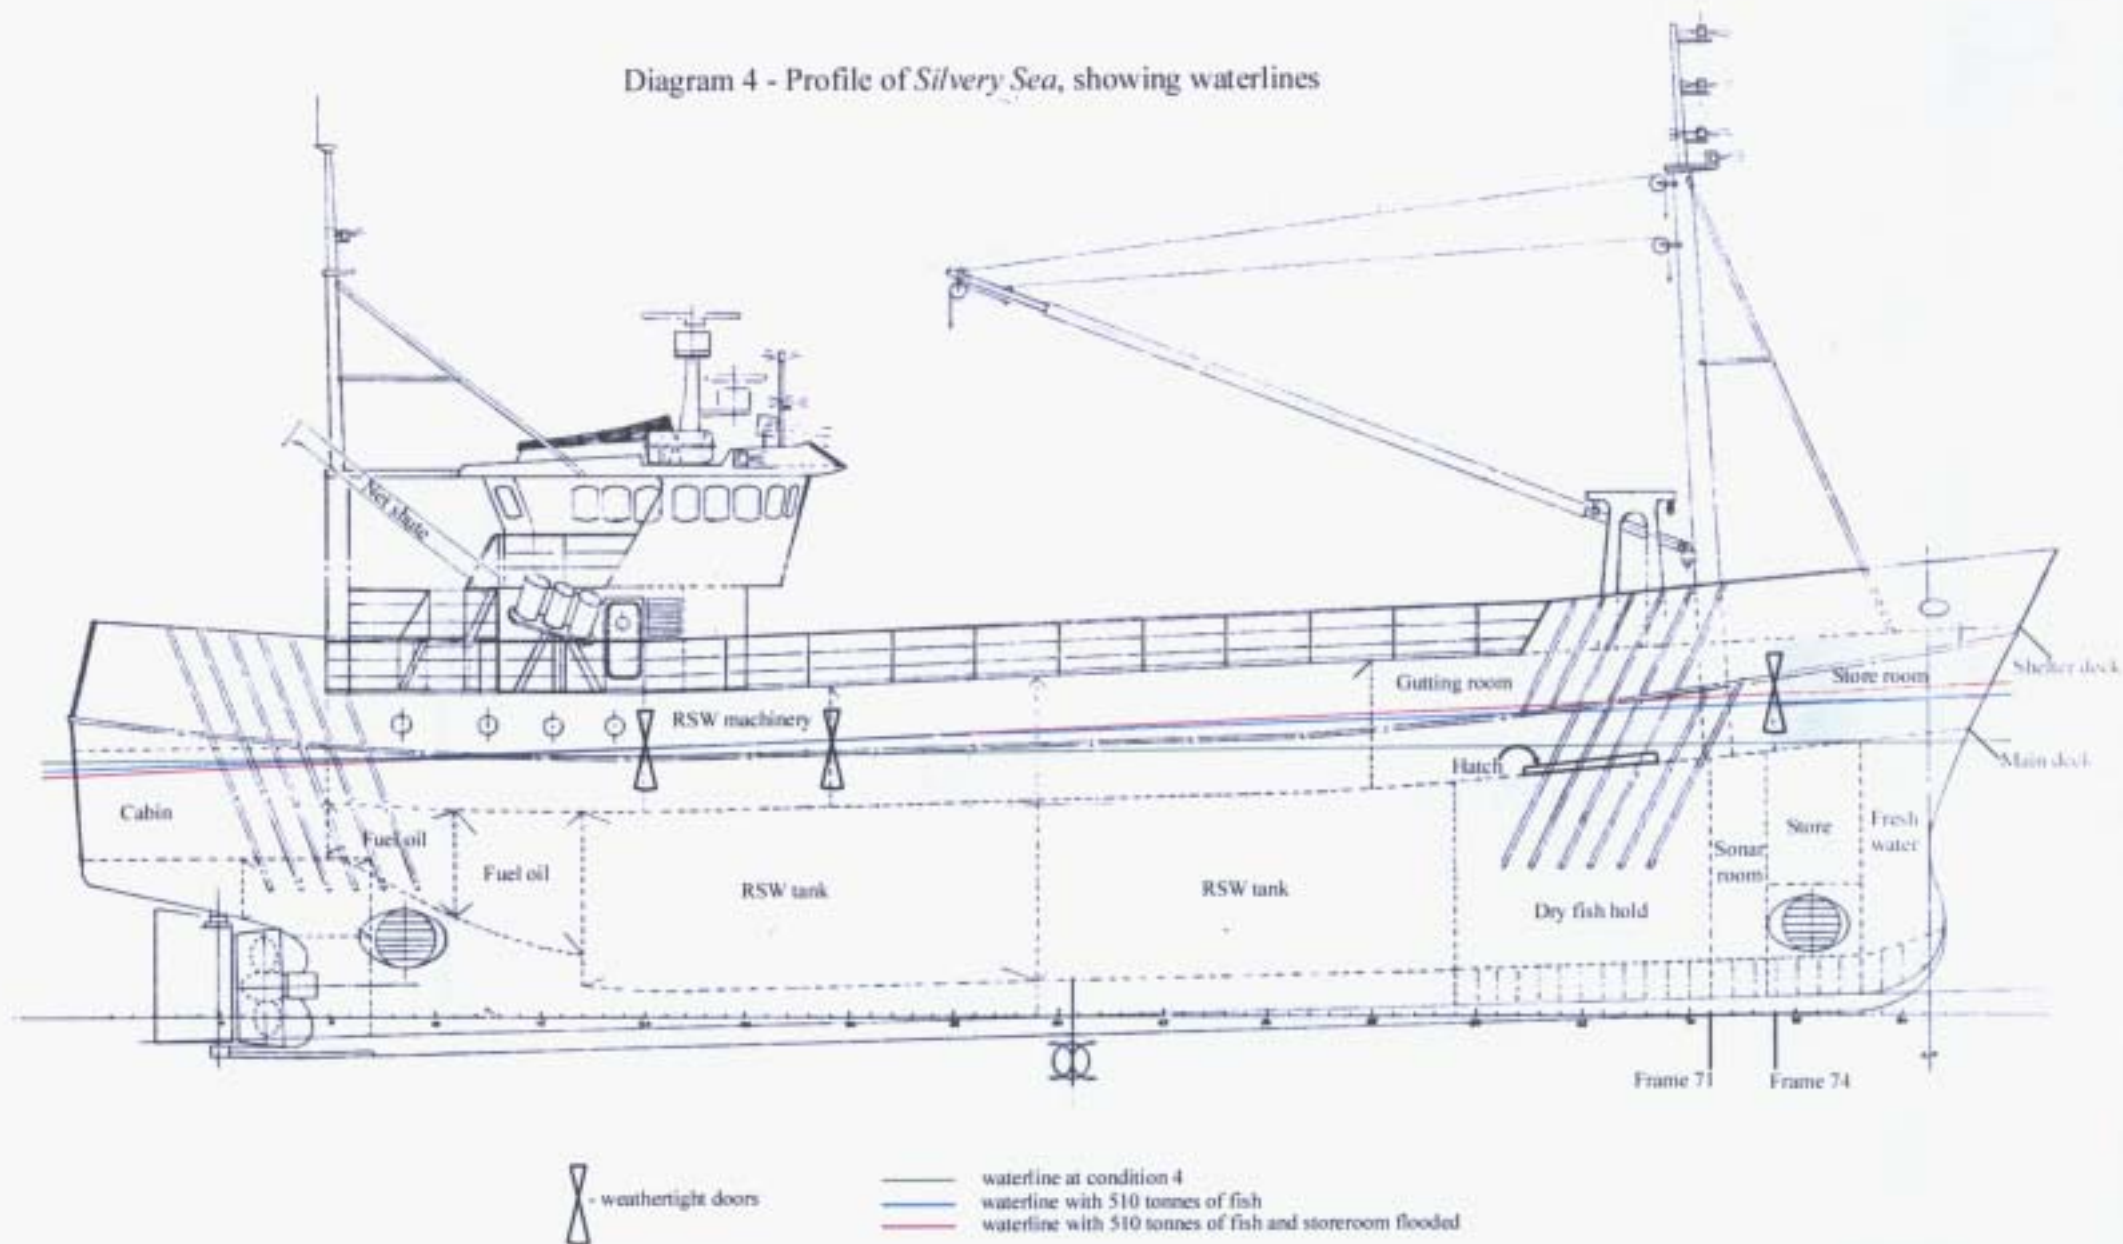
Diagram 4 - Profile of *Silvery Sea*, showing waterlines

**Diagram 4** opposite shows waterlines for various loaded conditions:

the green waterline represents condition 4 of the stability book;

the blue waterline represents the worst condition that the vessel could have been in before the accident with 55 tonnes in the fish hold; and

the red waterline represents the same condition as the previous one, but with the bow damaged and the forward store room flooded.

If, before the collision, the vessel had been in the deepest loaded condition (4) approved in the stability book, the damage would very largely have been confined to an area above the (green) waterline. As the waterline was only about 200mm below the sill of the starboard door at frame 74, assuming a normal sill height of 380mm, incoming water would have risen to a height just below the sill. Had the door been shut in this condition, the flooding would have been contained. The effect of *Silvery Sea* being pushed down in the collision, meant that any residual bow wave and any form of sea state would have allowed water to flow over the sill. The open door would have done nothing to stop it. The flooding would have been progressive but possibly at a slower rate in condition 4 than in that represented by the blue waterline in **Diagram 4**.

After the lengthening, an effective collision bulkhead would have extended up to the shelter deck. This could have been achieved by using the bulkhead at frame 74. The extended collision bulkhead would then have comprised the bulkhead at frame 71 below the main deck, the main deck between frame 71 and frame 74, and the bulkhead

at frame 74 above the main deck. The problem with this solution is that it would have required the removal or welding up of the doors in frame 74. The removal of these doors would have caused practical difficulties in accessing the forward spaces.

If *Silvery Sea* had been fitted with a collision bulkhead up to the shelter deck she would have survived.
