## Marine Accident Report 1/00

Report of the Inspector's Inquiry  
into the loss of

***mv Rema***

with the loss of four lives  
on 25 April 1998  
about 22 miles north-east  
of Whitby, North Yorkshire

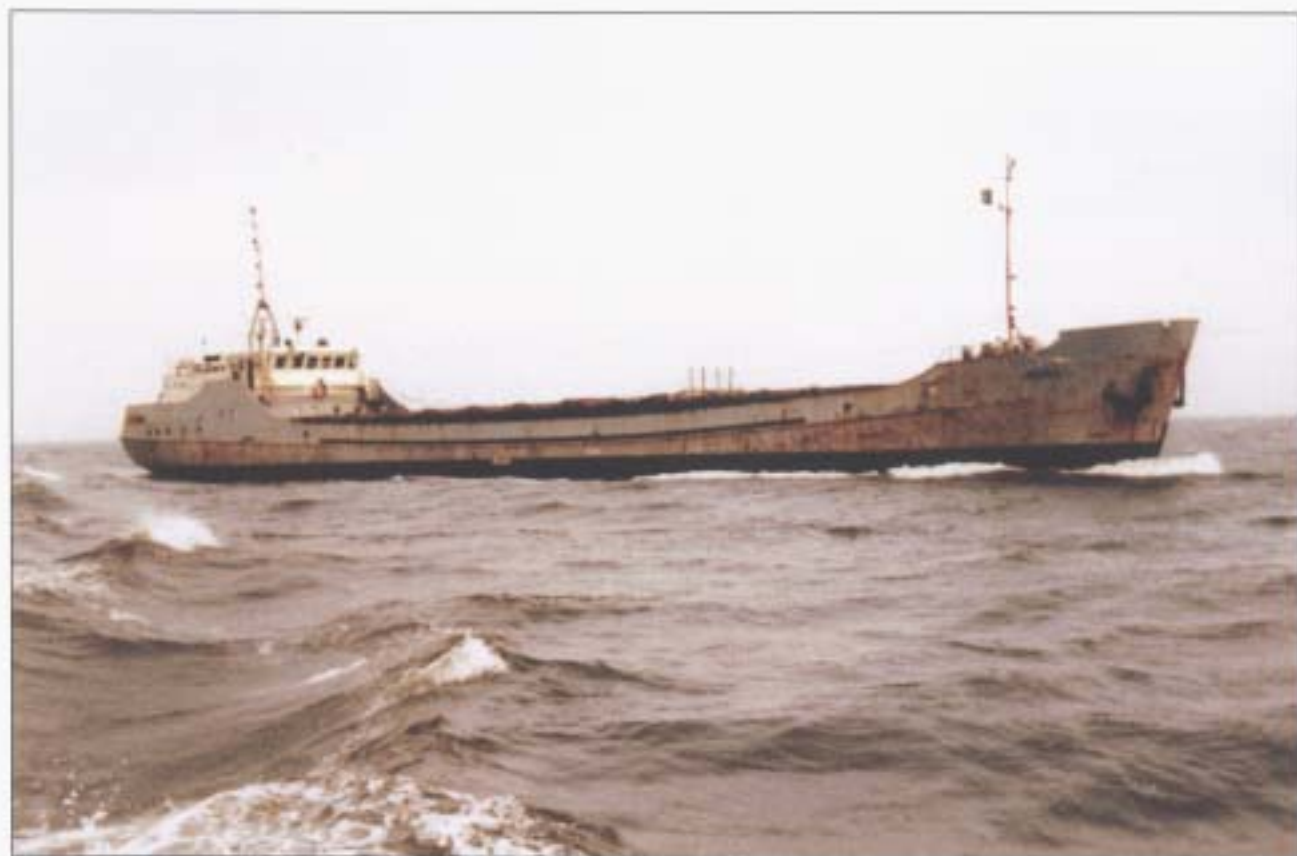
Rema arriving at Berwick-upon-Tweed on 22 April 1998

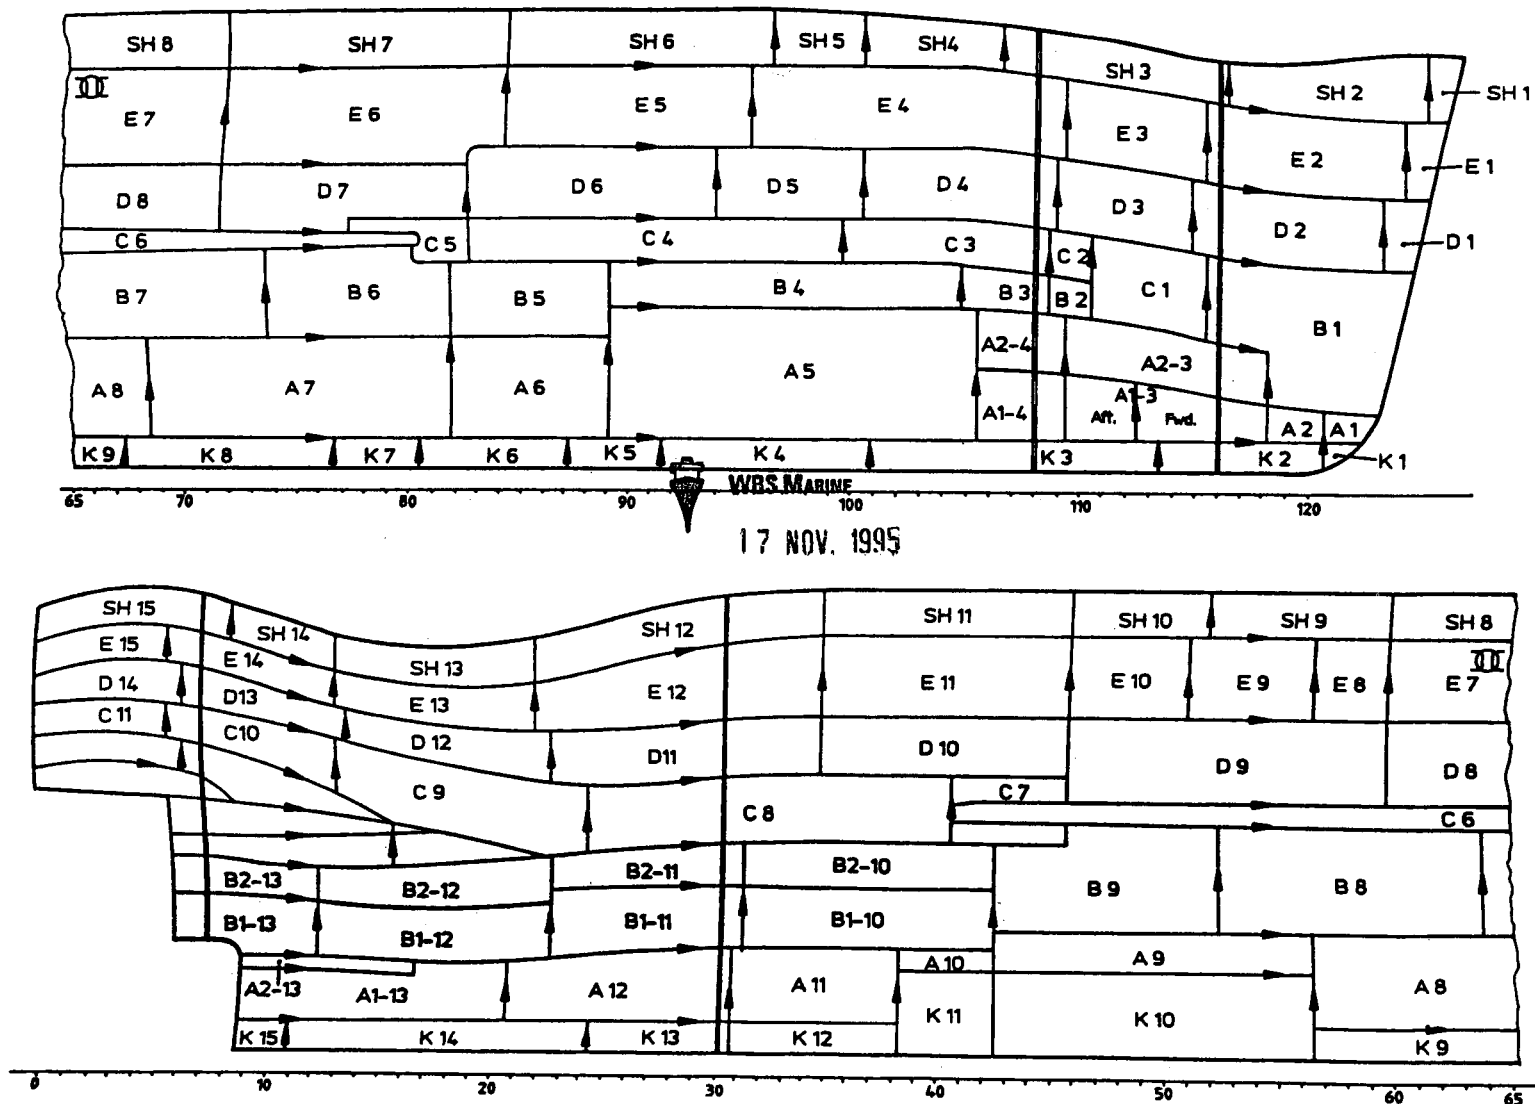
Figure 3: Bottom &amp; side shell plating, starboard side

The worst affected were in "A" strake, plate A1-4(s) on the starboard side, next to the keel between frames 110 and 105. Each plate was measured in two areas, forward and aft, with the worst readings showing that maximum wastage occurred in the forward part of the plate. This wastage in "A" strake, between frames 108 and 109, was very localised and in the form of "pits". These were repaired by welding.

A cracked streamline plate by frame 10 starboard, was repaired by a plate insert,  $600 \times 600\text{mm}$ .

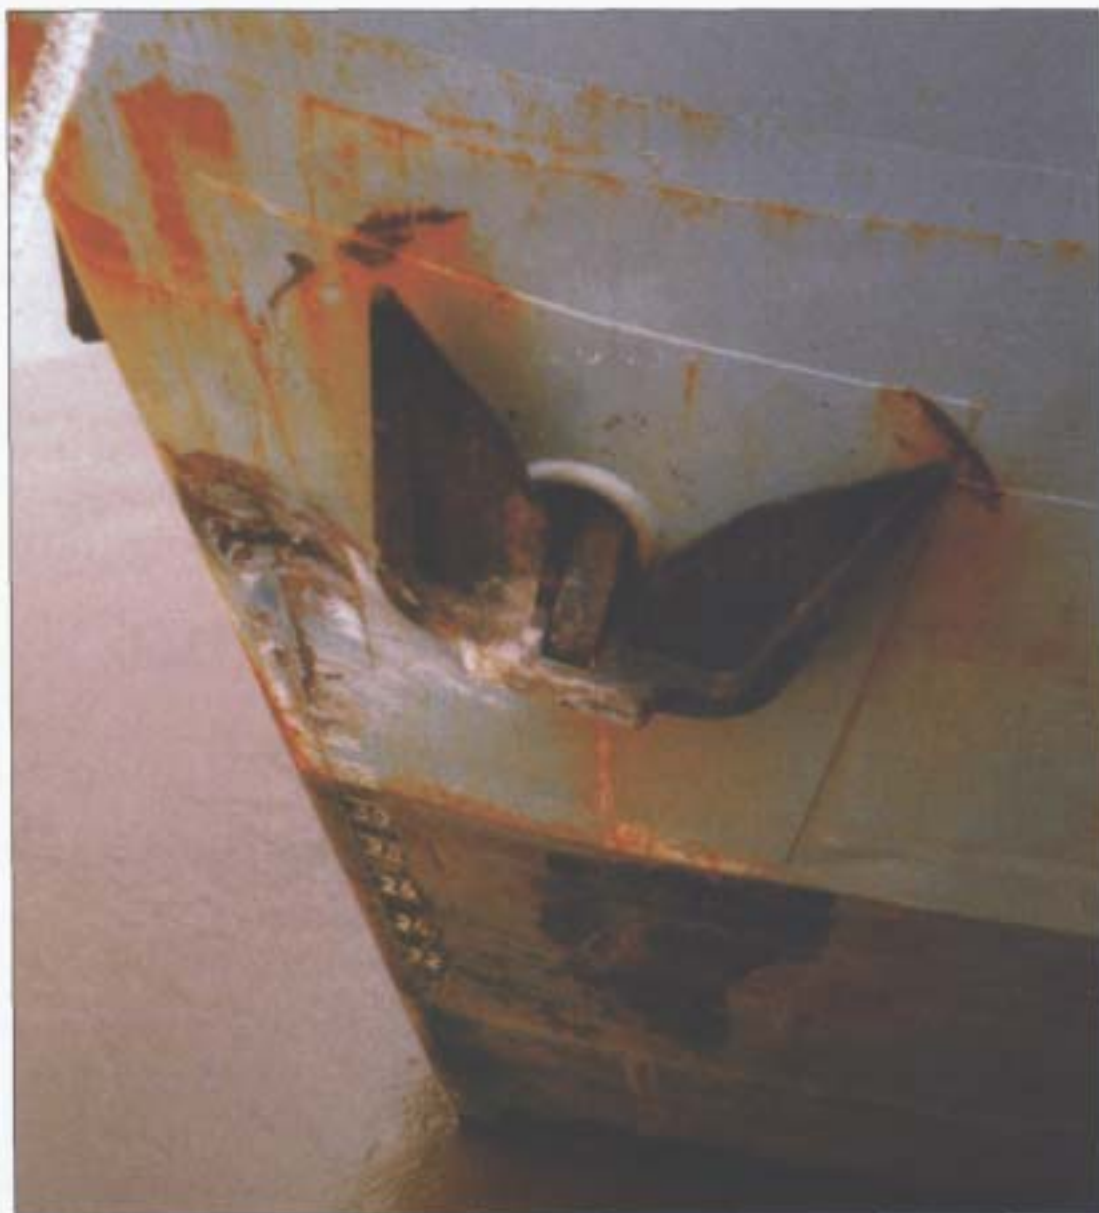
Figure 4: Port side bow damage to *Rema* after collision with service jetty at Keadby, River Trent — March 1998

In March 1998, while leaving in ballast from the top Gunness berth on the River Trent, she struck the service jetty at Keadby with her port bow, and sustained damage between the hawse pipe and the stem just above the boot topping. Scuff marks on the port anchor flukes indicated hard contact with the concrete jetty. A small hole in the forepeak tank, and a 6" to 8" split in the hull plating of the deep tank were the consequences (**Figure 4**). The crew repaired the split by welding while the hole was sealed by welding a bolt head into it. Other external damage was largely cosmetic. No further repair work was undertaken.

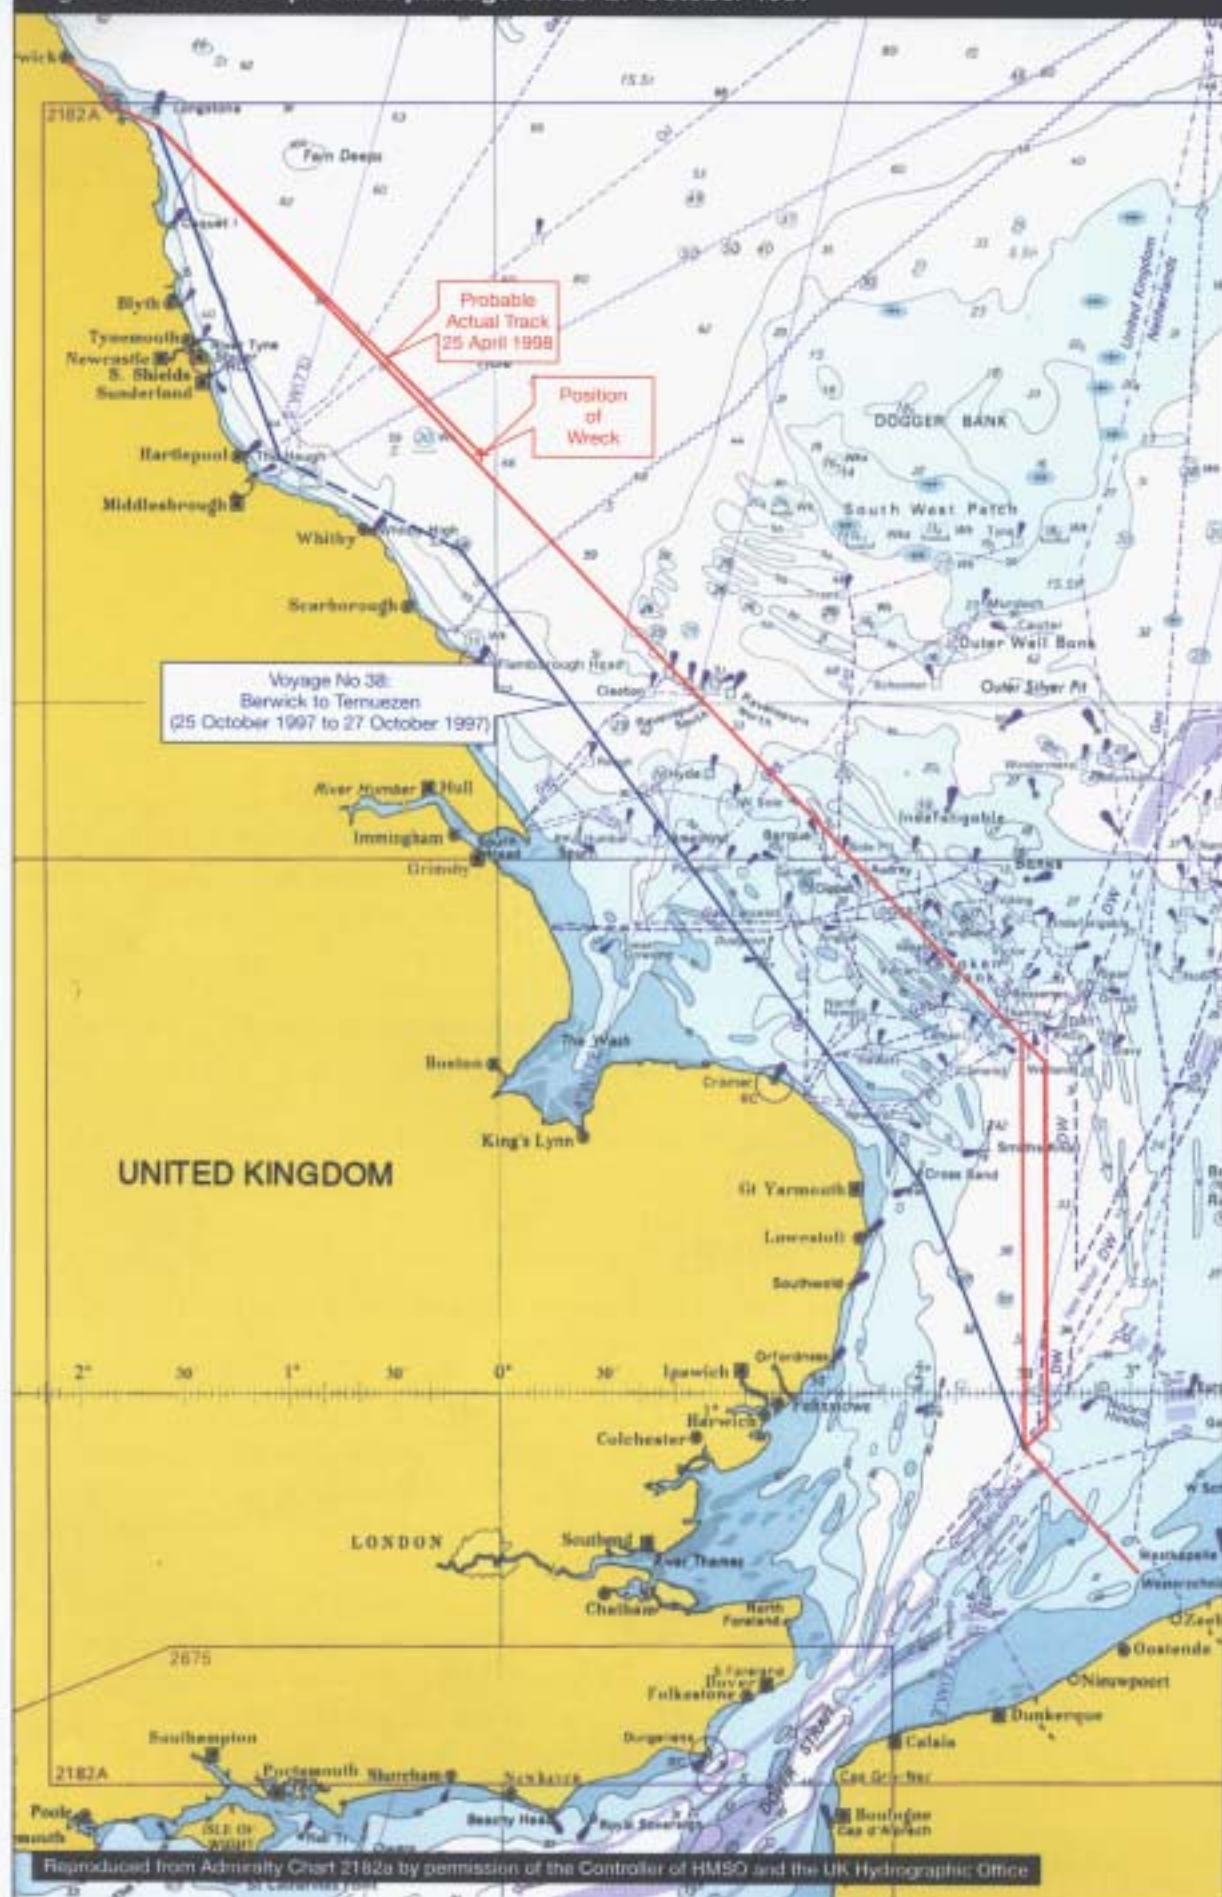
Scrutiny of the log reveals that on a very similar voyage between Berwick-upon-Tweed and Terneuzen in late October 1997, *Rema* had, in relatively calm conditions, selected a route that took her inside the Farne Islands and hugged the coast for some time before altering course to steer for the OG1 buoy off Flushing. Her average speed for that passage was 7.7 knots. Although there is no obvious explanation for this practice, there are a number of possible reasons why she might select an inshore route. It is known, for instance, that some vessels prefer an inshore track to remain within mobile telephone coverage for as much of a voyage as possible.

Figure 5: Track of a previous passage on 25–27 October 1997
