**Final report of the investigation
of a fire on the
the Passenger Cruise Liner**

mv *Saga Rose*

**whilst undergoing a refit at the
A&P Docks, Southampton
on 14 December 1997**

**Ref: 2056/97
File No: MAIB 1/2/124**

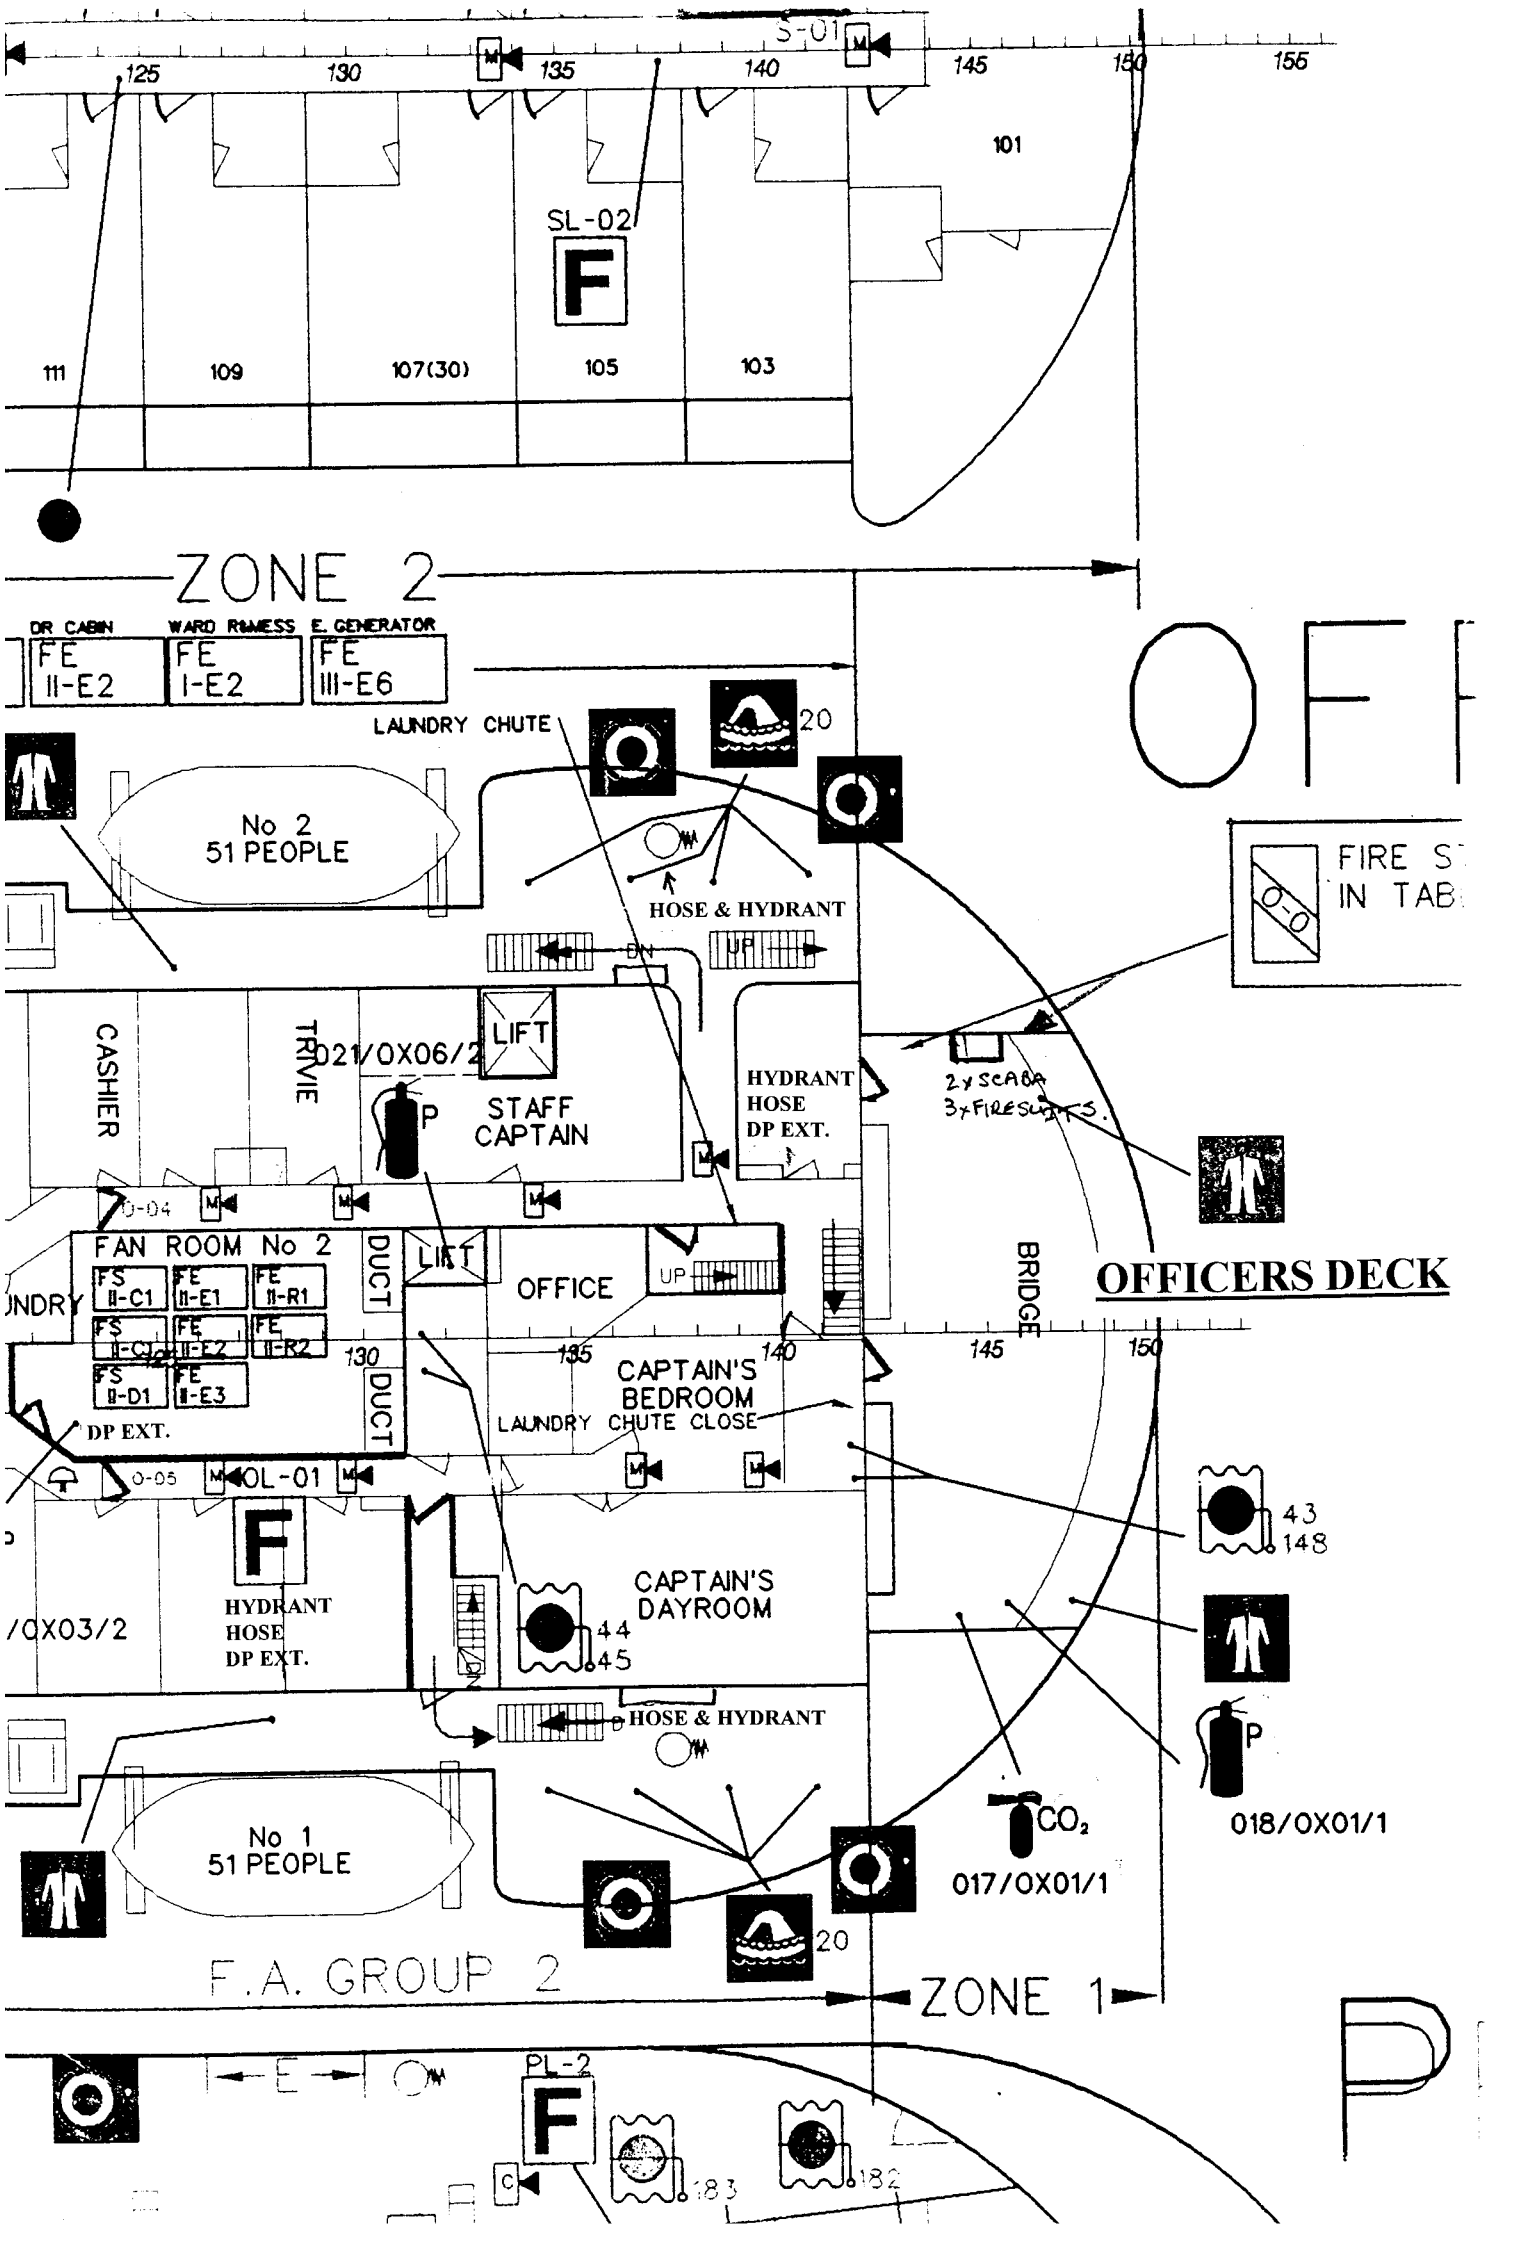
- 1. Copy of part "Fire Plan"**

POINT OF FIRE

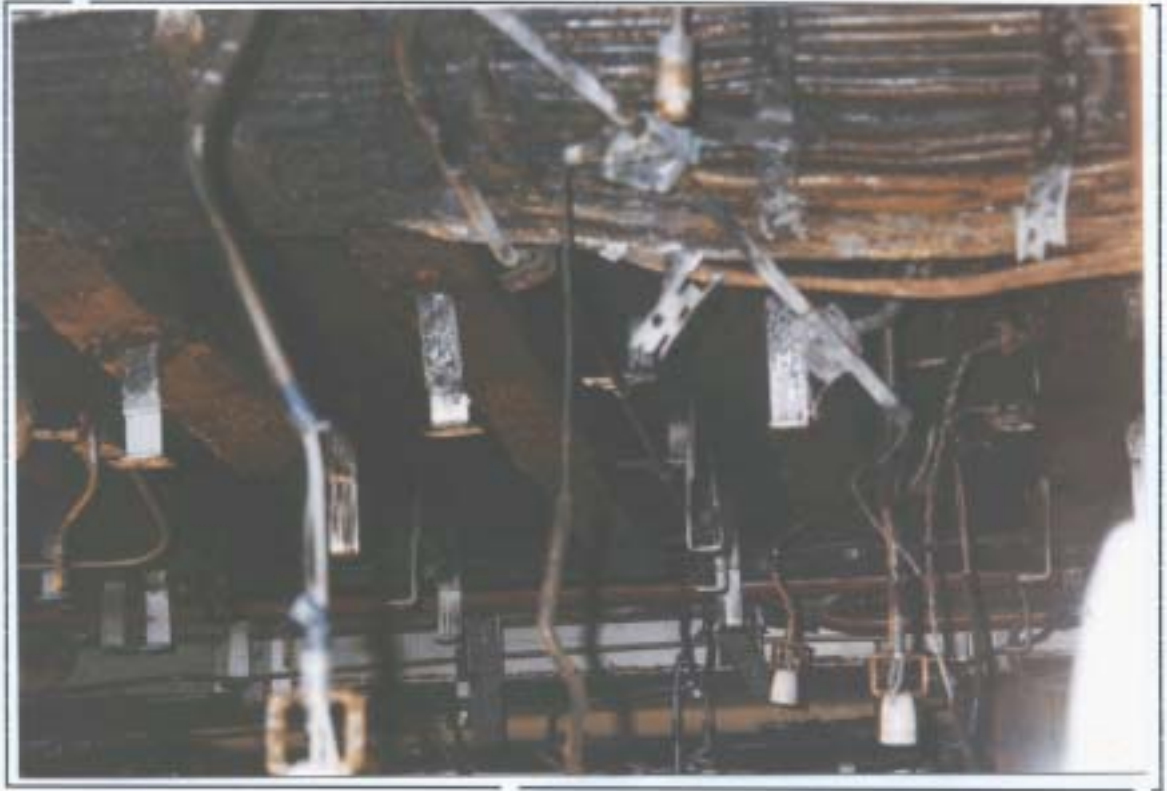
- 1.6.1 Fire damage was contained largely within the deckhead of the central locker room between frames 139 and 141 and the central portion of the deckhead of the forward stairway between frames 134 to 139.

Considerable fire and heat damage occurred to electric cabling in the immediate area, with smouldering fire damage travelling along the cable insulation causing secondary damage away from the seat of the fire. Other materials within the deckhead space also suffered fire and heat damage.

Fig 1 General view of fire and water damage to electrical locker deckhead.

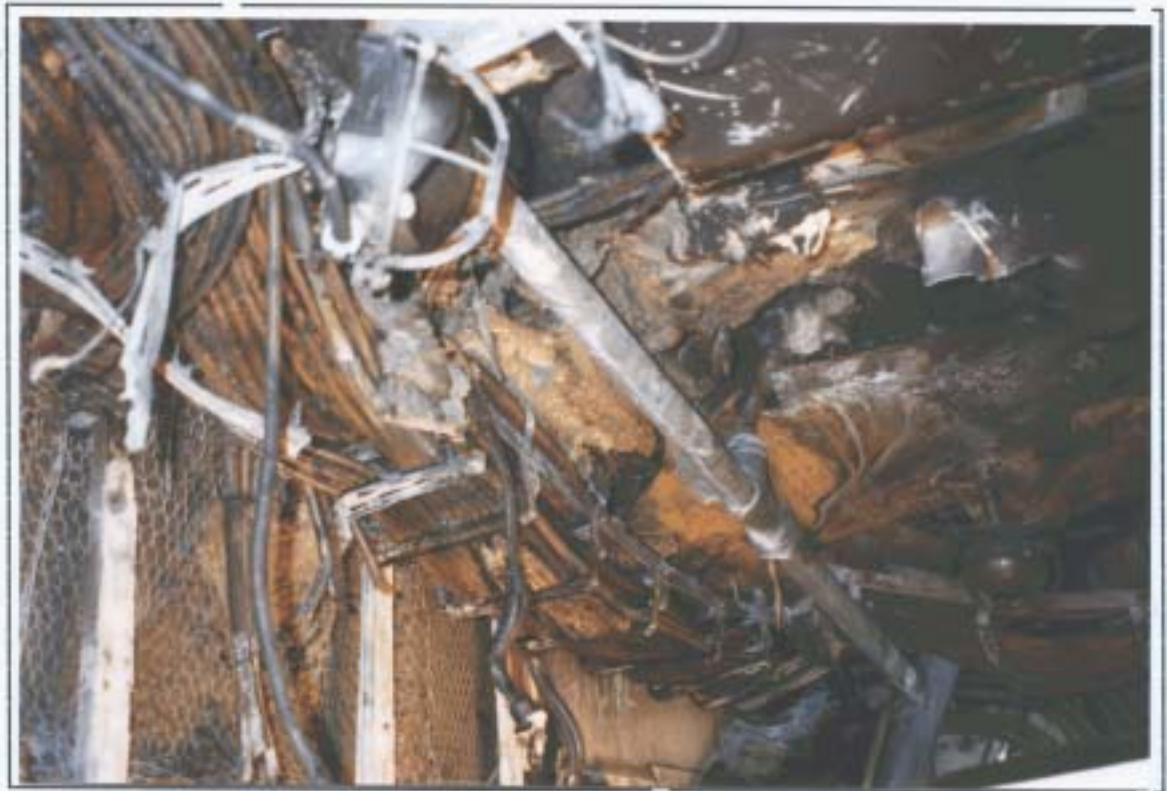
1.7.3 During the subsequent investigation and repairs, a considerable number of cables were found to have suffered both local heating and insulation damage in areas remote from the actual seat of the fire. Because the fire was in deckhead void spaces and steel cable trunkings, hot gases were able to penetrate adjacent areas causing local heating and the breakdown of cable insulation etc.

Fig 2 Close up view of damaged electrical cabling and deckhead insulation.

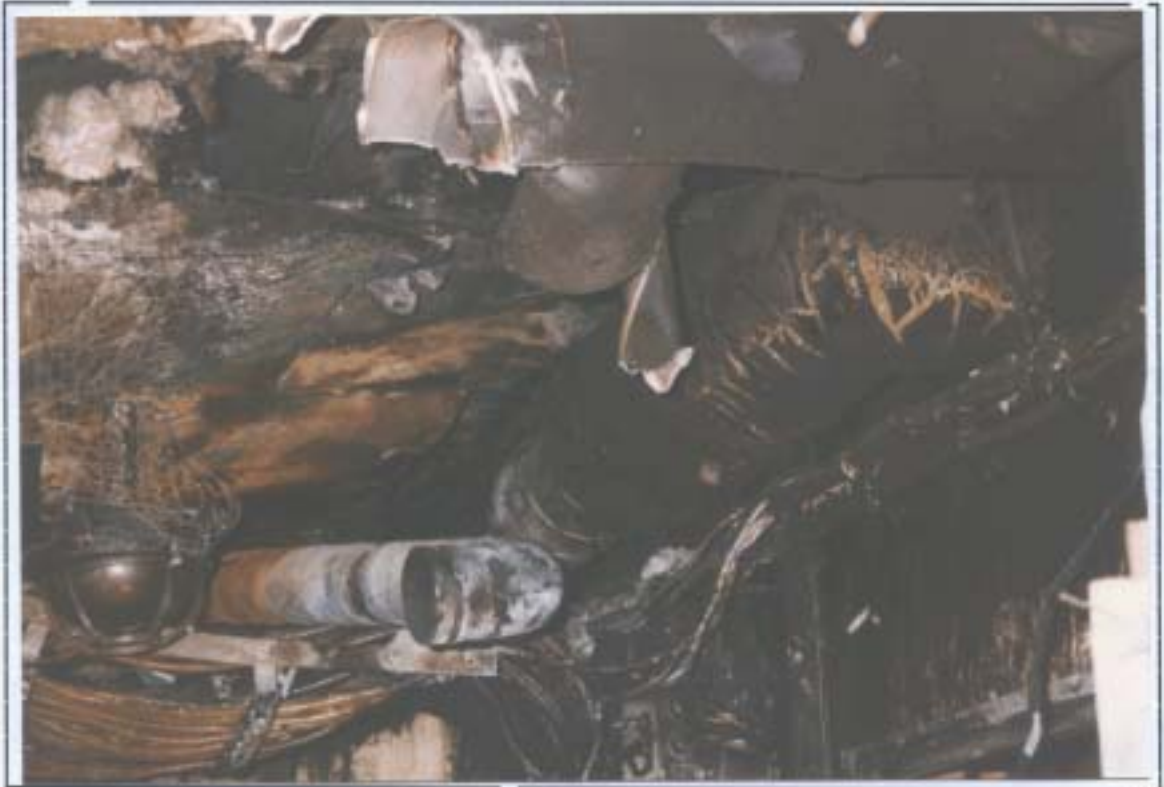
Fig 3 General view of fire and water damage to ventilation trunking and insulation.

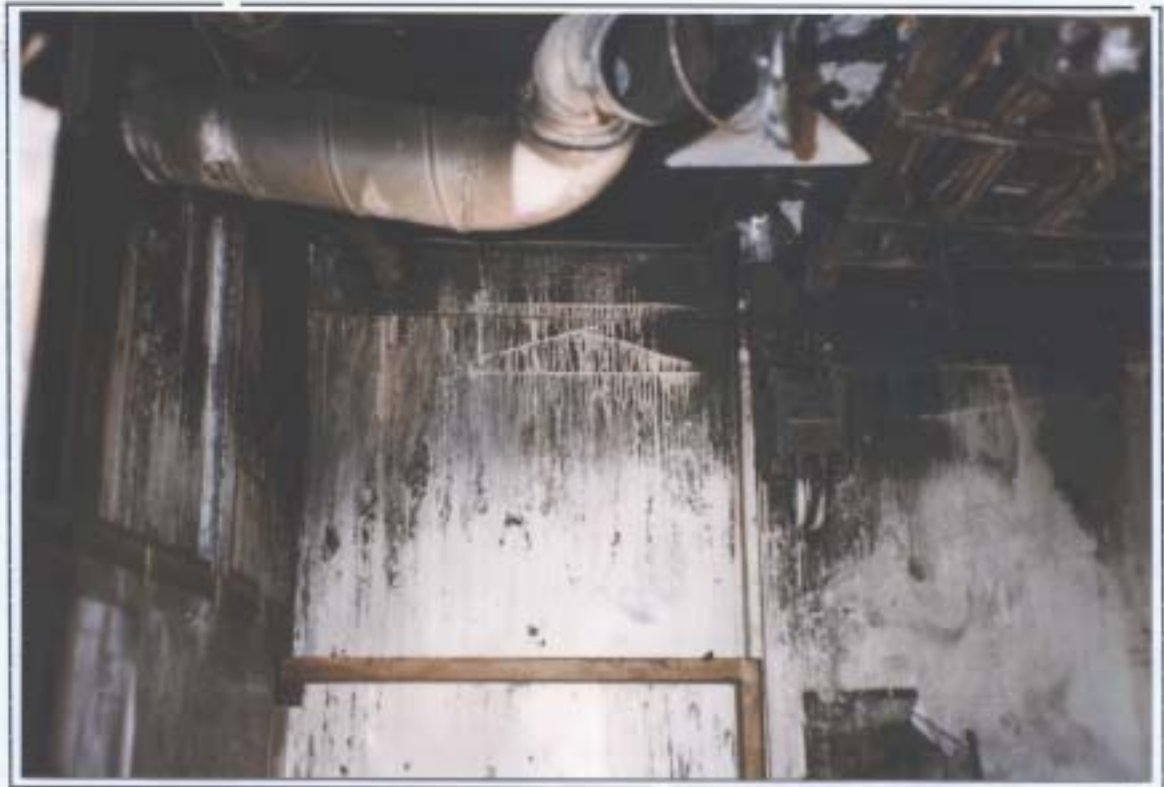
Fig 4 General view of smoke and water damage to upper parts of electrical locker bulkhead. Note evidence of fire in void space only.
