**Report on the investigation
of a rupture of the port economiser on board**

Island Princess

resulting in two deaths

Report No 37/2000

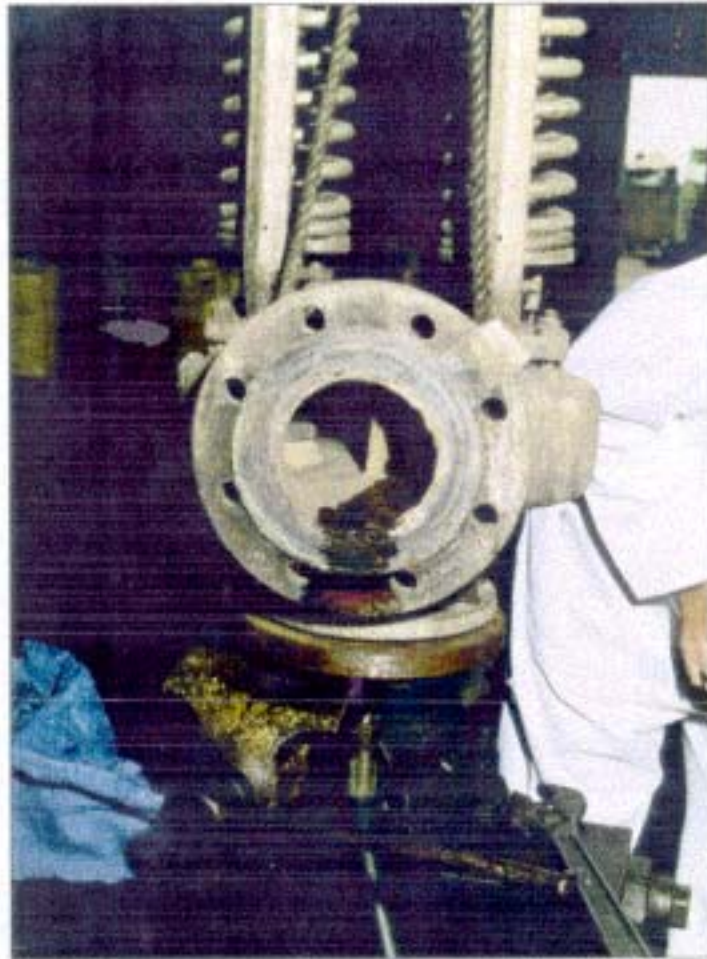
On 16 December, nine days after the accident, the Italian Authorities tested the valves. They were subjected to a hydraulic pressure to 12bar, 3bar above their lifting pressure. The valves did not lift, but the aft valve leaked oil at 0.5bar (**Figure 9**). The test was witnessed by an MAIB inspector, Princess Cruises and other interested parties.

Figure 9 - Port economiser safety valve leaking under hydraulic pressure of 0.5 bar

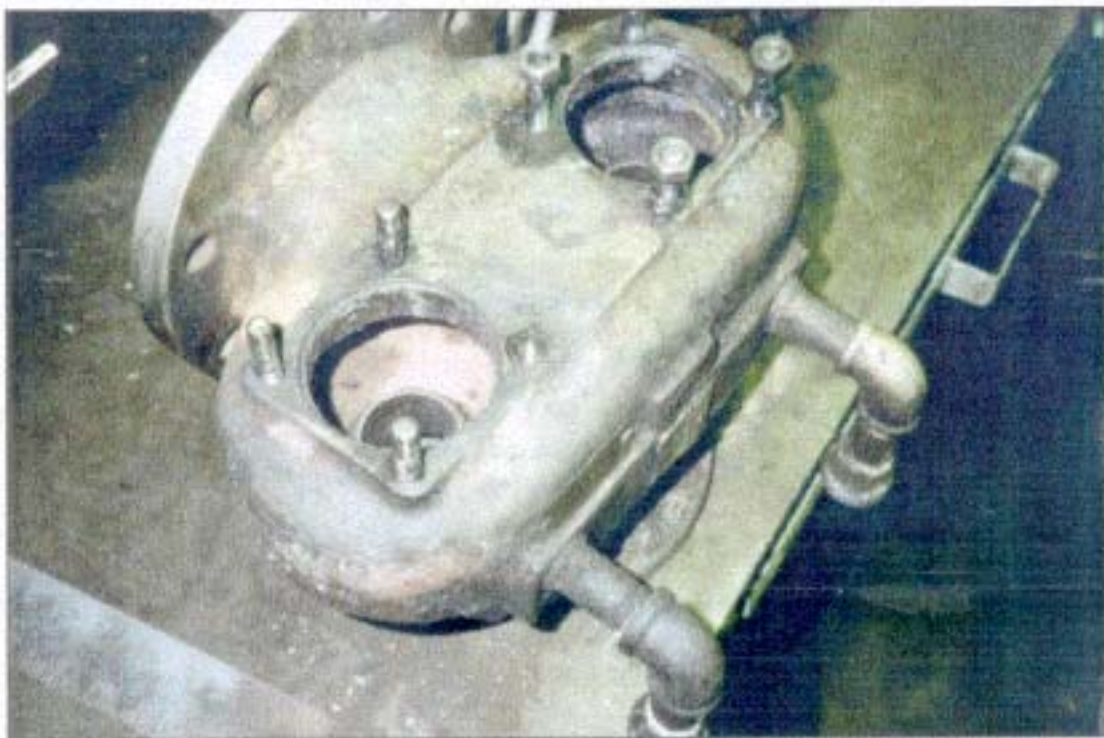
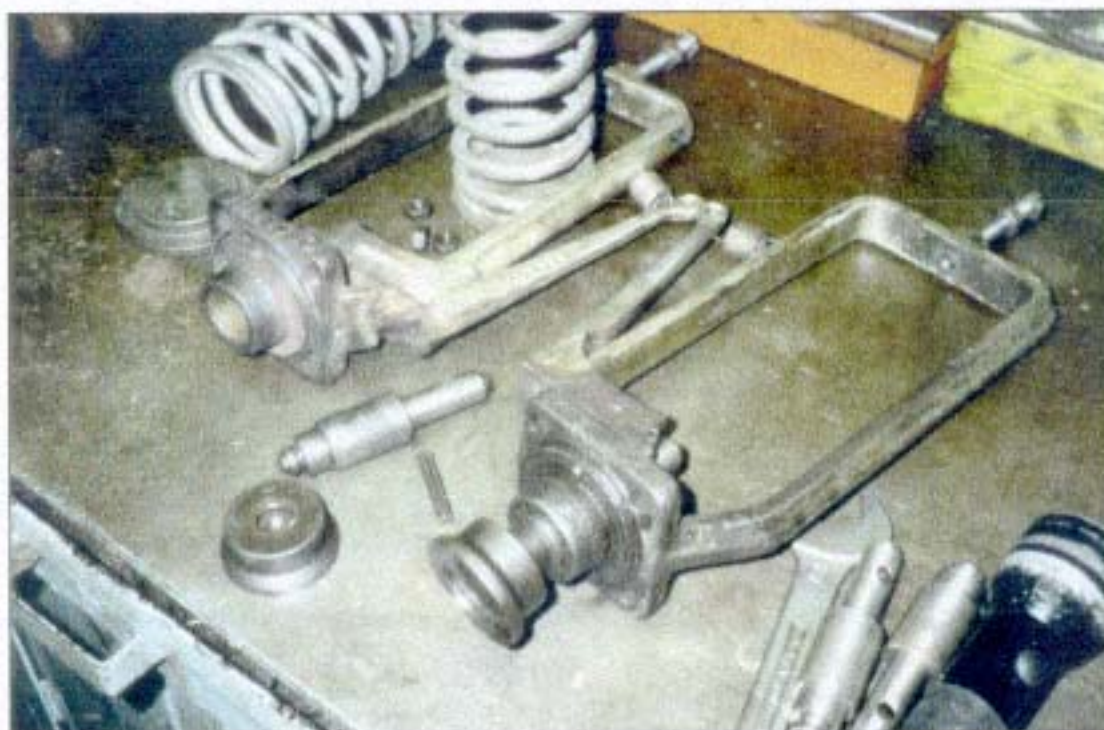
The valves were hydraulically tested in the ship's workshop, and found to lift at 9.0 bar. It was not possible to lift the safety valves by manually pulling the easing gear levers.

The safety valves were dismantled and inspected. Compared with the forward valve spindle, the aft valve spindle was a looser fit in its guide. Both spindles could be pushed through the guides without difficulty.

The engineers reported no chemical accumulation on the inside of the valve chest, with the exception of a very small amount on the valve lids and seats. Brown deposits observed on the spindles and guides were hardly enough to get a decent sample. There was pitting corrosion on the spindle surfaces.

Figure 10 - Starboard safety valves

At a post-accident survey of the safety valve components an LRS surveyor advised fitting new spindles. New ones were made but, because of the damage to the starboard economiser, the safety valves were not recommissioned.

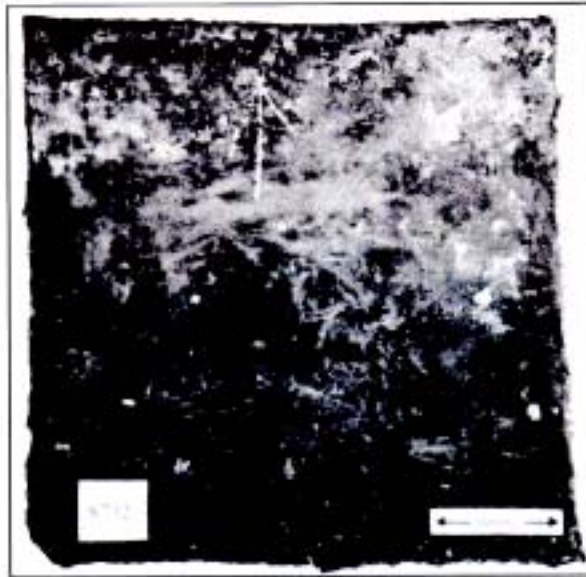
Ultrasonic testing identified continuous waterside cracking along the circumferences of top and bottom shell-to-endplate weld toes. Maximum crack depth was 8mm, 66% shell-plate thickness. A weld repair on the top seam completed in 1995 was cracked up to 25% shell-plate thickness.

Figure 11 - Boiler shell plate sample removed from port economiser

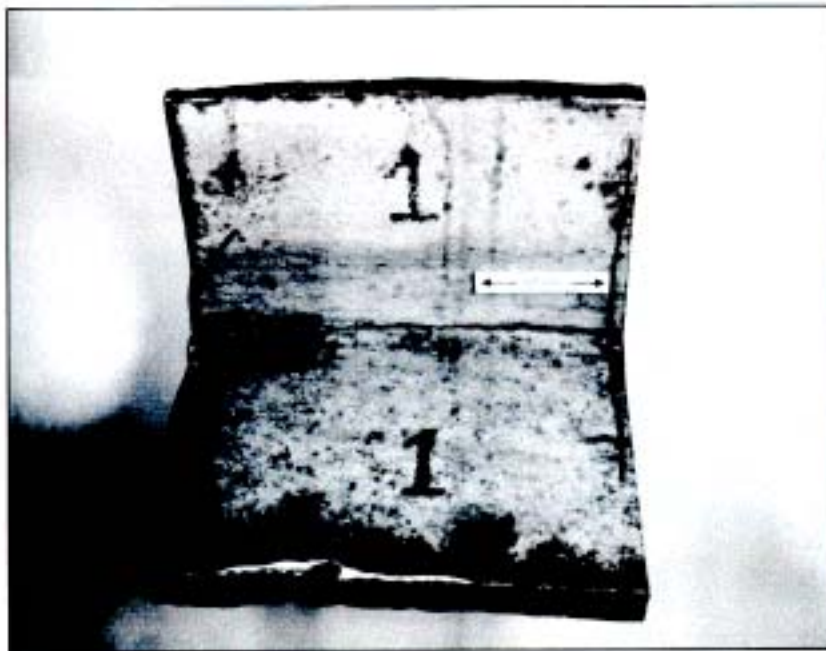
Figure 12 - Section of shell to bottom tube plate weld removed from the port economiser

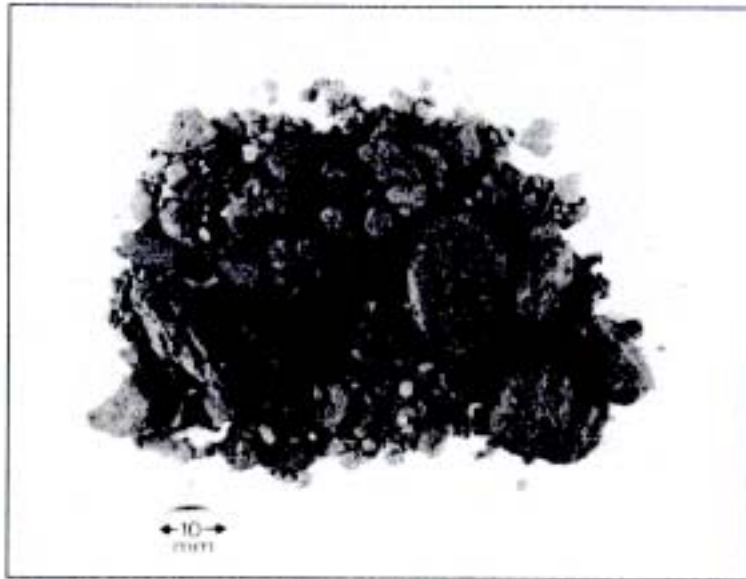
Figure 13 - Waterside deposit from port boiler, lower tube plate aft inboard mud hole

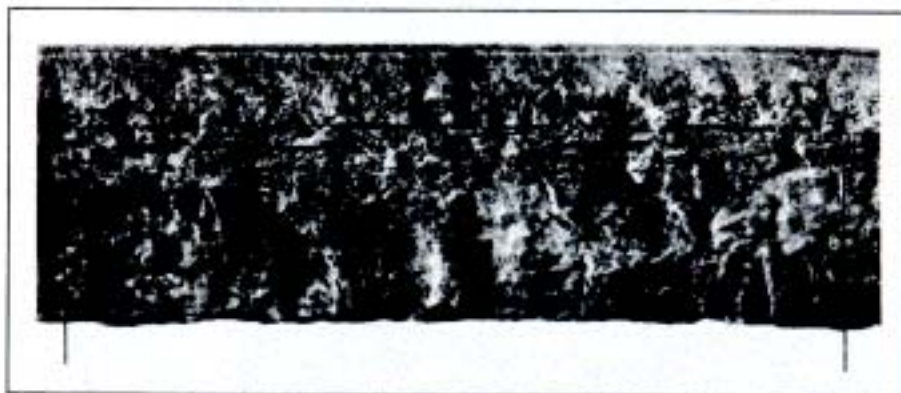
Figure 14 - Field of fracture face close to opposite end of shell plate sample.
Arrows define extent of sub-critical crack front.

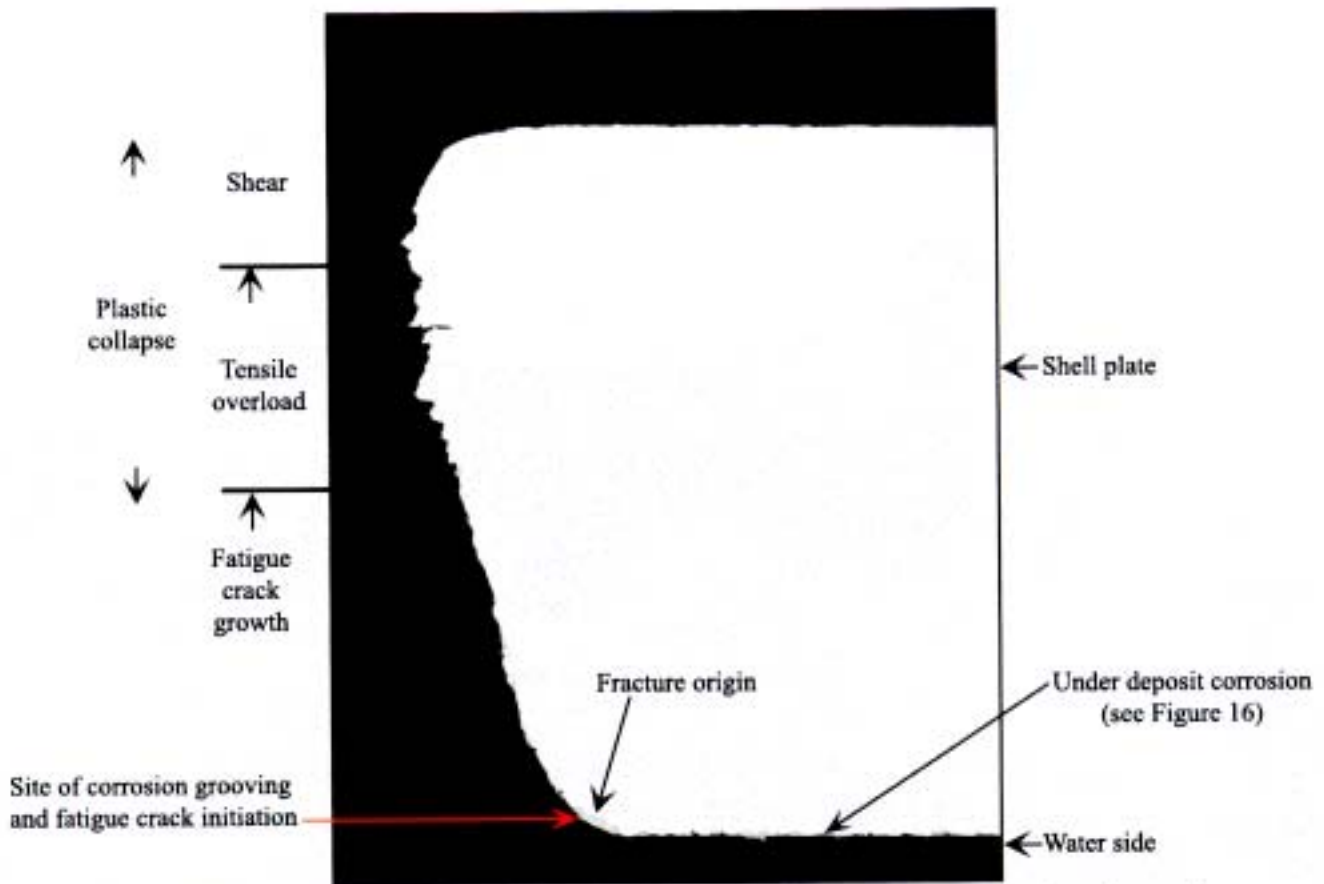
7. Microstructural features apparent at the fracture edge were consistent with a fatigue crack originating at the bottom tube plate weld toe. Beyond the fatigue-cracked region, evidence of a single event overload or plastic collapse was apparent (**Figure 15**).

Figure 15 - Photomicrograph x8, as polished. Fracture face edge showing scale coated fracture origin, arrowed.

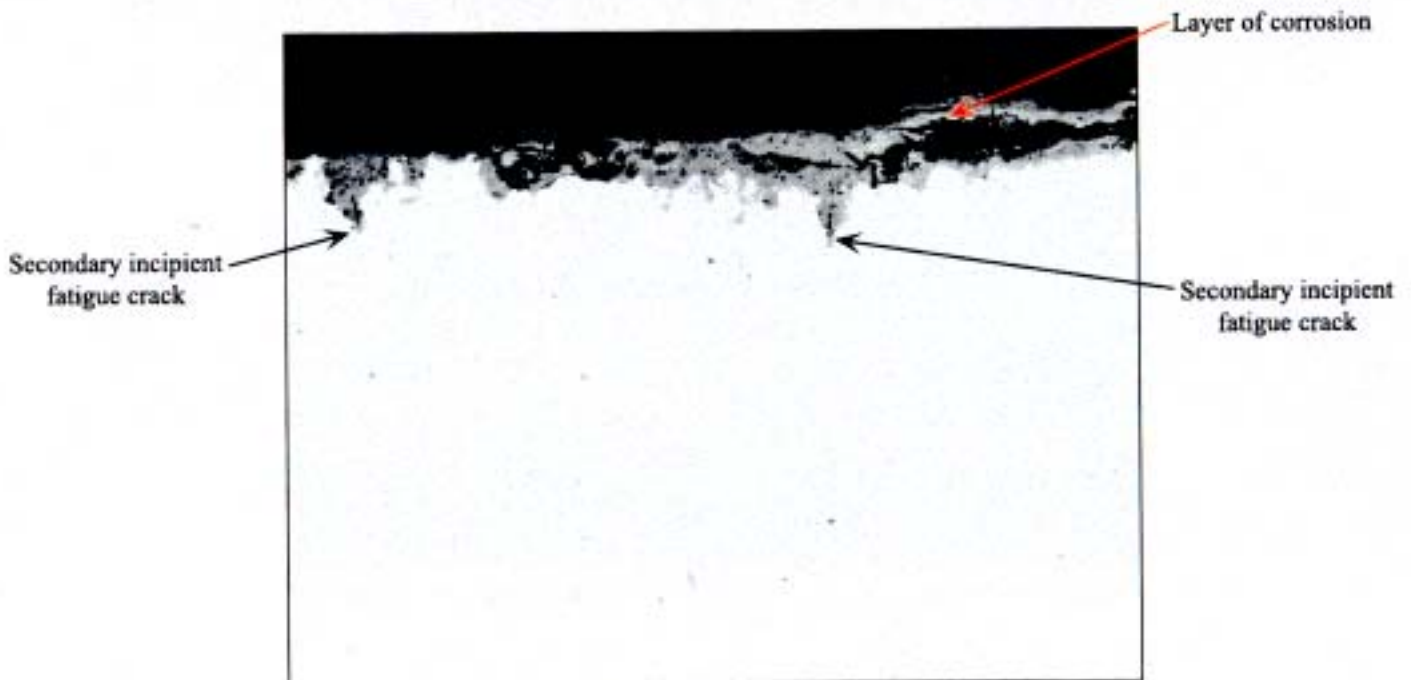
6. Appearance of the under-deposit corrosion front, and presence of free elemental copper in the deposit, were both consistent with either low or high pH type gouging corrosion (**Figure 16**).

Figure 16 - Photomicrograph x50, as polished. Area of waterside shell plate surface adjacent to fracture edge showing under deposit corrosion and incipient secondary corrosion fatigue cracks.

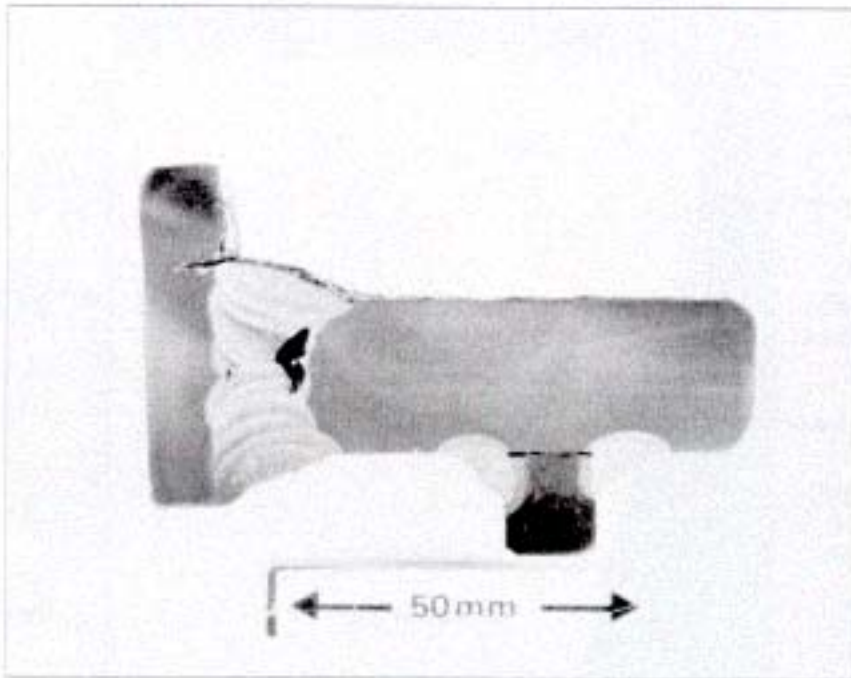
Figure 17 - Shell to bottom tube plate weld showing fatigue crack and apparent welding defects

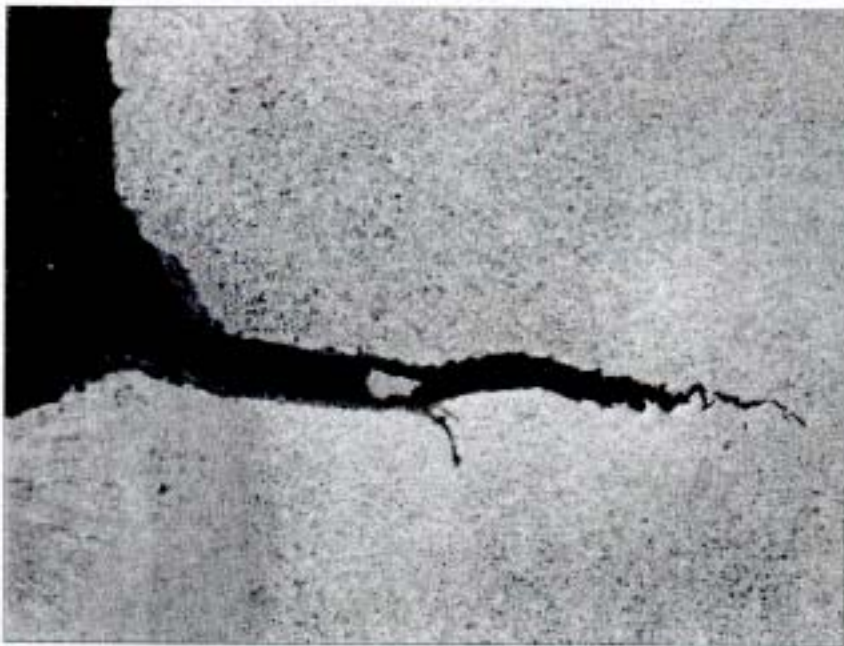
Figure 18 - Scale coated fatigue crack with overload tear extension

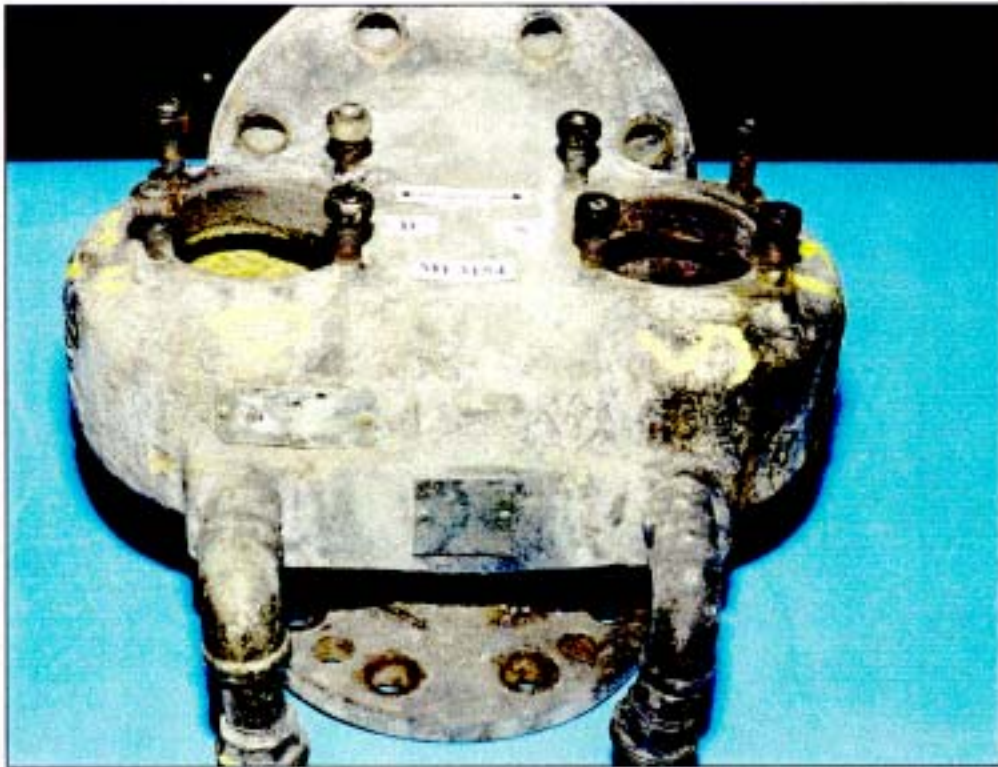
Figure 19 - Valve body showing repairers plate top left, makers plate bottom right and redrilled boiler mounting flange

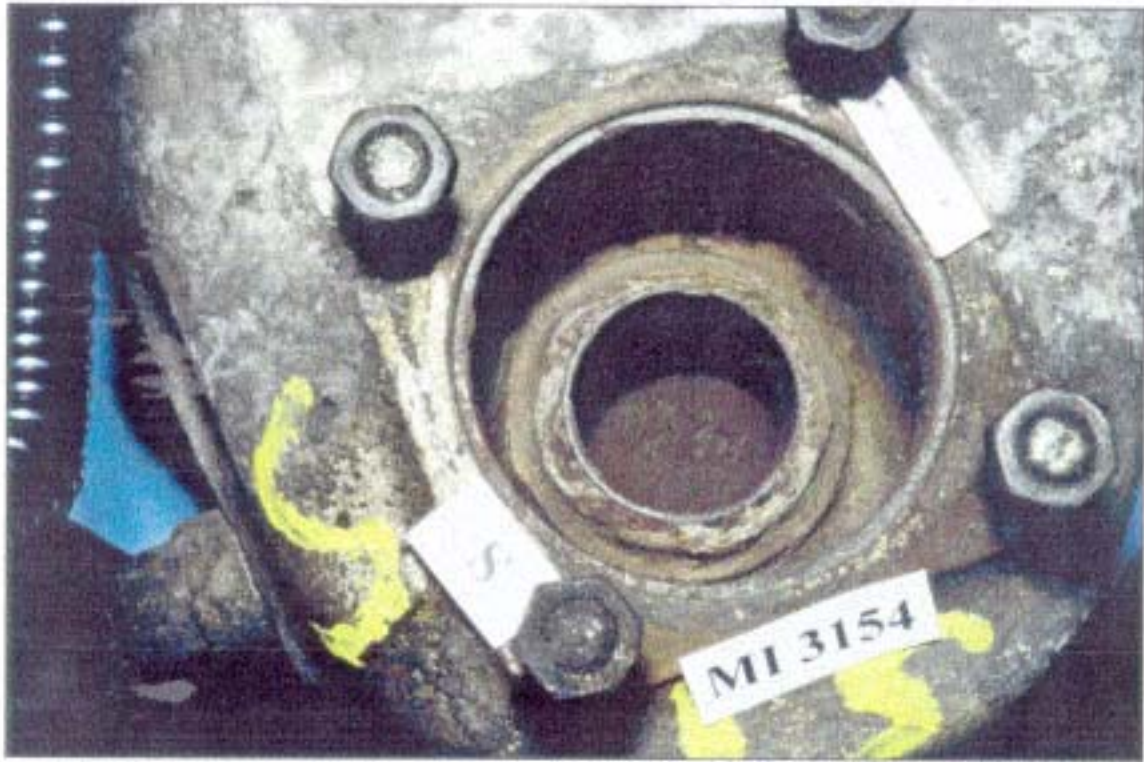
Internal surfaces of the valve body had suffered earlier pitting corrosion and were of a red hue (**Figure 21**).

Both seats exhibited accumulated boiler water deposits consistent with significant steam/water passing having occurred. Analysis of the deposits was consistent with a sludge from a phosphate conditioned boiler water. It indicated a high proportion of

Figure 21 - Forward side valve seat and associated deposits

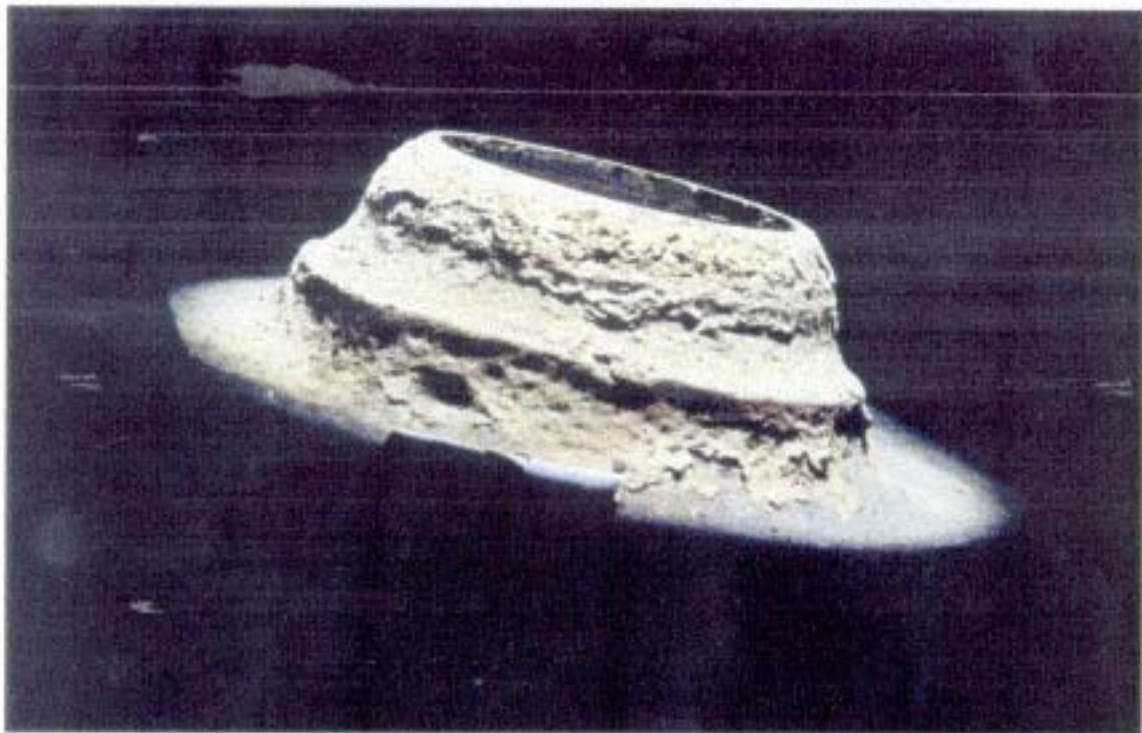
Figure 22 - Forward side valve seat and associated deposits

calcium carbonate in the deposits, which suggested that the boiler phosphate reserve had, recently, been overwhelmed by an ingress of hard, untreated, water. Based on the deposits calcium/magnesium ratio, shore-side potable water appeared the most likely origin of the water hardness constituents (**Figure 22**).

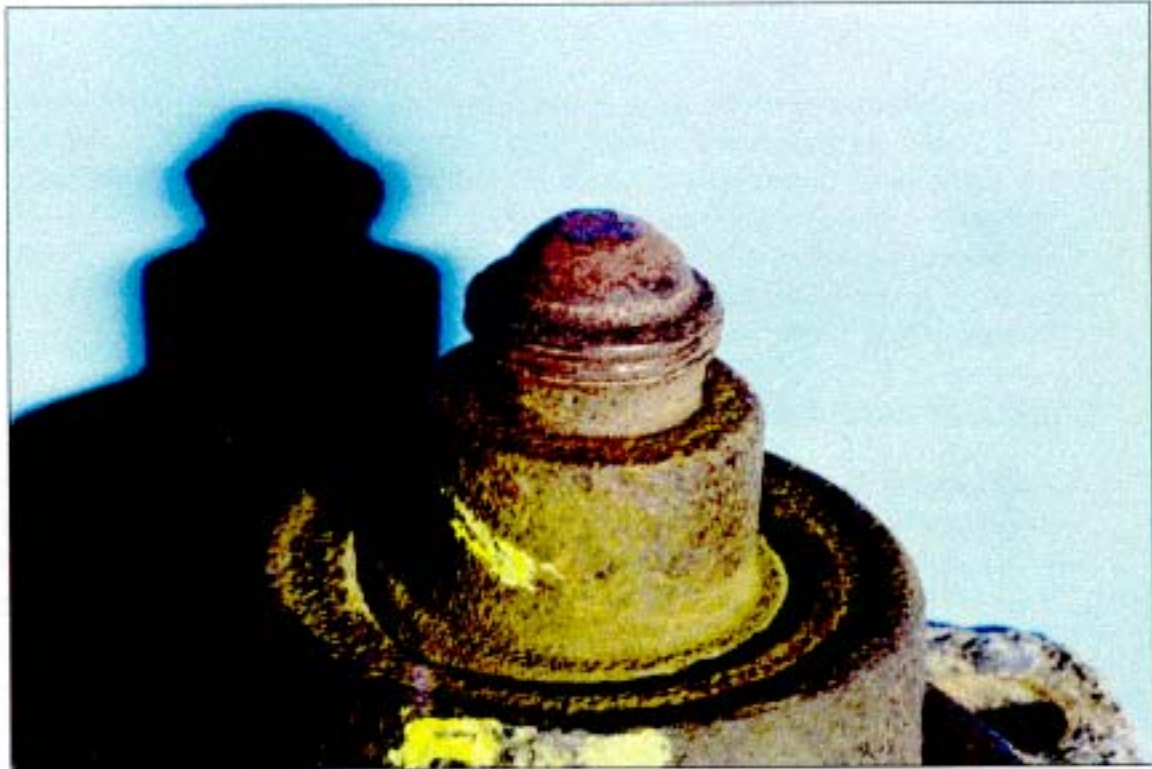
Figure 23 - Aft side valve spindle, showing worn or stripped cap retaining threads

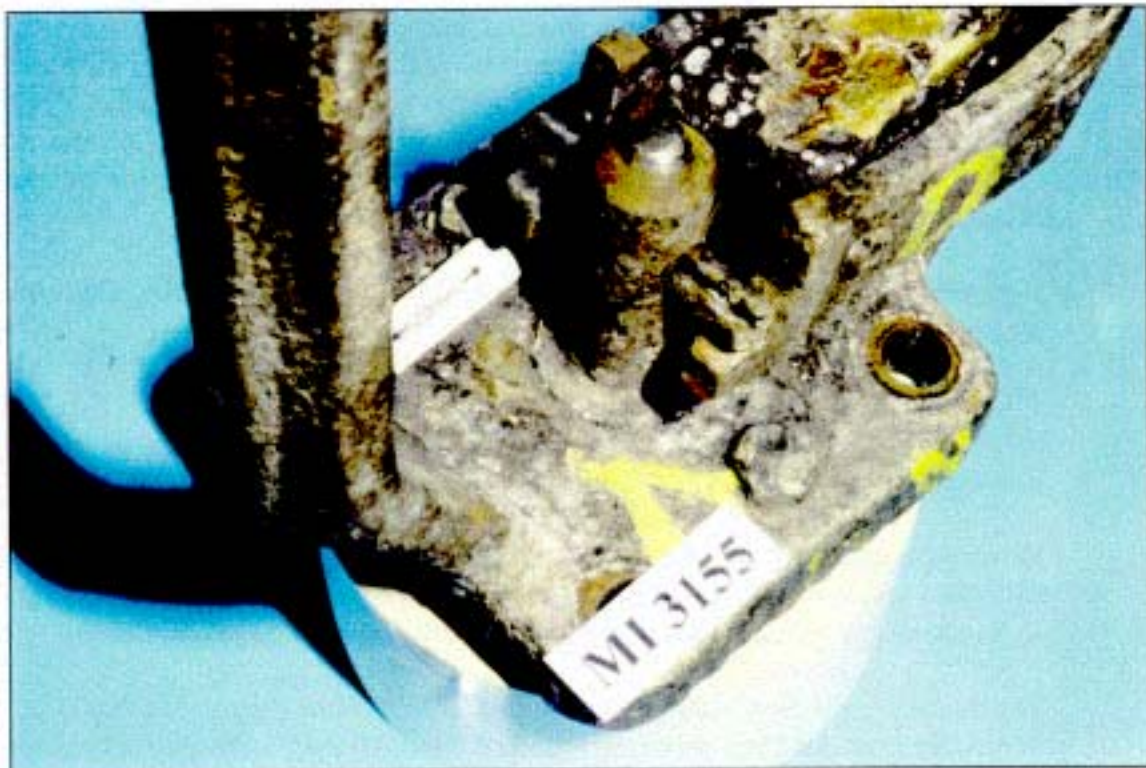
Figure 24 - Aft side valve lid and spindle, showing bright hammer type marks at the spindle top

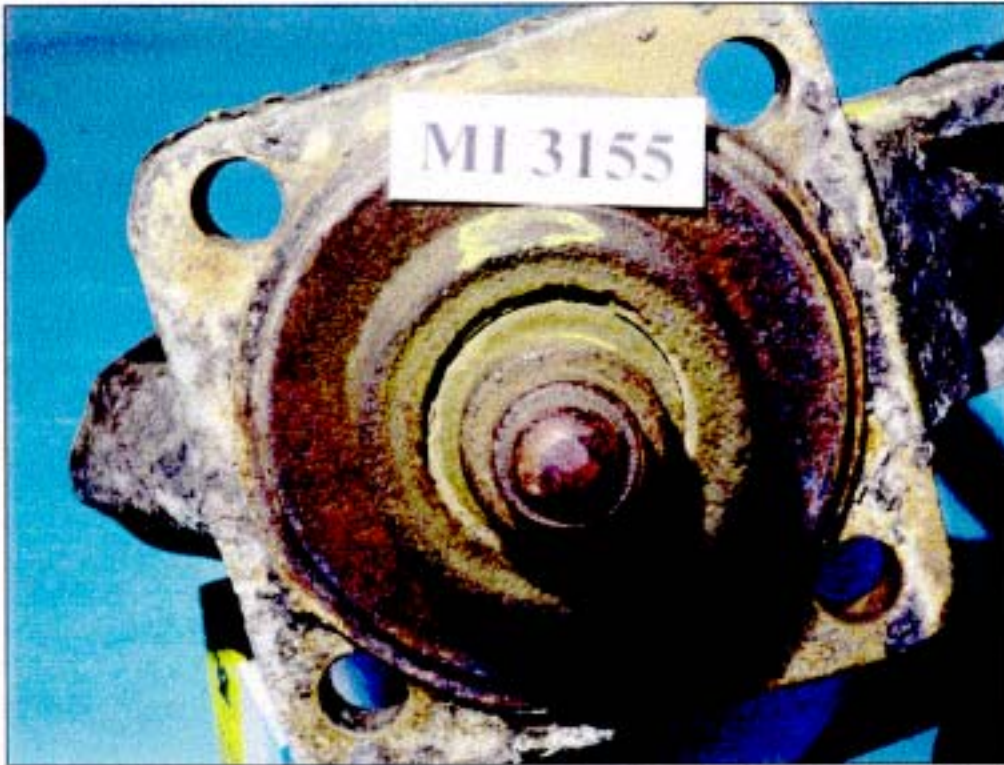
Figure 25 - Aft side valve lid underside and spindle, showing heavily oxidised hammer type marks at the spindle bottom

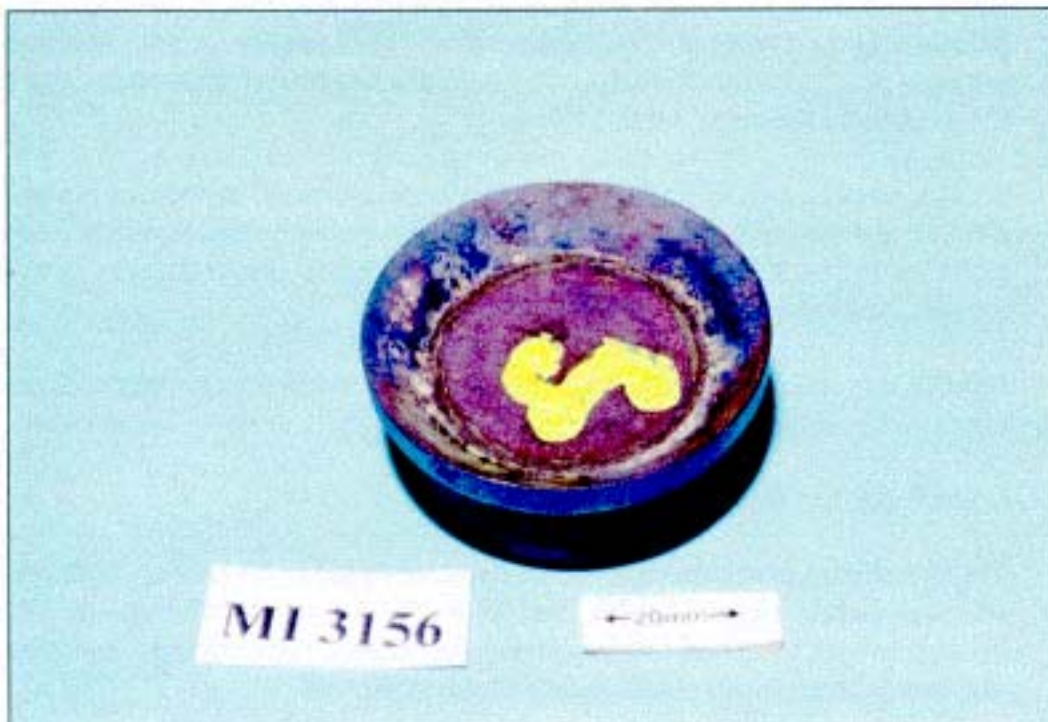
Figure 26 - Forward side valve cap, showing raised seating face, steam / water passing marks and associated deposits

originals, or that they had been re-machined. Based on the actual measured raised face diameters, it should still have been possible to effect a seal with the seat.

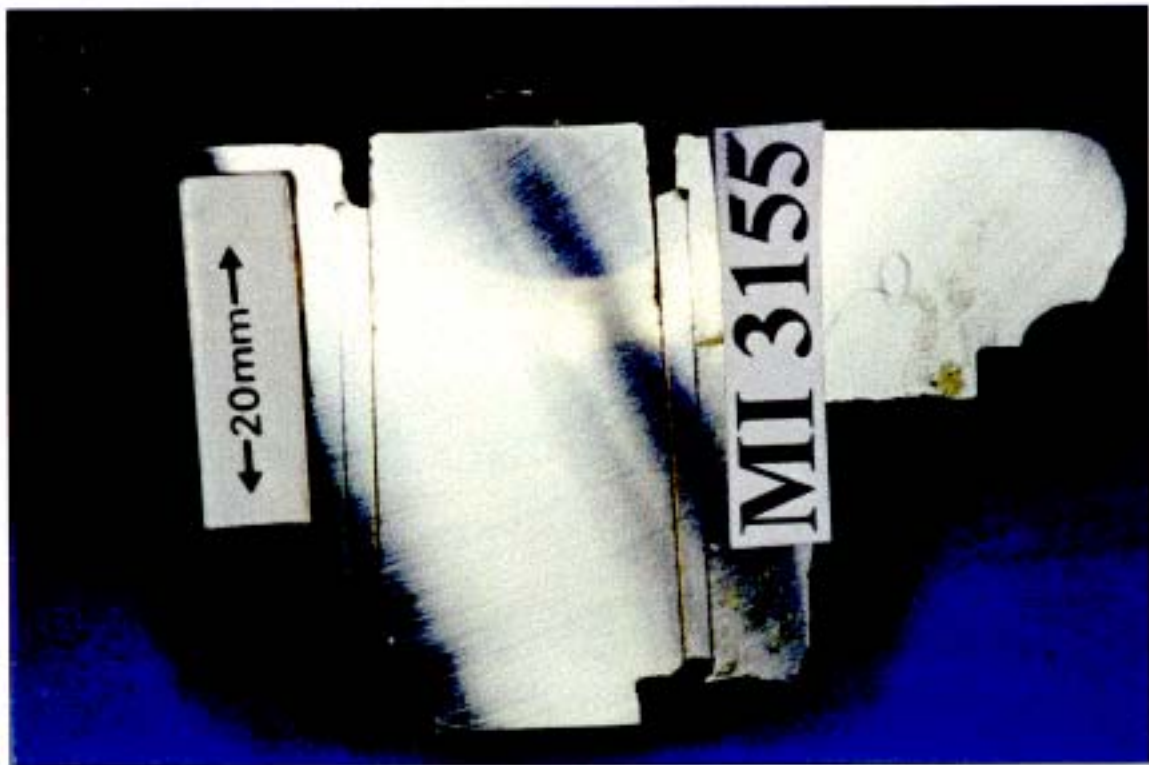
The Test House concluded that the safety valve failed to lift because both spindles seized in their respective guides. Seizure was in turn attributed to spindle corrosion damage and accumulated corrosion products, boiler sludge deposits, and other extraneous material at spindle to guide bush interfaces.

Figure 27 - Aft side spindle to guide interface - off centre longitudinal section

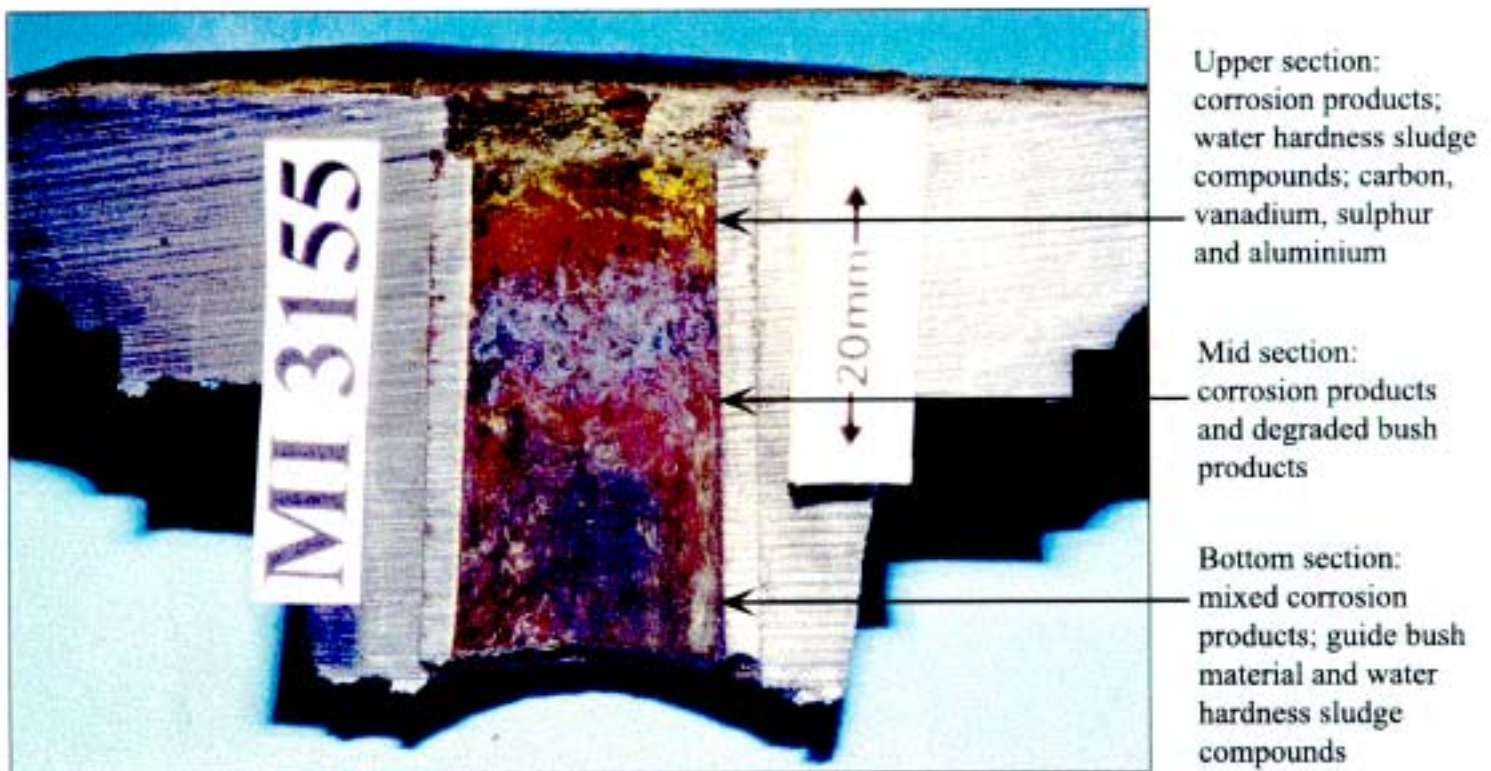
Figure 28 - Aft side spindle guide bush - off centre longitudinal section

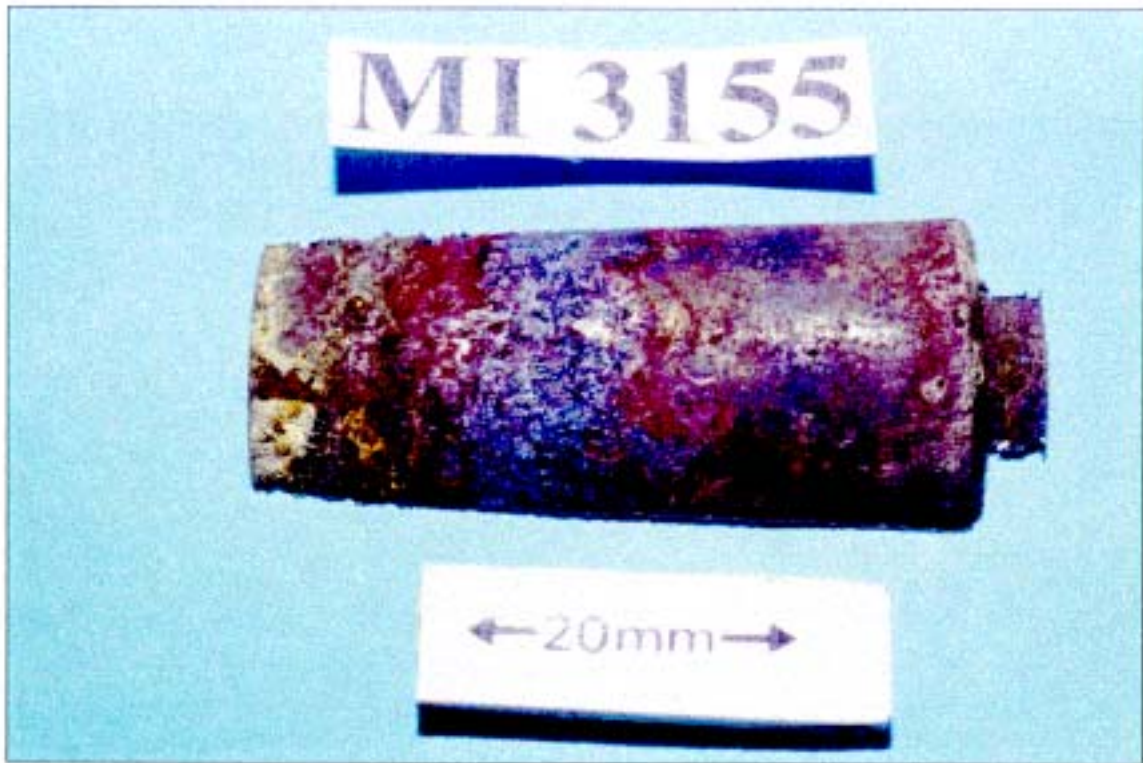
Figure 29 - Aft side spindle - off centre longitudinal section
(lower installed location shown to figures right)

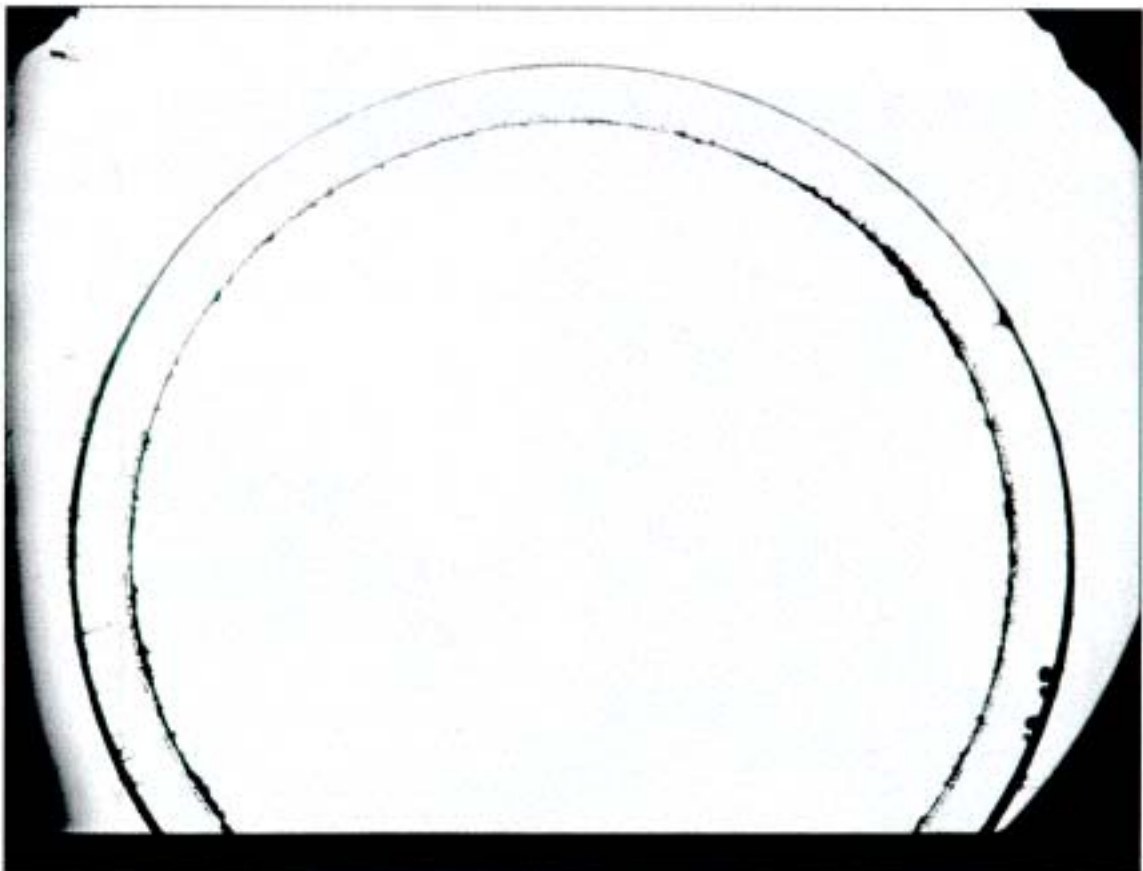
Figure 30 - Forward side spindle to guide bush interface - cross section x3.5

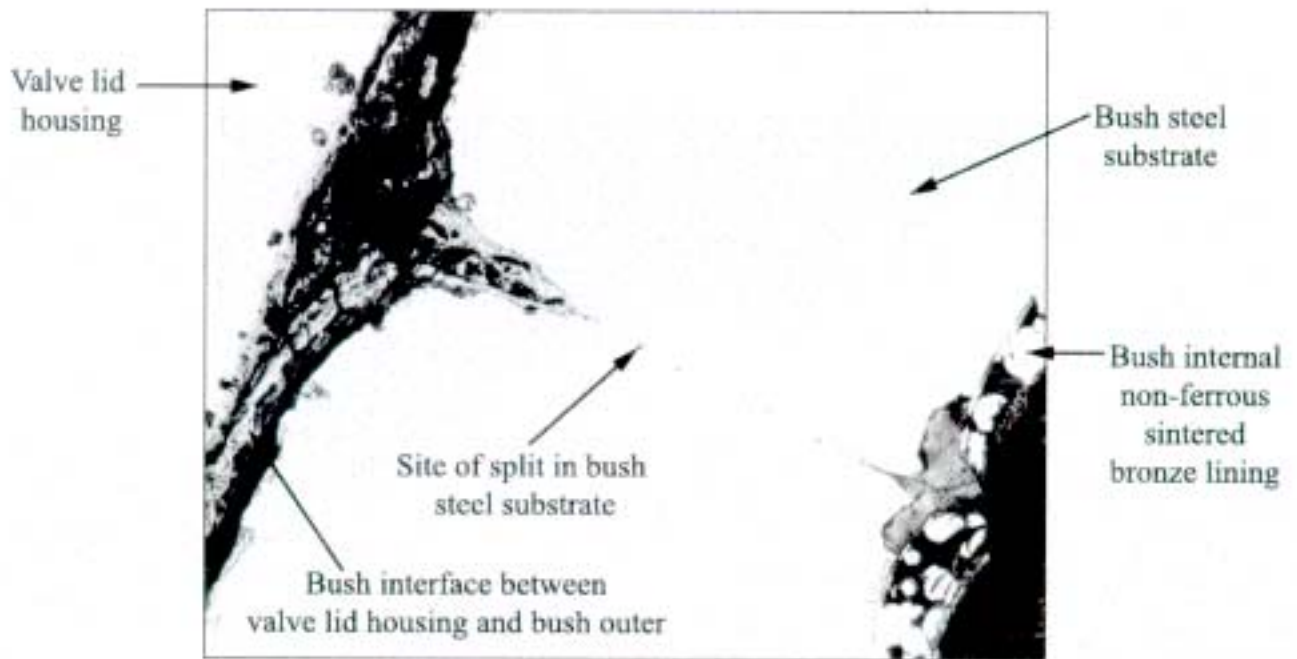
Figure 33 - Micrograph x50, unetched. Forward side spindle guide bush cross section, showing crevice corrosion at the split side.

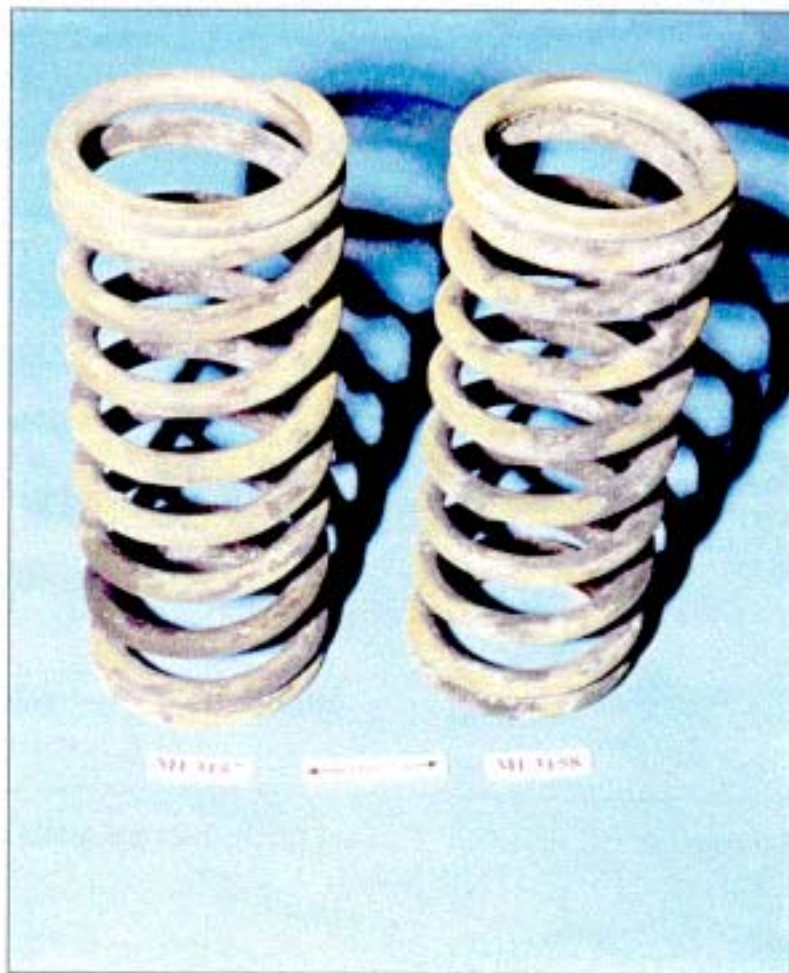
Figure 34 - Valve springs, aft side shown right and forward side shown left
