Marine Accident Report 3/99

Report of the Inspector's Inquiry
into the Sinking of the Fishing Vessel

Margaretha Maria **BM148**

with the loss of four crew
between 11 and 17 November 1997

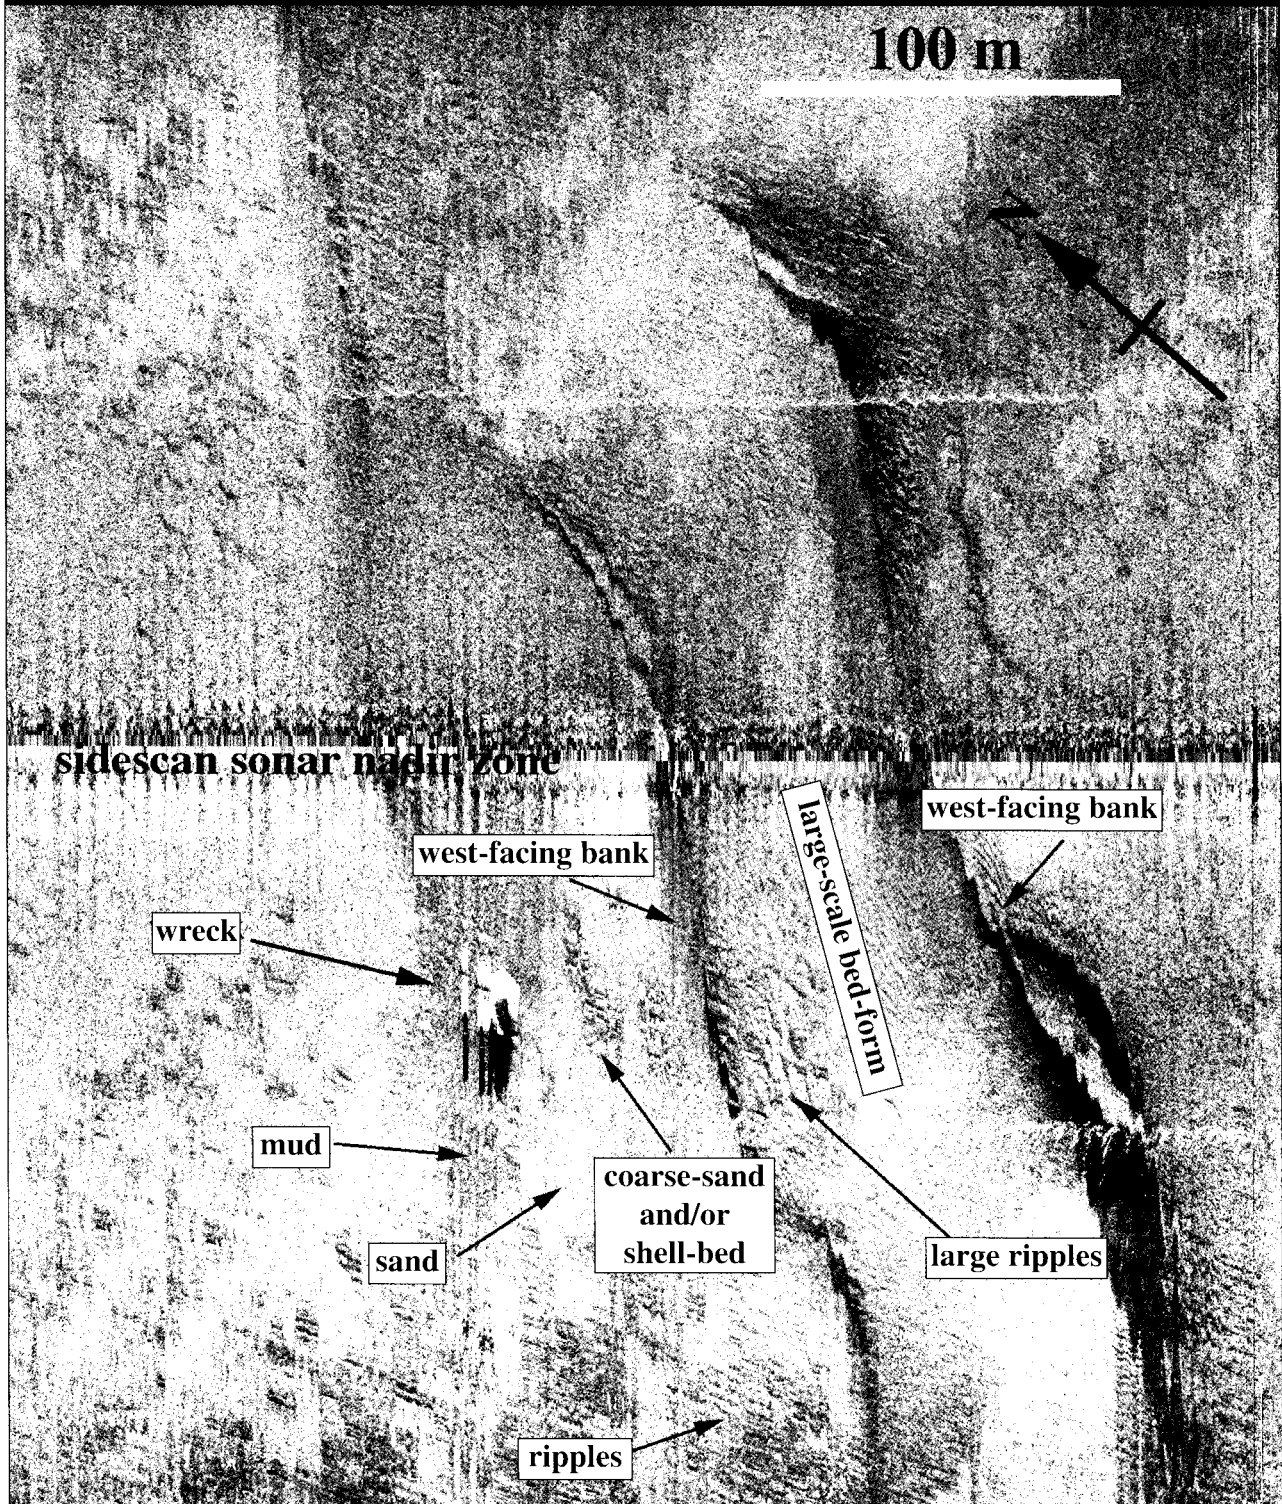
Figure 5: Sonar scan of wreck and surrounding sea bed

The hull of the wreck was inclined 5° to 10° to starboard in about 120m of water. Some items, particularly wires and ropes, had acquired a significant covering of marine growth. Most other surfaces were generally covered in a light film of growth and silt.

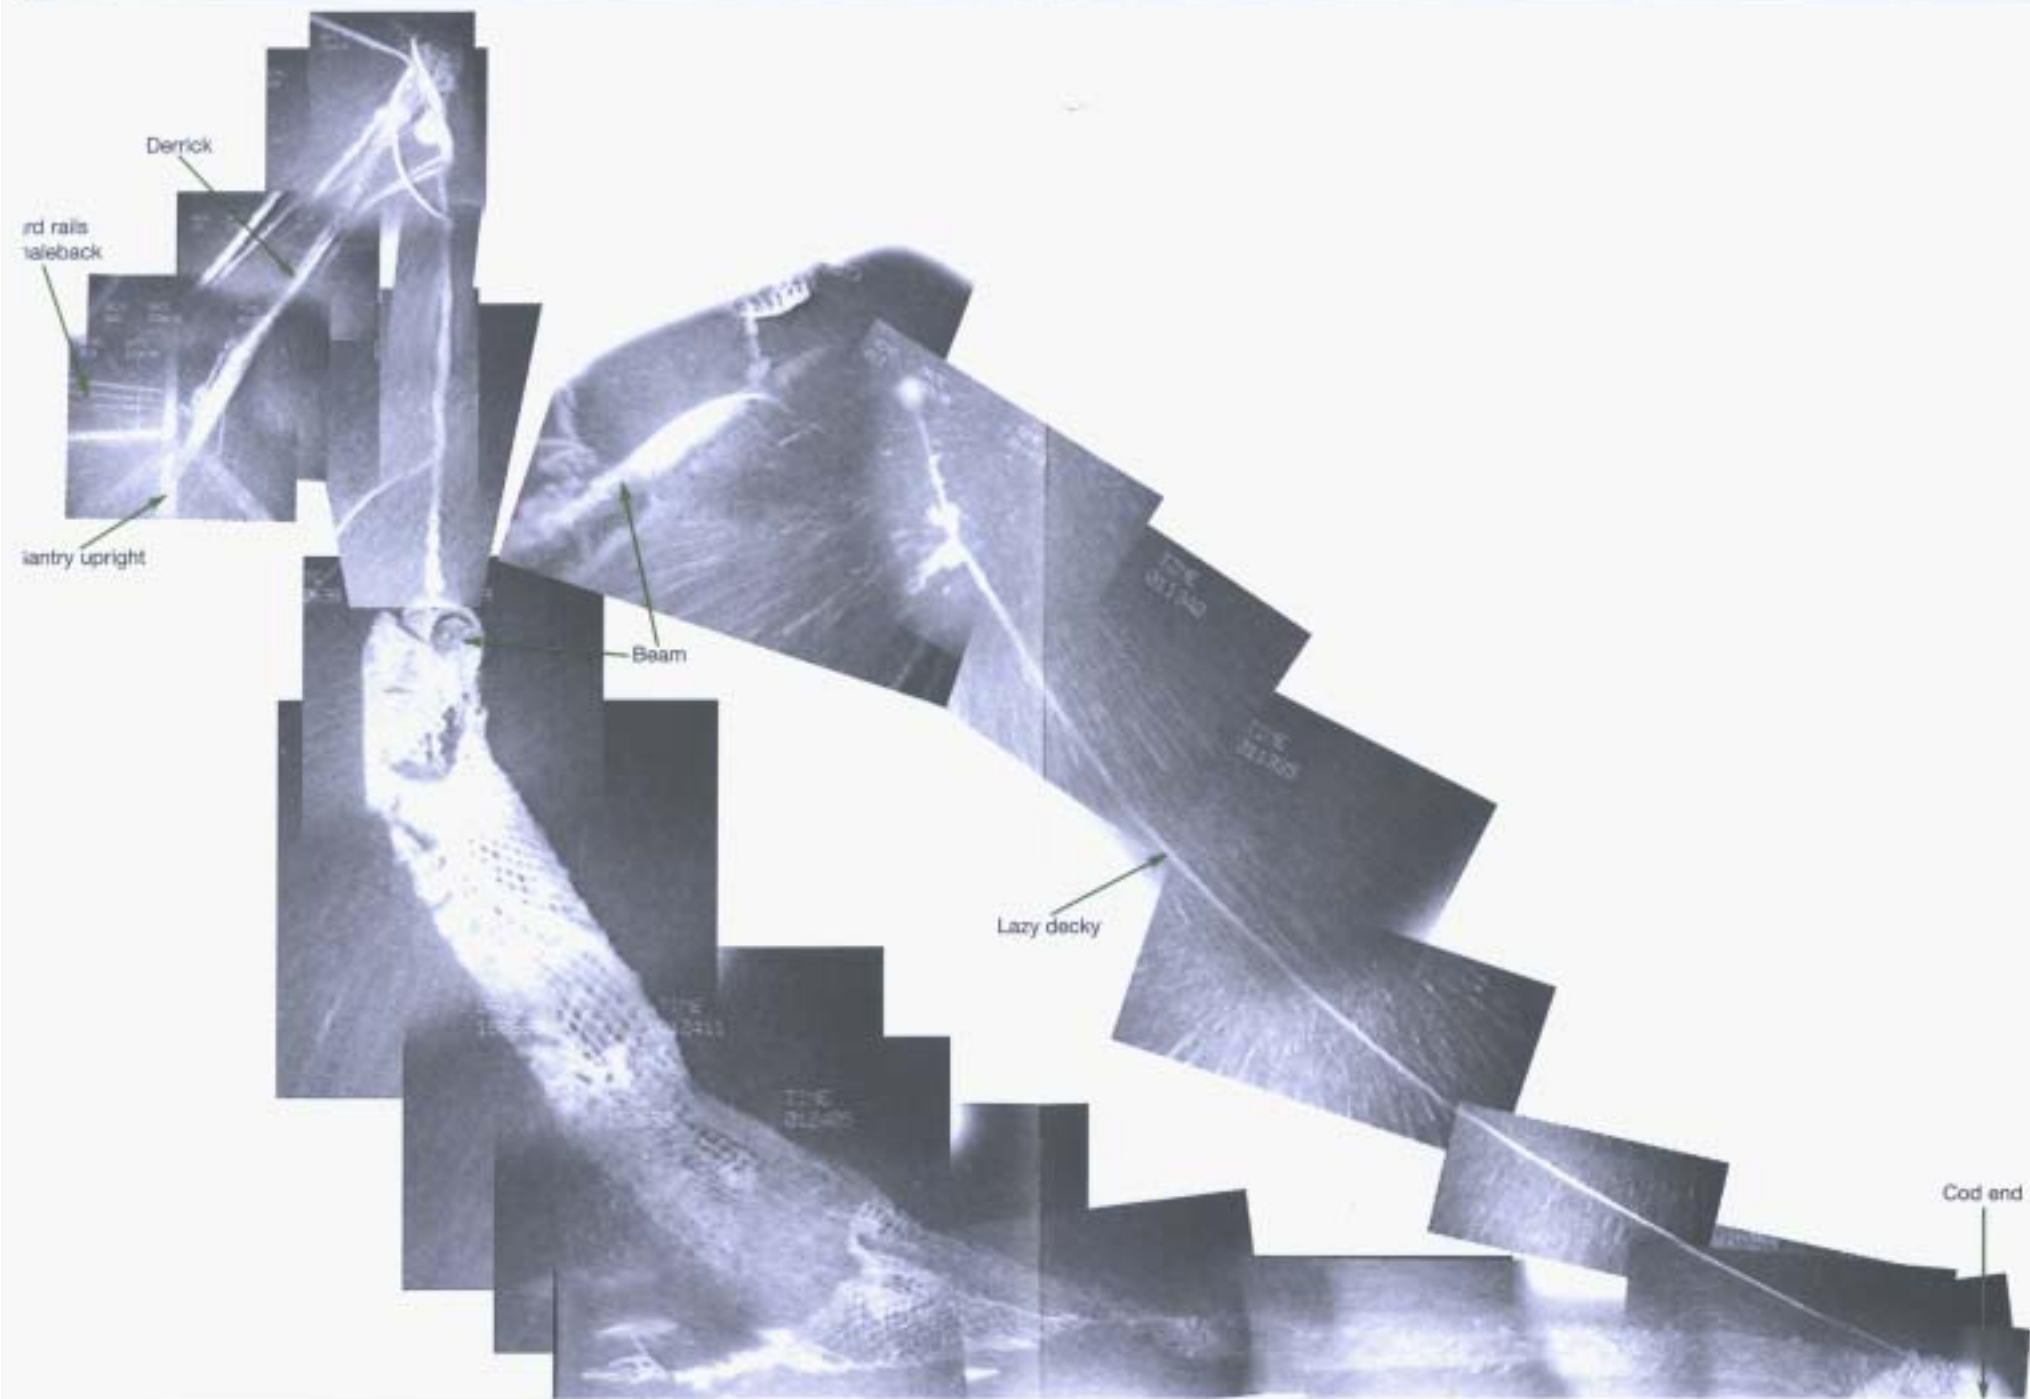
Port net and beam

The port derrick was about 30° to 45° above the horizontal with the topping wire supporting its weight. The forward and back stays were in place and intact. The towing wire was taut and followed its normal route from the winch drum to the chain plate via blocks on the whaleback and the derrick head. The beam, suspended from the chain plate by five chains, was approximately on a level with the bulwark rail. The beam's shoes were in place at each end of the beam.

Hanging from the beam were the chain mat and net, with the net sloping down, outwards and forwards onto the sea bed. The net showed some signs of damage in the belly area, but the cod end was intact and contained a large quantity of shells and other debris.

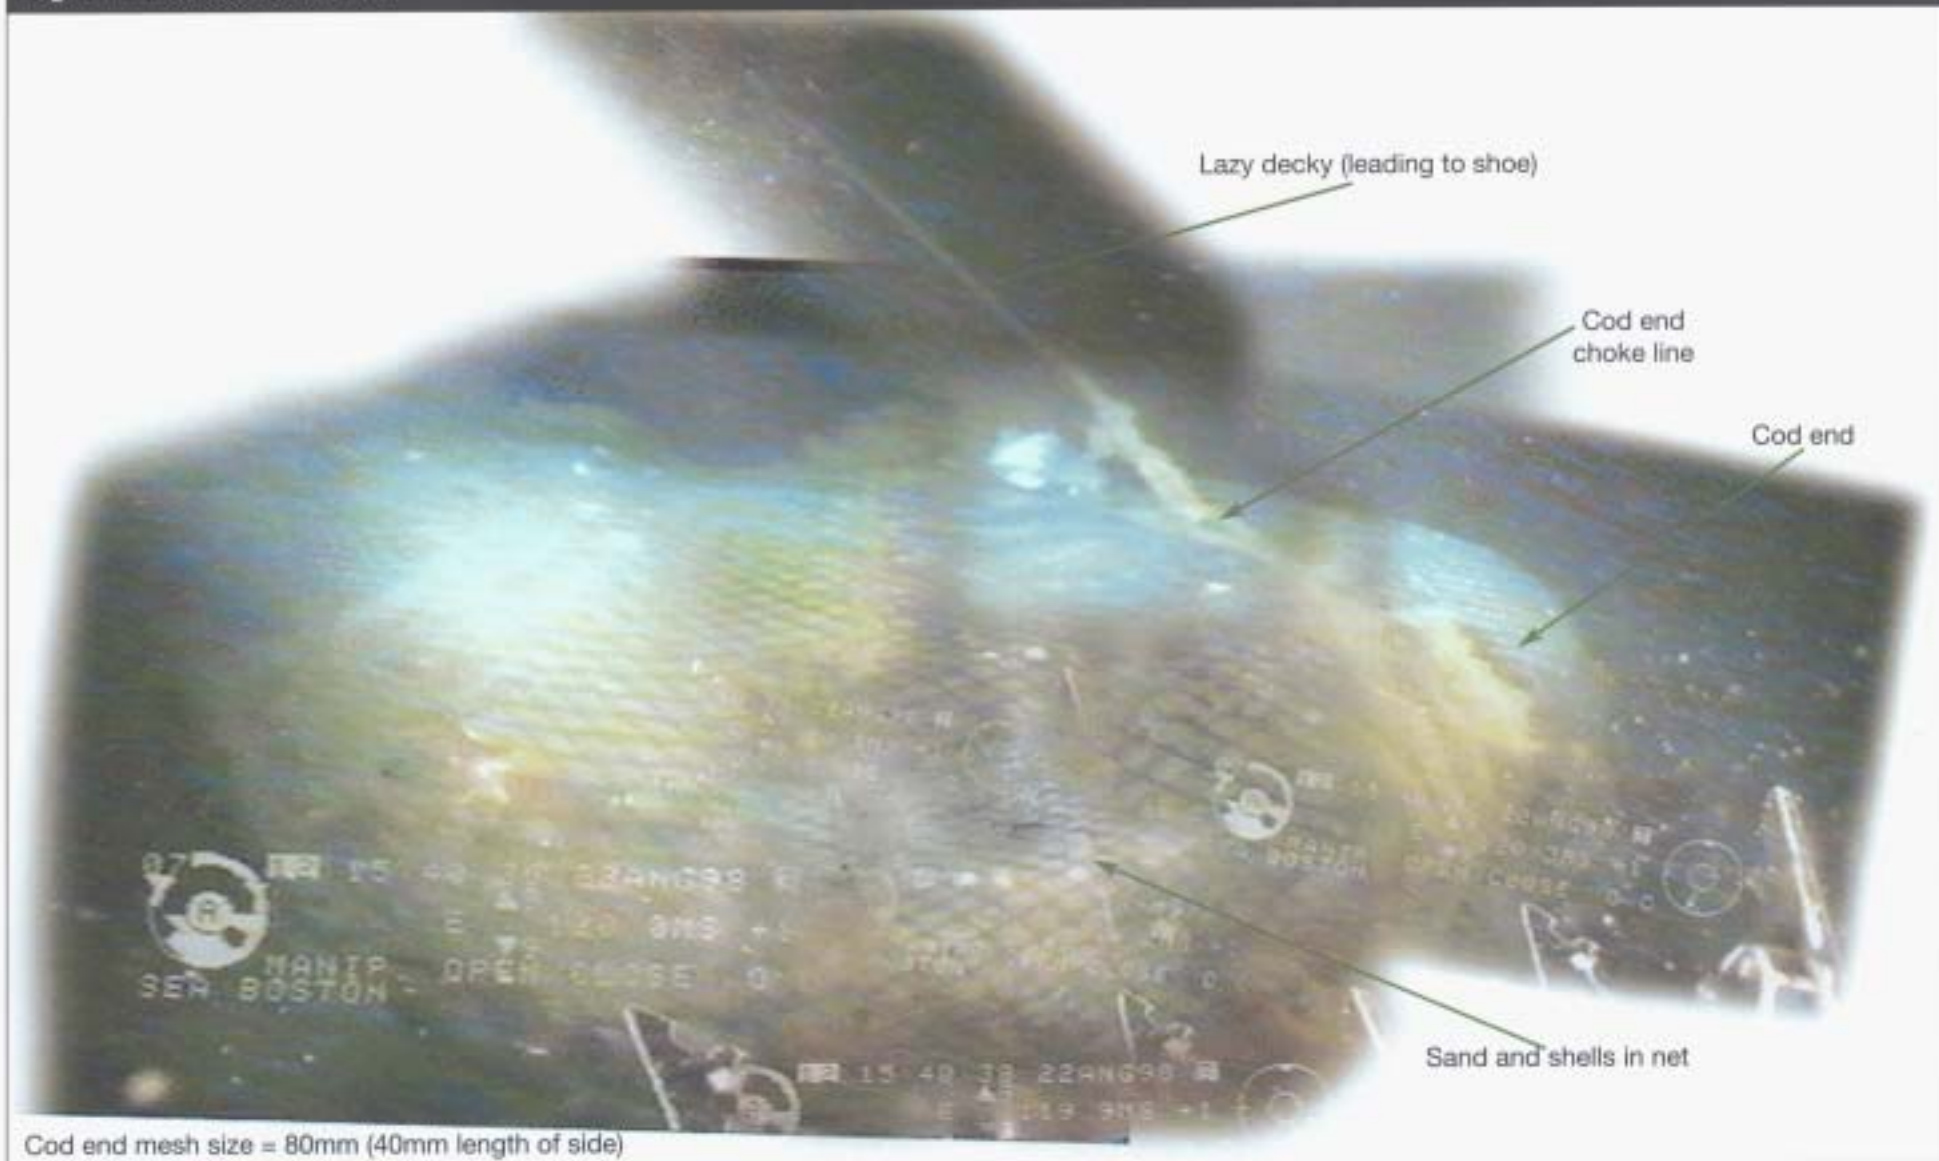
Figure 7: Port cod end debris

The sea bed in the vicinity of the wreck was sand with widely scattered boulders of moderate size and clumps of shells. Below and immediately adjacent to the wreck a significant quantity of shells was found. These were similar in size and appearance to those found in the port net's cod end.

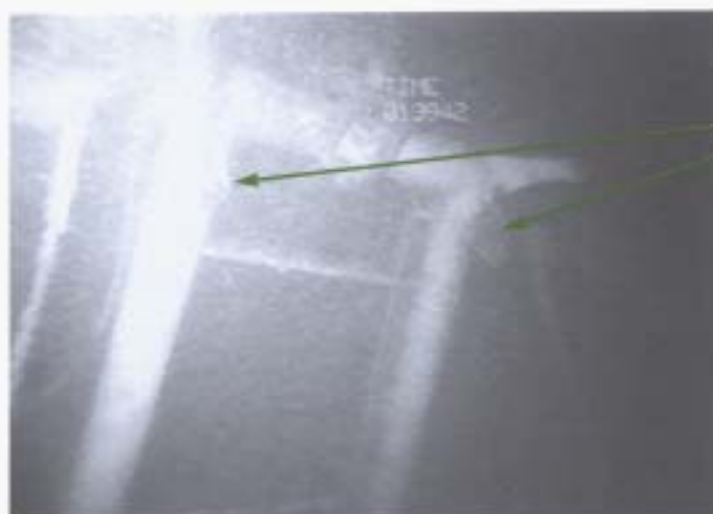
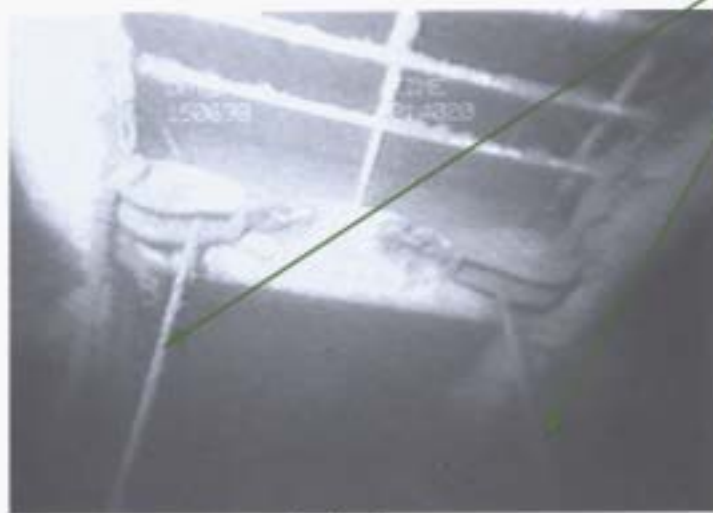
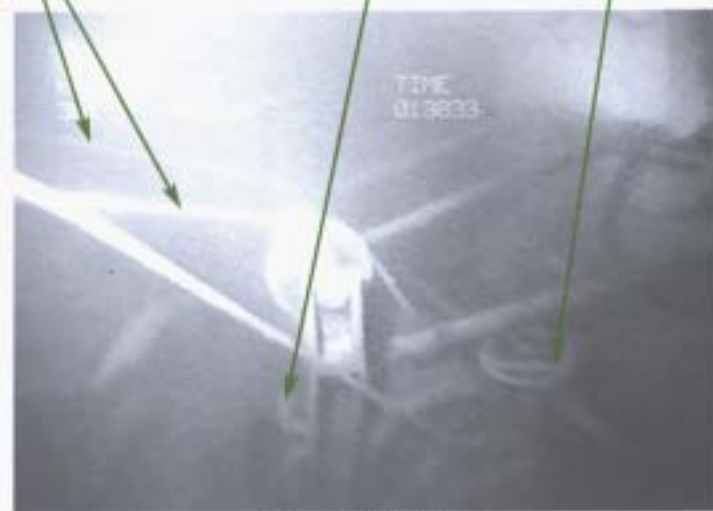
Figure 9

The port and starboard topping and towing wires were in place and followed their normal runs between winch drums to derrick and chain plate on each set of gear.

Stays between the frame and deckhouse front were fractured. The winch was slightly and unevenly displaced, forward and down.

Both wires from the towing drums were in place over the sliding sheaves on the horse, and were under load. The topping wires ran directly from each topping drum to the gantry top and were under load.

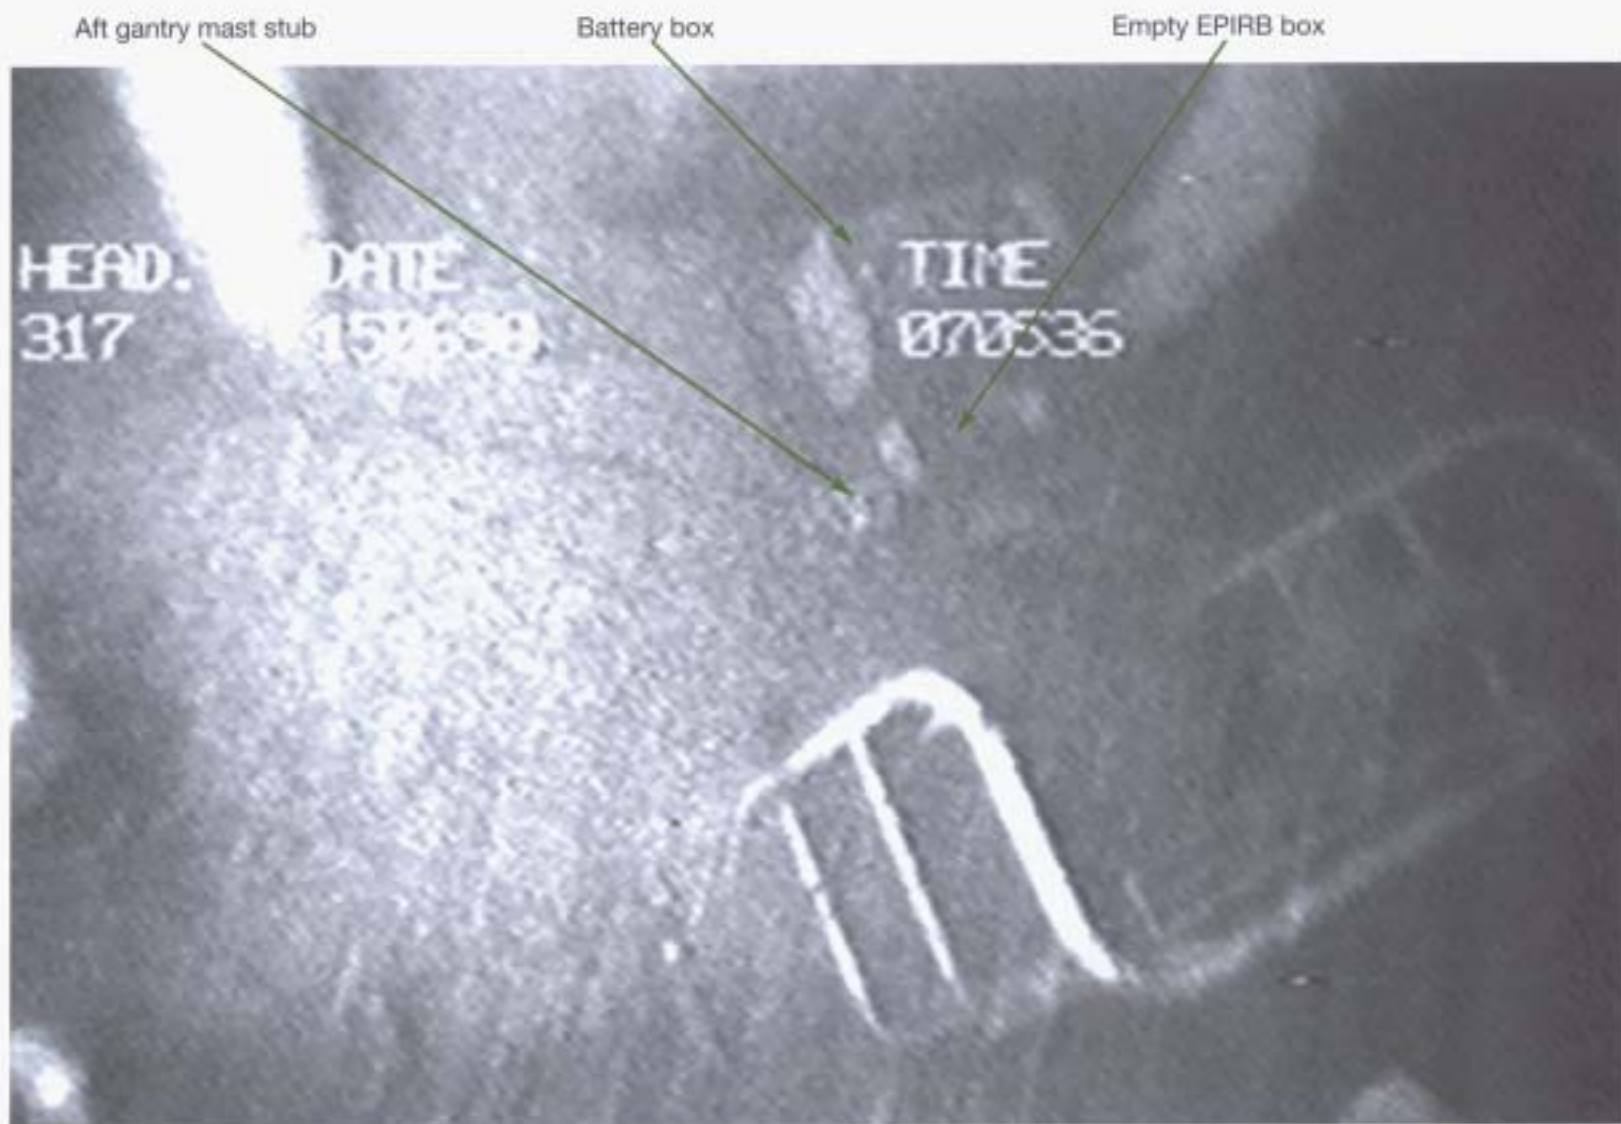
Figure 14: Shelter top (starboard)

The cover of the EPIRB stowage box, on the shelter top, was missing and the box itself was empty. Neither the EPIRB nor the cover of its stowage box was seen in any part of the wreck or its equipment (**Figure 14**).

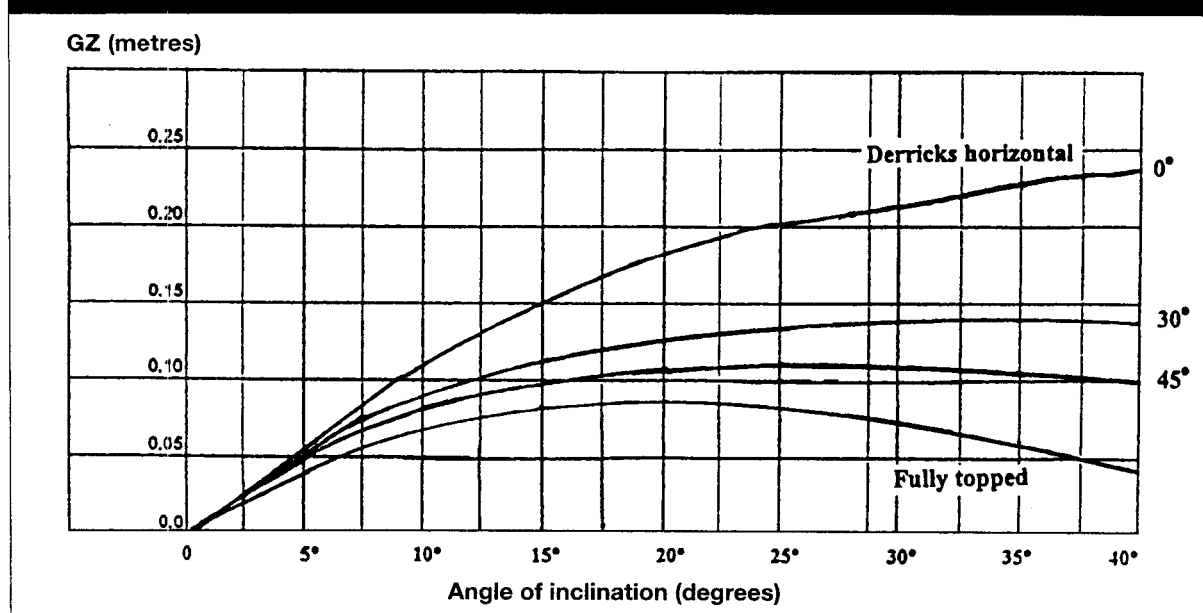
Figure F: GZ curve showing influence of topping derricks. Shelter doors closed (see Conditions 8, 9, 10 and 11 Annex 1)

With both derricks horizontal, and the weight of the beams at their ends, the stability of *Margaretha Maria* exceeds all statutory requirements for a beam trawler (**Figure F**).

The number of combinations of beam weights, derrick lengths and gooseneck heights may make the application of a blanket set of stability criteria for twin beam trawlers unreliable. The prediction of forces caused by snagging is, likewise, impracticable. Once a vessel's gear has been selected however, its weight and dimensions will be known and it is possible to calculate the effects on stability during normal planned seagoing operations. It will also be possible to assess the effects of any subsequent changes in gear weight or derrick sizes. Being easily quantified, the direct effects of derrick and beam sizes on stability are known and should not be allowed to totally consume the 20% uplift in stability requirements.

As already stated, when both her derricks supporting fishing gear at their ends were topped significantly above the horizontal, *Margaretha Maria's* stability was less than that required of a non-beam trawler. This configuration was, however, a quite normal seagoing condition which meant there were many occasions when she would have failed to meet minimum stability standards required of any type of fishing vessel over 12m long. This inquiry has failed to identify any reason why beam trawlers should not be required to possess the same minimum standard of stability as in other vessels. With lower stability standards, safety would have been compromised. To achieve this minimum standard on *Margaretha Maria* it might have been necessary to limit the angle to which the derricks were topped, which might have been impractical, or limit the weight of fishing gear carried.
