**Report of the
Marine Accident Investigation Branch
Investigation into the capsizing of the Yacht**

OCEAN MADAM

**with the loss of one life
in the Bay of Biscay
8 October 1997**

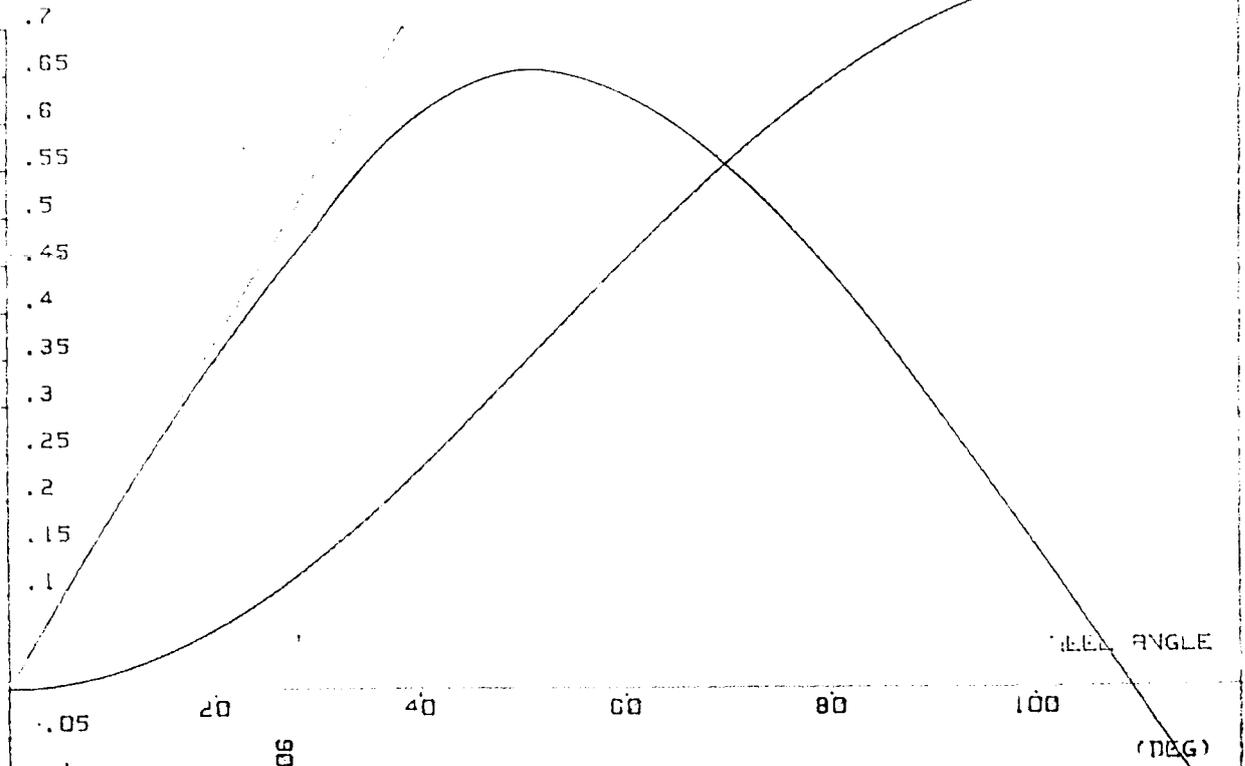
Stability Information provided by Beneteau (builders)

The builders have supplied some stability information for the Oceanis 390 that indicates a point of vanishing stability of 109.37°. This means that beyond that angle of heel the vessel will possess negative stability and continue capsizing until completely inverted. In conditions likely to be encountered by most owners or charterers, this level of stability is quite adequate. If knocked flat the boat will recover, but in steep breaking seas there is a danger that the point of vanishing stability will be passed and the boat will invert. It will only right if further waves affect the boat in such a way that it regains positive stability. If the mast breaks while the yacht is inverted, the negative stability will be reduced and, together with resistance to rolling provided by the mast and any sails which might be rigged, could increase the likelihood of the yacht being righted. The stability data is reproduced at Annex B.
