**Collision between fishing vessels *SAPPHIRE STONE* and
KAREN resulting in the
loss of *KAREN*
11 miles south-east of Campbeltown
22 January 2014**

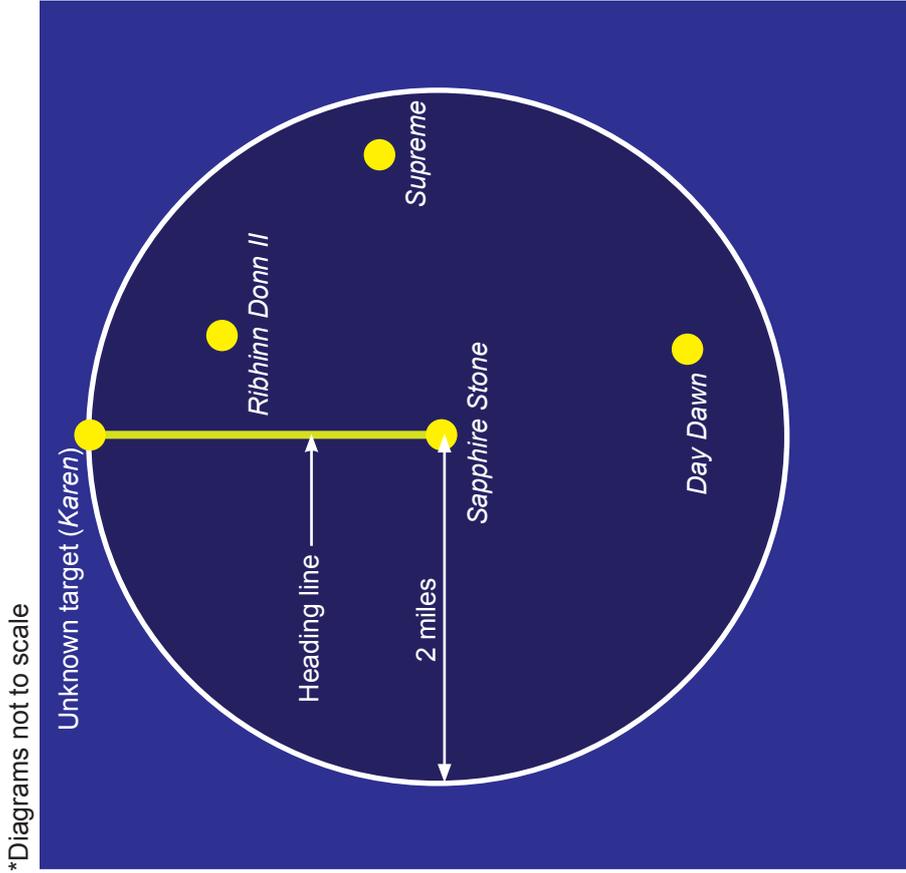
Figure 3: Diagram showing recalled approximate relative positions of contacts on *Sapphire Stone's* radar display at around 1545

At around 1545, *Sapphire Stone's* skipper checked his radar display and chart plotter and was content that no vessels were likely to pose a problem while he altered course as necessary to recover the nets (**Figure 3**).

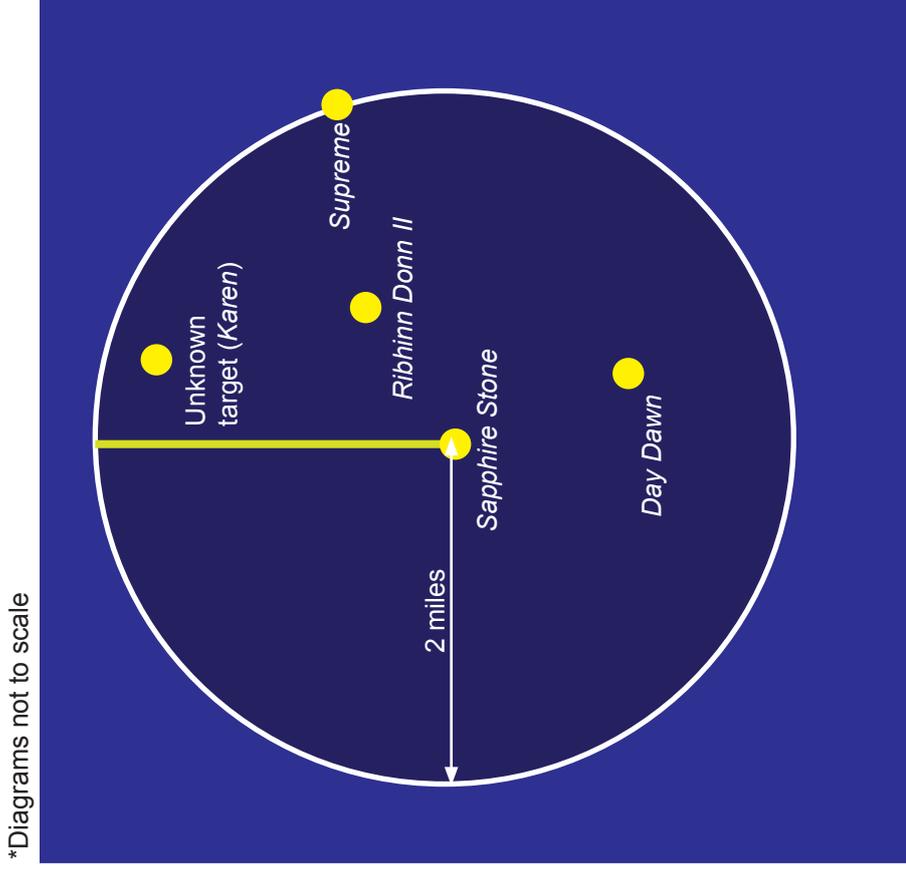
Figure 4: Diagram showing recalled approximate relative positions of contacts on *Sapphire Stone's* radar display at about 1620 (*Sapphire Stone* heading north-westerly)

When the skipper next checked the radar display, at about 1620, *Sapphire Stone* was steering a steady course (**Figure 4**). The skipper did not systematically observe *Karen* visually, or its radar contact, to establish whether it was on a steady relative bearing or to establish its course and speed. Instead, he assumed that *Karen* was towing in a similar direction to that of *Sapphire Stone* and *Ribhinn Donn II*.

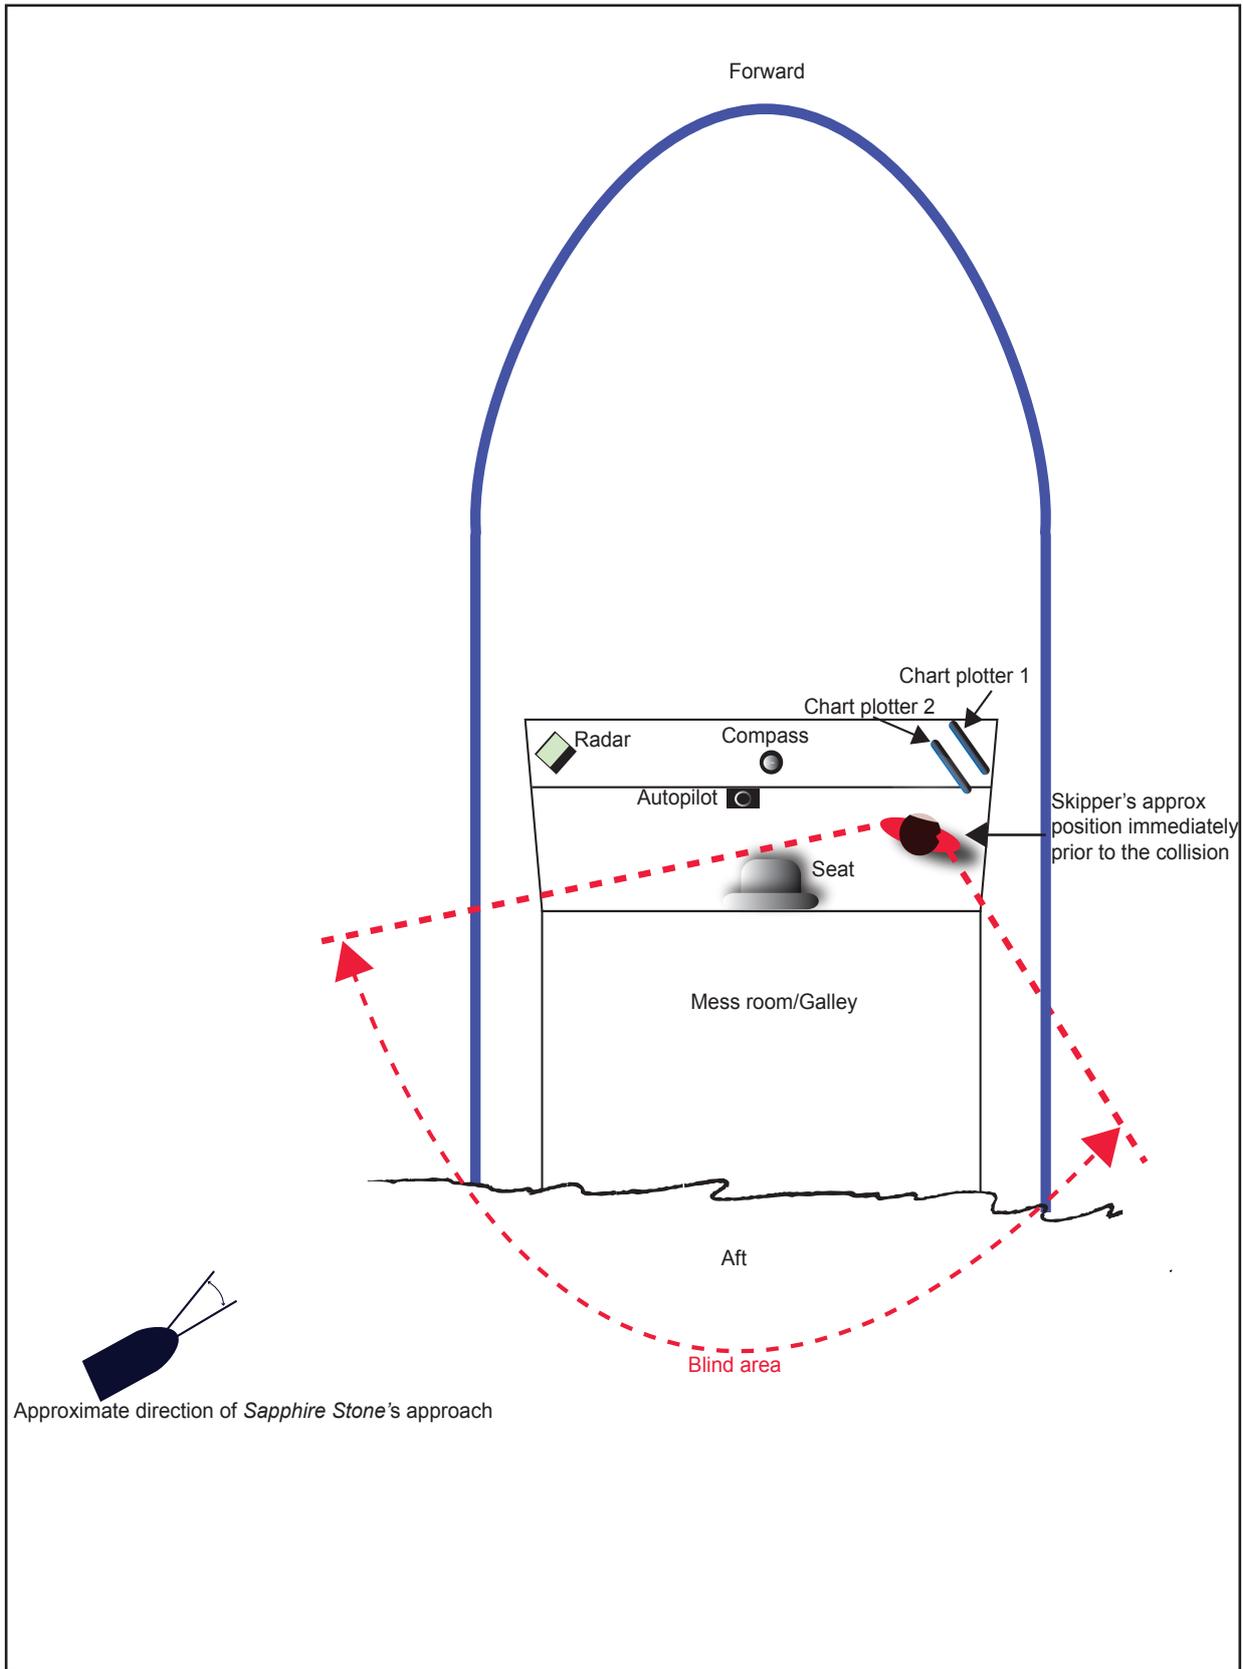
Figure 6: Diagram showing *Karen's* blind area from the skipper's position at the chart plotter and approximate direction of *Saphire Stone's* approach (not to scale)

From the skipper's position at the chart plotter, *Karen's* wheelhouse provided good visibility through a horizontal arc ahead from abaft the port beam to the starboard quarter. However, his view aft of the port beam was obstructed by the vessel's accommodation (**Figure 6**). As *Sapphire Stone* was approaching on *Karen's* port quarter, and this blind area was unchecked, the skipper remained unaware of its approach until the collision occurred.

- *Sapphire Stone*'s skipper was distracted by *Ribhinn Donn II*'s deck lights, which resulted in loss of situational awareness.
- From his position in the wheelhouse, *Karen*'s skipper's view aft from the port beam was obstructed by the vessel's accommodation.
