MAIB SAFETY BULLETIN 1/2011

Overweight rescue boat identified during the investigation
into the failure of a fall wire with the loss of one life
on the car carrier *Tombarra*

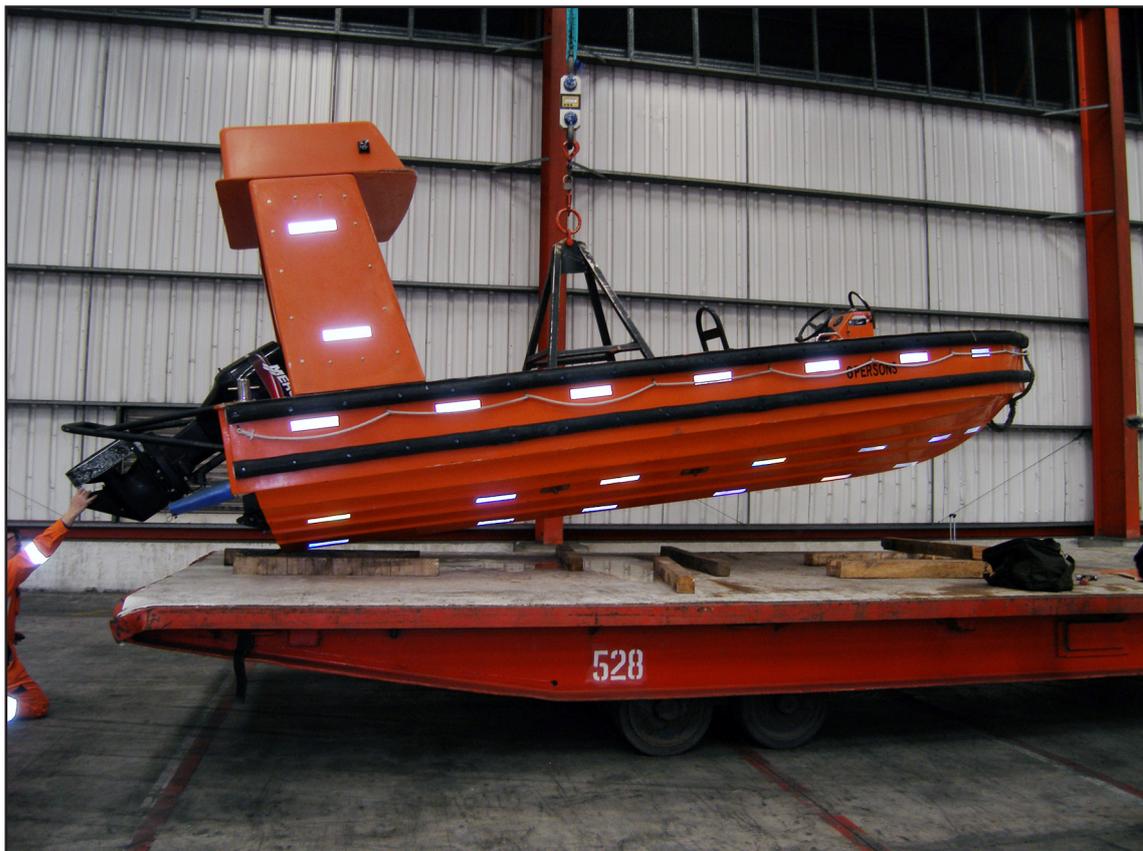
Figure 1

The rescue boat, a Watercraft WHFRB 6.50 had a certified weight of 980kg, but was 1450kg when weighed after the accident (**Figure 1**). Subsequently, several rescue boats of the same model carried on board *Tombarra*'s sister vessels were also inspected and weighed, and they too were found to be significantly heavier than when supplied.

Weighing of the rescue boat

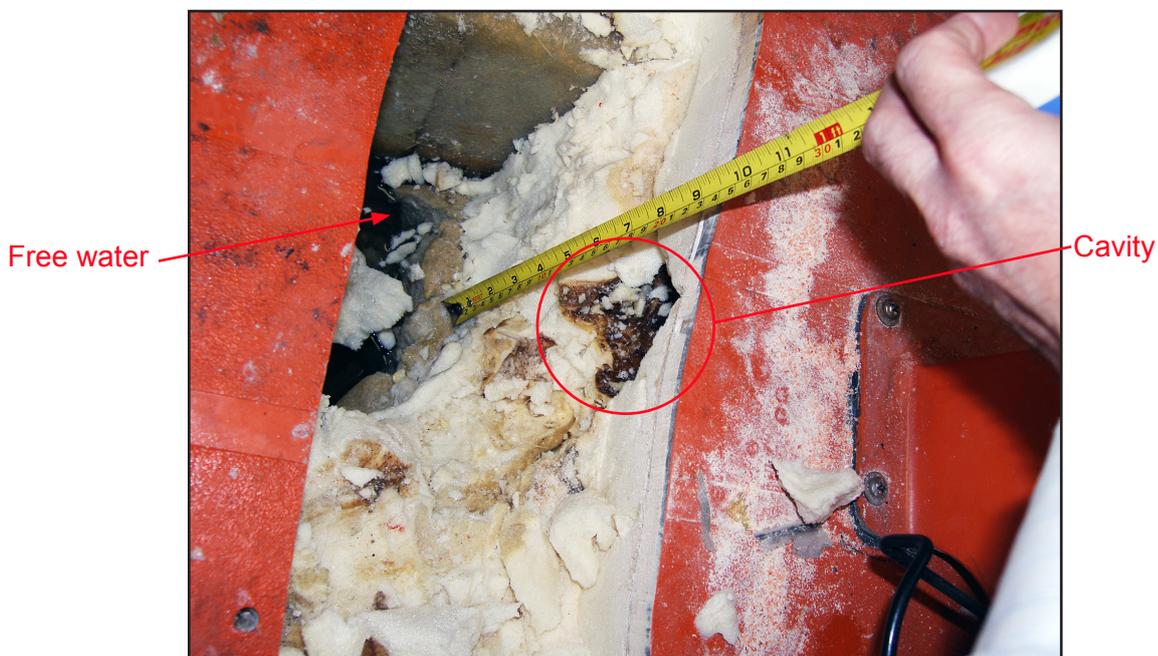
Figure 2

Investigation has identified that 14 of the 15 foam-filled compartments in *Tombarra's* rescue boat had been penetrated by water. In addition, the foam in the lower sections of the hull contained cavities and there were voids between the foam and the hull. In these areas the foam appeared to be of varying consistency and colour (**Figures 2 & 3**).

Below deck inspection

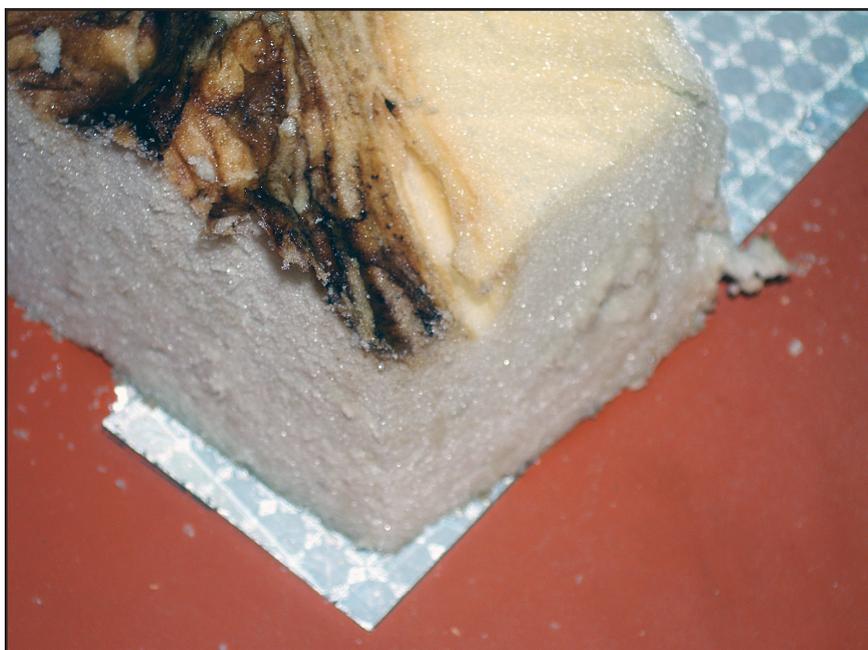
Figure 3

Foam sample from cavity

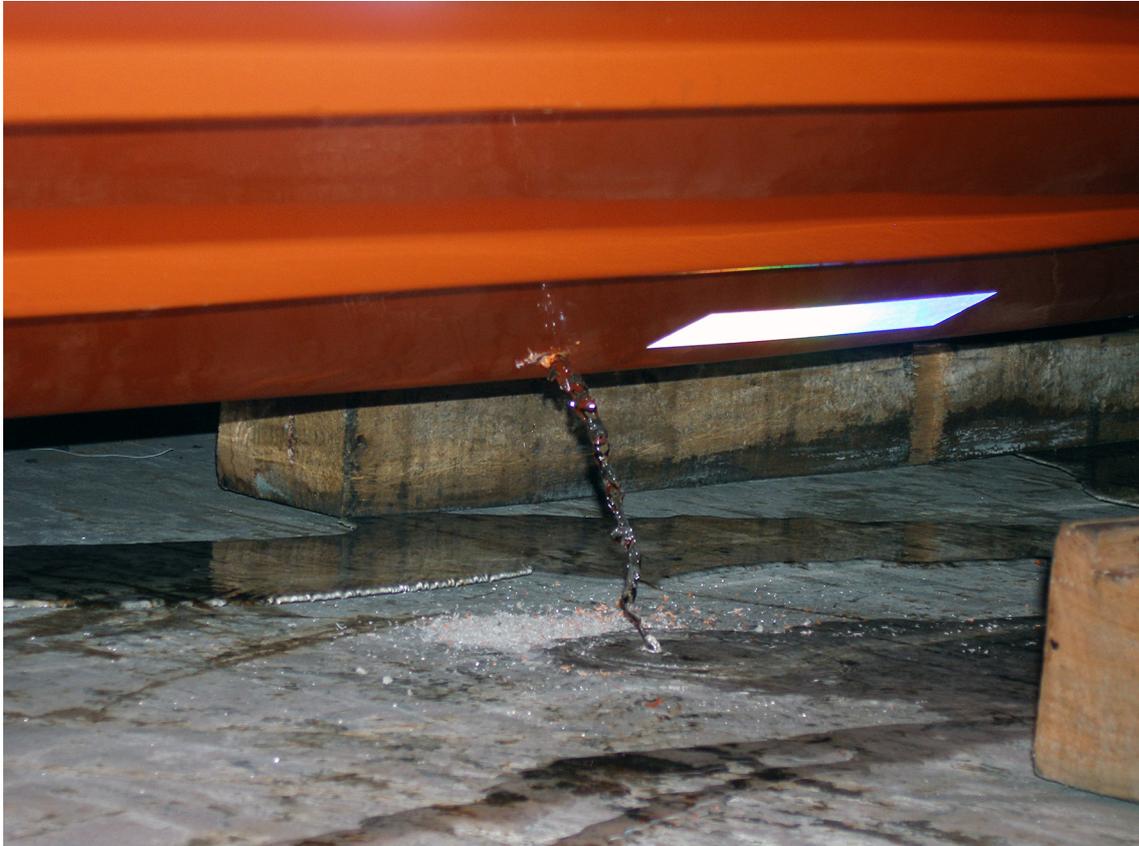
Figure 4

Although the boat was fitted with a drain plug on the transom, the internal compartments were not interconnected. The removal of the plug therefore allowed the water to drain only from the aftermost compartment. The water in the remaining compartments was trapped and had to be drained by separately drilling into each compartment through the hull (**Figure 4**).

Water draining from foam-filled compartments
