MAIB SAFETY BULLETIN 4/2010

Catastrophic failure of a capacitor and explosion in an 11kV harmonic filter
on board the passenger cruise vessel RMS *Queen Mary 2*

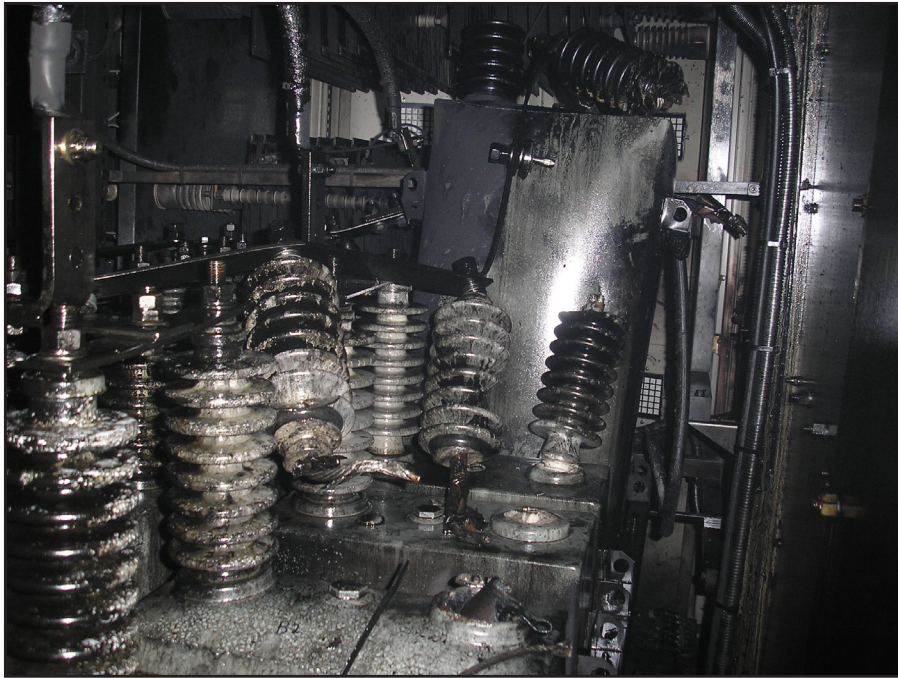
Figure 1

At 0426 (UTC+1) on 23 September 2010, the cruise liner RMS *Queen Mary 2* was approaching Barcelona when one of 12 capacitors in a harmonic filter¹ failed (**Figure 1**), accompanied by a loud explosion. The explosion resulted in extensive damage to the surrounding electric panels and caused the vessel to black out. There were no navigational hazards nearby, main power was restored at 0455 and the ship was able to get back underway at 0523.

Capacitor which failed causing it to rip off the foundation bolts and rise approximately 60cm

Preliminary findings of the investigation carried out by the manufacturer of the capacitor indicate that the capacitor had deteriorated gradually. The monitoring device based on current unbalance detection did not give any indication of the fault developing. The dielectric oil appeared to have vaporised due to internal short circuiting, causing internal pressure to build up and resulting in the oil leaking out and being sprayed onto the high voltage bus bars. The oil vapour is likely to have provided a conducting path between the live phases of the 11kV terminals, resulting in a major arc flash event.

- Inspect the capacitors and check for any physical distortion, unusual smells (indicating dielectric fluid leakage) and signs of external overheating.
- Ensure that the cooling and ventilation systems are functioning correctly.
- Calibrate and function test any fault detection or condition monitoring system fitted.
- Ensure that if there is a history of capacitors in the equipment needing to be replaced, the underlying causes are understood.
- Carry out a thorough check for the cleanliness of all exposed conductors as well as for external signs of chaffing damage on high voltage cables.

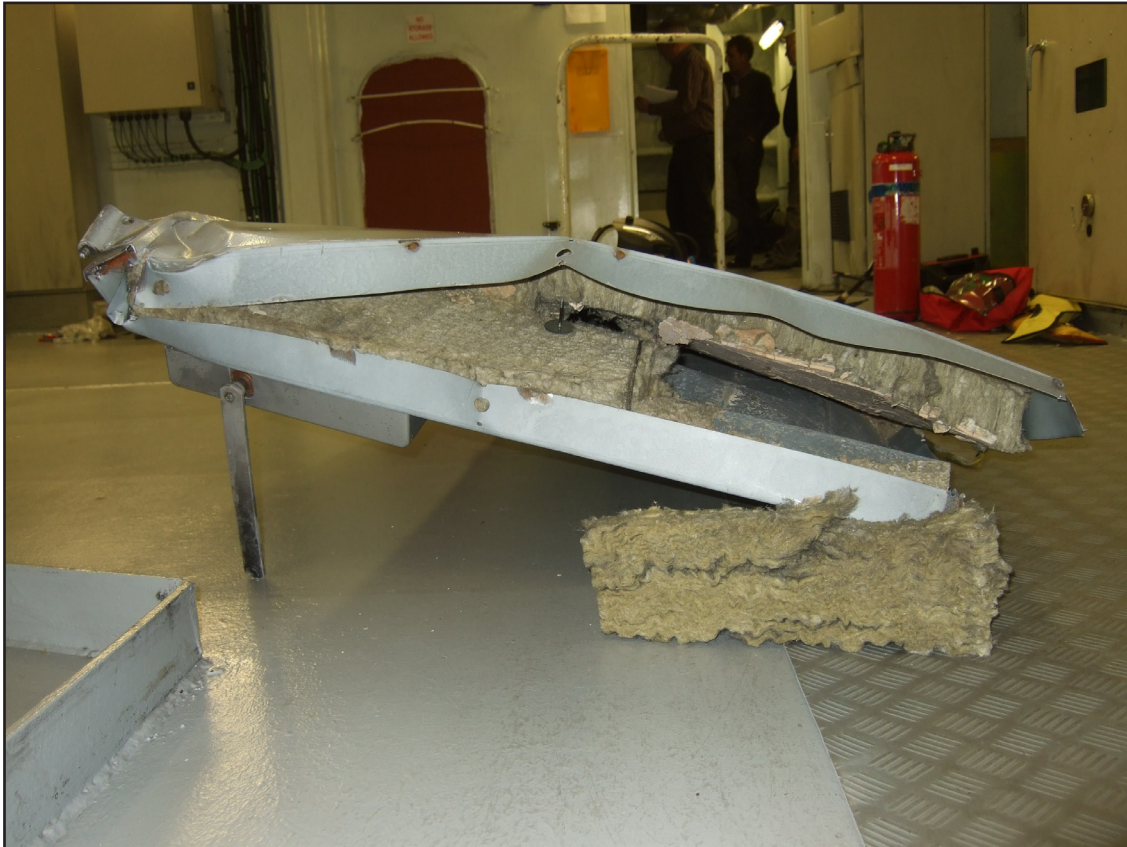
Figure 2

The harmonic filter was connected directly to 11kV bus bars and was located in a compartment within the aft main switchboard room. The blast forced the steel door to the compartment out through its frame and also caused serious damage to an adjoining steel door into the main switchboard room (**Figure 2**). The stiffeners on the bulkhead of the compartment were buckled and the steel cover plate on a cross-flooding duct was blown out into the main switchboard room. Fortunately there were no personnel in the vicinity. The steel casing of another capacitor in the same group was found to have bulged severely and was possibly on the verge of failure (**Figure 3**).

Damaged steel door to the harmonic filter compartment

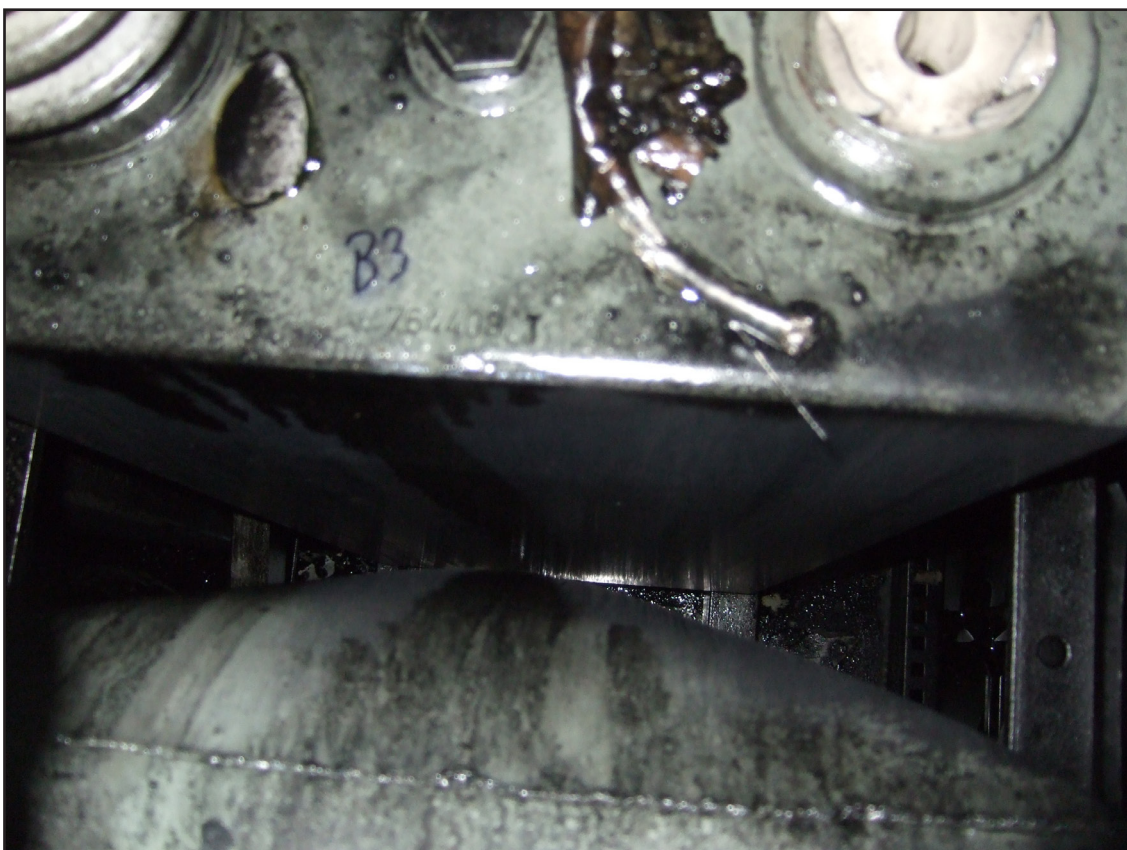
Figure 3

Top view of two capacitors indicating one which had developed a severe bulge due to internal pressurisation

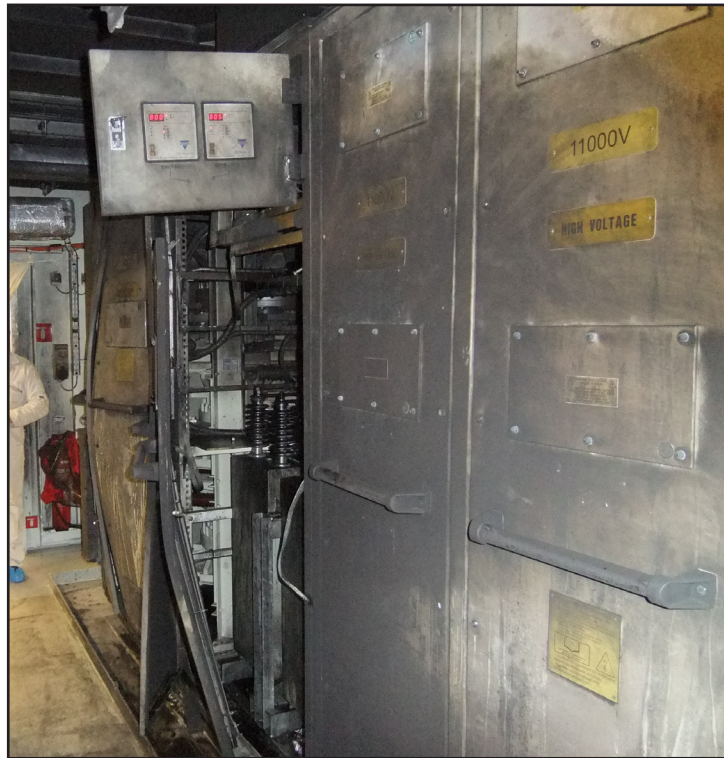
There was evidence of smoke and heat in the compartment (**Figure 4**), and any fire was probably extinguished by water from the hi-fog system. Two hi-fog outlets, one in the harmonic filter compartment and the other in the main switchboard room, were activated in the wake of the blast.

Soot staining on the blown-out doors of the harmonic filter casing
