Report on the investigation of
contacts made by the
high speed craft

Norman Arrow

with quays in Portsmouth International Port,

Report No 7/2011
May 2011

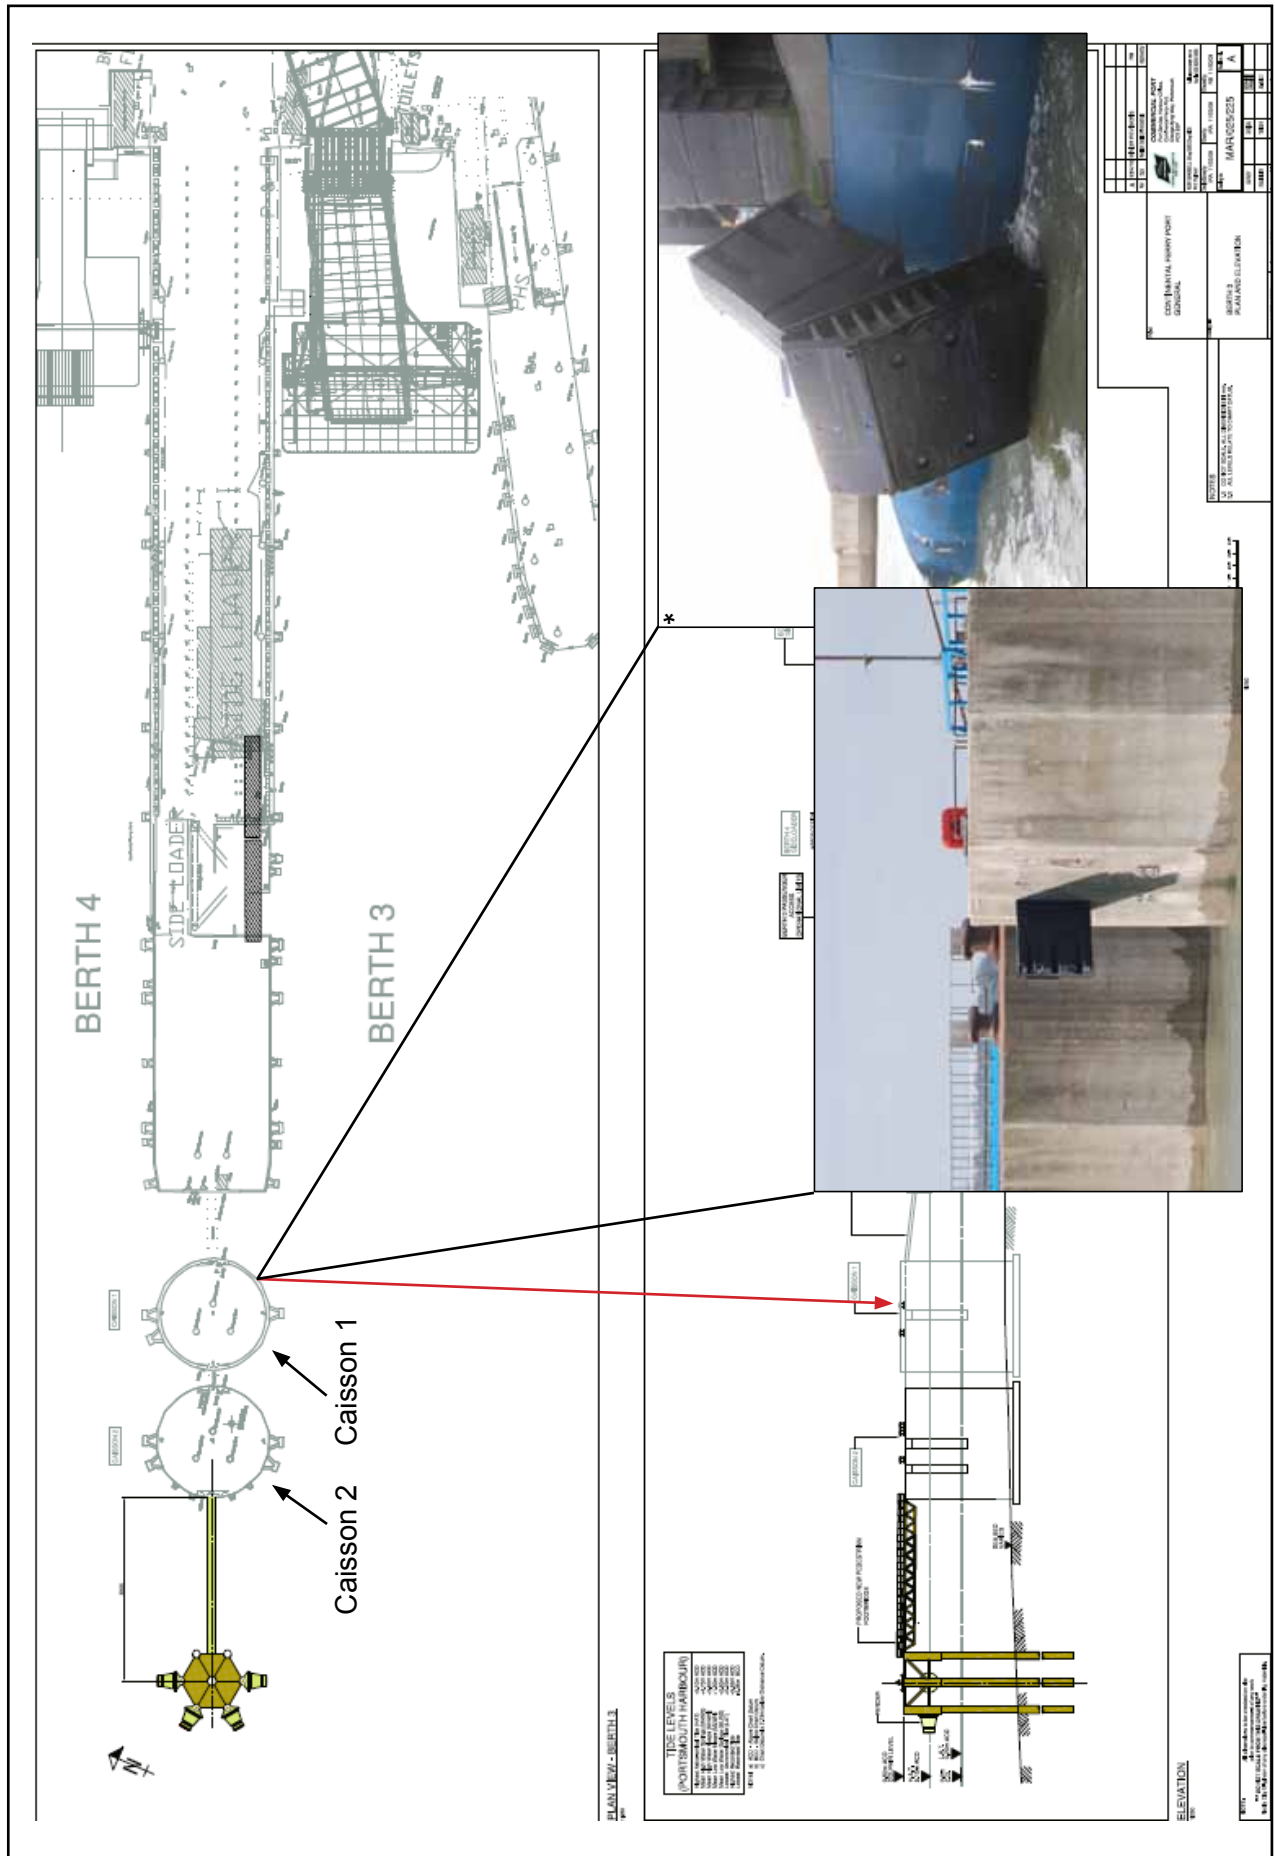
Caisson 1

By 1632, the wind had decreased to 20 knots, and the master was able to manoeuvre the vessel off the finger jetty (**Figure 5**). He advised the pilot and chief officer that he intended to manoeuvre *Norman Arrow* into the tidal basin to await the tug. As the vessel moved ahead, her bow came very close to the fenders on caisson 1 and her starboard prow became wedged between the back plate of the first fender and the caisson wall. The fender was detached from the wall and lodged on the starboard prow (**Figure 6**).

Fender 1 on caisson 1 was totally removed (**Figure 6**), leaving only a support beam attached to the quay.

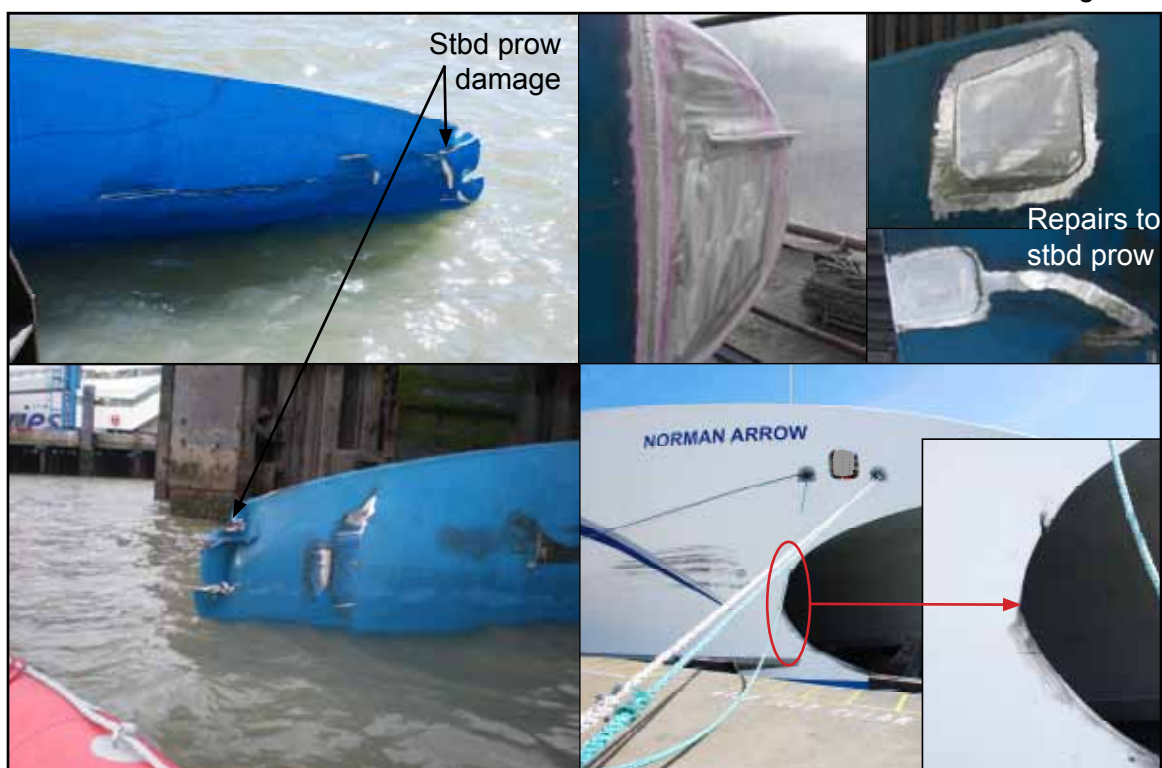
Figure 7

Norman Arrow's starboard prow was torn and indented; its tip was set inboard and split open. The shell plating forward of the collision bulkhead was punctured and gouged (**Figure 7**).

Damage to *Norman Arrow*

Det Norske Veritas (DNV), *Norman Arrow*'s classification society, gave the vessel permission to sail to Dunkerque, subject to:

- Frame 86 plugs and frame 83 hatch and plug remaining secured in place
- Frame 83 being temporarily shored up
- Monitoring of the damaged areas during the voyage
- A speed limitation of 15 knots.

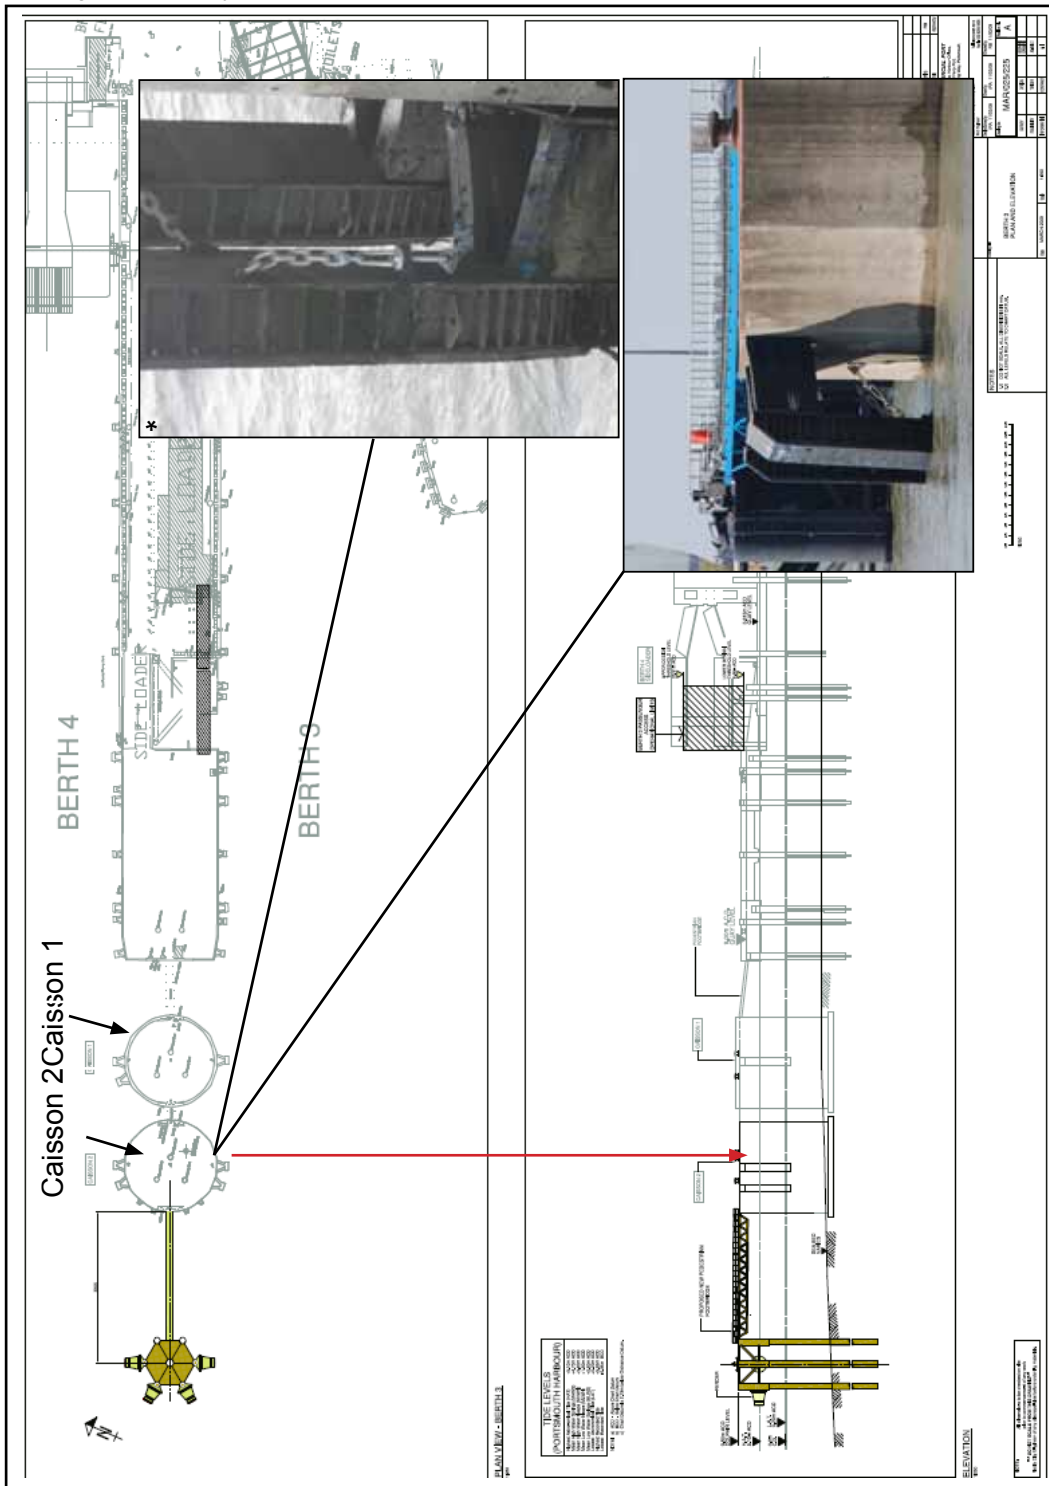
Figure 8

The base plate of fender 1 on caisson 2 (**Figure 8**) was bent and a support chain was severed. Fender 2 on caisson 2 was slightly displaced from the perpendicular.

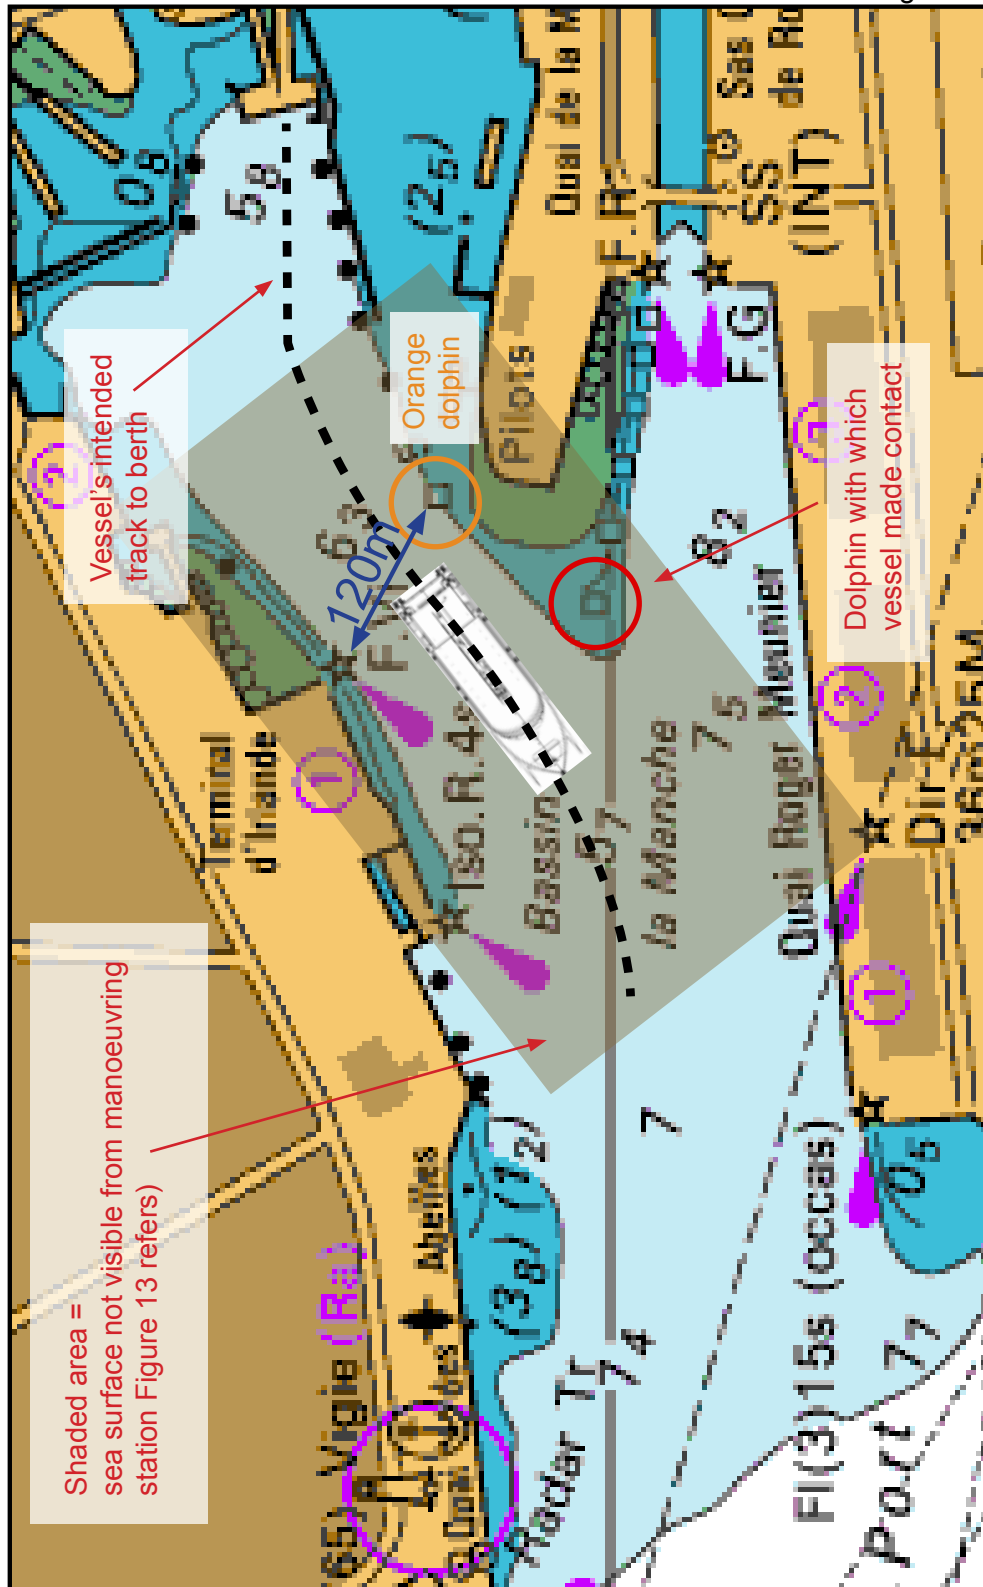
Norman Arrow - approach to the orange dolphin

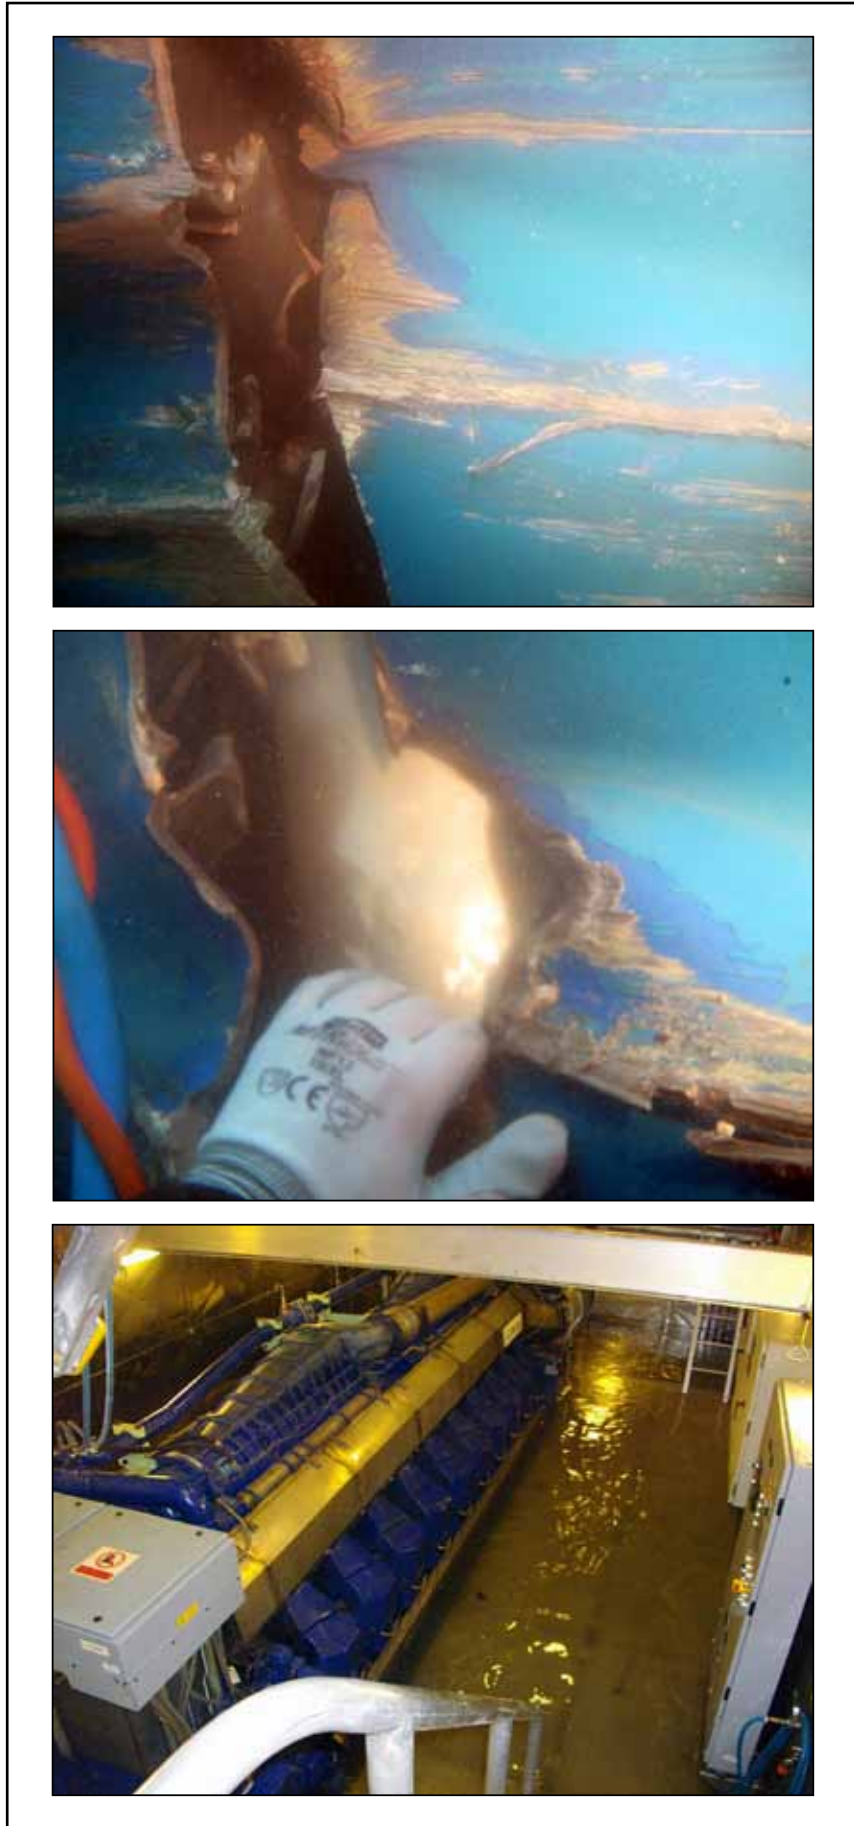
Norman Arrow's port hull was heavily indented and holed about 1m below the waterline, in way of the forward engine room. Water entered through three holes, and the space flooded to cover the engine access platform (**Figure 19**). The extent of the damage was such that the vessel was withdrawn from service for the remainder of the summer season.

Norman Arrow hull damage and flooded engine room
