Report on the investigation of  
contacts made by the  
high speed craft

***Norman Arrow***

with quays in Portsmouth International Port,

**Report No 7/2011  
May 2011**

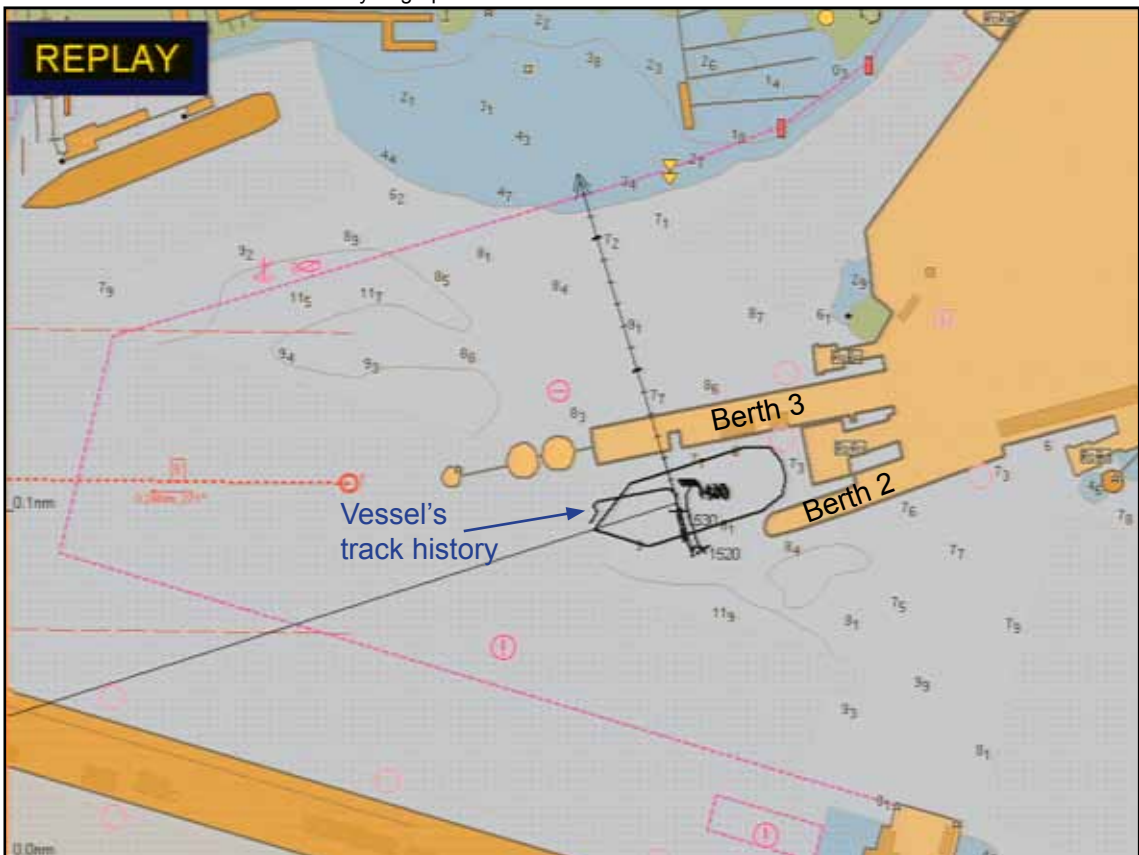
By 1632, the wind had decreased to 20 knots, and the master was able to manoeuvre the vessel off the finger jetty (**Figure 5**). He advised the pilot and chief officer that he intended to manoeuvre *Norman Arrow* into the tidal basin to await the tug. As the vessel moved ahead, her bow came very close to the fenders on caisson 1 and her starboard prow became wedged between the back plate of the first fender and the caisson wall. The fender was detached from the wall and lodged on the starboard prow (**Figure 6**).

*Norman Arrow manoeuvring back to berth 3*

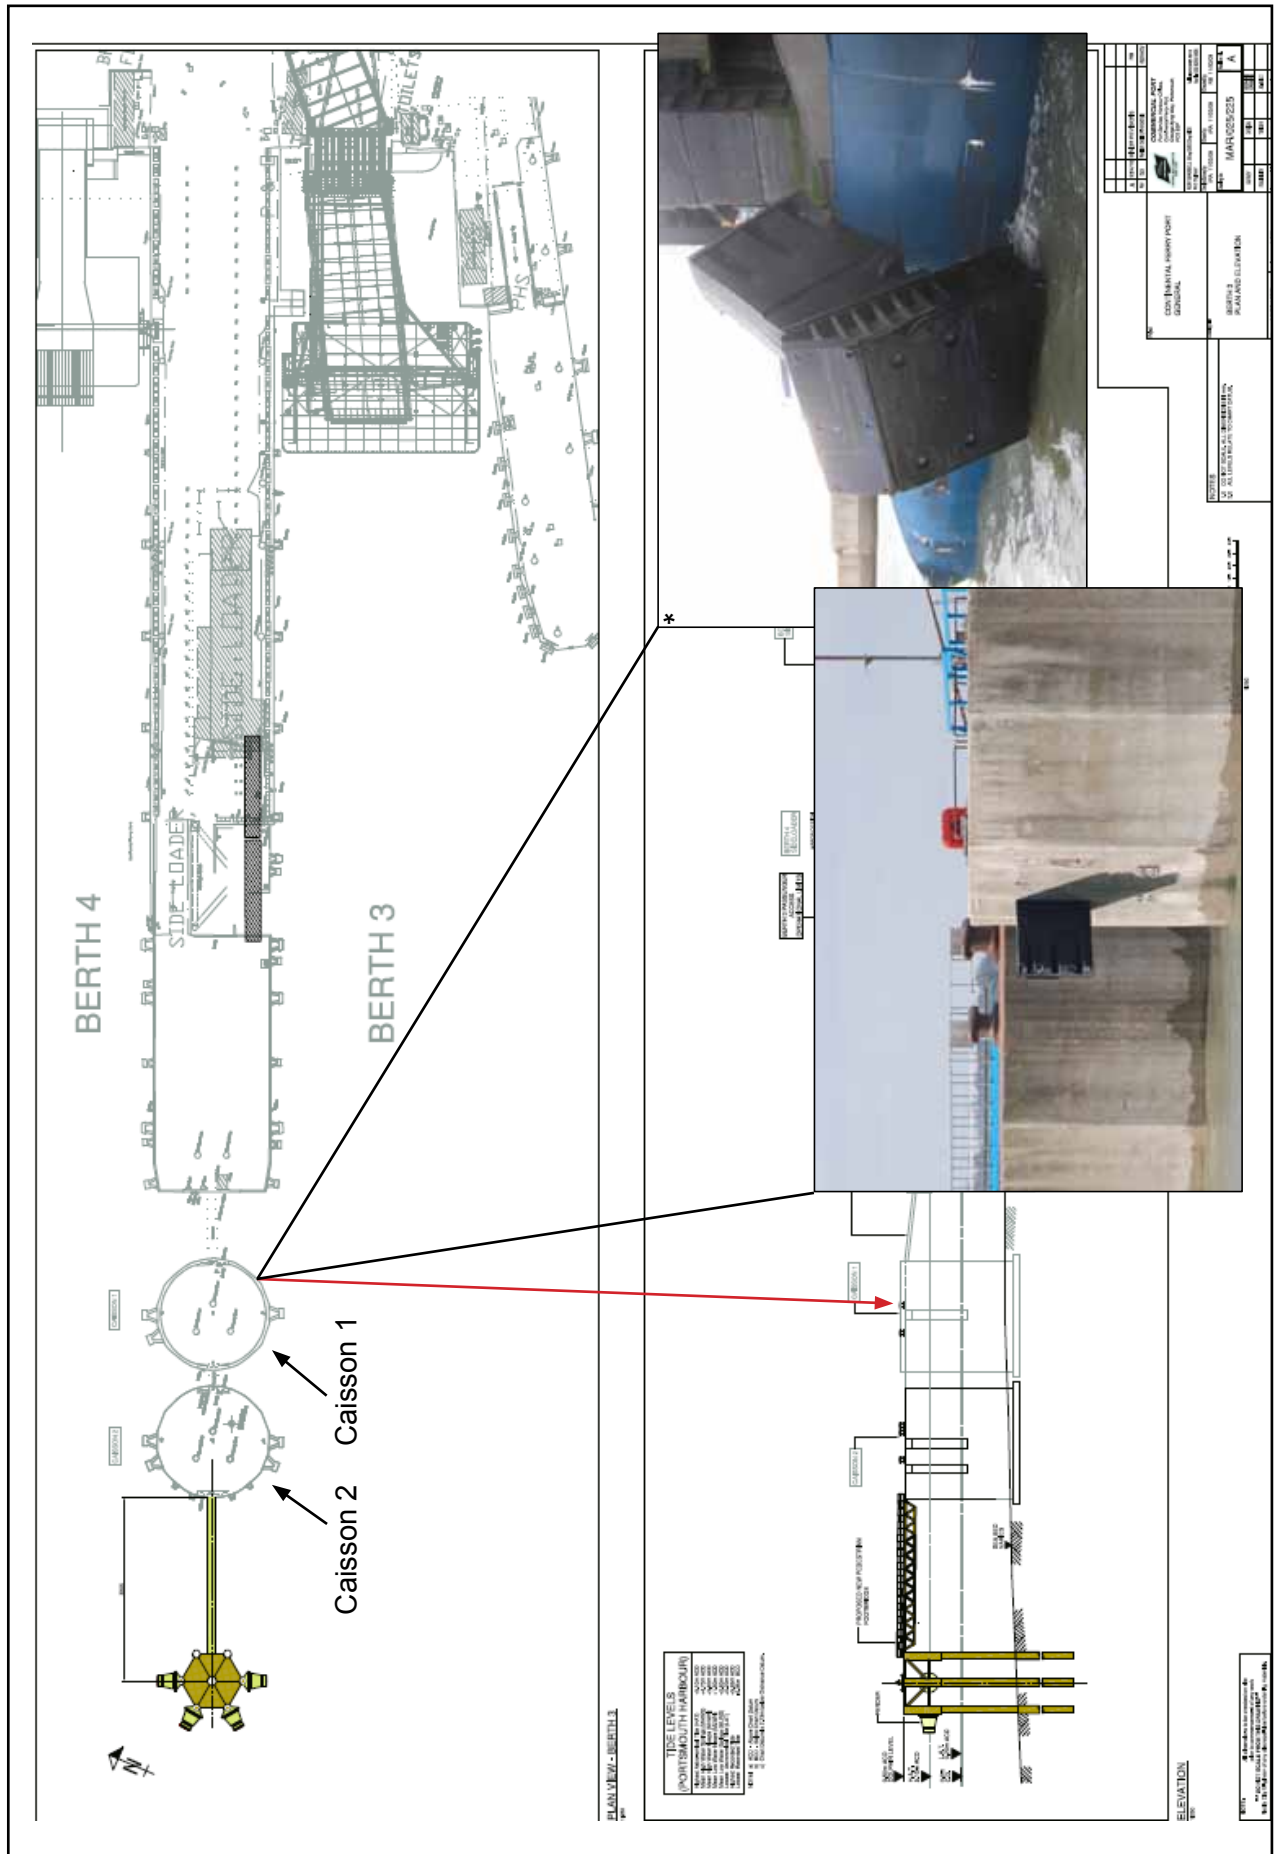
Caisson 1

Fender 1 on caisson 1 was totally removed (**Figure 6**), leaving only a support beam attached to the quay.

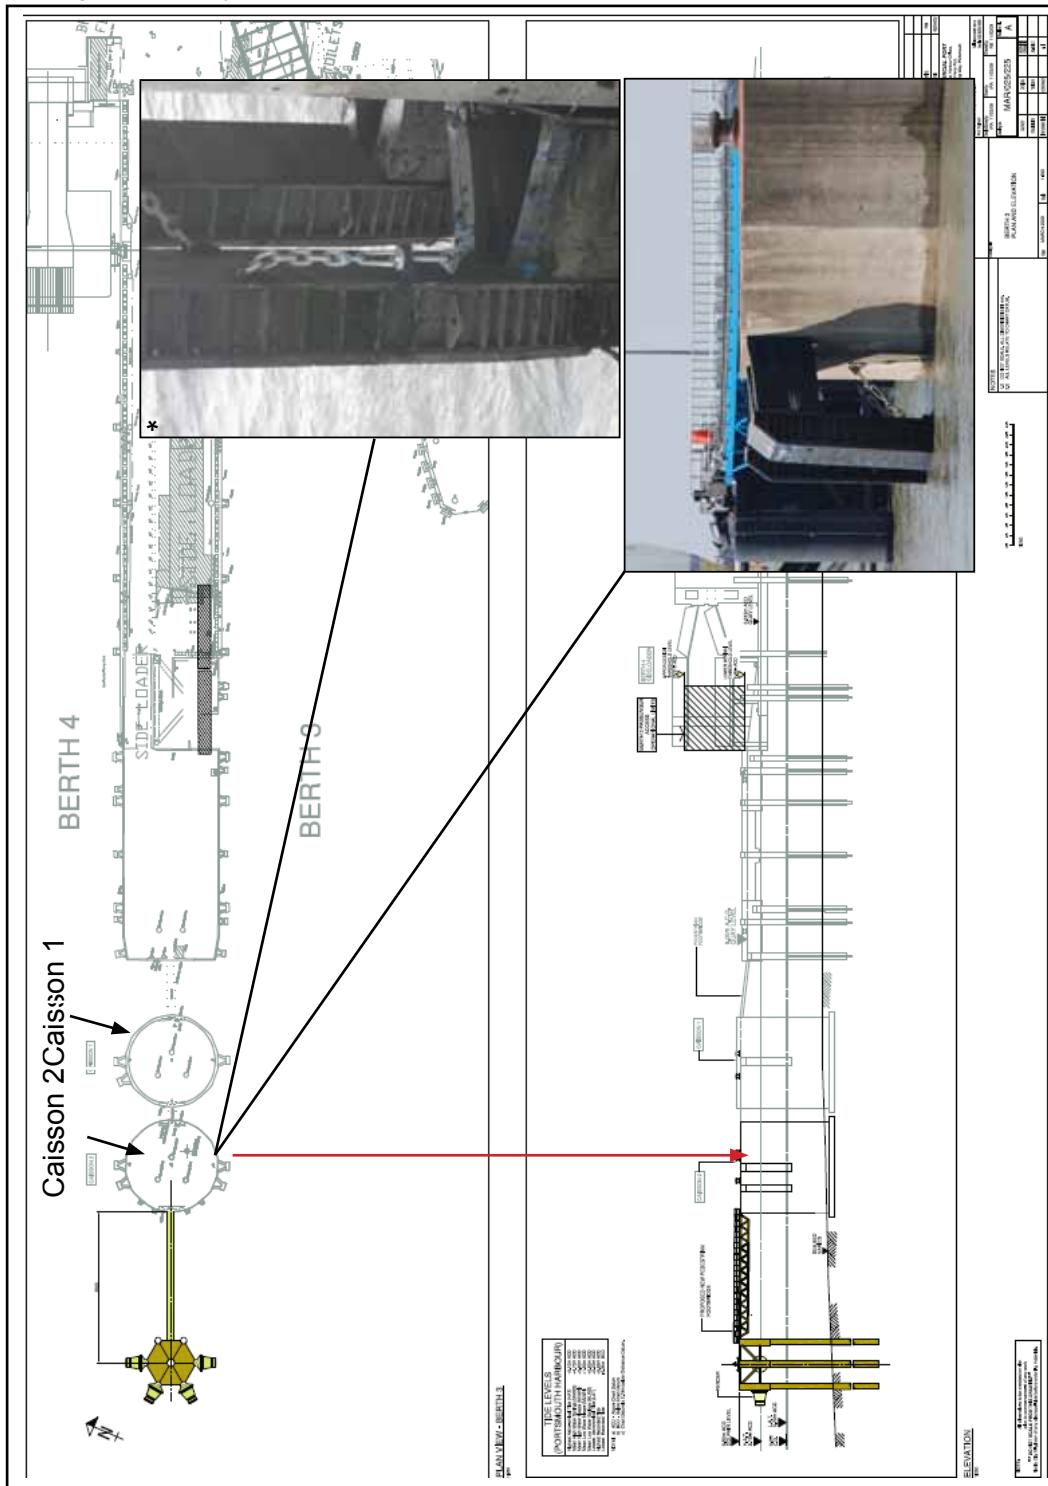
Figure 8

The base plate of fender 1 on caisson 2 (**Figure 8**) was bent and a support chain was severed. Fender 2 on caisson 2 was slightly displaced from the perpendicular.

Caisson 2

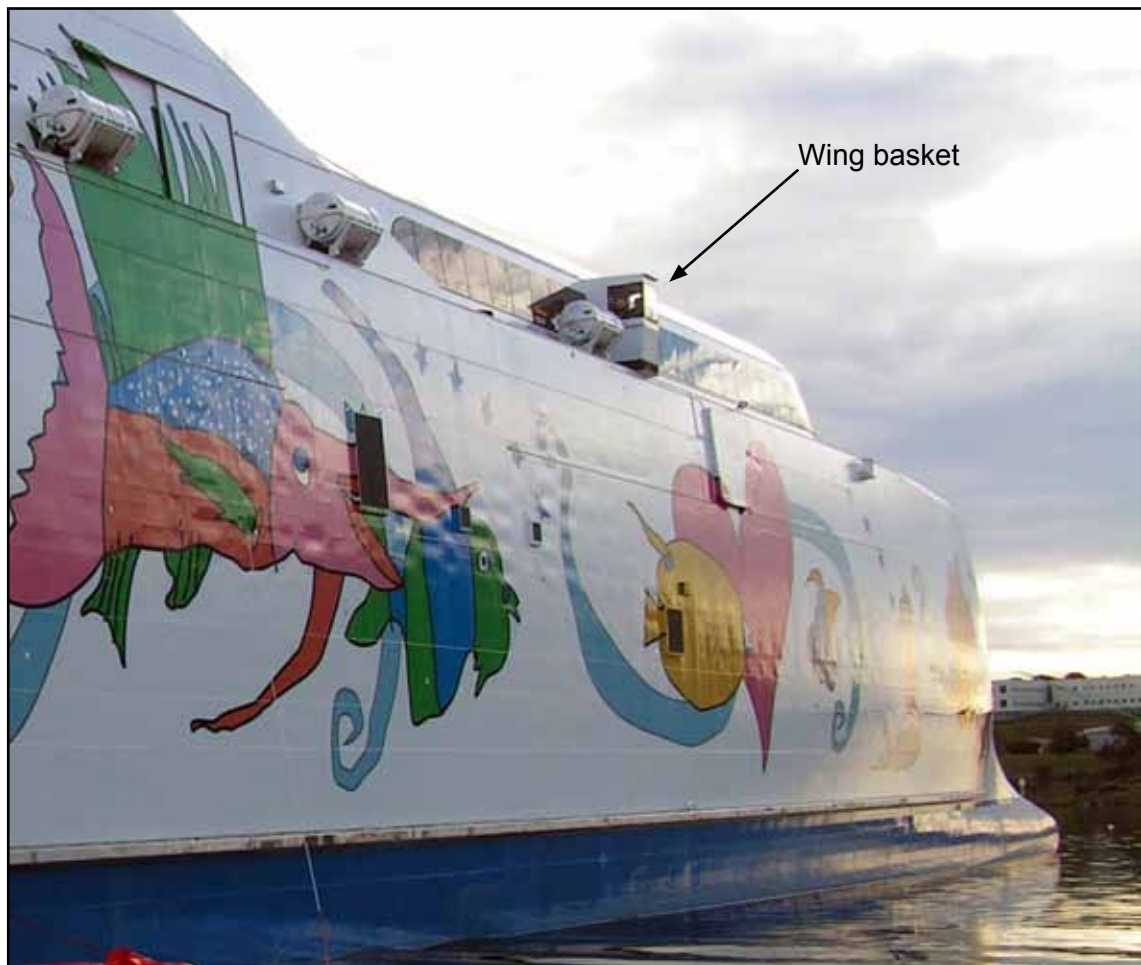
Figure 14

The control station arrangement for the previous two vessels of this class, *Natchan Rera* and *Natchan World*, included manoeuvring stations or wing baskets sited at the vessels’ sides (**Figure 14**). The side manoeuvring stations were also fitted with a talkback communications system that connected to the fore and aft mooring parties.

‘Wing basket’ fitted to sister vessels
