Report on the investigation of  
contacts made by the  
high speed craft

***Norman Arrow***

with quays in Portsmouth International Port,

**Report No 7/2011  
May 2011**

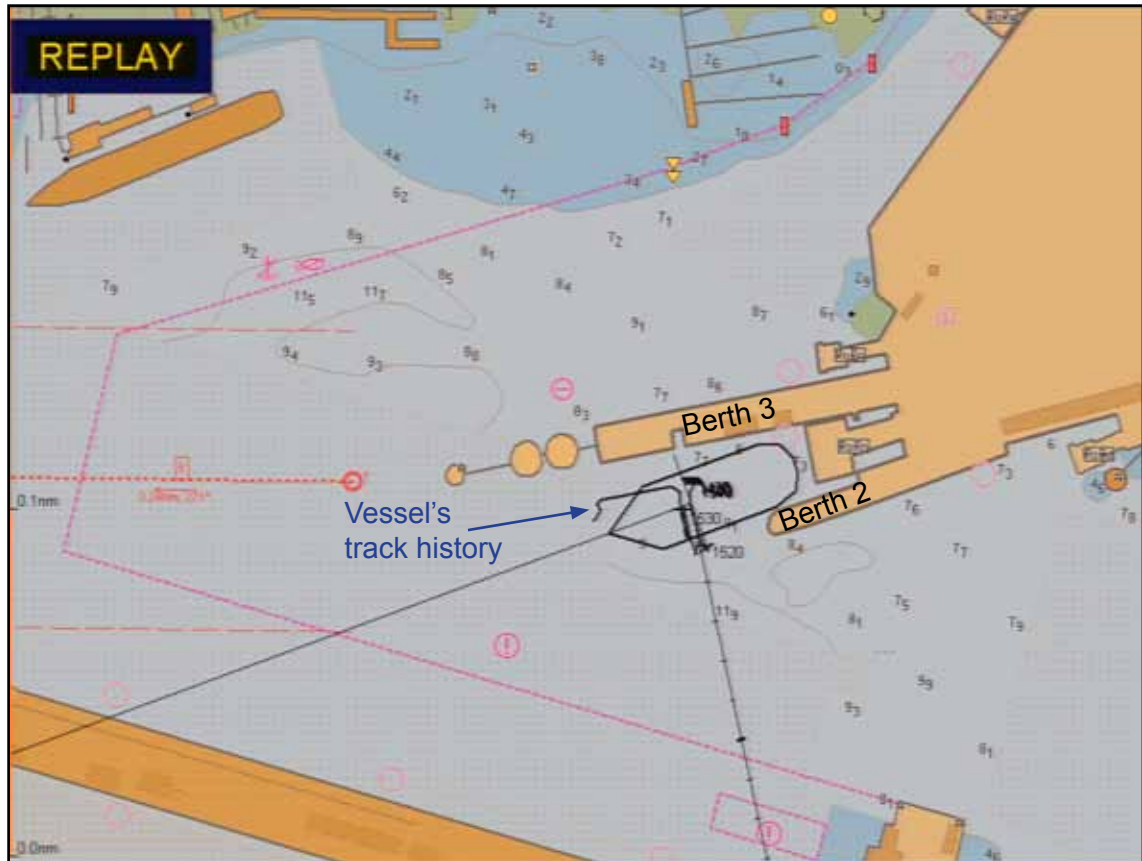
By this time, *Norman Arrow's* heading had passed 250° and the vessel continued to swing very quickly to port until, at 1619, her port side made contact with the northern side of the western end of the finger jetty of berth 2 (**Figure 3**). *Norman Arrow's* bow continued to swing to port, but the master was able to manoeuvre the vessel to prevent her stern from hitting berth 3.

*Norman Arrow* contact with finger jetty of berth 2

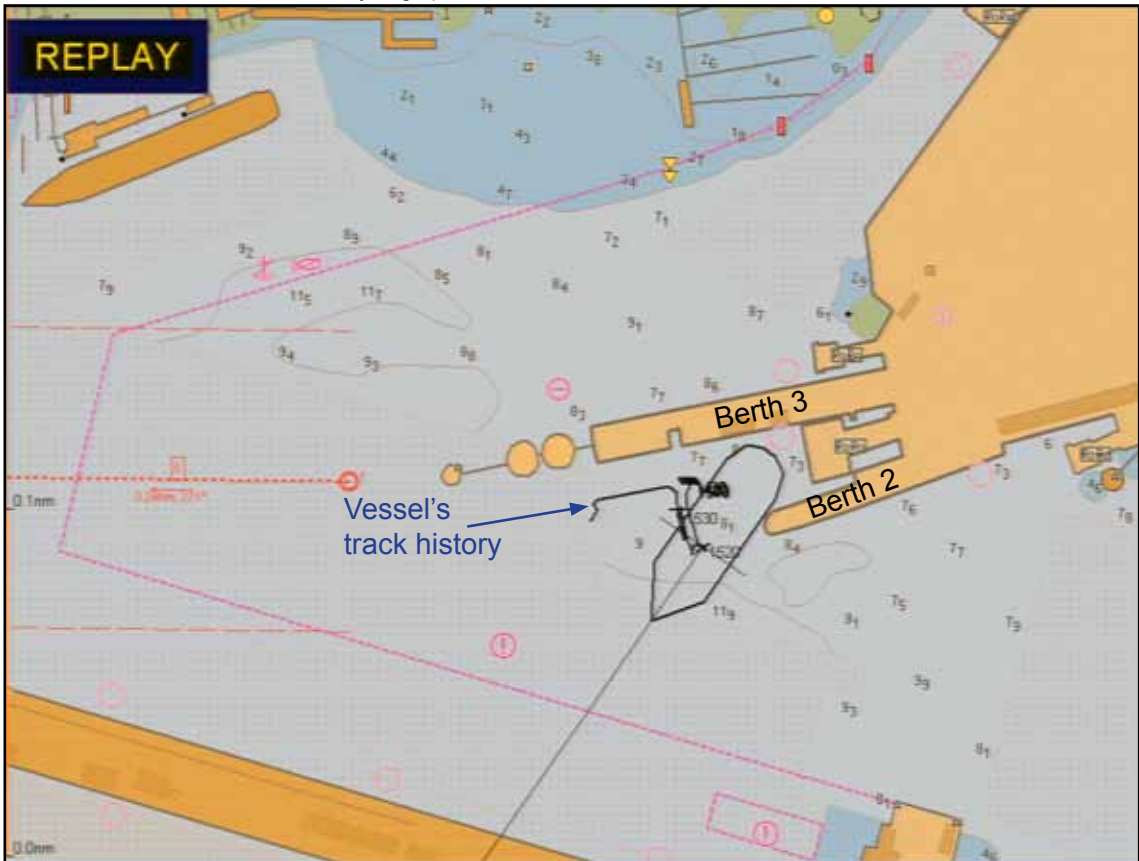
The master immediately asked the pilot for tug assistance. Accordingly, the pilot passed this request to the Queen's Harbour Master (QHM) using very high frequency (VHF) radio and was informed that the duty tug would arrive in 20 minutes. While the master waited for the tug, he attempted to manoeuvre the vessel's bow back towards berth 3, but was unable to do so. *Norman Arrow* remained balanced on the end of the finger jetty, and was now oscillating around a heading of 217° (**Figure 4**). The wind was now 294° at 37 knots.

*Norman Arrow* on finger jetty of berth 2, heading 217°

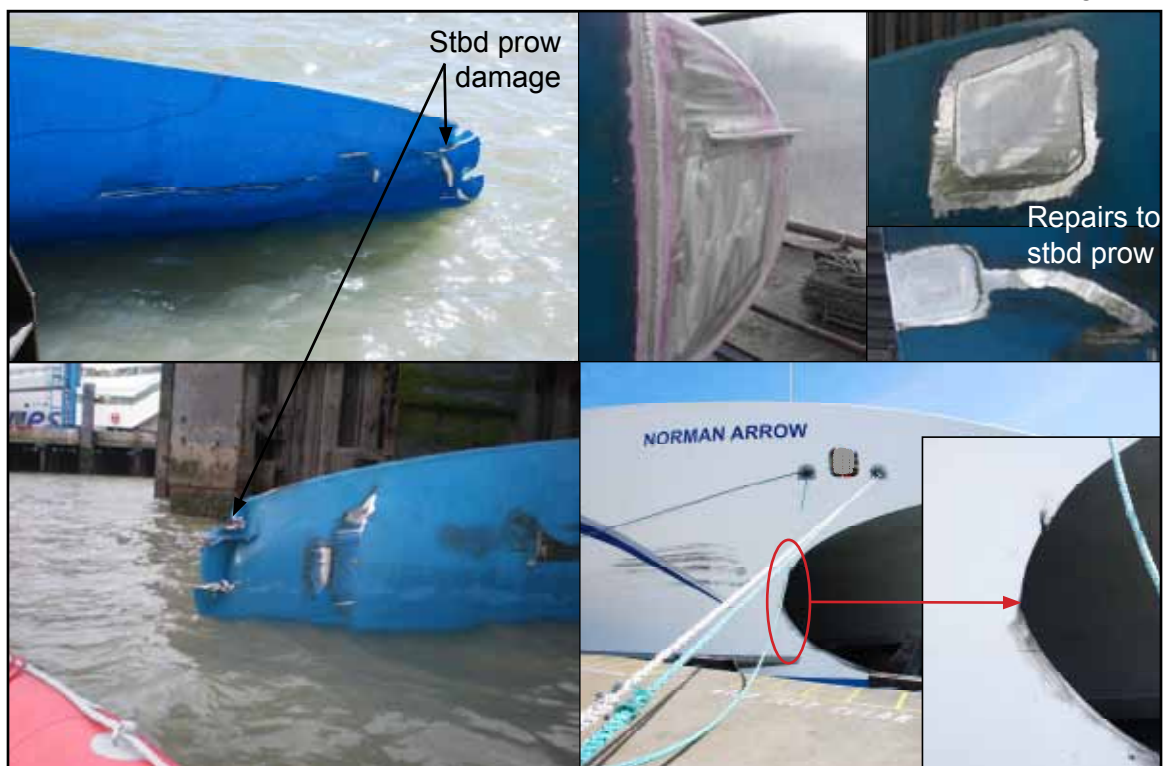
Figure 7

Damage : Vessel: Starboard prow split, forepeak penetrated and shell plating of starboard number 1 void torn

Damage to *Norman Arrow*

Det Norske Veritas (DNV), *Norman Arrow*'s classification society, gave the vessel permission to sail to Dunkerque, subject to:

- Frame 86 plugs and frame 83 hatch and plug remaining secured in place
- Frame 83 being temporarily shored up
- Monitoring of the damaged areas during the voyage
- A speed limitation of 15 knots.

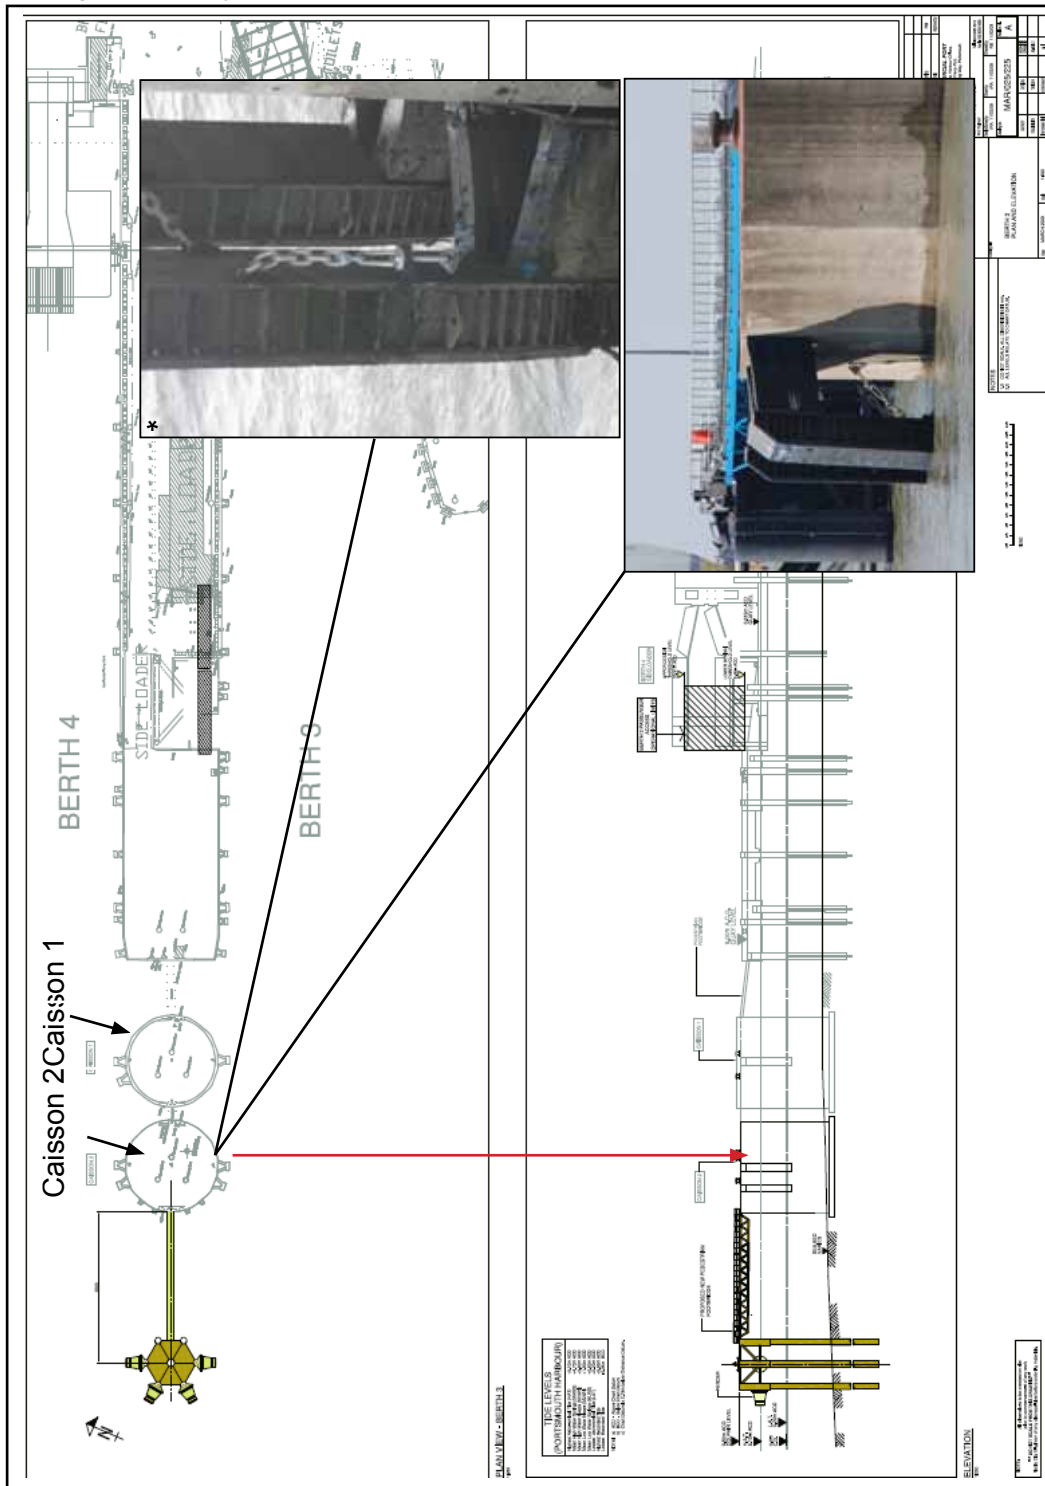
Figure 8

No 3 berth: Damage to fixed fendering; one fender detached

Caisson 2

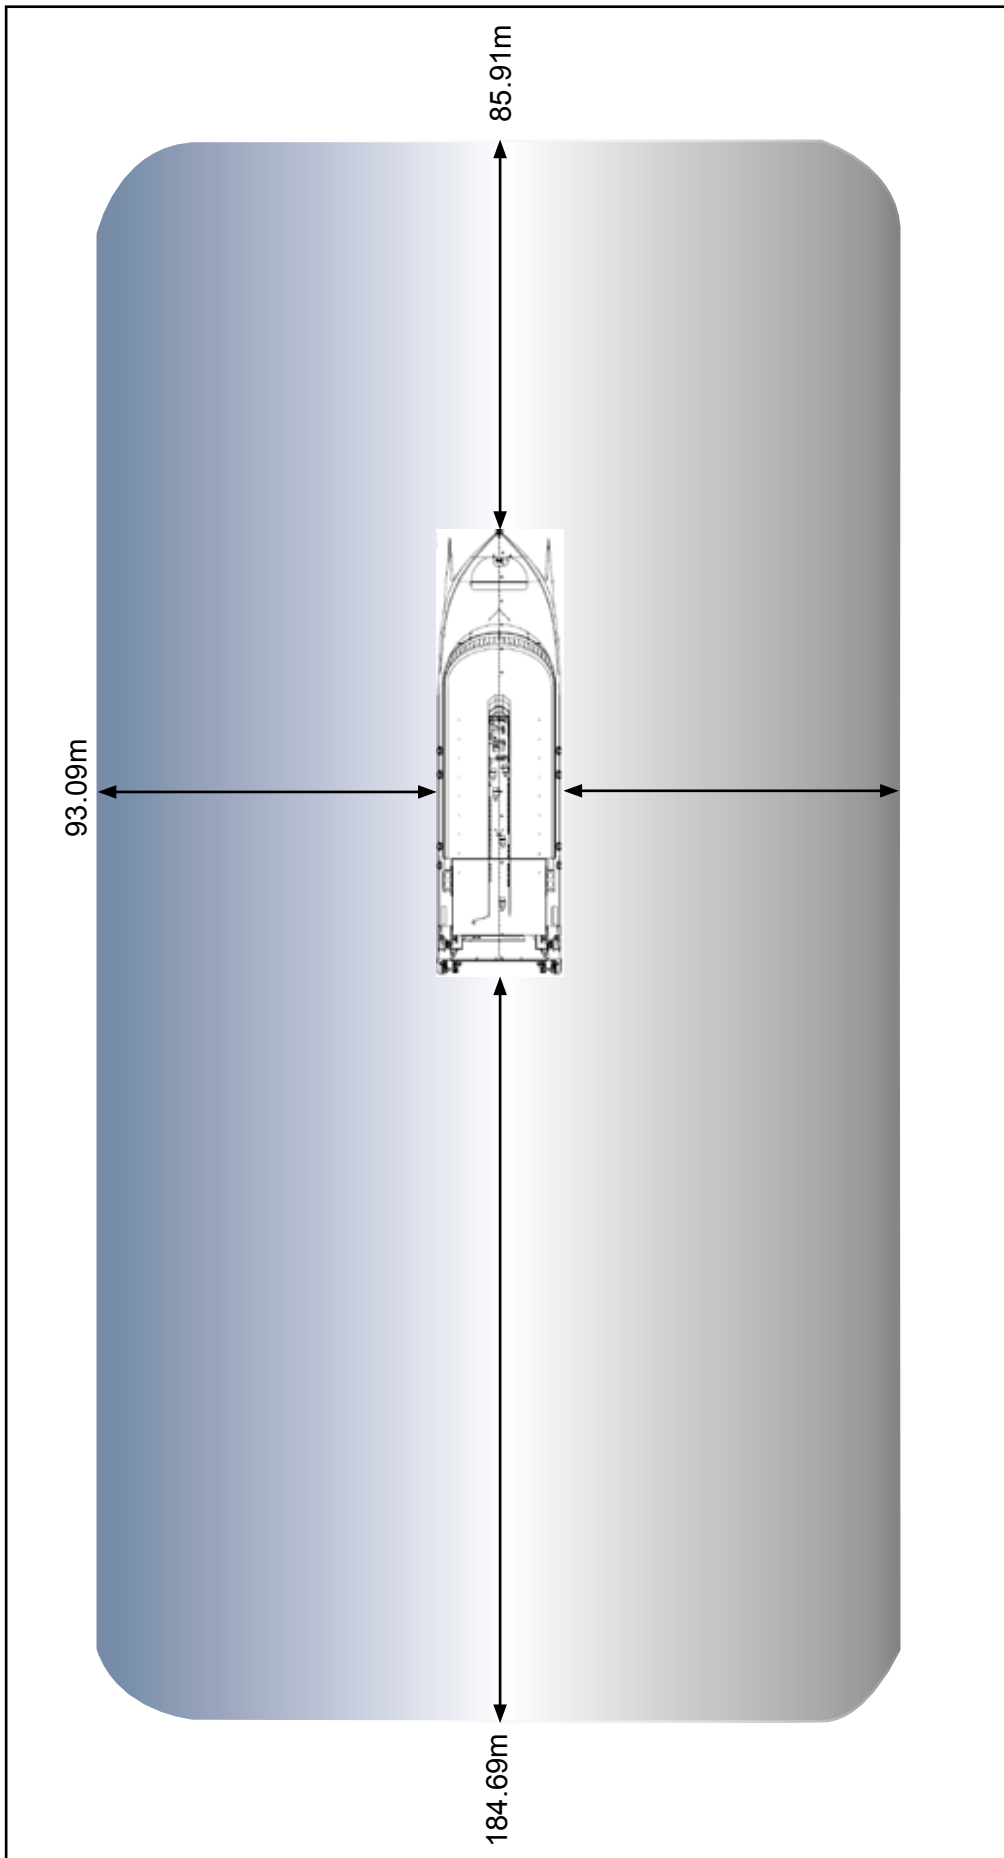
Figure 10

Bridge visibility shadow area at sea surface

Given the difficulty in manoeuvring *Norman Arrow* at slow speeds in winds over 25 knots, the lack of near-field visibility and poor bridge ergonomics, effective teamwork was essential to the vessel's safe operation when navigating in and out of ports. However, several omissions and deficiencies indicate that the organisation and management of the bridge team and outstations was not effective during either accident.

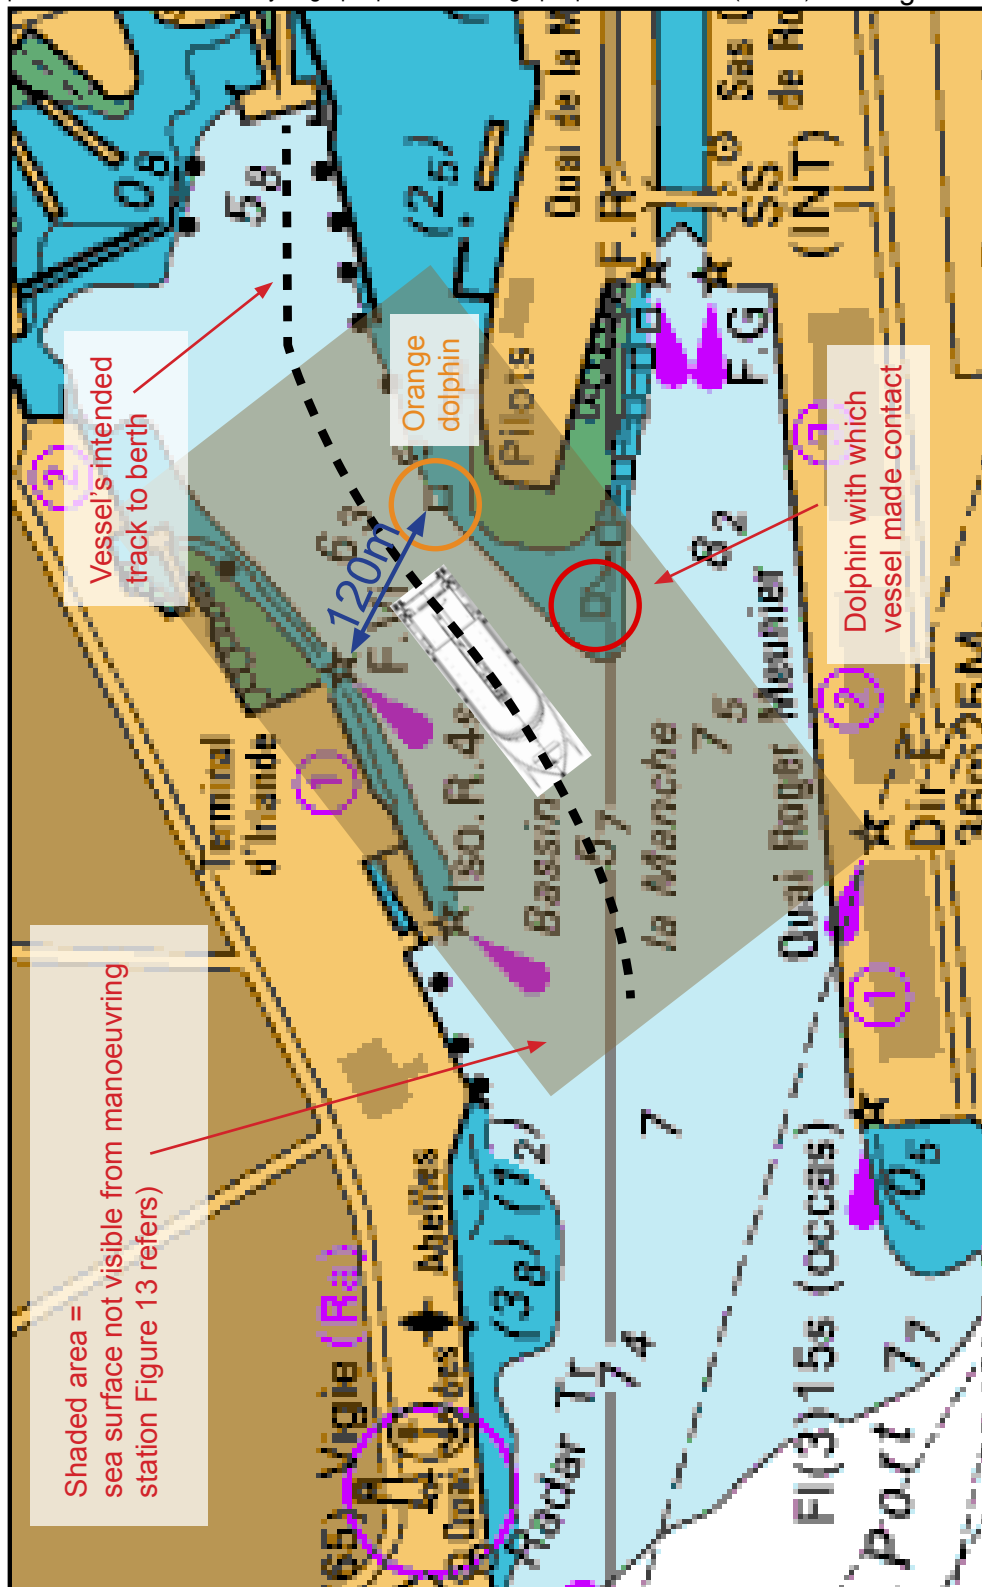
The senior master placed the engine controls into back-up mode to try and increase the effect of the water-jets. He also asked the pilot if the wind was from the north-west; the pilot advised that it was from the west-by-north. By 1132, the senior master had manoeuvred the vessel off the dolphin and was heading east; the vessel then proceeded astern towards the outer harbour.

Norman Arrow - approach to the orange dolphin
