Rail Accident Investigation Branch

# RAIB Bulletin 01/2014

## Engineering train collision at Kitchen Hill, near Penrith, 12 January 2014

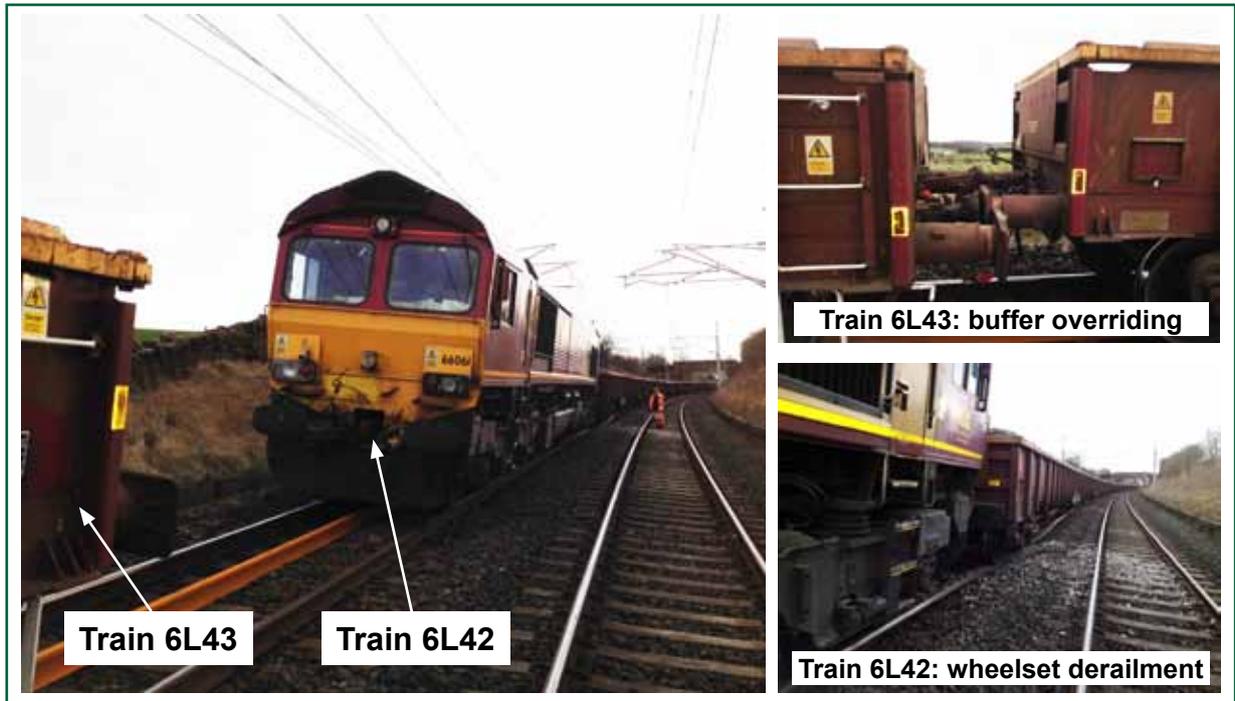
- 3 Around 20 metres of rail fastenings unclipped as a result of the collision, allowing the track gauge to spread and causing four wheelsets of train 6L42 to derail. Wagon buffers overrode at two locations: between the leading wagon on train 6L42 and the locomotive, and mid-way along train 6L43 (figure 2). The driver of train 6L42 jumped from his cab just before the collision. He sustained abdominal injuries and was detained in hospital overnight. No-one else was injured.

Figure 2: Trains 6L43 and 6L42 after the collision (photographs courtesy of Network Rail)

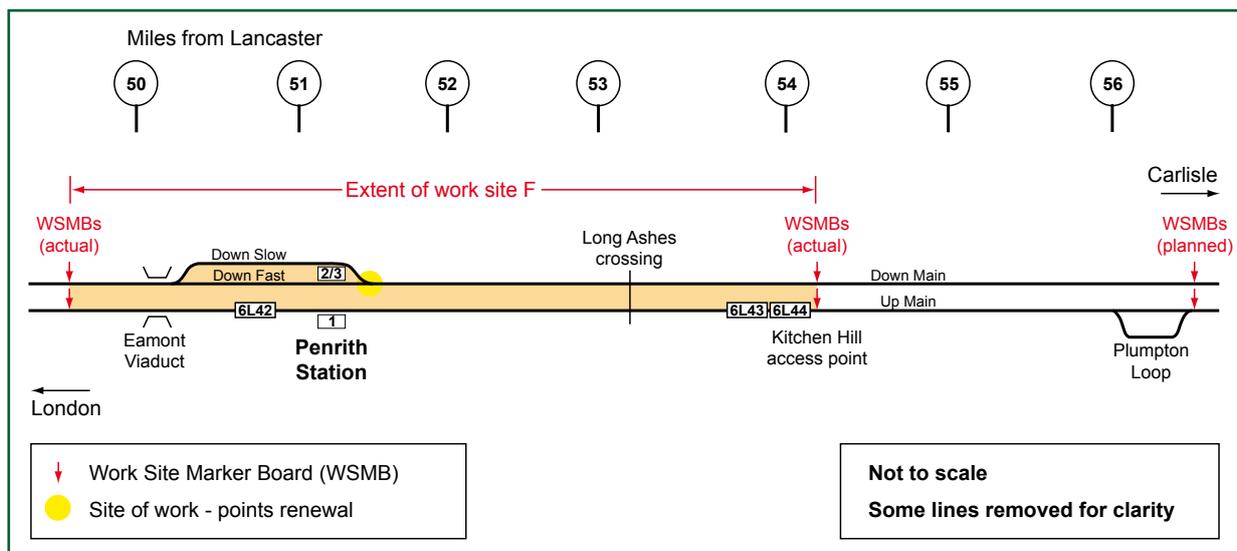
Figure 3: Work site F – also showing the stabled location of the trains on the Up Main (paragraph 12)

- 12 The trains on the Up Main finished working overnight and were shut down awaiting new drivers. Train 6L44 was *stabled* just inside the marker boards at Kitchen Hill, with train 6L43 close behind; train 6L42 was stabled approximately half a mile south of Penrith station (figure 3).

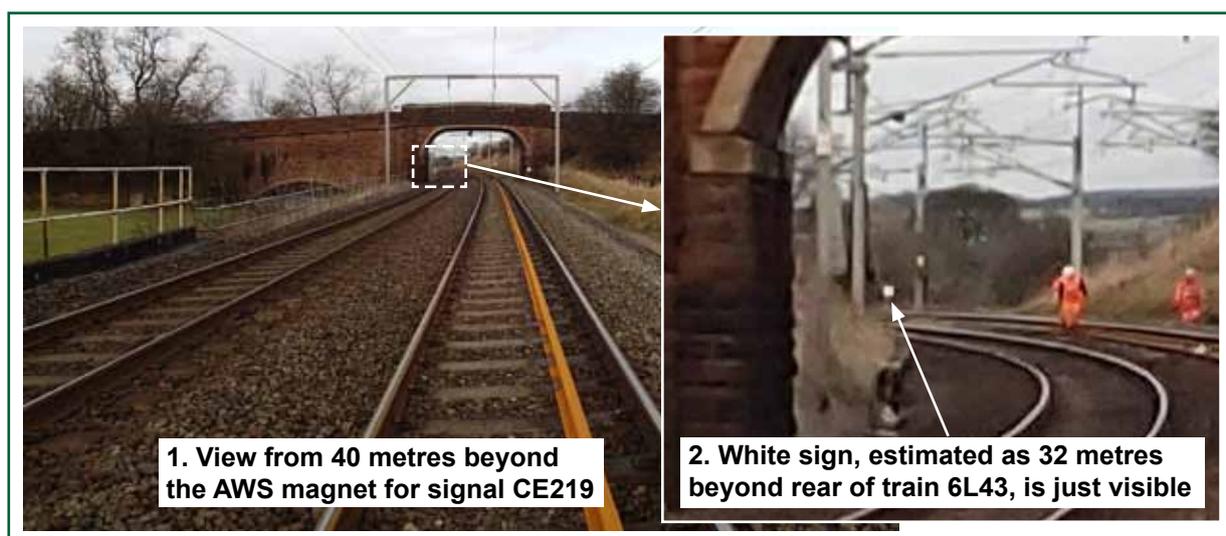
- 30 The RAIB surveyed the sighting on the Up Main line and estimated that the rear of train 6L43 would have come into view shortly after train 6L42 had passed over the *AWS magnet* for colour-light signal CE219 (figure 5). The locomotive’s OTDR recording showed that the driver had operated the emergency brake around a second after responding to the AWS cab warning he received, indicating that alertness and distraction were not factors in this accident. The driver also reported that he did not feel under any particular time pressure. Although he was aware that those engaged with the renewal work were tidying up and were keen for the engineering trains to leave, he was also aware that the possession was not due to be given up until 15:30 hrs and that he therefore had sufficient time for the movement he had to make.

Figure 5: Sighting of the location of train 6L43

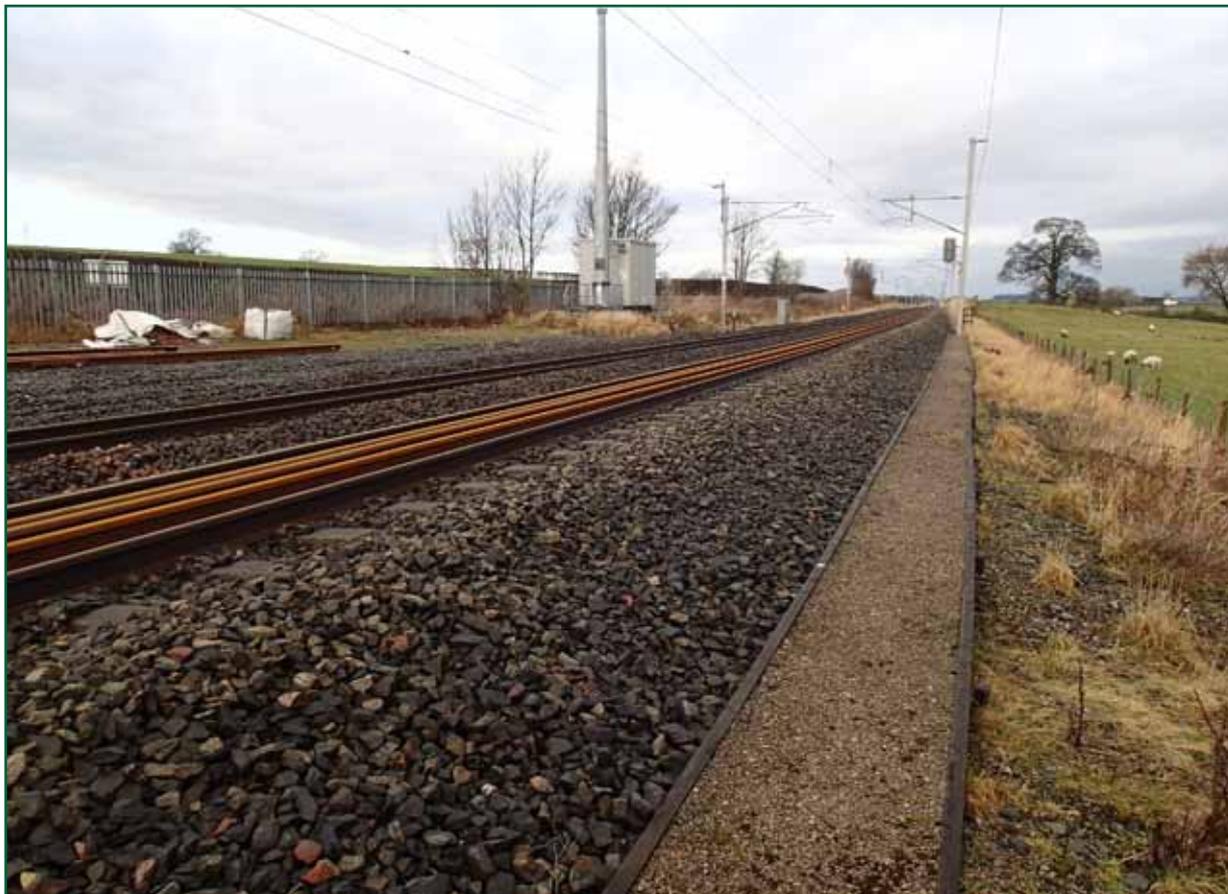
- 13 The new drivers arrived at Penrith station (the work site access point) around mid-day on Sunday, and the ES assistant took the drivers of trains 6L43 and 6L44 by road to Kitchen Hill where he made arrangements with the PICOP for train 6L44 to leave the work site.

*Figure 6: View from the up cess at Kitchen Hill access point towards Plumpton Loop*

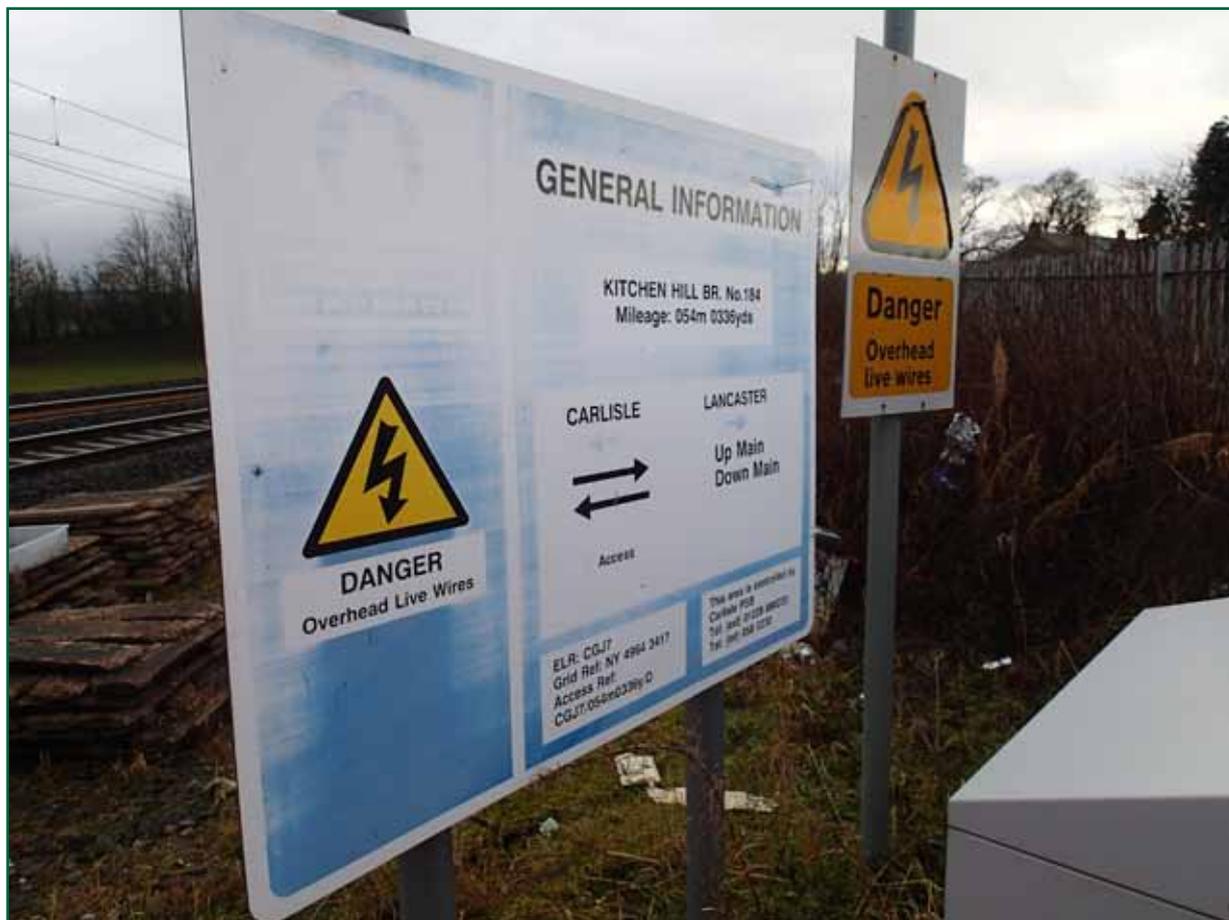
- 39 The driver stated that he knew where Plumpton Loop was and that marker boards had been sited there on previous occasions.
- 40 Various Network Rail sources of information list the names of locations on the railway. However, the same names are not always used to describe the same locations, and some locations that are well known to certain parties may not be referred to in reference documents used by others. The RAIB found this was the case with Kitchen Hill. Kitchen Hill is an official access point on the West Coast Main Line (figure 7) that local infrastructure staff would be familiar with. However, while both 'Long Ashes' crossing and 'Plumpton Loop' are referred to, Kitchen Hill is not listed in Network Rail's Sectional Appendix - one of the key documents that operations staff, such as drivers, use. Similarly, while 'Long Ashes', 'Kitchen Hill' and 'Plumpton' are all place names in Network Rail's Local Hazard Directory, some of them are used to define a number of different locations. Significantly, 'Plumpton' is used to describe places both north and south of Kitchen Hill access point.

Figure 7: Signage at Kitchen Hill access point
