Rail Accident Report

Passenger train collision at Norwich 21 July 2013

Report 09/2014
May 2014

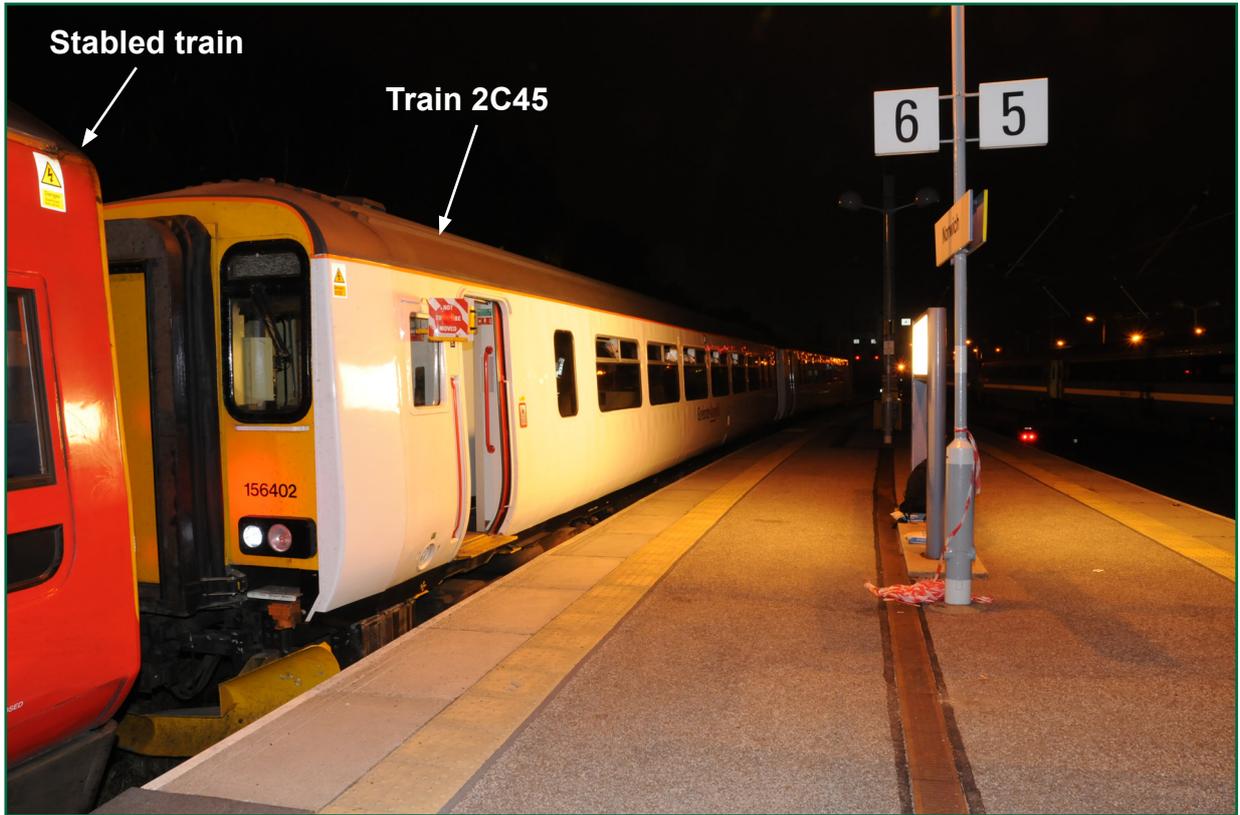
- 9 Train 2C45 was a two-car class 156 *diesel multiple unit* (DMU). The train stabled in platform 6 was a two-car class 158 DMU. There was some minor damage to the gangway of train 2C45 and to the couplers of both trains (figure 3).
- 10 During the collision the train stabled in platform 6 was pushed back against another train also stabled in the same platform. This second stabled train, which was also an empty two-car class 158 DMU, was not damaged.

Figure 2: Train 2C45 after the collision (courtesy British Transport Police)

- 113 Based on the mass of the trains involved and the associated speed, the RAIB estimated that the collision energy was low (of the order of 0.25 MJ). The low level of damage to the vehicles (limited to the couplers and gangway) is consistent with this collision energy and reflects the low severity of the collision.

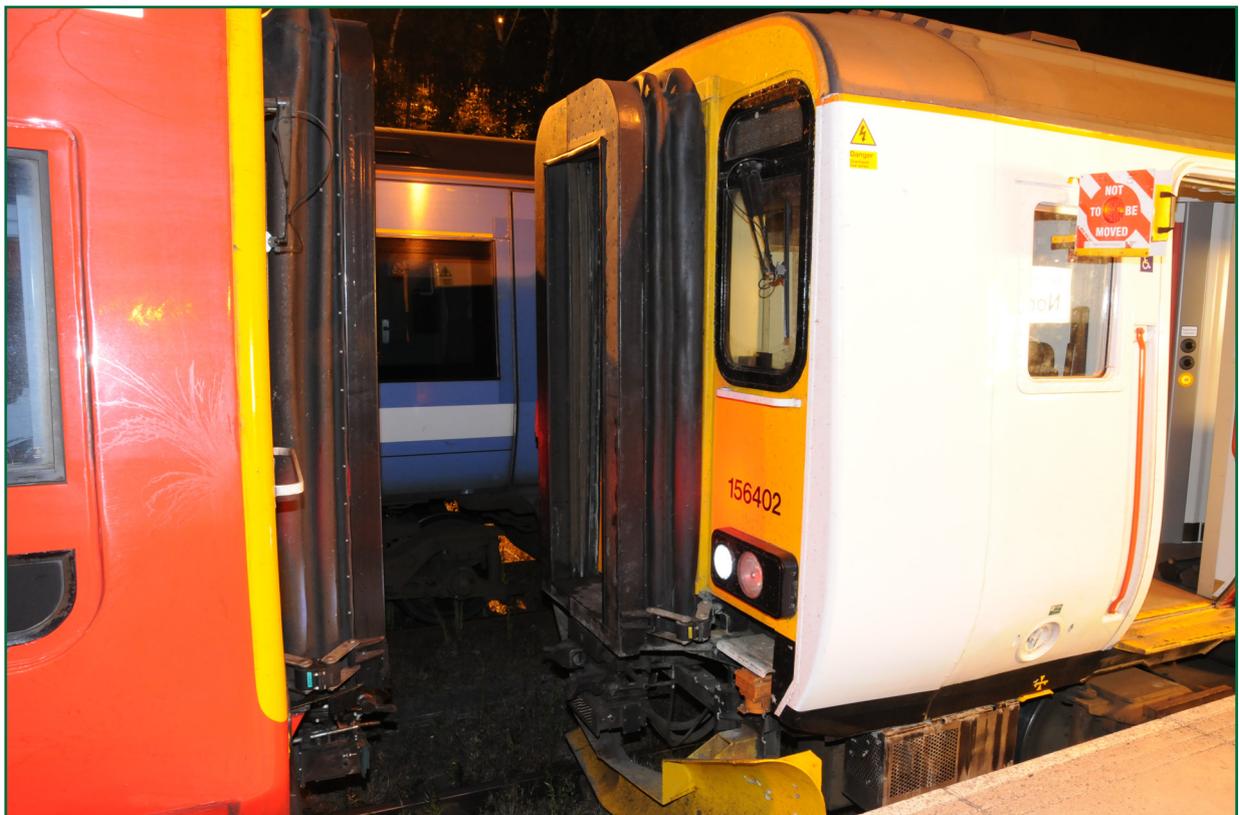
Figure 3: Train 2C45 after the collision (courtesy British Transport Police)

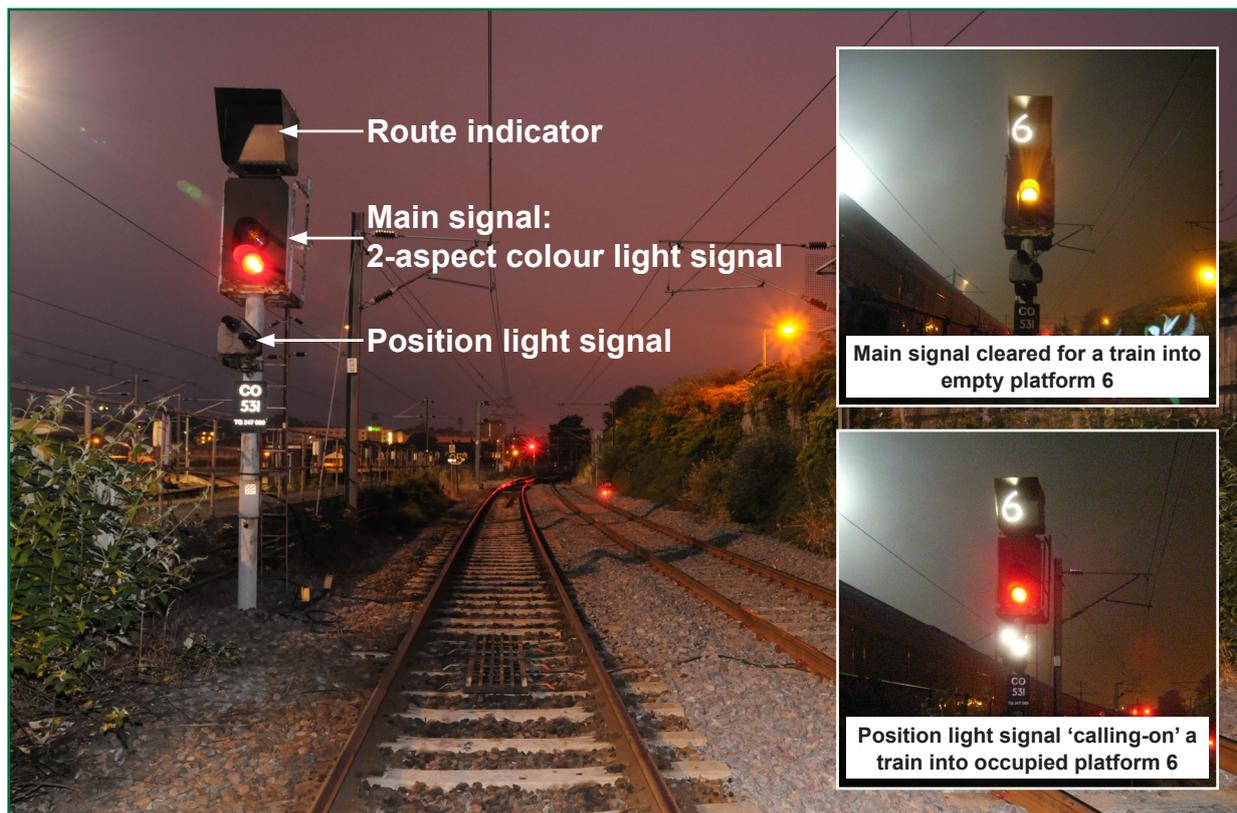
Figure 5: Signal CO531 (main photograph courtesy of British Transport Police)

- 15 Signal CO531 is a 2-aspect colour light signal (*main signal*) with a *position light signal* and a *route indicator* (figure 5).
- 16 If there is no train in the signal section ahead, once the signaller at Colchester signal box has requested the *route* and the *interlocking* confirms that the route has been set, the main signal *clears* to show a single yellow aspect¹ indicating to the driver that there are no trains in the signal section up to the buffer stops (figure 5). The position light signal will not clear if the main signal has cleared.

- 17 If there are already one or more trains in the platform that a train is routed into, the main signal will not clear. Instead, after the track circuit immediately on the approach to the signal has been occupied for a minimum of 22 seconds² (and provided that there are no conflicting movements ahead of the signal), the position light signal will clear to two white lights. This informs the driver that the platform ahead of his train is occupied by one or more trains and that he should drive at caution, ready to stop short of any obstruction (figure 5). This is usually referred to as *calling-on*.

- 18 The route indicator is used in combination with either the main or position light signal to inform the driver which platform the train is routed into.

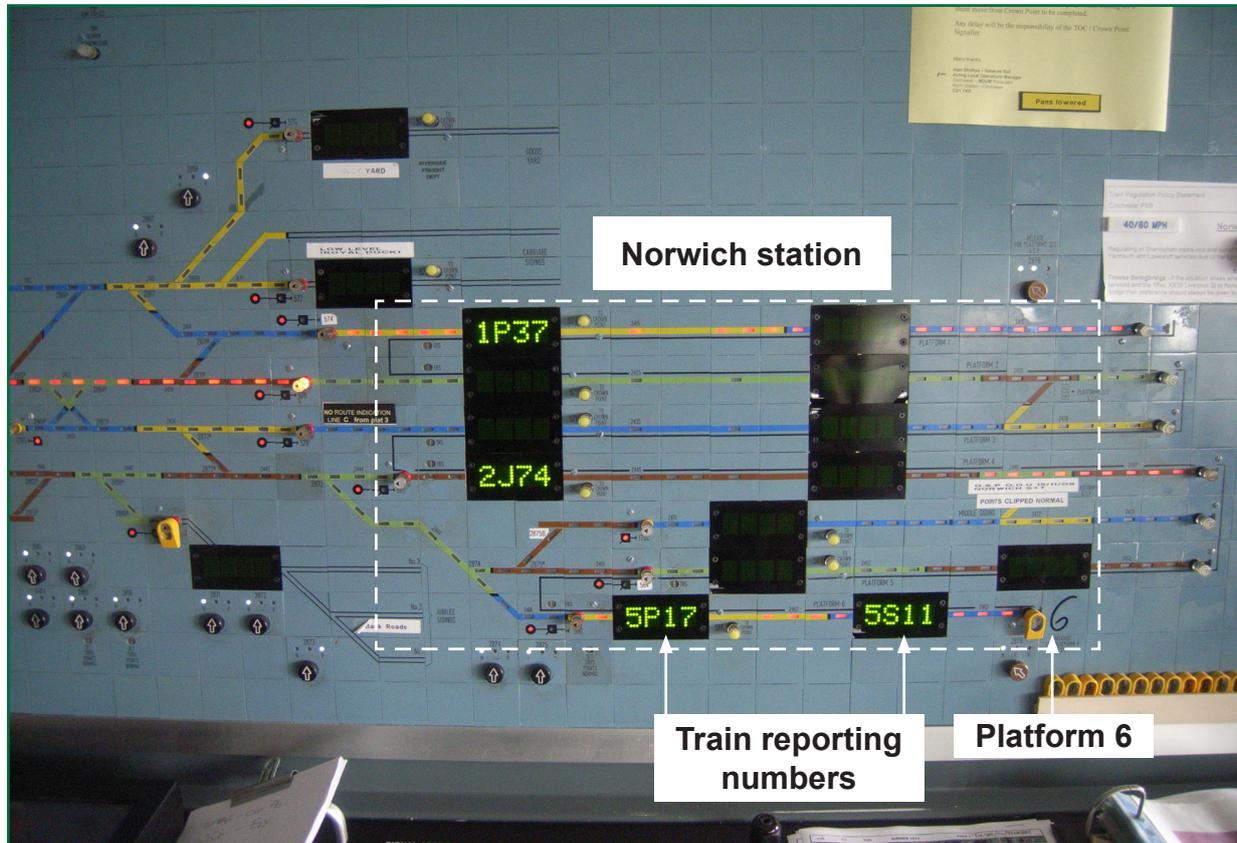
Figure 6: Norwich station on Colchester signal box panel

- 29 Within Colchester signal box, the signaller's panel for Norwich station can display the reporting numbers of two trains in each platform (figure 6). This is insufficient for the signallers to understand the platform occupation remotely as there can be more than two trains in any platform, as was the case in platform 6 on the night of the accident³.

- 30 The overall effect of the working arrangements is that the signallers at Colchester signal box rely entirely on the information given to them by the Norwich station staff for platform allocation. They do not routinely challenge any request made for platform allocation, as they assume that the station staff have reasonable grounds for the decision.

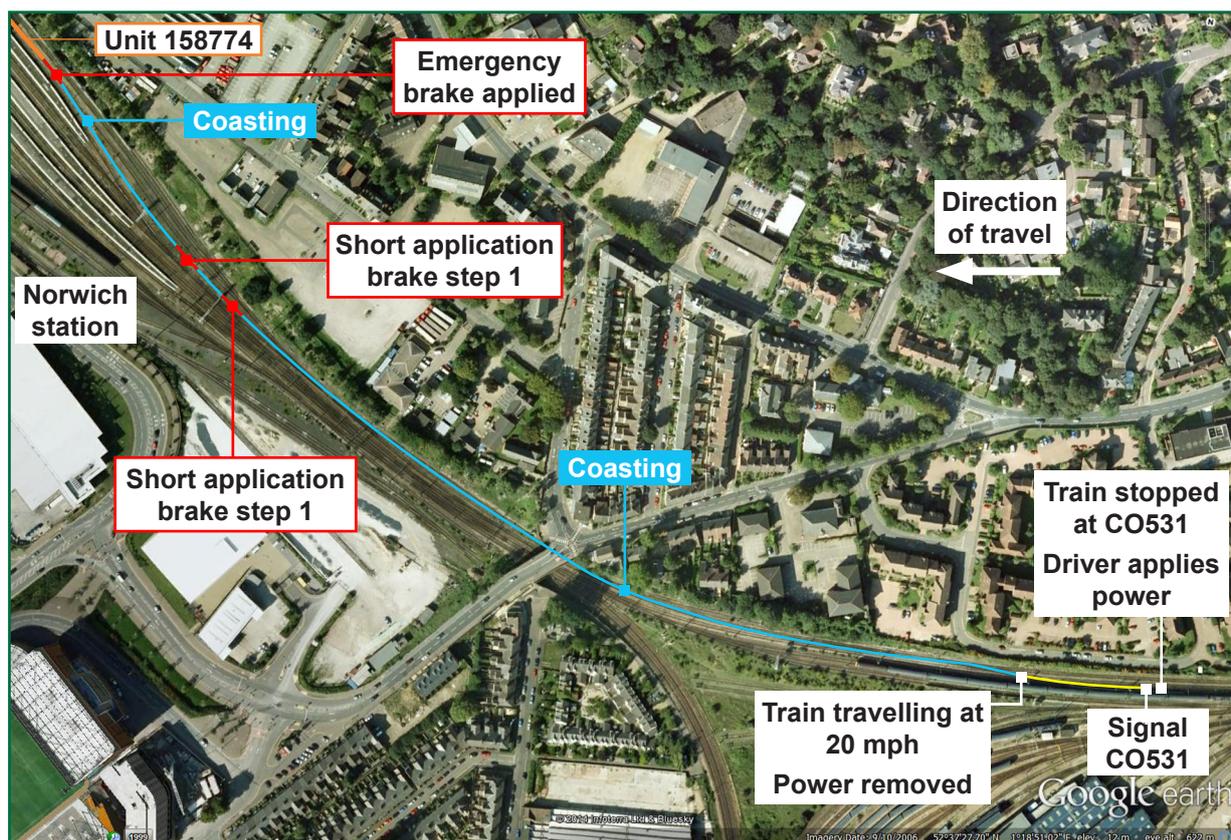
Figure 7: Journey from CO531 to the point of collision

- 55 The driver said he could not recall all of the events between passing signal CO531 and the collision with unit 158774. However, there is no evidence to suggest that the driver struggled to understand the situation he was facing: he was clear that he had seen and was aware of the four vehicles already stabled in platform 6. The driver also stated that it was not the first time that he had been faced with this situation in platform 6 at Norwich station.
- 56 The RAIB considers that the accident was caused by either of the following scenarios taking place during the 20 seconds before the emergency brake application:
- the driver, due to a lapse in concentration⁸, did not notice that his train was not in brake step 1; or
 - the driver had a *microsleep*.

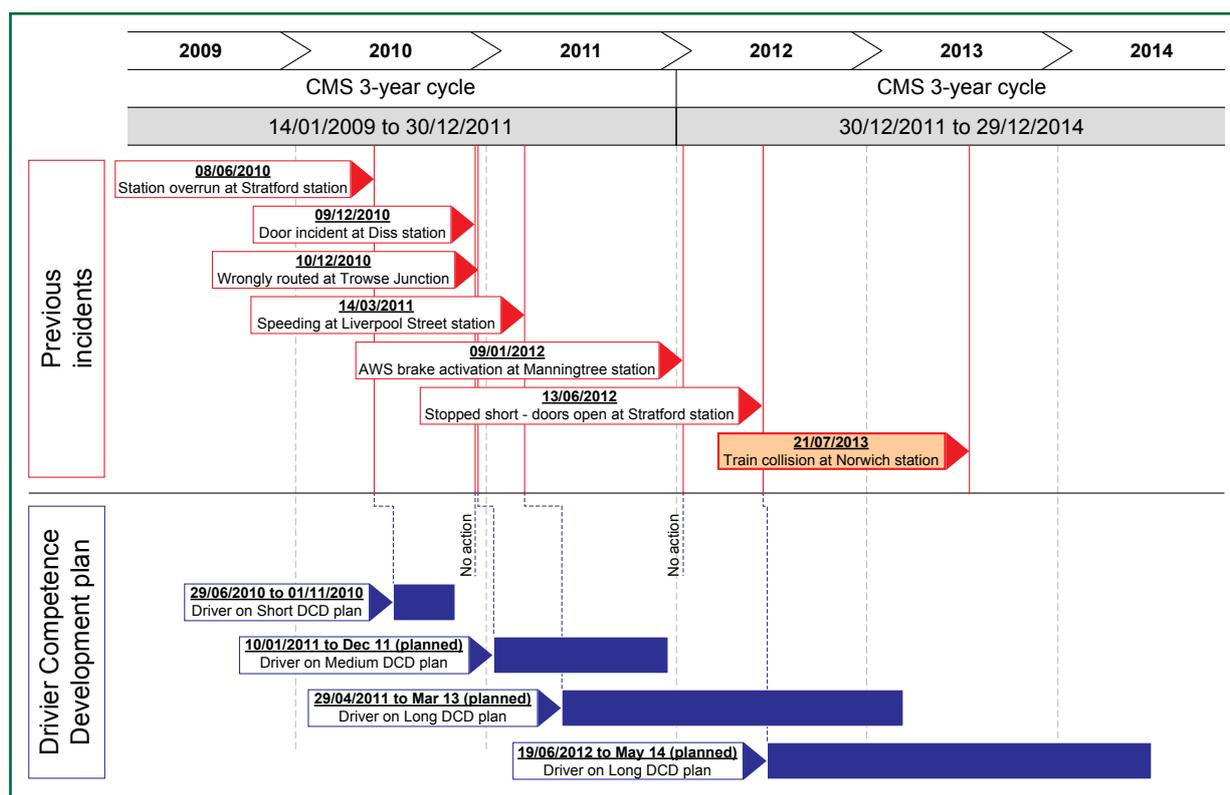
Figure 8: Driver incidents, CMS and DCD plan history

- 80 Following each incident since 2010 (except the incidents at Diss and Manningtree where mitigating circumstances led the driver manager to decide not to put the driver on a development plan despite the incidents remaining on his records), the driver was placed on a Driver Competence Development (DCD) plan. This process is also part of Greater Anglia's CMS. The timescales and contents of each DCD plan are defined on the basis of the importance of the incident and the previous operational history of the driver.

- 81 The duration of the DCD plans for the driver involved in the accident at Norwich gradually increased from a short plan (three-month duration) after the first incident in June 2010 to a long plan (two-year duration) after the speeding incident at London Liverpool Street in March 2011. The DCD plans overlapped and superseded each other as the driver was involved in a new incident before each of the previous DCD plans had been completed (figure 8). The driver had therefore been on a development plan for most of the three years before the accident at Norwich.
