Rail Accident Investigation Branch

Rail Accident Report

**Collision at Buttington Hall user worked
crossing, Welshpool
16 July 2013**

Report 06/2014 v2
May 2014

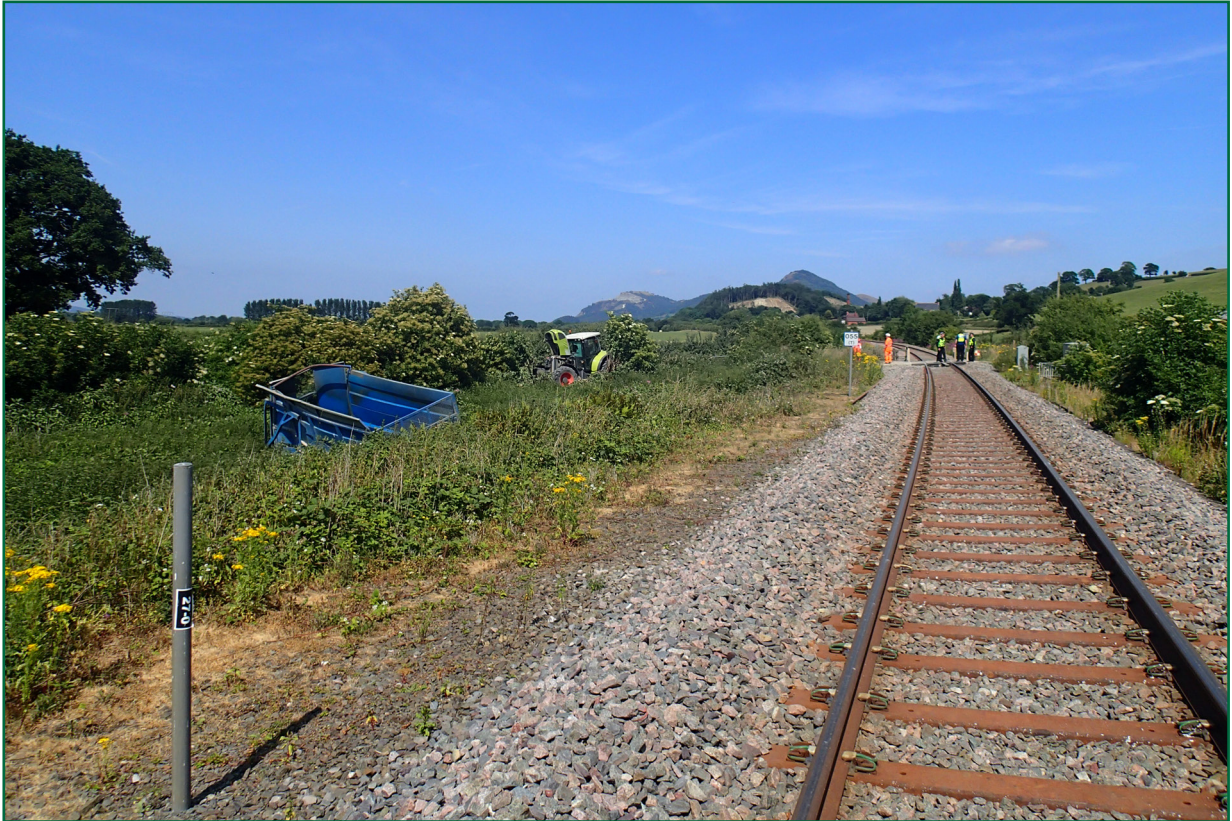
- 7 The impact caused extensive damage to the trailer and to the tractor that was pulling it (figure 2). The tractor driver and two other agricultural workers who were standing close by at the time sustained minor injuries.
- 8 Several passengers on the train were injured and two were taken to hospital for treatment, but were discharged later that day.
- 9 The train did not derail, but sustained significant damage to the front end (figure 3). A window in the passenger compartment was broken and some interior panels were dislodged during the impact.
- 10 The railway was closed until 17:30 hrs on the same day for recovery of the train.

Figure 2: Buttington Hall crossing, looking towards the Shrewsbury direction showing the tractor and trailer in their post-accident positions

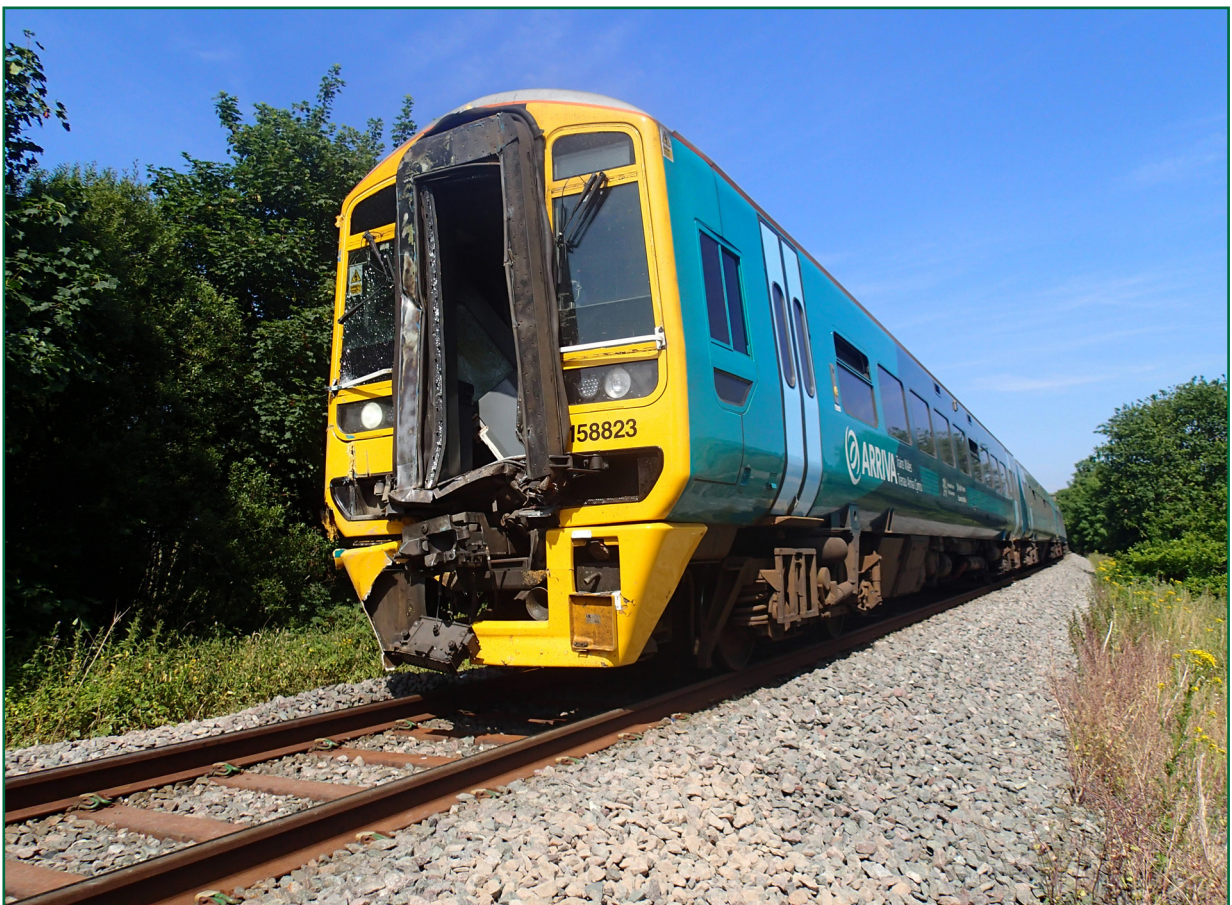
Figure 3: The front of the train involved

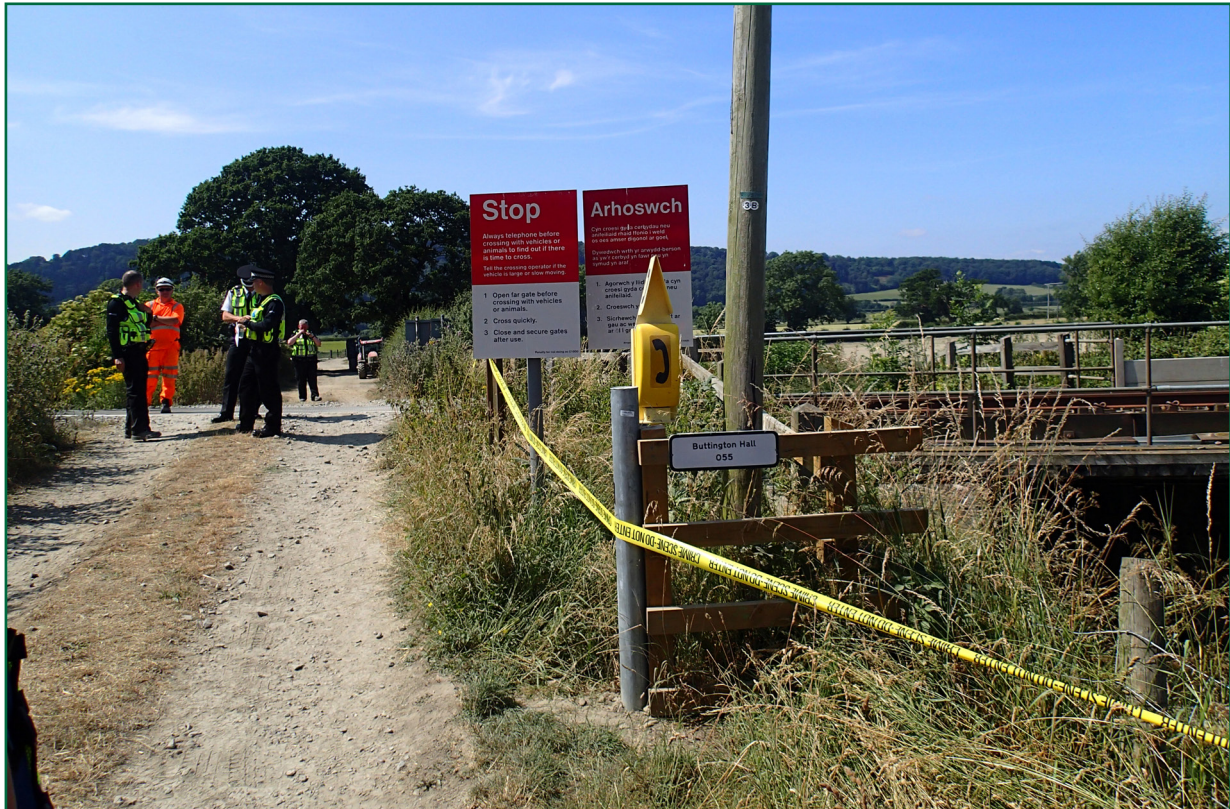
Figure 4: Buttington Hall crossing, looking in the direction that the tractor was travelling, showing the signs and telephone
