Rail Accident Investigation Branch

Rail Accident Report

Near-miss at Llandovery level crossing, Carmarthenshire 6 June 2013

Report 11/2014
May 2014

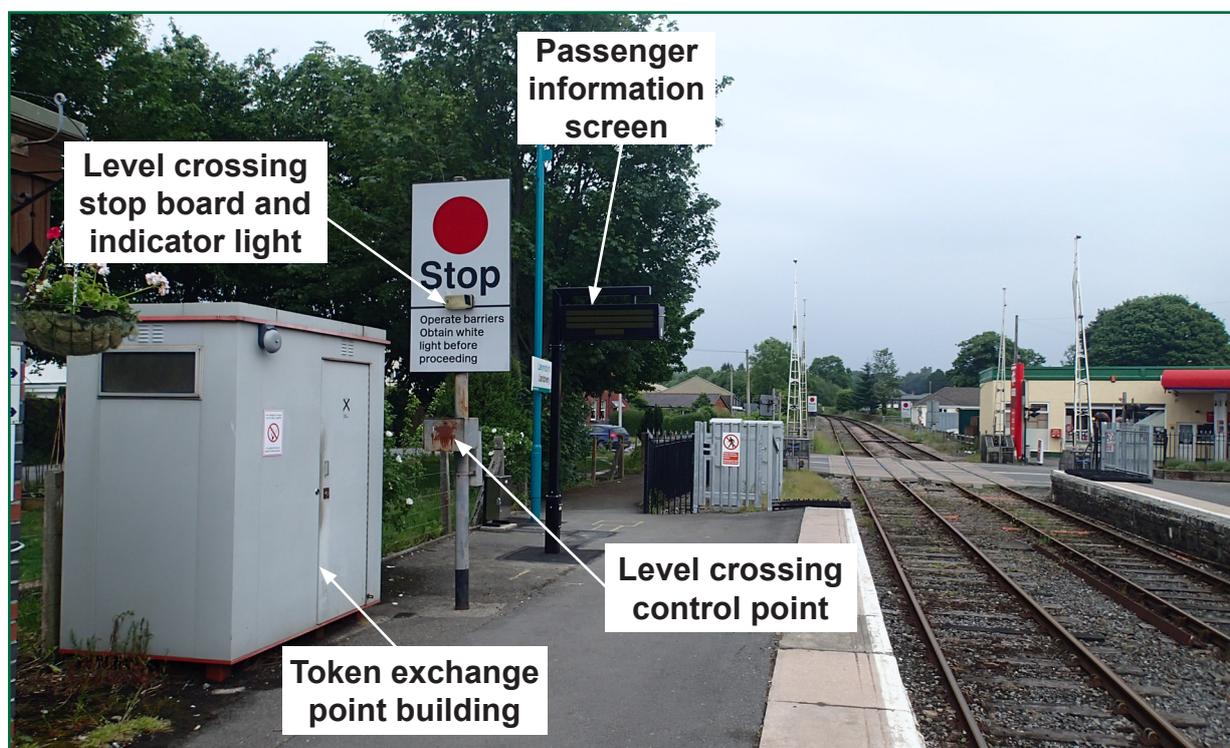
Figure 3: Llandoverly up platform and level crossing

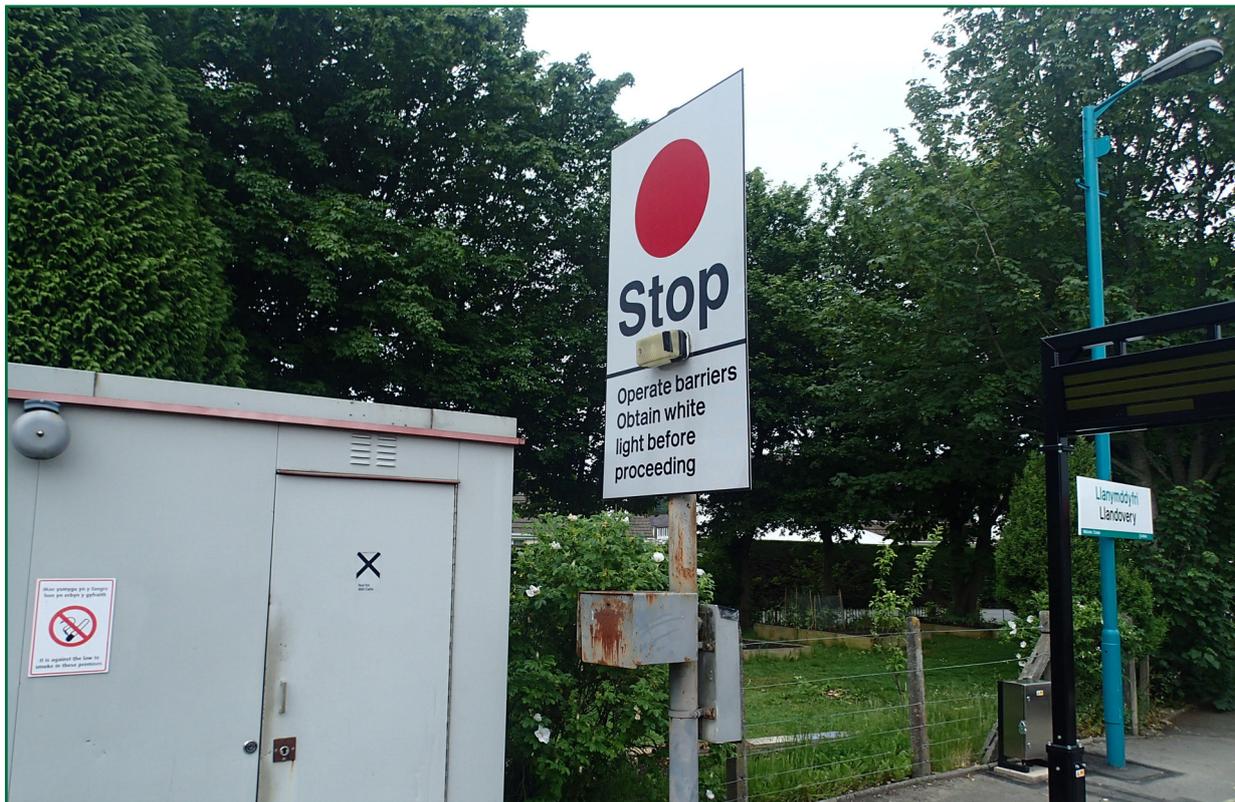
Figure 4: The up platform level crossing stop board

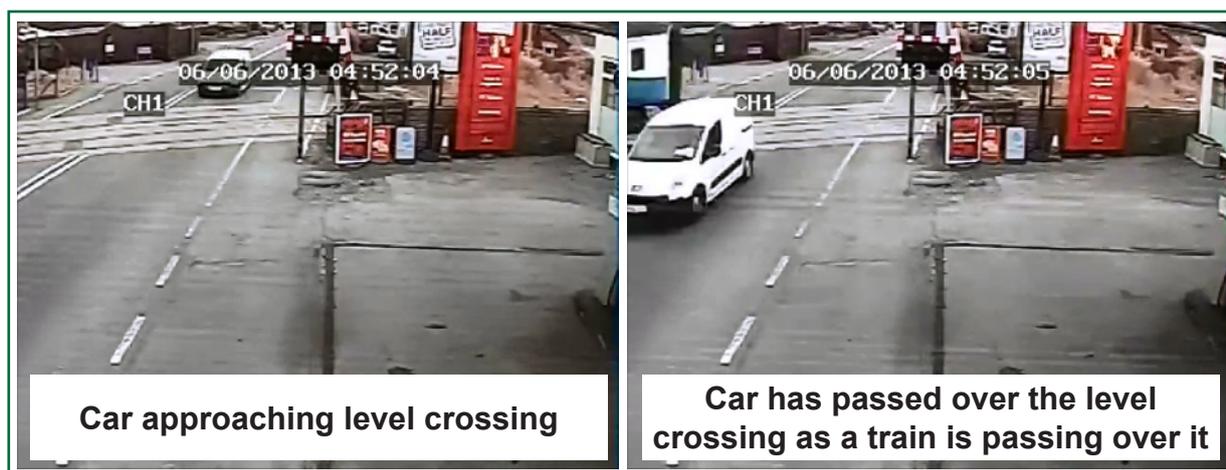
Figure 5: CCTV from the nearby garage showing the near-miss (note: the time stamp on the CCTV images reflect GMT and did not represent the actual time of the incident) (images supplied courtesy of McCanns Group and Morris Isaacs Garage, Llandovery)

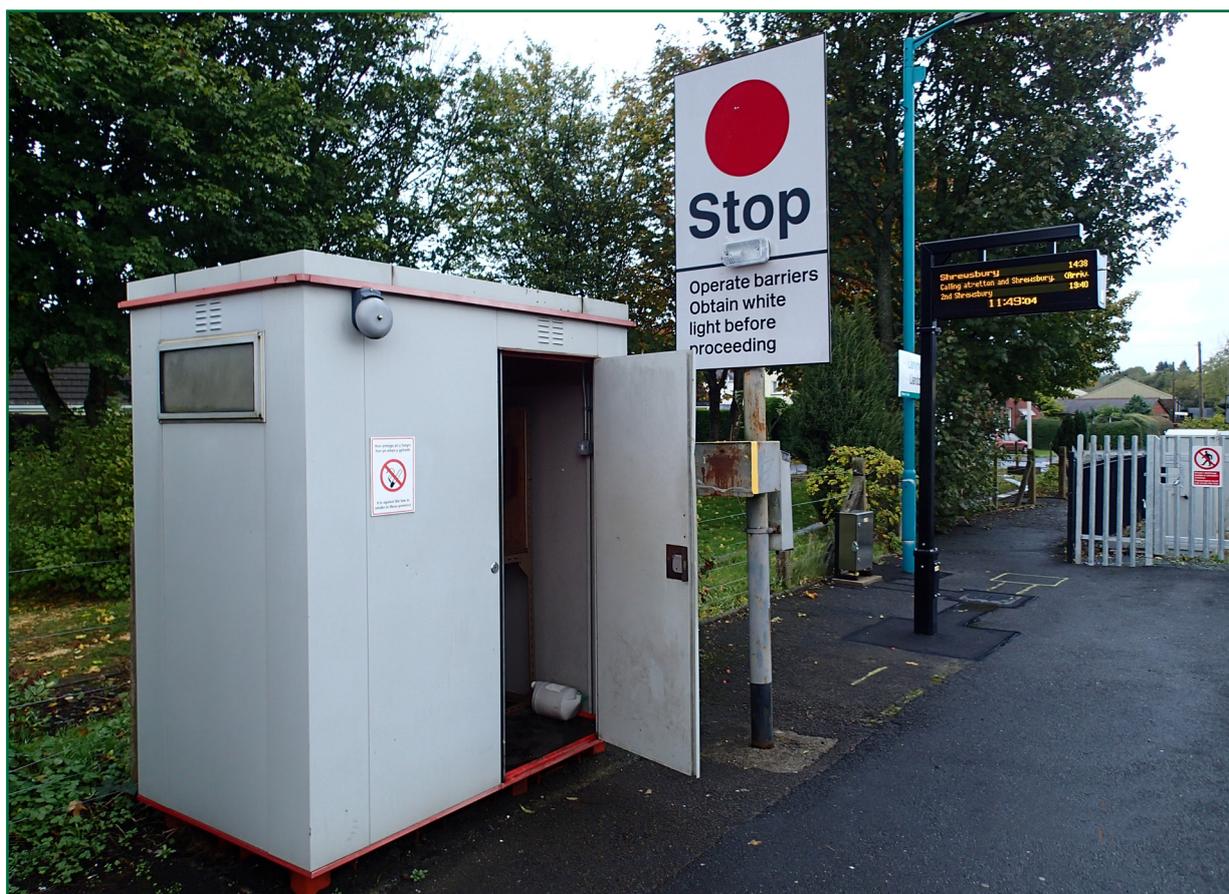
- 38 While the driver was carrying out the token exchange, the level crossing control unit was out of the conductor's sight because when fully open, the token hut door can partially obscure the level crossing control panel (figure 6). Had the level crossing controls been fully visible, the conductor might have noticed them and realised he had not yet operated the crossing. However, the fact that the conductor did not observe that the white light on the crossing stop board was not illuminated, and did not notice that the level crossing barriers were in the raised position, indicate the extent to which he was not alert to the task, as these were key elements of his duties at this location.

Figure 6: The level crossing control panel partially obscured by the open token hut door

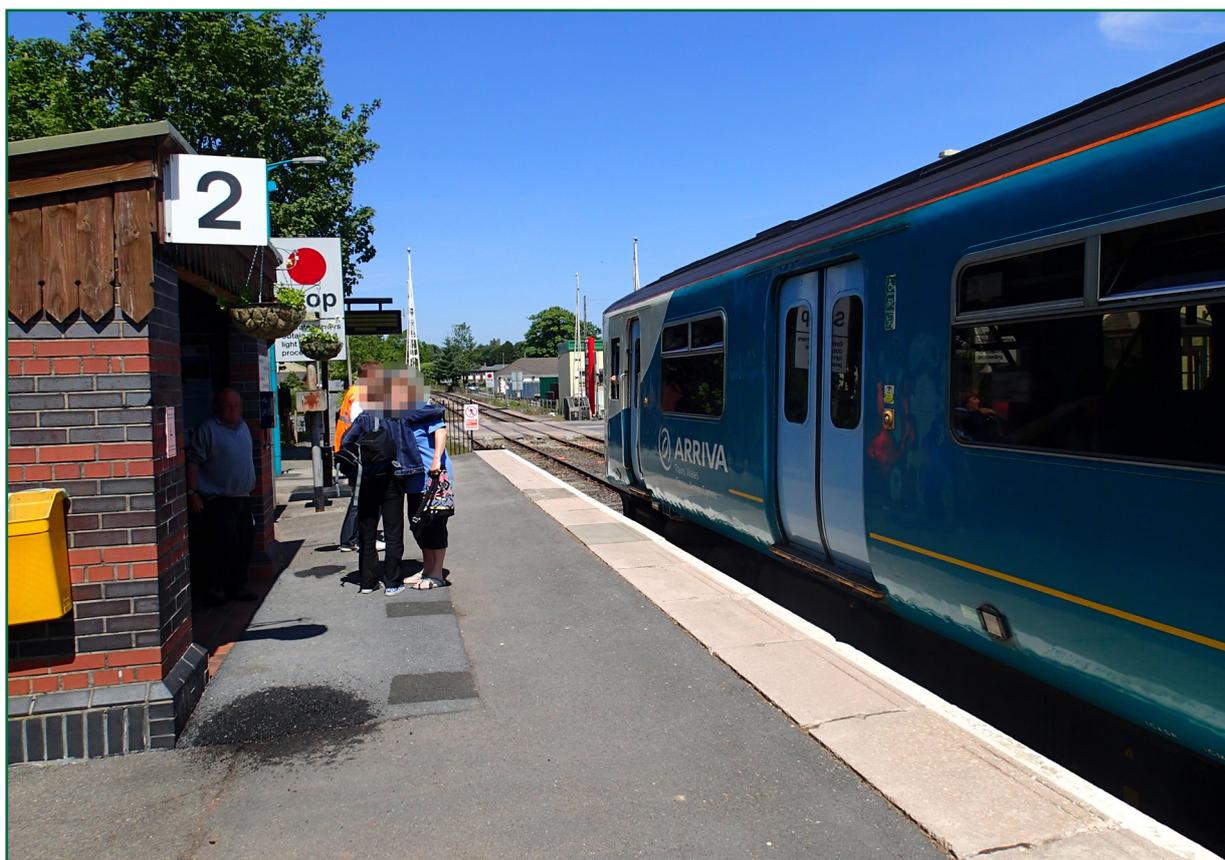
- 55 The stop board and associated flashing light were not positioned as well as they could have been at Llandoverly. The requirements for positioning of stop boards are described in Railway Group Standard GK/RT0192 'Level crossing interface requirements'. This standard says that stop boards should be positioned 50 metres before level crossings, or 25 metres where a level crossing is located immediately beyond a station platform. The stop board at Llandoverly was positioned around 27 metres from the level crossing, meaning that the usable length of the platform was 48 metres (since trains could not pass the stop board until the level crossing had been operated). The length of a two-car class 150 train is around 40 metres, so drivers had limited flexibility in deciding where to stop their train as they needed to ensure that the whole train was on the platform. No sign had been provided to tell drivers where to stop their trains, and they were therefore in the habit of stopping with the front of the trains close to the level crossing stop board, because it was positioned close to the token exchange hut on the platform (and close to the platform shelter where passengers waited for trains) (figure 7).

Figure 7: A train stopped in the up platform at Llandovery adjacent to the level crossing stop board (not the train involved in the incident)

- 56 When a train was stopped with the driver's cab opposite the token exchange hut, the level crossing stop board was not in the driver's direct line of sight, although it was visible out of the driving cab side window if looked for. Had a *car stop marker* been provided before the stop board⁹, or the stop board located to a position closer to the crossing¹⁰, it would have been more easily seen by drivers as it would be in their field of view when looking forward.
