Rail Accident Investigation Branch

Rail Accident Report

**Passenger trapped in a train door and dragged
a short distance at Newcastle Central station
5 June 2013**

Report 19/2014
September 2014

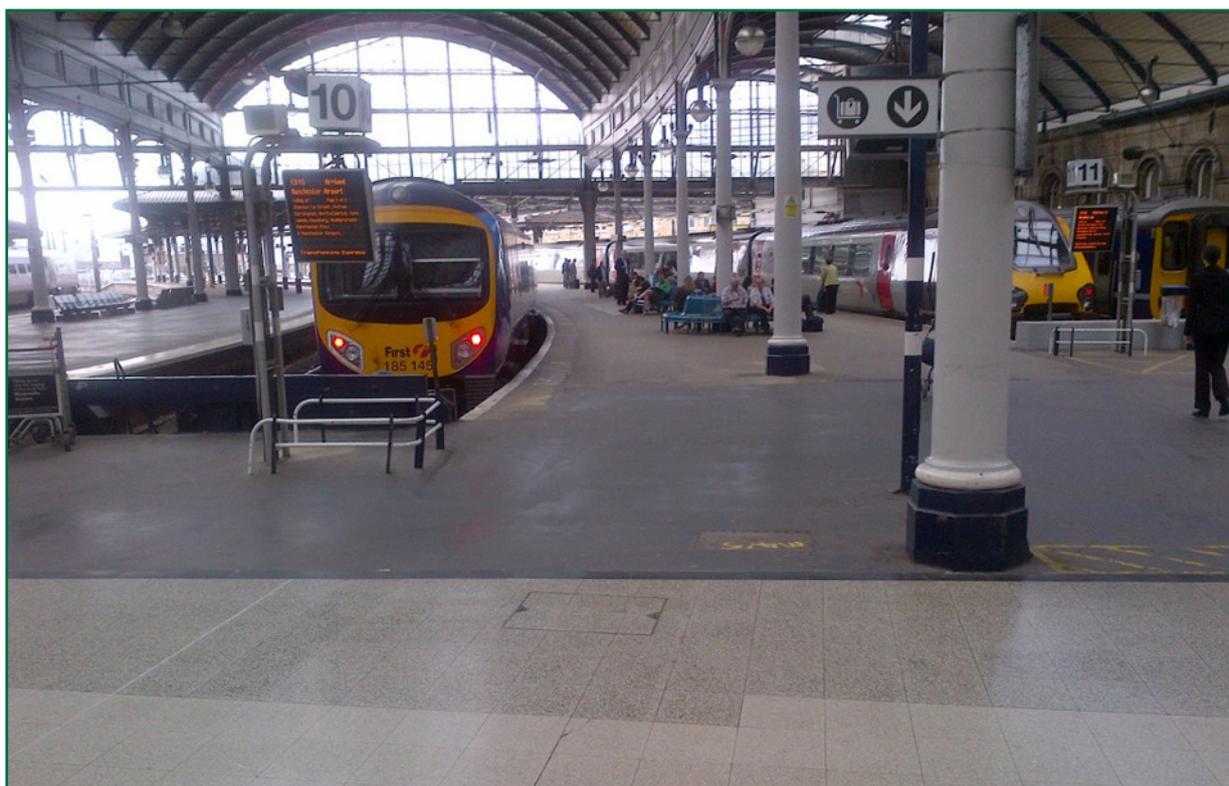
- 8 Platform 10 is a curved terminal platform, as are the adjacent platforms 9 and 11. It has a radius of curvature of approximately 170 metres. When viewed in the direction of a train departing from platform 10, the curve is towards the left with the platform on the right-hand (convex) side of the train (figure 2).

Figure 2: Class 185 unit standing at platform 10 at Newcastle Central station (Image courtesy of First TransPennine Express)

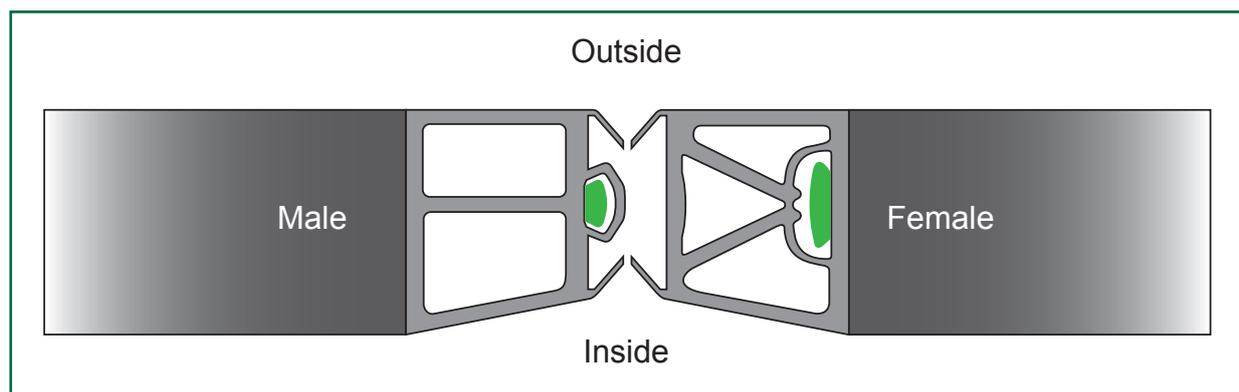
- 48 The electrical detection sensor in each door leaf runs from the top to the bottom of the door and is housed within the leaf's leading rubber edge (figure 9). The rubber edge of one of the door leaves is a 'male' edge and the other a 'female' edge. A feature of this design is that it is necessary to switch off the detection of the female sensitive edge shortly before the two leaves meet to prevent it sensing the opposite door leaf when they touch (which would cause the door to reopen). The male sensitive edge remains active until the door is detected to be closed and locked.

Figure 9: Cross-section through the sensitive door edges, showing the rubber sealing edge profiles housing the electrical sensing elements (shown in green)

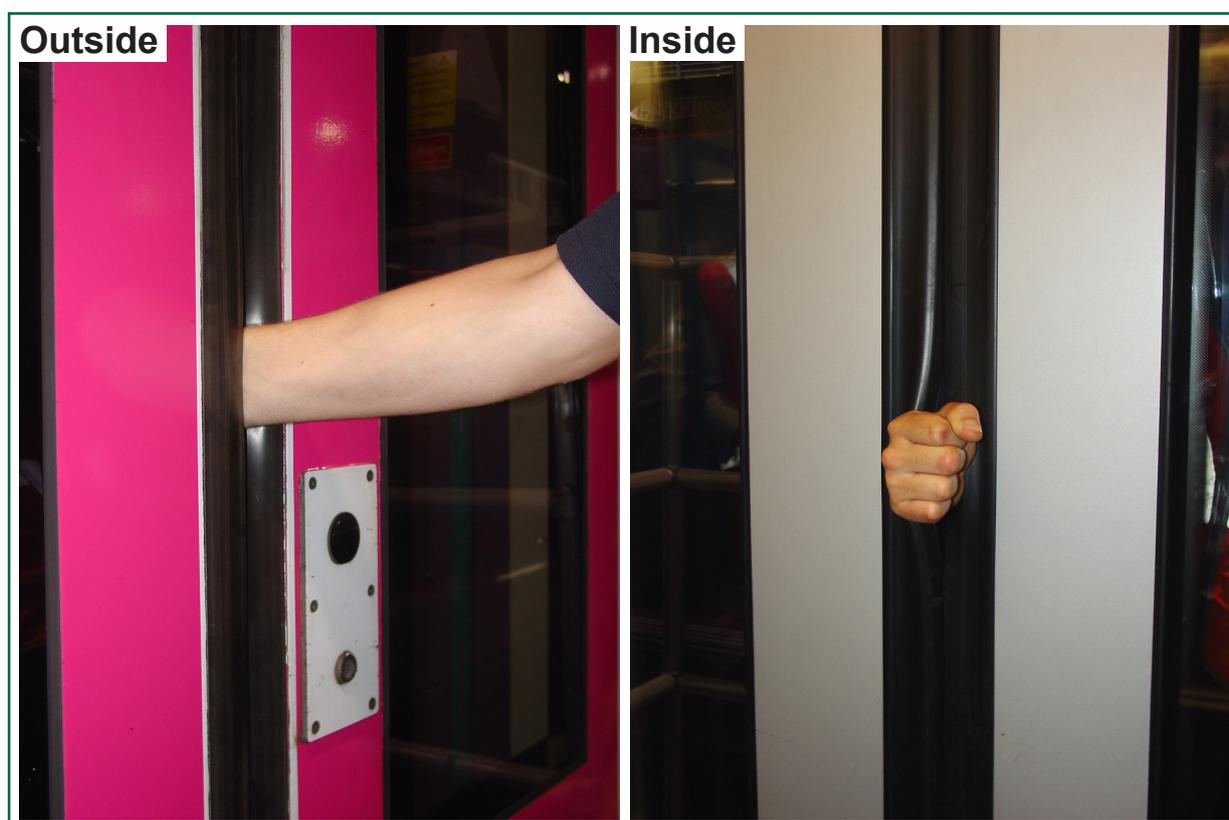
Figure 10: Adult male wrist (approximately 45 mm by 70 mm) trapped in a door detected as closed and locked

- 53 Siemens depot staff were then able to demonstrate to the RAIB how a correctly functioning door that met the design and maintenance test criteria could, nevertheless, trap an adult wrist and indicate to the train control system that the leaves were closed and locked (figure 10). This could be done by deflecting the male rubber edge inwards or outwards, ie away from the female rubber edge. This caused the male edge's sensing element to be moved away from the direction of the movement of the closing leaf and not detect the obstruction. By the time the leaves came together, the female sensitive edge had been switched off (paragraph 48). In this way it was possible, but not always easy, to trap the test pieces and also a reasonably large adult male wrist (figure 11).

- 54 With a stationary train, removal of a trapped wrist in these circumstances is possible but not easy. Following the Newcastle accident, FTPE undertook a risk assessment (paragraphs 104 to 110) within which it was recorded that a member of FTPE staff recreating the trapping of his wrist, reported that it was painful and difficult to remove. The view was also expressed that a trapped test piece (the size of which was not recorded) was difficult to remove, requiring a 'foot braced against the door' to achieve.

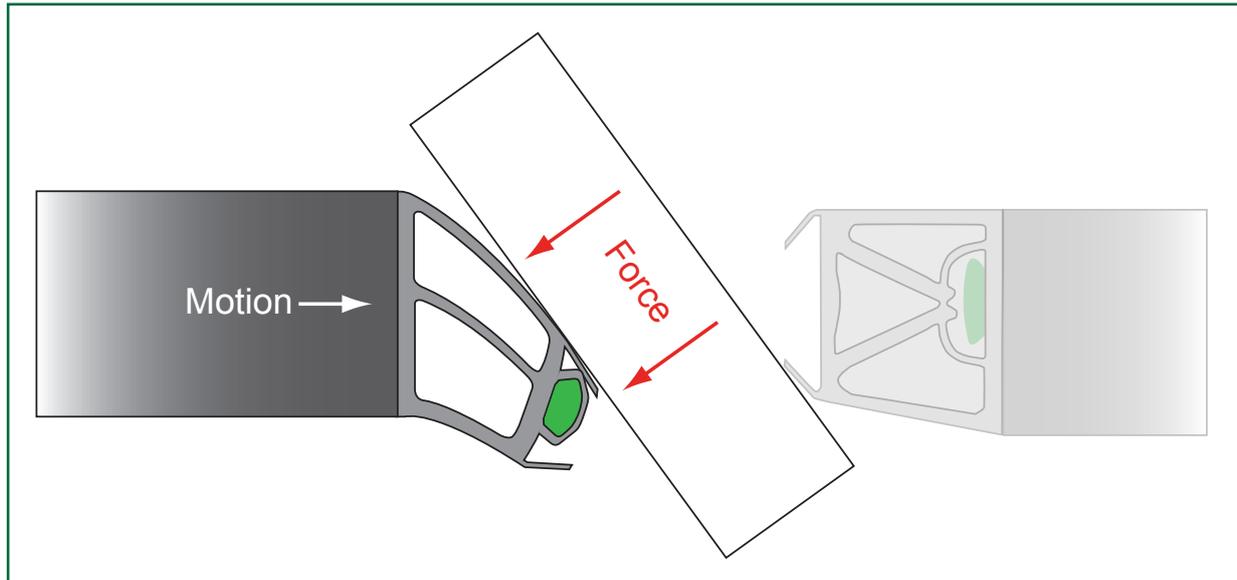
Figure 11: Cross-section through the sensitive door edges, showing the rubber sealing edge profiles and the deflected male edge

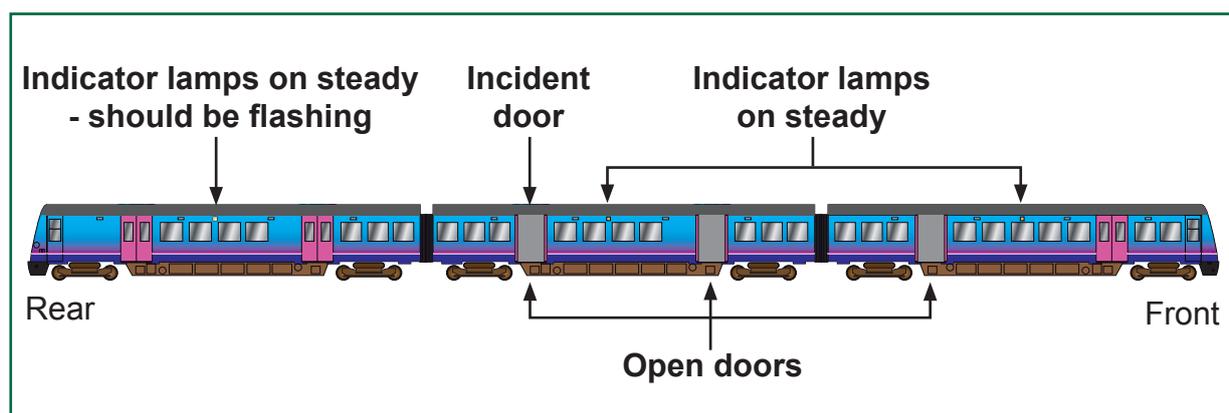
86 RAIB's analysis of the on-board CCTV recordings indicates that once he had turned the DKS on, the conductor's action of pressing the 'close doors' button closed three passenger doors which had not already closed automatically by 'auto-closing' (figure 12). One was the rear door of the front carriage and the other two were the front and rear doors of the centre carriage. The door at the front of the centre carriage had been open for over 2 minutes before the conductor closed it. The door at the front carriage and the rear door of the centre carriage (which trapped the passenger) had both been open since they were first opened more than 7 minutes earlier.

Figure 12: Condition of passenger doors and bodyside indicator lamps at the time the conductor reported that he was undertaking the train safety check
