Rail Accident Investigation Branch

Rail Accident Report

Runaway of a road rail vehicle and the resulting collision in Queen Street High Level Tunnel, Glasgow 21 April 2013

Report 15/2014
July 2014

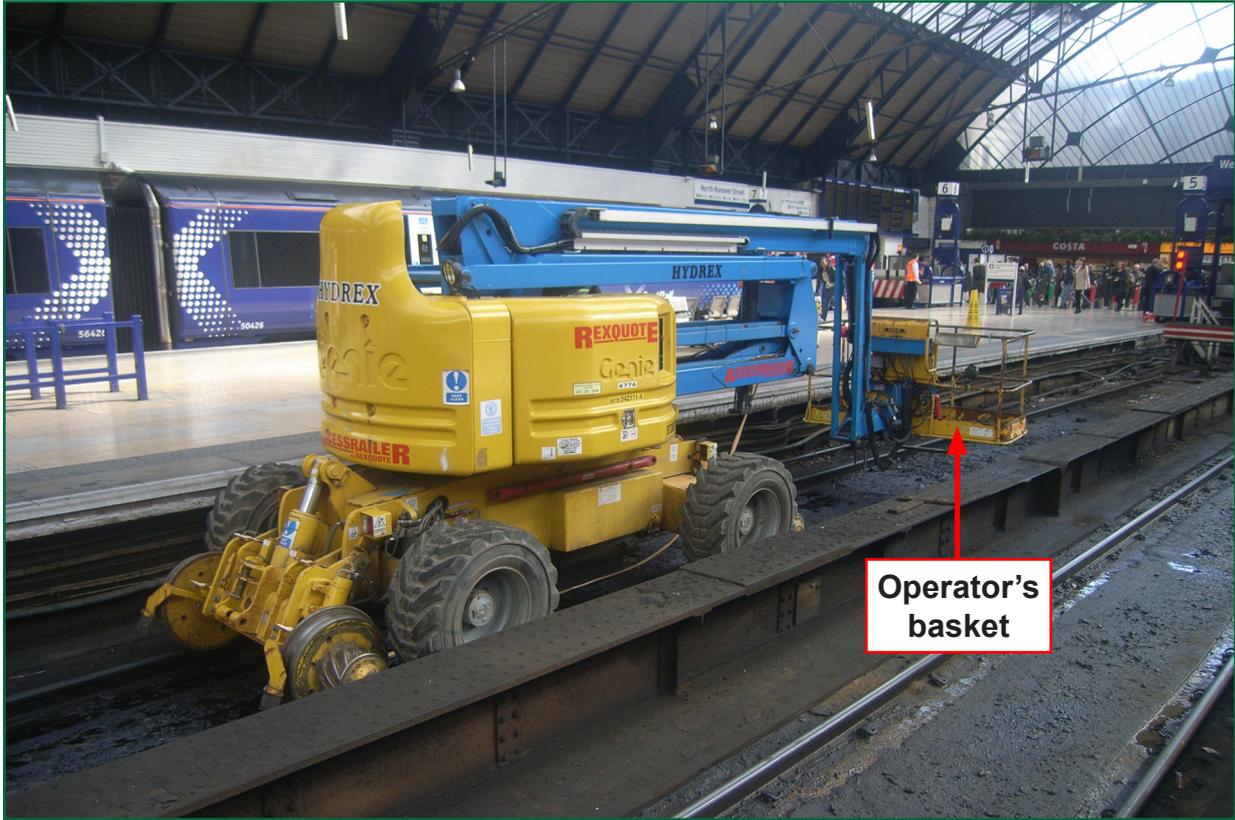
- 8 The RRV was a Genie Z60/34 *Mobile Elevating Work Platform* (MEWP), which was owned and operated by TXM Plant Ltd (figure 2).
- 9 The RRV ran into platform 5 at Glasgow Queen Street High Level station, and came to a stop about 20 metres short of the buffer stop.
- 10 The maintenance worker who was working on the tunnel walls was knocked unconscious and suffered severe shoulder injuries that required urgent hospital treatment. The operator of the RRV suffered minor injuries to his neck and back when he fell while running beside the RRV after it had started to run away, but these did not require hospital treatment.
- 11 The two scaffolds were destroyed by the collision (figure 3). There was minor damage to the RRV.

Figure 2: The RRV in Glasgow Queen Street station after the accident

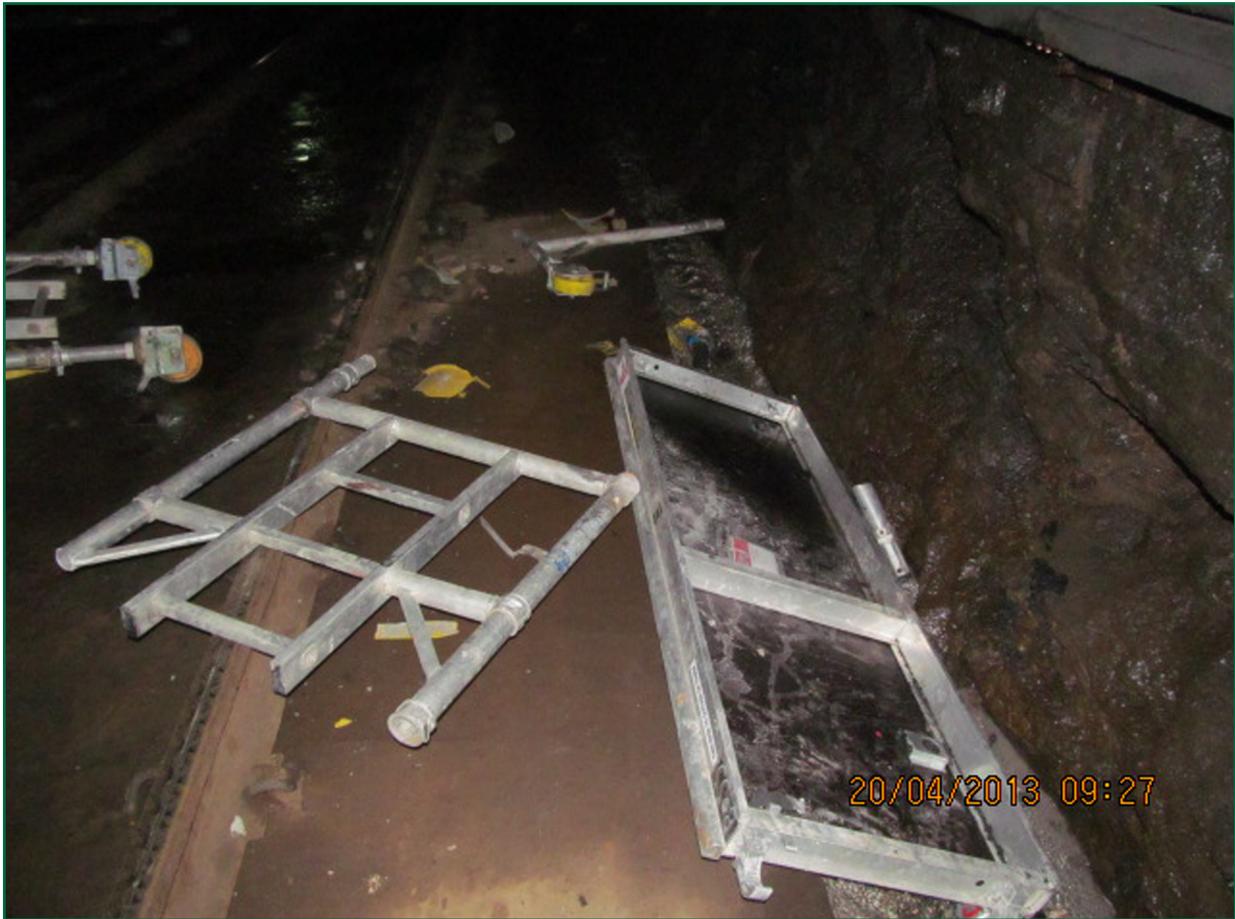
Figure 3: One of the scaffolds in the tunnel after the accident (Courtesy of British Transport Police)

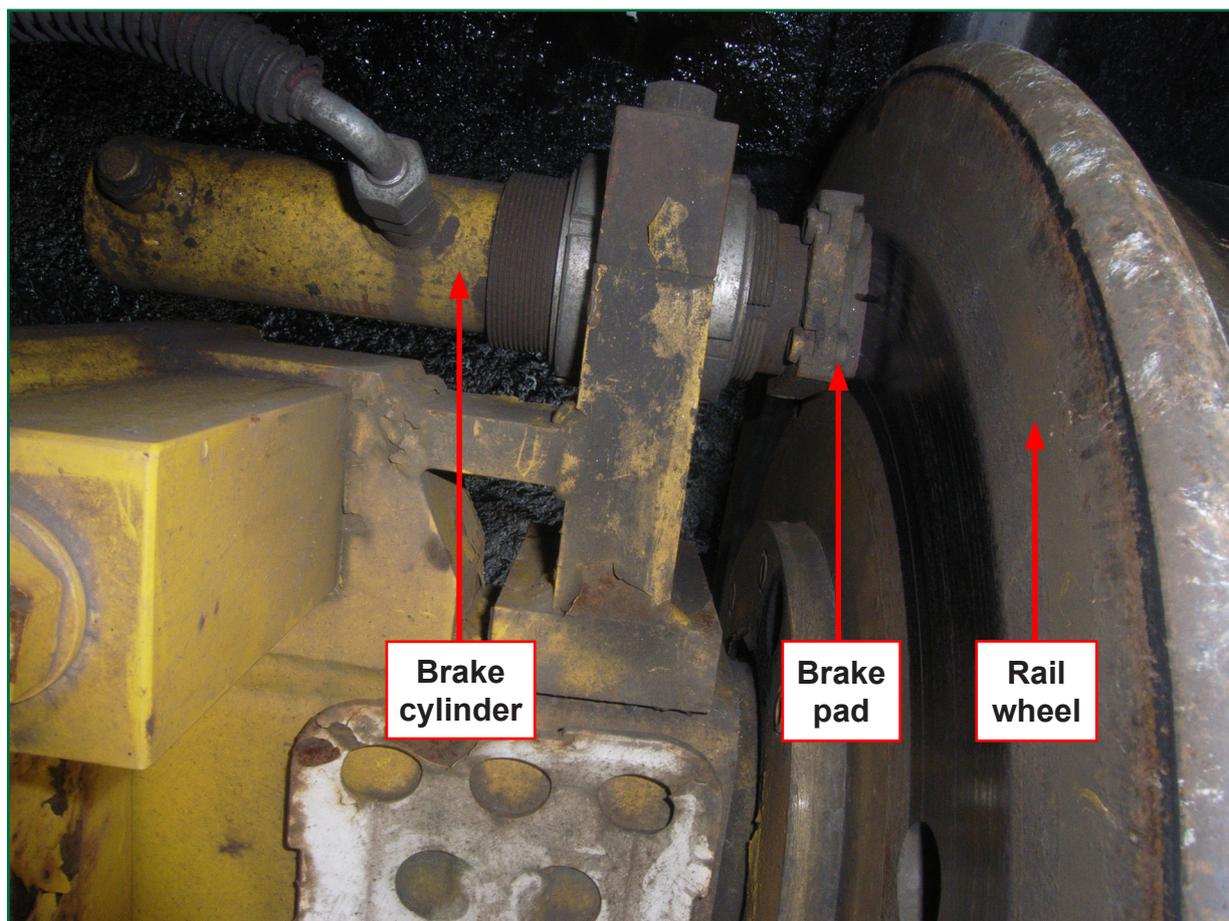
- 51 The RRV is also fitted with a secondary braking system, which consists of a rail wheel holding brake intended to prevent a runaway during on-tracking. This system operates directly on the rail wheels at the fixed axle end (figure 9). This holding brake is only released when the RRV is in rail mode and a joystick control is operated to move it along the track. When this control is released, the service brake and the rail wheel holding brakes are both applied. Consequently, the rail wheel holding brake pads experience some wear during normal operation.

Figure 9: Rail wheel holding brake

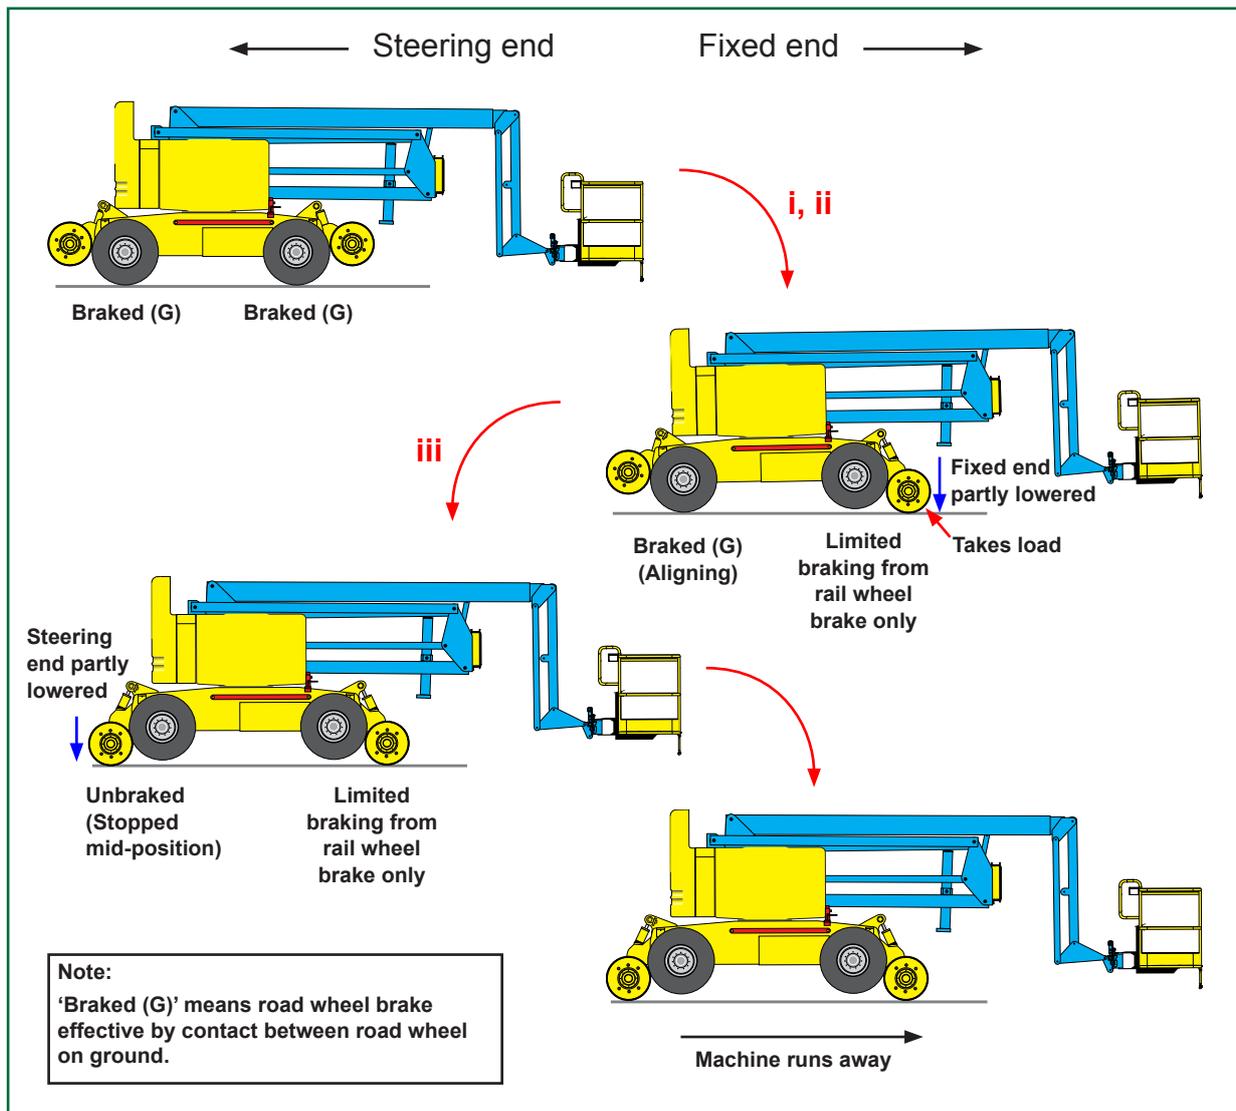
- i. the machine operator manoeuvred the RRV so that the fixed end rail wheels were in line with the track, and lowered the fixed end rail wheels part way to engage the flanges with the rails. In doing so, he lowered the rail wheels further than he intended, so that they took the weight of the RRV, but without them coming into contact with the road wheels. In this condition the fixed end road wheels provided no braking, but the rail wheel holding brake was applied;
- ii. the machine operator manoeuvred the RRV so that the steering end rail wheels were in line with the track. This took a number of attempts at alignment;
- iii. the machine operator lowered the steering end rail wheel.

Figure 13: On-tracking sequence carried out by machine operator on 21 April 2013

- 65 The RRV started to roll down the hill as soon as the steering end rail wheels took the RRV's weight (when the road wheel braking was no longer acting on the ground), despite the rail wheel holding brake, which was intended to prevent such a runaway, still being applied (paragraph 51).

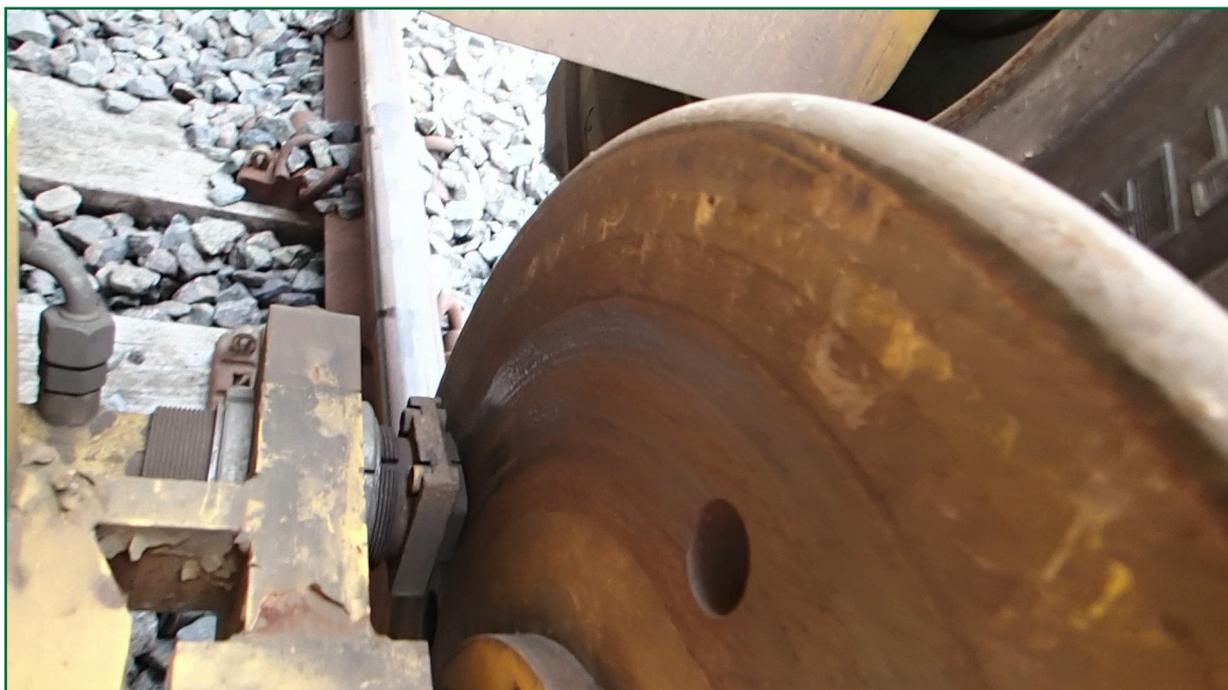
- 90 Examination of RRVs showed that a film of surface rust formed on the wheels if the RRVs were not used for a period of time (figure 16). Tests on the incident machine showed that the available brake retardation force was about 280 kg when a surface layer of rust was present on the wheels. This was likely to have been the condition of the RRV wheels when the runaway occurred, after the RRV had been standing at the RRAP for two weeks.

Figure 16: Surface rust present on wheel photographed during testing

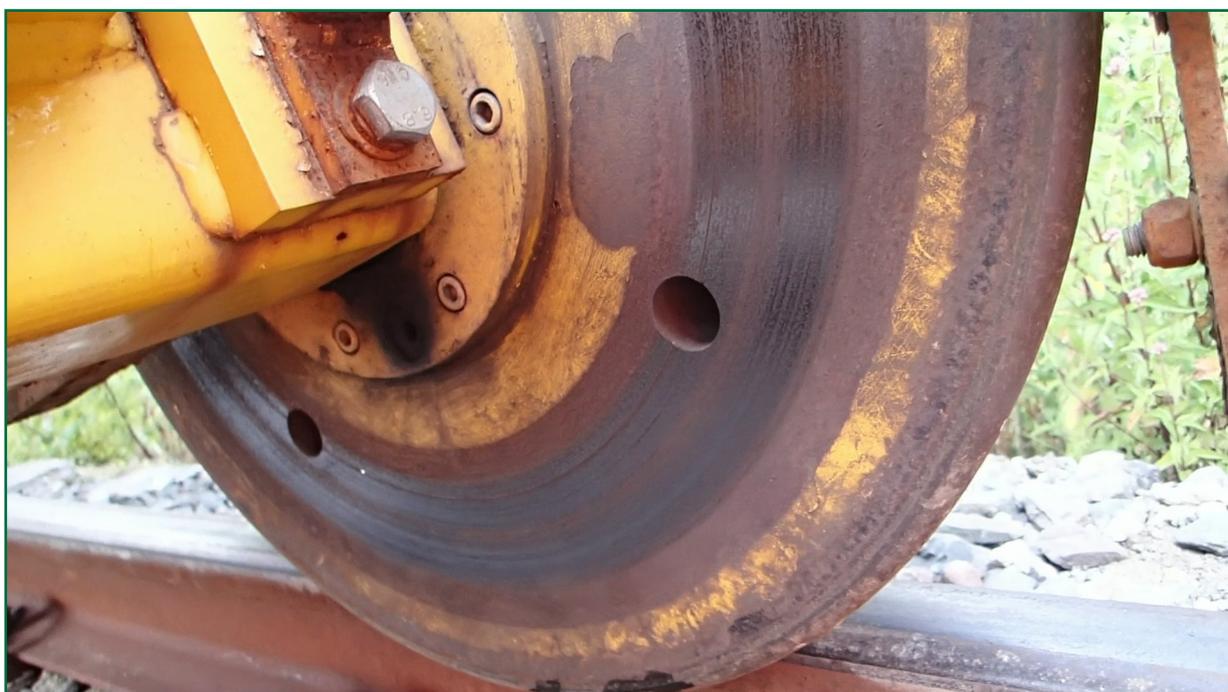
- 91 The tests also showed that the brake retardation force increased to around 310 kg when this rust layer rubbed off (figure 17). Calculations, based on the test during recovery of the RRV, show that the brake retardation force would have been at least 400 kg when the brake pads were acting on the polished surface present after the runaway (figure 18).

Figure 17: Typical in-service wheel contamination present photographed during testing

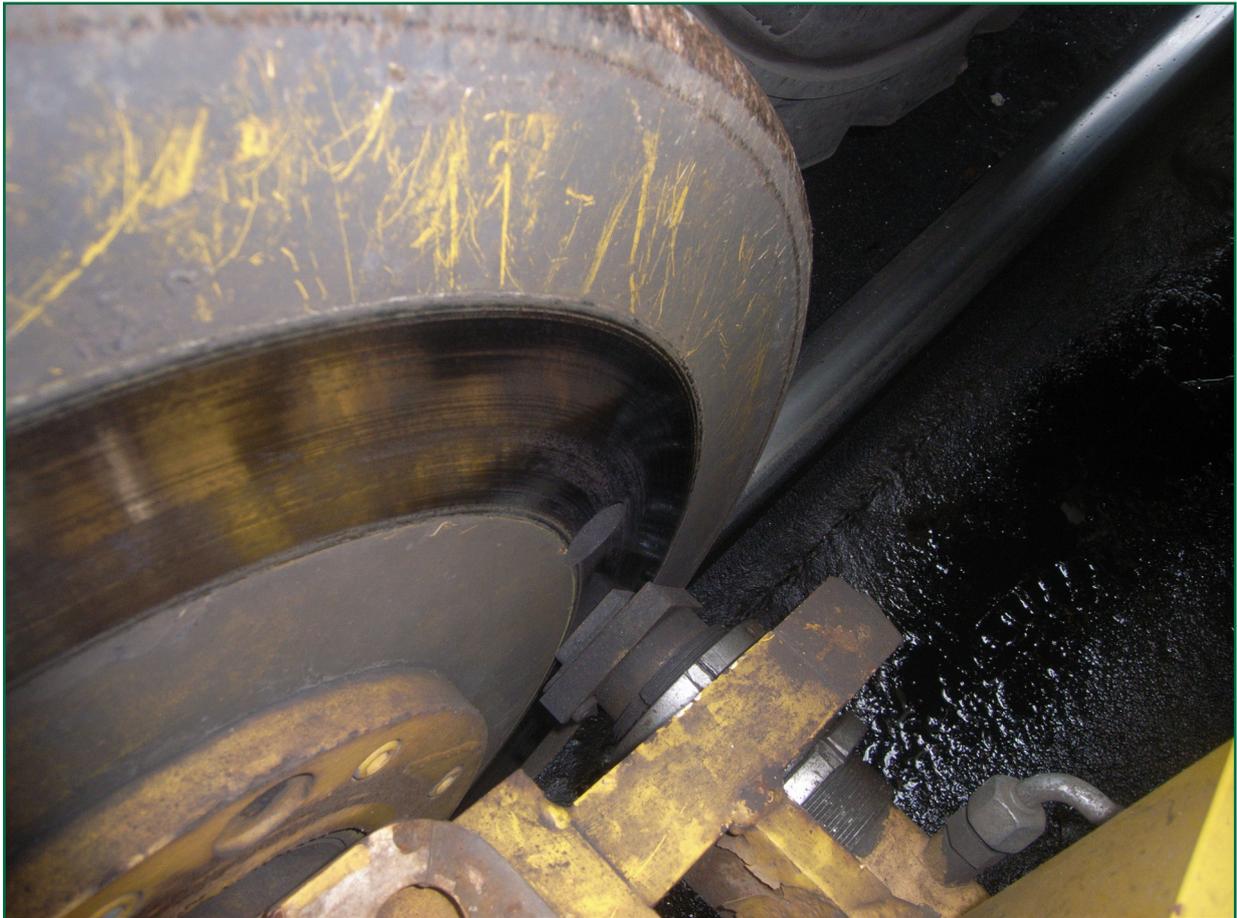
Figure 18: Clean (reflective) brake contact surface immediately after runaway

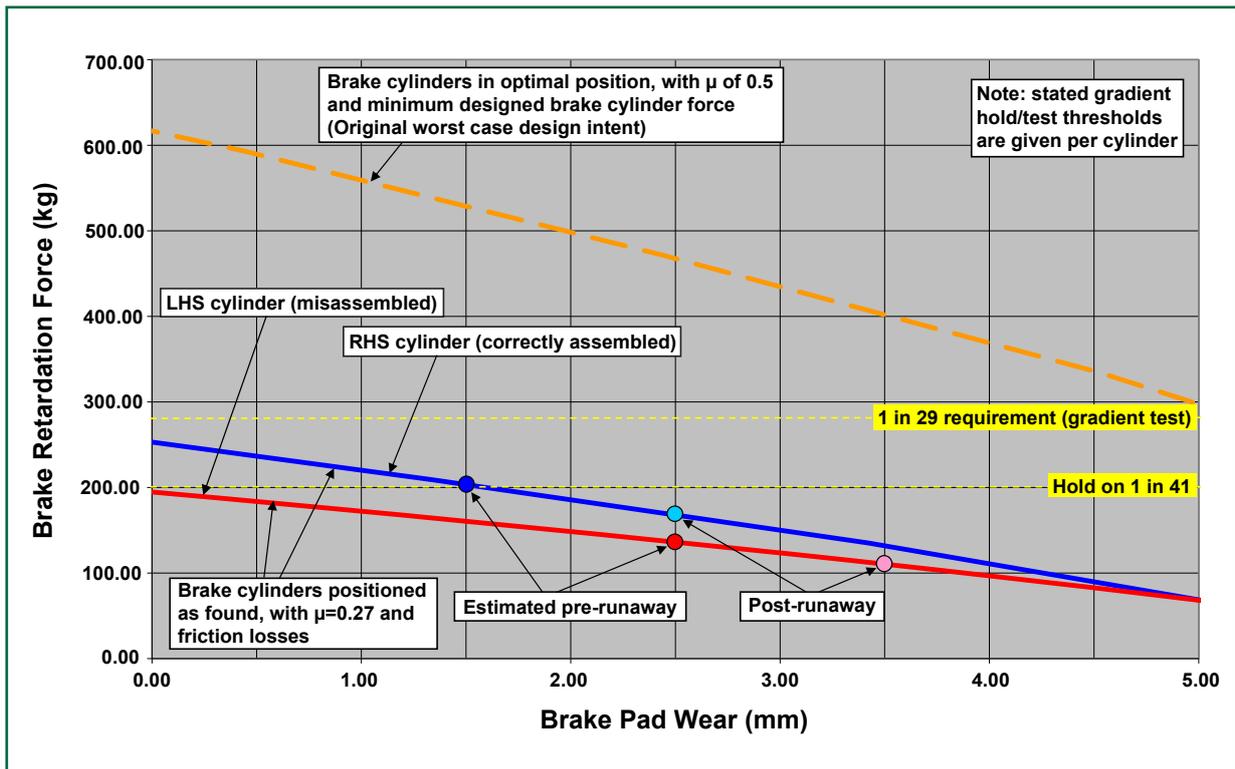
- 100 The effect of pad wear is shown in figure 20, assuming a layer of surface rust on the brake pads. This is the most likely condition when the runaway started, because the RRV had been standing unused at the RRAP for two weeks before the runaway. Figure 20 is based on direct pull tests (appendix D), the slope of the brake cylinder force characteristic (figure 19) and the post-accident position of the brake cylinder (paragraph 101).

- 101 Post-accident examination of the incident RRV showed that the left-hand cylinder was positioned 8 mm away from the optimal position (paragraph 86) with 3.5 mm of pad wear and 4 mm of spring compression. The right-hand cylinder was positioned 5.5 mm away from the optimal position with 2.5 mm of pad wear and 5 mm of spring compression.

Figure 20: Rail wheel holding brake characteristic, set up as found, showing effects of pad wear

102 If the RRV had been on-tracked in this configuration, but with a layer of surface rust on the wheels, the available brake retardation force would have been about 280 kg (paragraph 90). This is based on testing which directly replicated the condition, and would have been insufficient to hold the RRV on the 1 in 41 gradient (a situation requiring approximately 400 kg of brake retardation force).

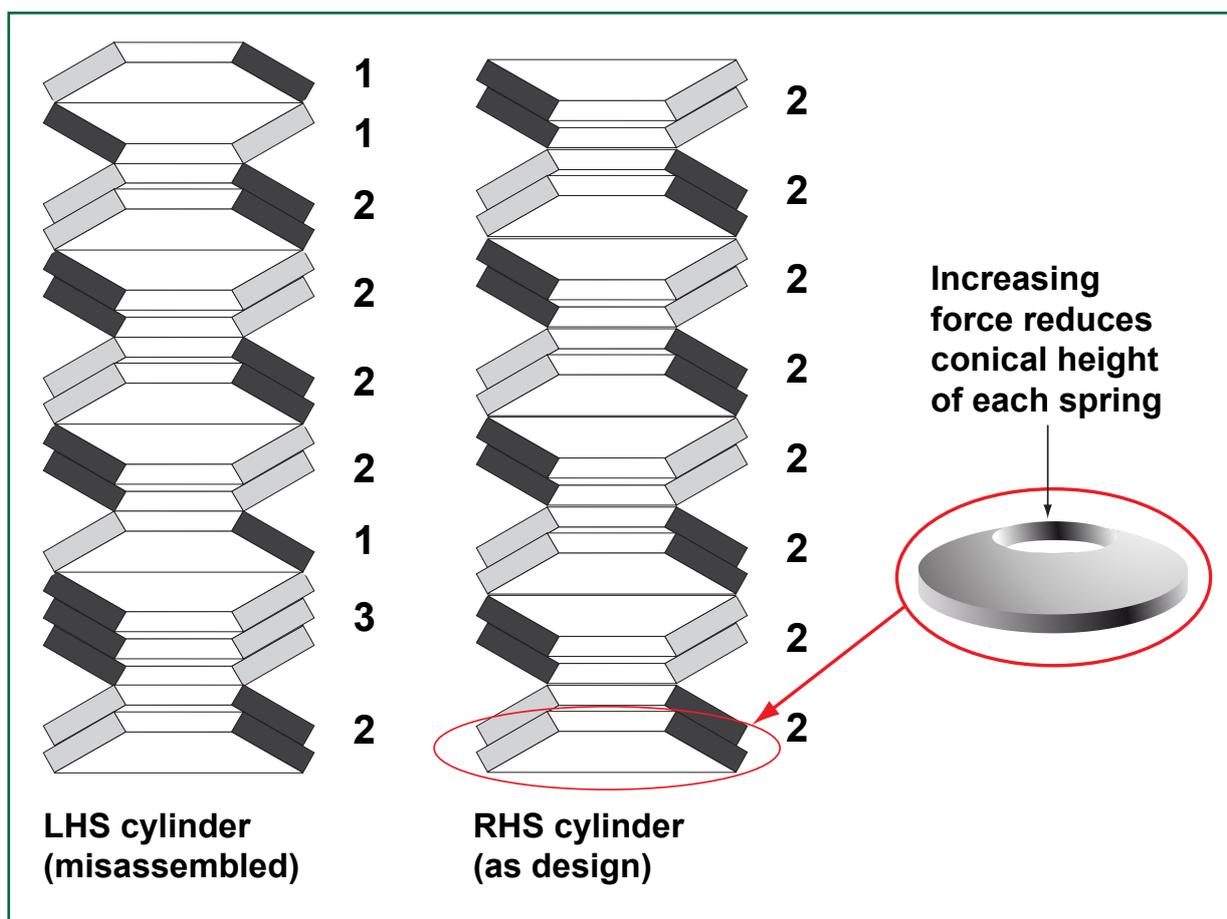
112 One of the RRV brake cylinder springs had been assembled incorrectly; this is a possible causal factor.

113 The spring in the brake cylinder consists of a stack of 16 disc springs, intended to be assembled as 8 back to back pairs, giving the intended spring force to compression characteristic for the brake cylinder. During inspection of the RRV after the accident, the rail wheel holding brake cylinders were disassembled, and this showed that the left-hand side brake cylinder spring stack was assembled incorrectly, with two of the discs inserted upside down (figure 21).

Figure 21: Holding brake cylinder disc spring assembly (misassembled and as designed)

114 This misassembly meant that for a given force applied to the springs, the compression would have been larger than intended. For the 1750 kg of compression that the hydraulic cylinder was able to provide, the misassembled spring assembly would have compressed by approximately 12 mm, instead of 10.5 mm for a correctly assembled cylinder. Figure 19 shows the calculated effect of misassembly of the springs in one brake cylinder on the relationship between spring compression and brake cylinder force.

115 The misassembled spring resulted in a lower brake cylinder force than a correctly assembled spring would have delivered with the brake cylinder in the same position as found after the runaway. It is possible that the reduced force provided by the incorrectly assembled spring may have been a factor in the runaway.
