Rail Accident Report

Derailment at Castle Donington, Leicestershire 21 January 2013

Report 02/2014
January 2014

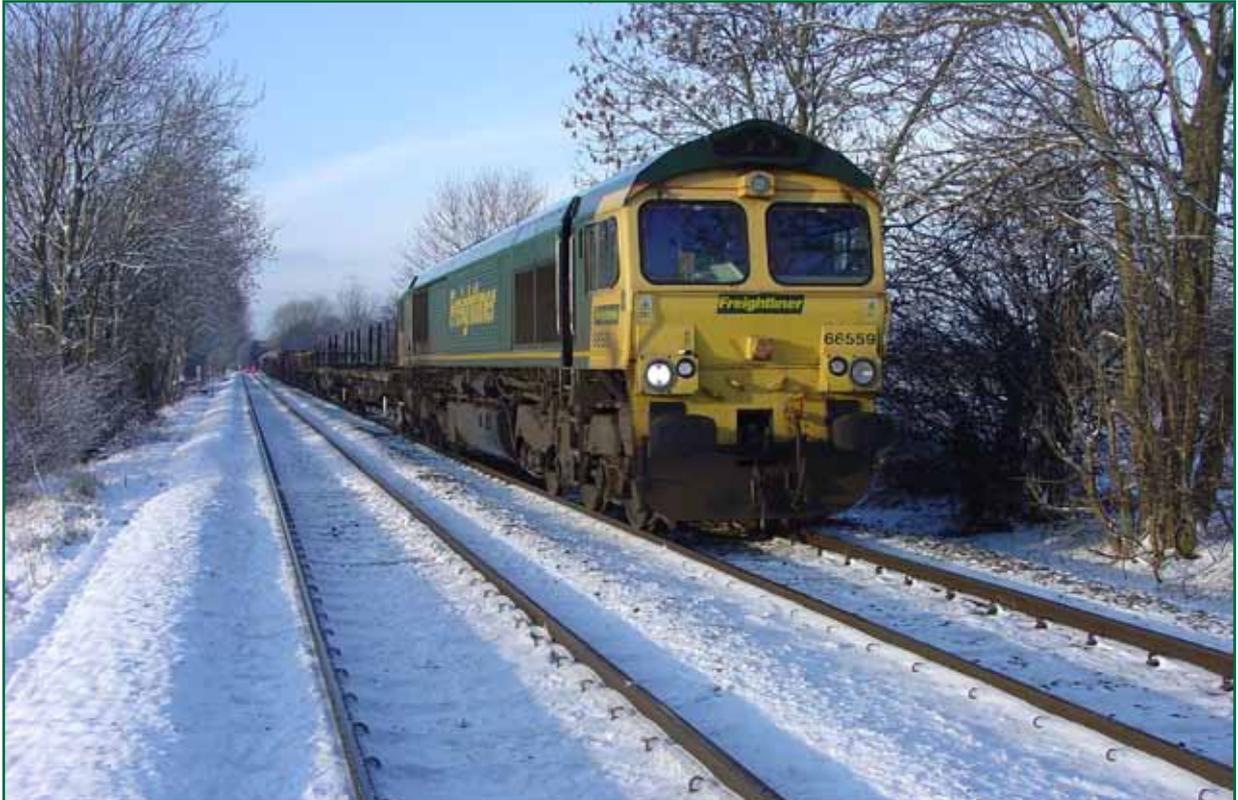
Figure 4: Train 6Z68, the day following the derailment. Hemington Road overbridge (figure 3) can be seen in the background

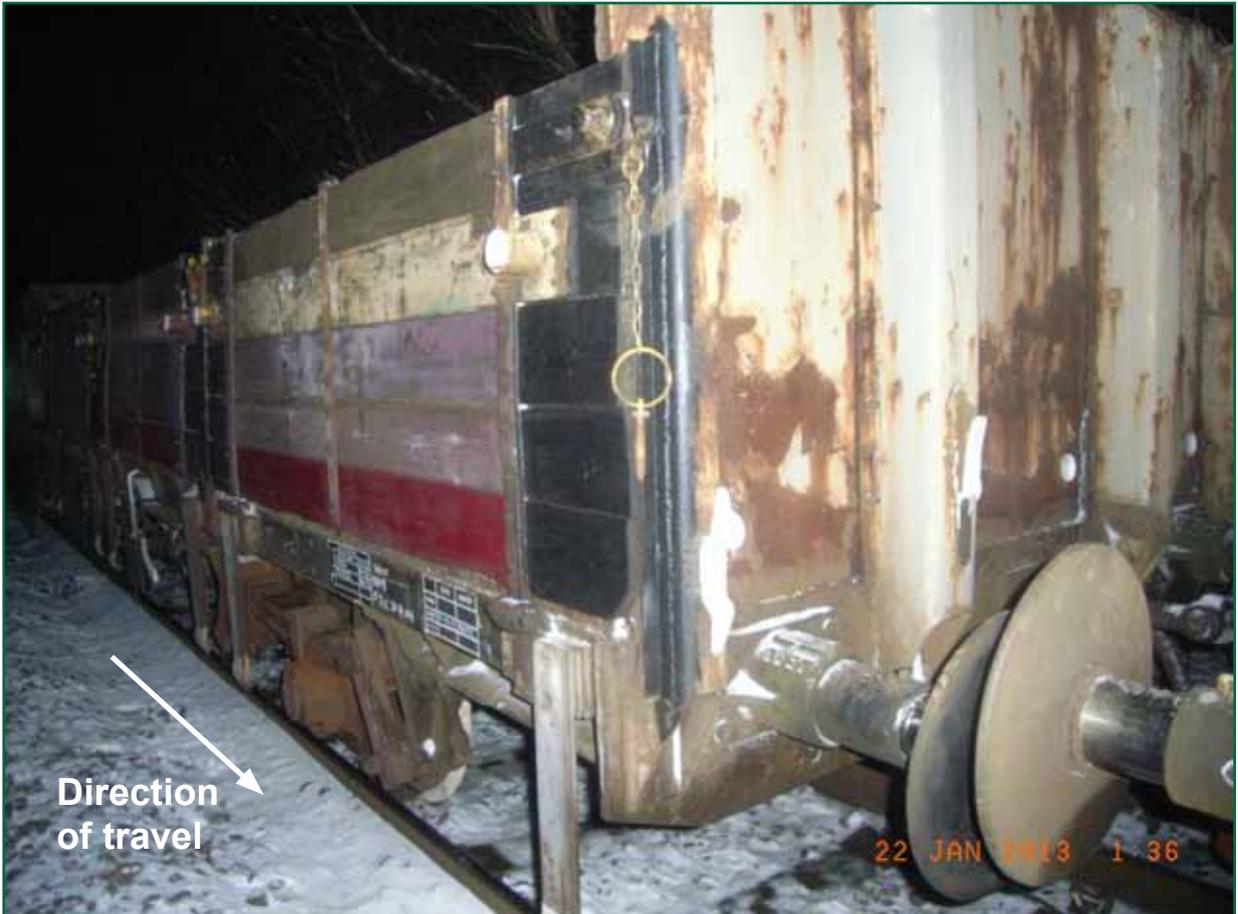
Figure 5: The first wagon to derail, OBA110223

63 The RAIB found marks on the left-hand running rail indicating that all the wheels of the wagon OBA110223 became derailed at 123 miles 1502 yards. No marks were found before this point.

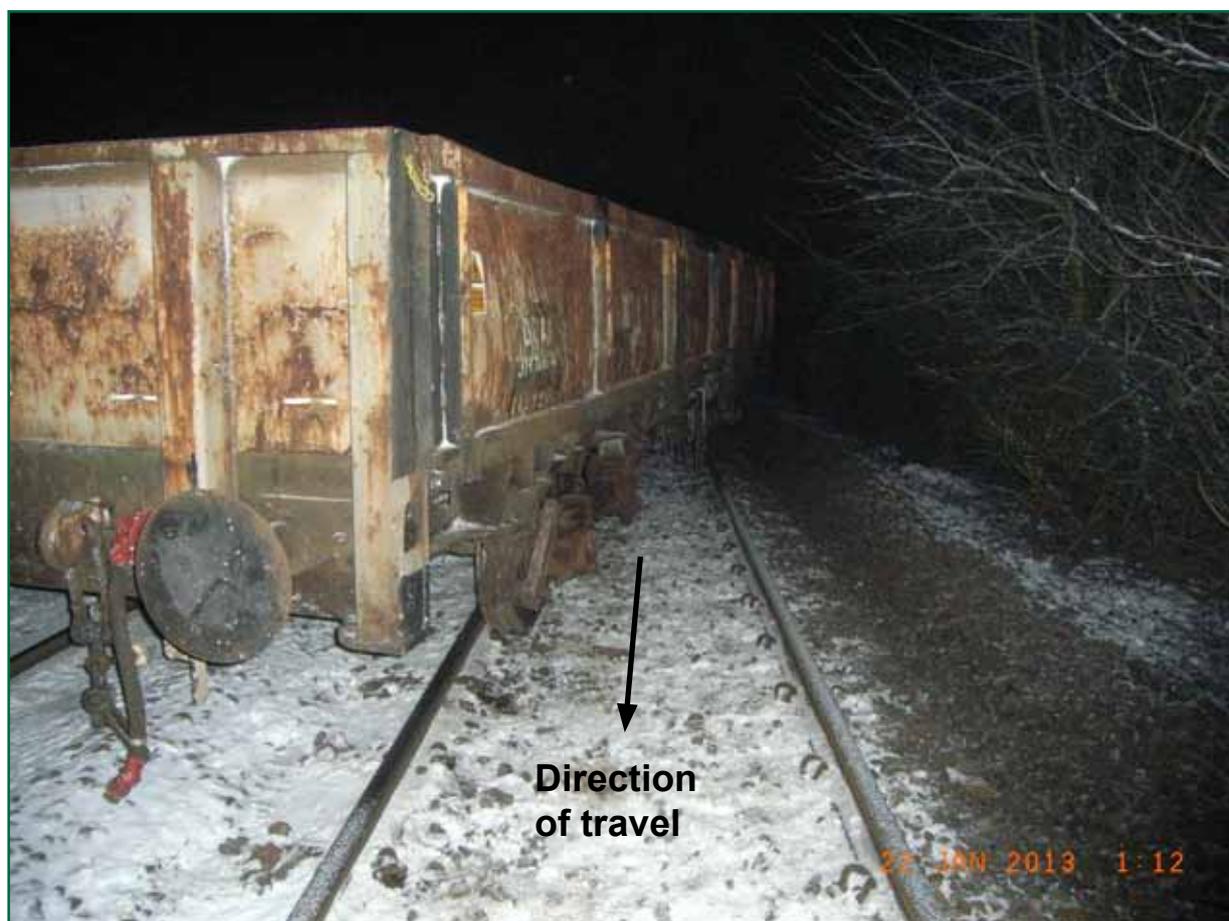
- 36 The train then divided between the nineteenth and twentieth wagons, approaching the Hemington Road overbridge at 122 miles 1554 yards (figure 3). The parting of the *automatic brake pipe* hoses caused an automatic brake application to occur, causing the two portions of the train to stop. The rear portion stopped about 60 metres before the overbridge, with its leading wagon obstructing the adjacent line (figure 7). The front portion stopped about 80 metres beyond it. The first wagon to derail, the eighteenth wagon, ran in a derailed state for about 1668 metres.

Figure 7: The rearmost derailed wagon (the twentieth wagon) which ended up foul of the down Chellaston line

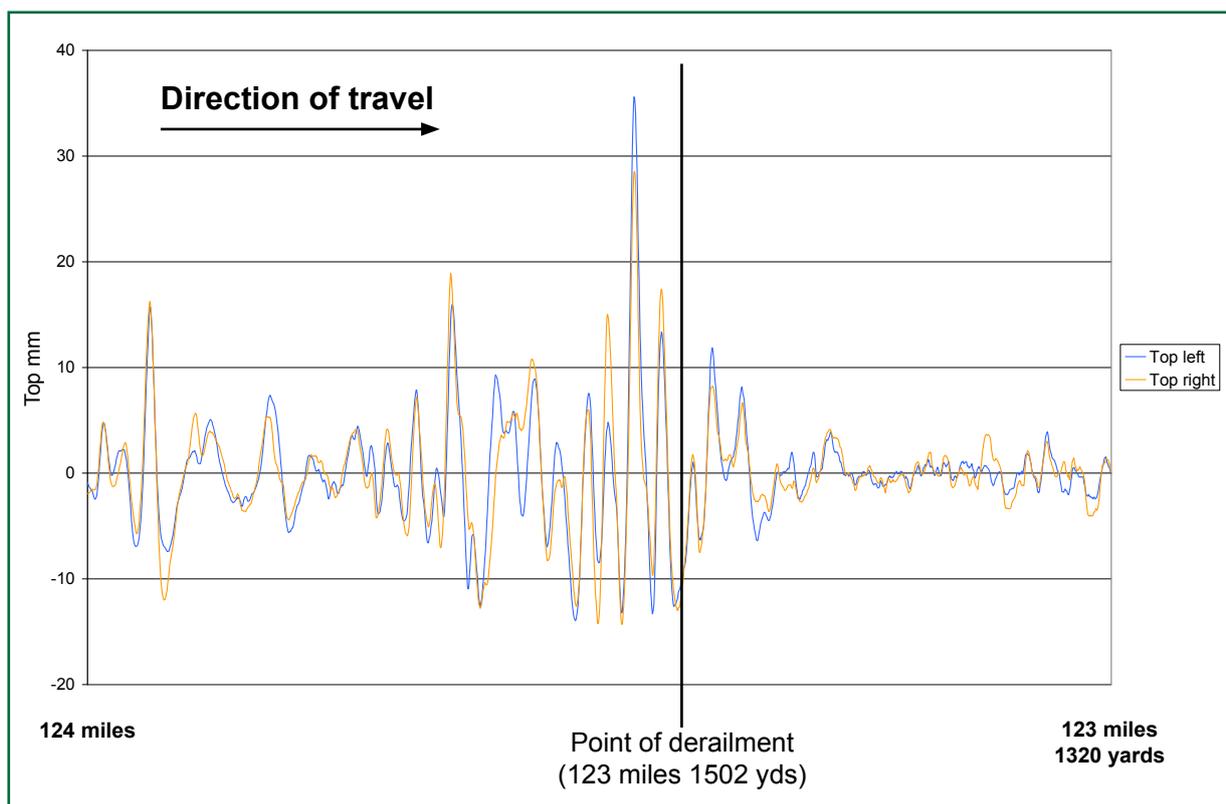
- 60 On 5 November 2012 the track geometry recording train reported cyclic top faults requiring immediate action in the vicinity of the former Back Lane level crossing (figure 3), between 123 miles 1521 yards and 123 miles 1398 yards; and just under 200 yards before Hemington Road bridge (figure 3), between 123 miles 129 yards and 122 miles 1741 yards. Figure 8 shows the condition of the track top in the vicinity of where the derailment occurred. The severity of the faults required the immediate implementation of an immediate 30 mph (48 km/h) emergency speed restriction, followed by action to remove the faults within 36 hours. Paragraphs 79 to 89 describe the work undertaken by Network Rail in response.

Figure 8: Left and right top as recorded by a track geometry recording train on 5 November 2012

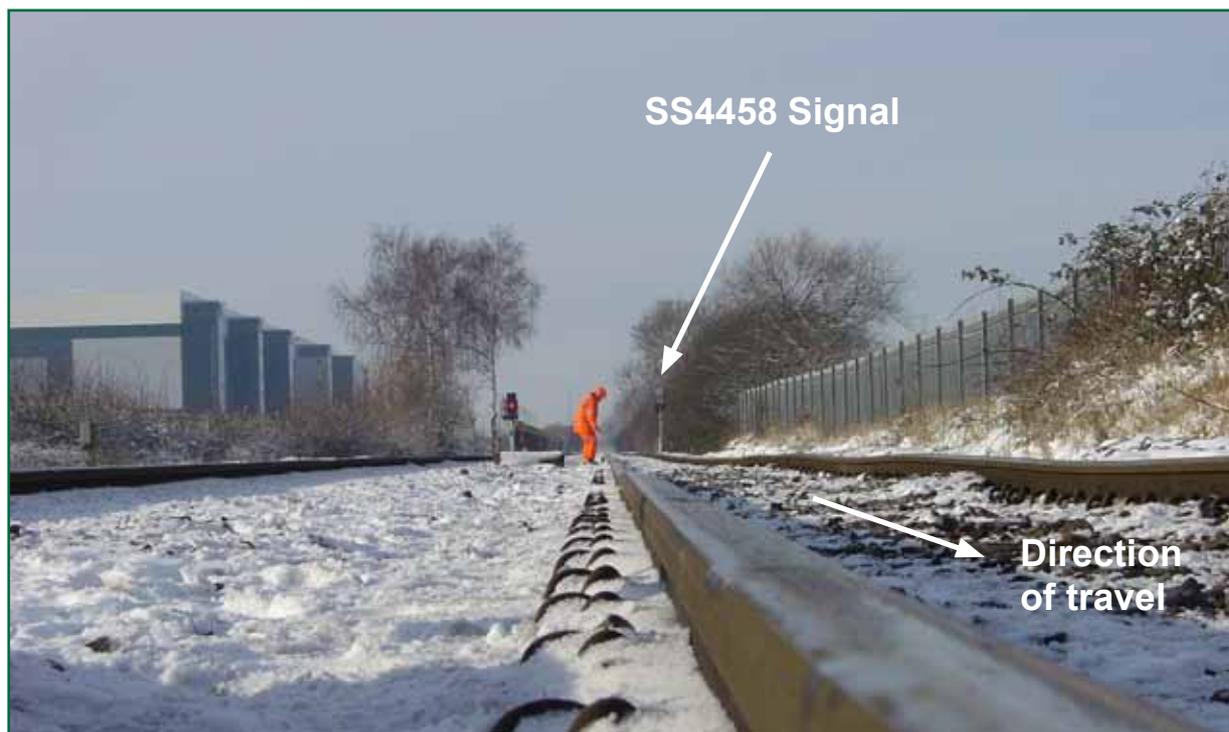
- 52 The high and low spots in the track which combine to make up cyclic top may not be seen during a visual inspection because of voids under the sleepers. As a train passes over voids, its weight depresses the track to fill them and they then reform afterwards. This may cause the track geometry to appear to be acceptable visually, but exhibit cyclic top under load.

Figure 9: Cyclic top on the up Chellaston just before the point of derailment on the day following the derailment

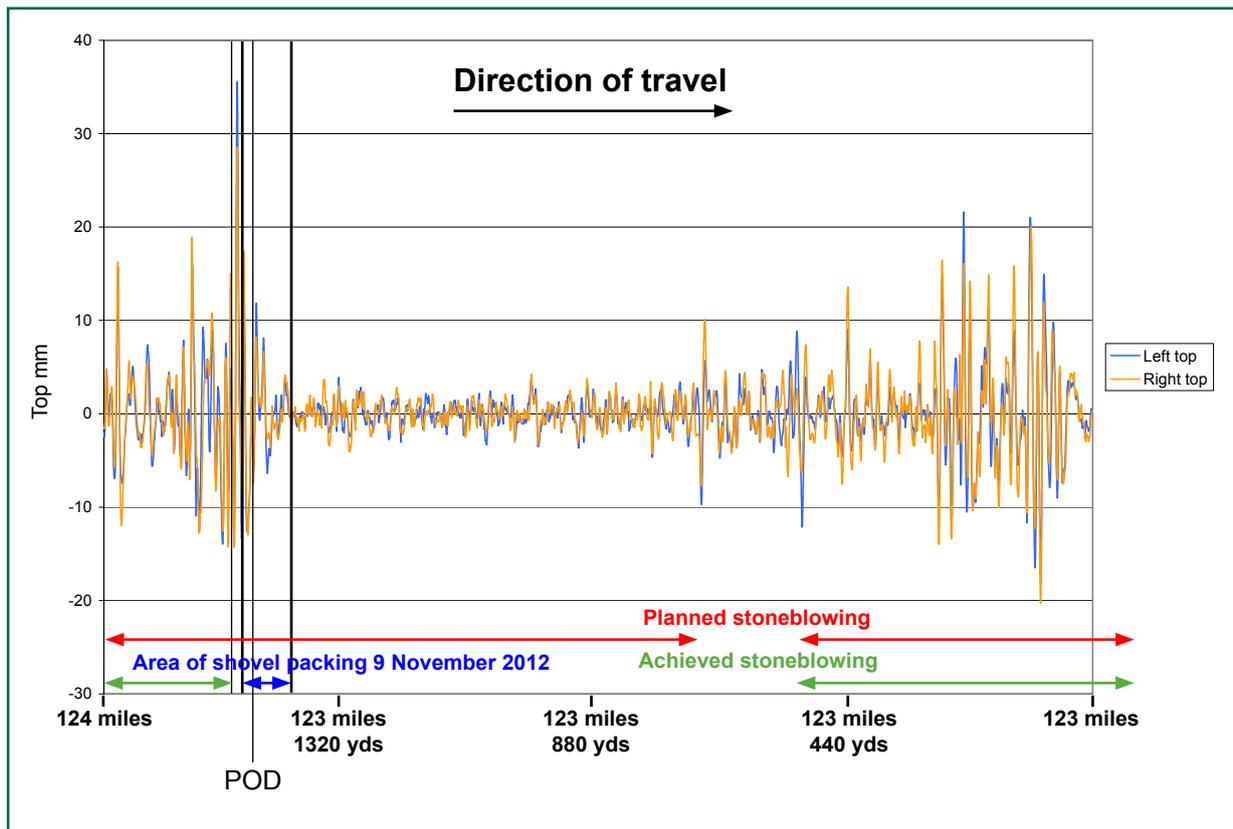
- 90 **The stoneblowing in the Hemington Road bridge and Back Lane areas on 20 November 2012 did not cover the location of the cyclic top which caused the derailment because it was terminated early and was not subsequently planned to be completed.**
- 91 Not all the planned work was completed during the stoneblowing on 20 November 2012 due to there being insufficient time. The stoneblowing stopped before it reached the point of derailment (figure 10). There being insufficient time to complete the stoneblowing is a further factor in the derailment.

Figure 10: Plot of track top showing the shovel packing carried out on 9 November 2012 and the stoneblowing on 20 November 2012 against the track recording trace of 5 November 2012 (POD = Point of derailment: 123 miles 1502 yds)

- 92 The plan was to stoneblow two separate sites: the first (deemed by the section manager to be of higher priority) was near the Hemington Road overbridge (figure 3), from 123 miles 550 yards to 122 miles 1584 yards; the second was in the Back Lane area from 124 miles 0 yards to 123 miles 704 yards. In the event, the first site was completed as planned, but the records show that only 220 yards of the second site was stoneblown, from 124 miles 0 yards to 123 miles 1540 yards. This distance included ramping in and ramping out in which the amount of stone blown increases/reduces in order to provide a smooth transition with the untreated track. The work therefore stopped before reaching the point of derailment at 123 miles 1502 yards.

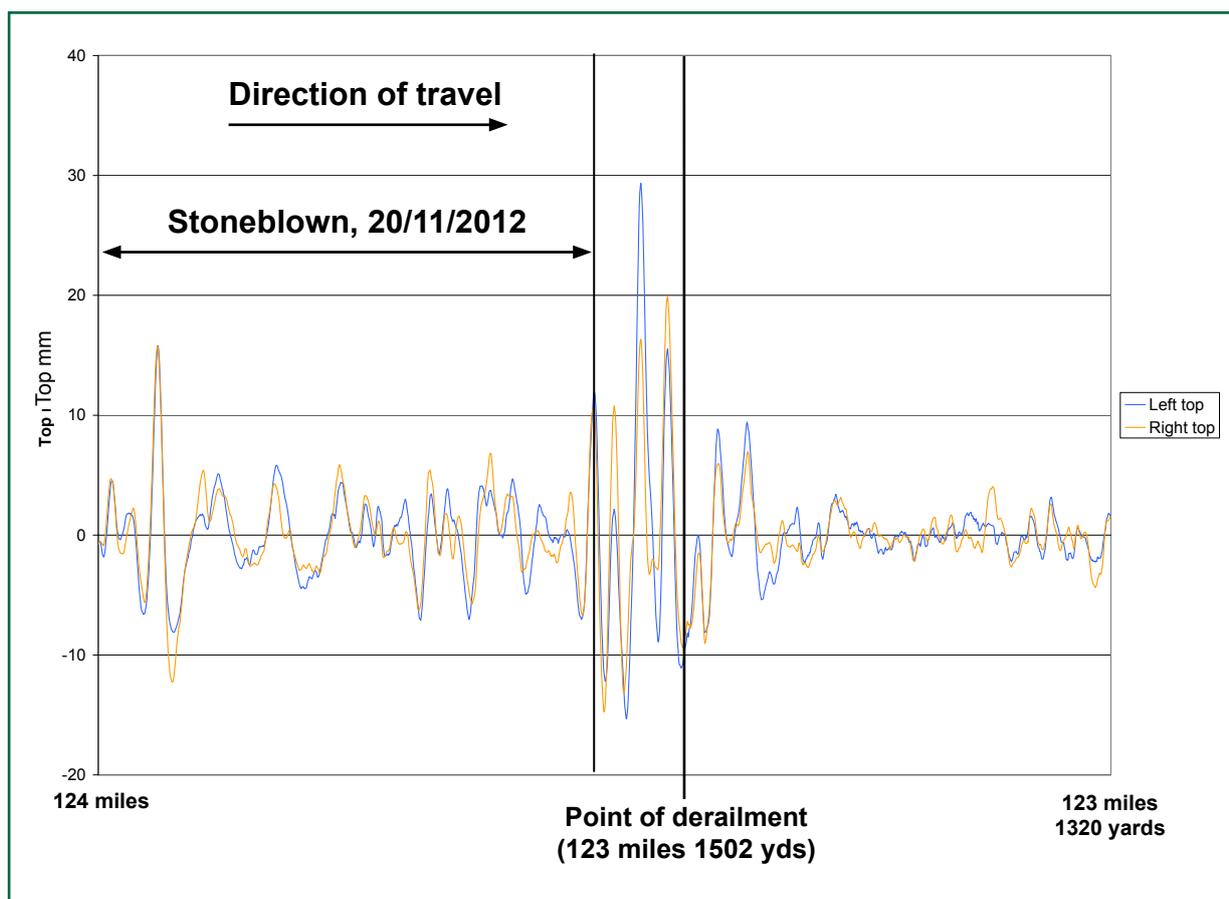
- 97 Two days after the derailment, Network Rail arranged for a track geometry recording train to run over the up Chellaston line. This reported immediate action limit cyclic top faults in the area of the point of derailment. The recording of the top showed the effect of the stoneblowing (figure 11). Figure 11 also shows that there was poor top between where the stoneblowing was completed and the point of derailment, indicating that, by this time, and following the passage of many trains, the shovel packing done on 9 November 2012 was no longer effective. Figures 12a and 12b show a comparison of the track top on 5 November 2012 and 23 January 2013.

Figure 11: Track top following the derailment as measured on 23 January 2013

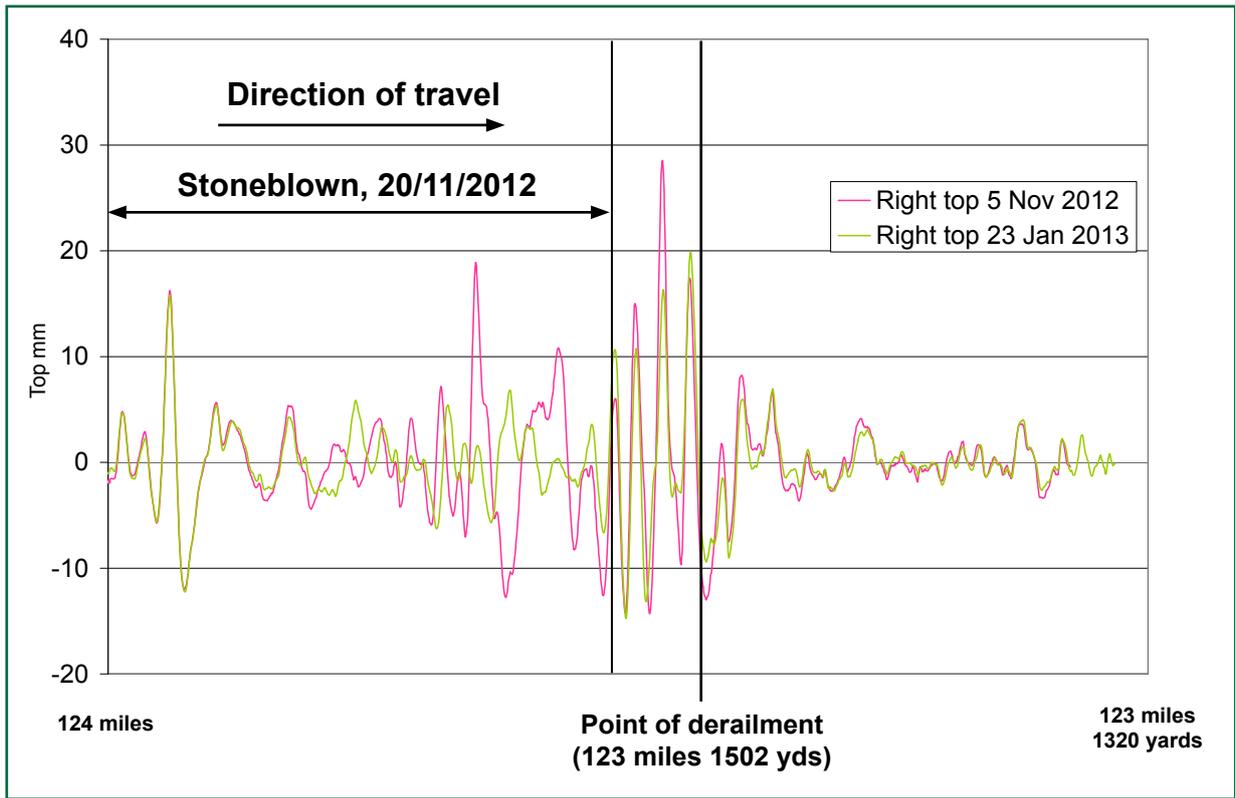
Figure 12a: Comparison of right top 5 November 2012 and 23 January 2013

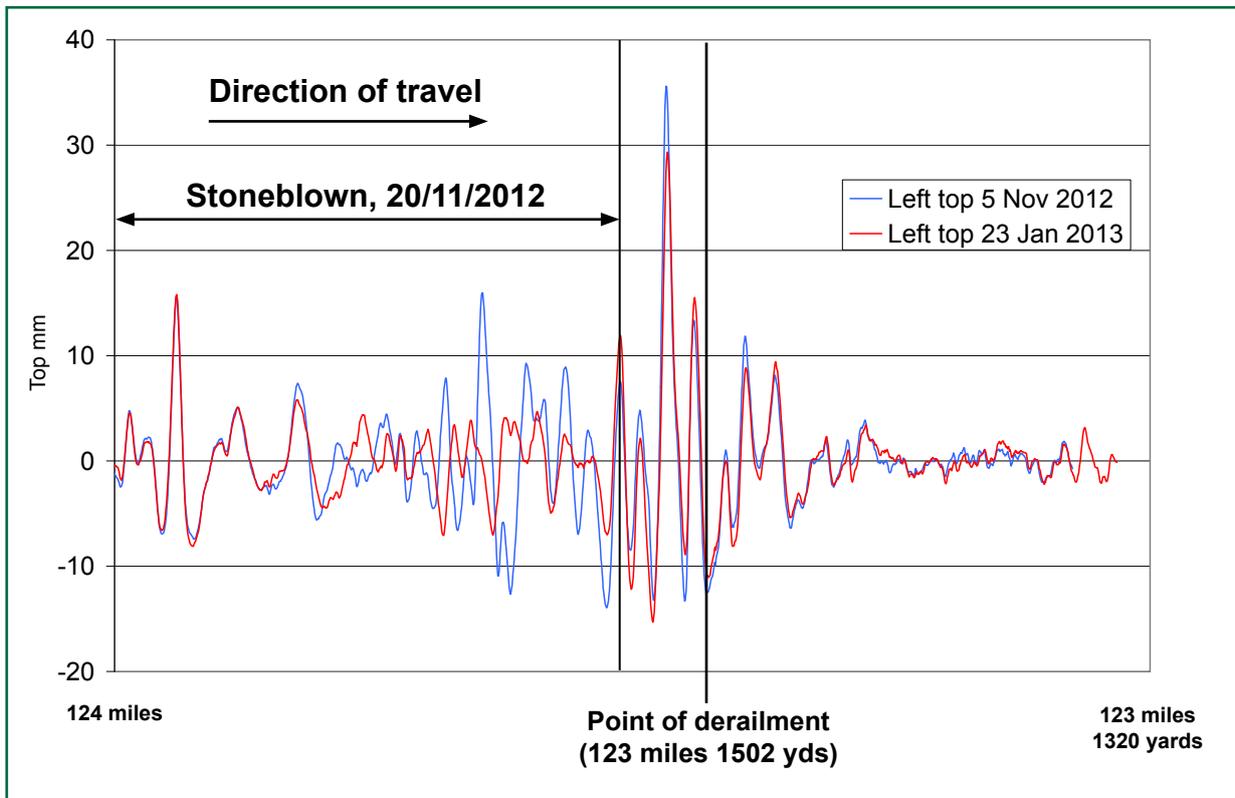
Figure 12b: Comparison of left top 5 November 2012 and 23 January 2013
