Rail Accident Investigation Branch

Rail Accident Report

Collision between a train and a car at Beech Hill level crossing, near Finningley 4 December 2012

Report 17/2013 v2
September 2013

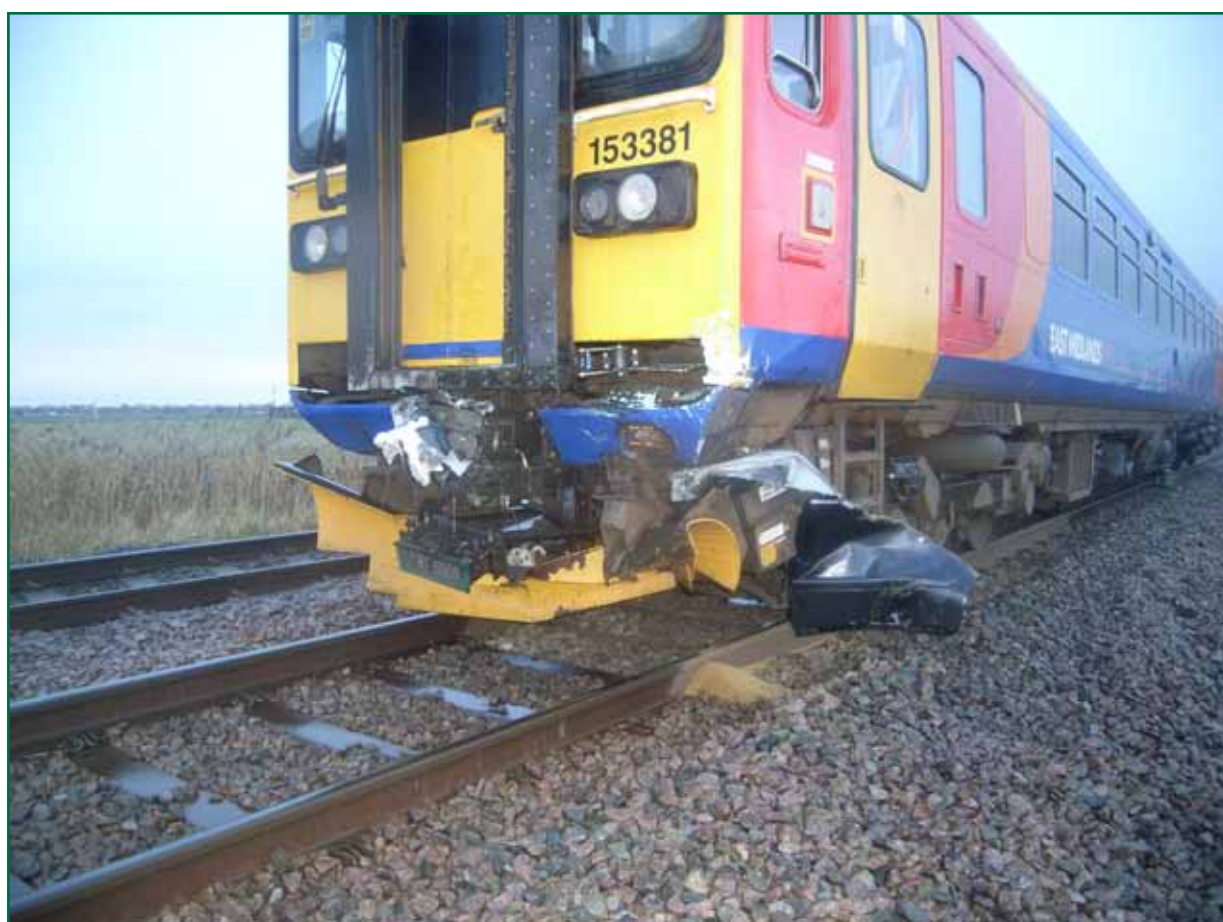
- 28 The train driver could not see the car approaching the level crossing as his view of the road approach was obstructed by buildings and vegetation. He was looking towards a signal further up the line and was unaware of the car's encroachment onto the crossing as it was below his field of view. After the collision he went to apply the brake and found that it had already been applied automatically as a result of damage sustained by the train in the collision.

Figure 3: The train involved

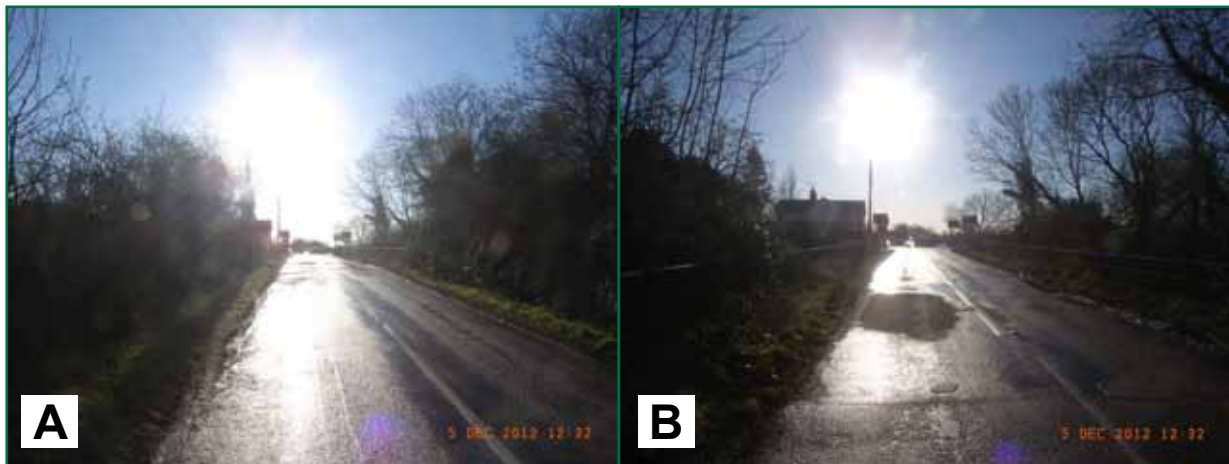
Figure 4: The approach to the crossing in similar conditions at the same time of day on the day after the accident – (a) shows the view from 62 metres and (b) shows the view from 45 metres away

43 The crossing barrier was down, with the boom lamps lit and the wig-wag lights were flashing when the photographs of the approach were taken. The optical response of the camera may not match that of the human eye, however the photographs match the observations made by the RAIB inspector who was accompanied by several observers from Network Rail. That the crossing was activated was not readily apparent to any of those present when viewing the crossing from a range of distances between 129 metres and 45 metres. The wig-wag lamps became more clearly visible at distances closer to the crossing than 45 metres.

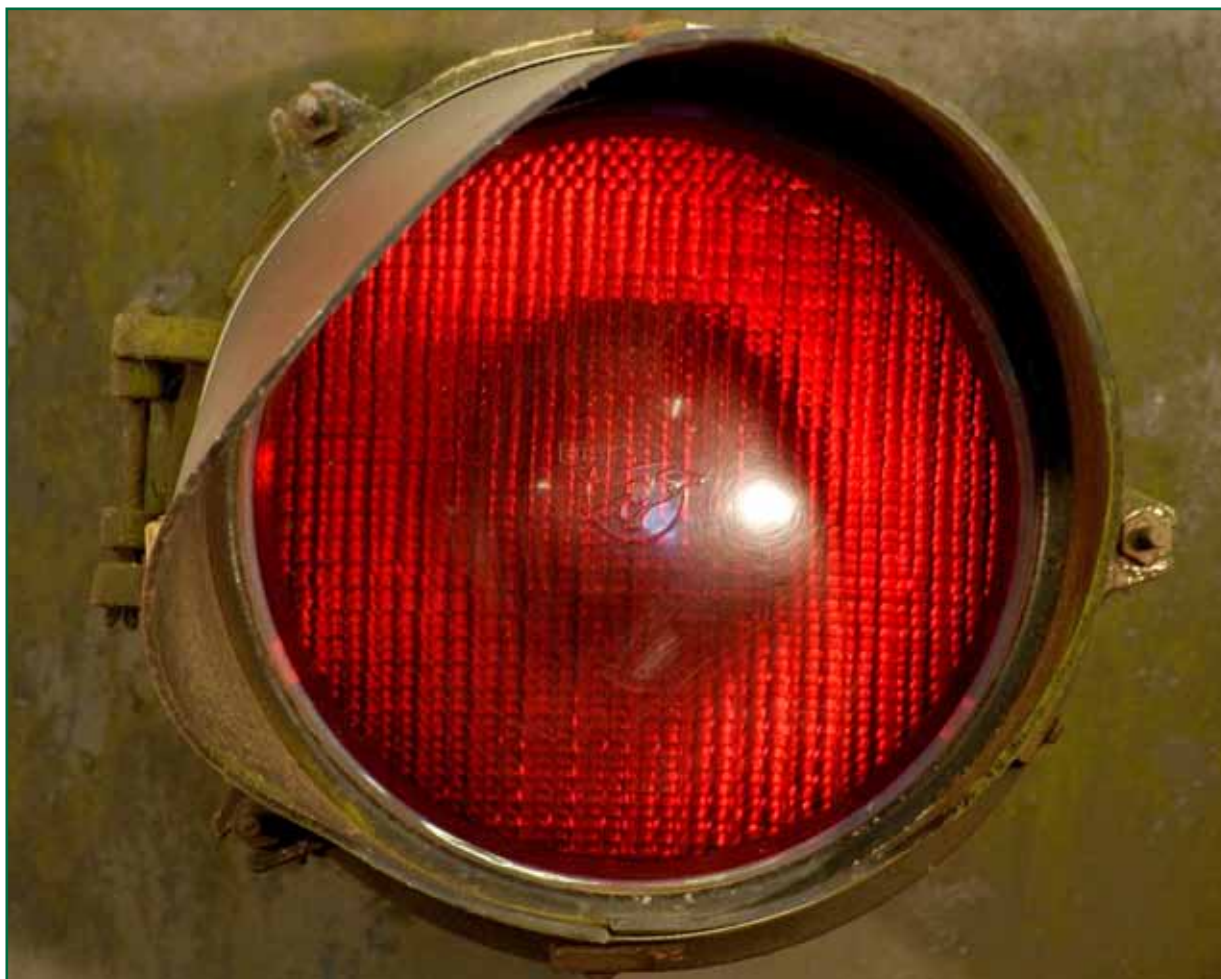
- 57 The lenses fitted to the wig-wag light units were marked with a raised motif of an eagle and the word 'Bliss' at their centre (figure 5). The markings are the trademark of the company which manufactured them, E.W.Bliss Eagle Signal Company. The BRB 908 specification requires that the external surface of the lens is completely smooth, so the lenses did not comply with the specification in this respect, though it is possible that these lenses might predate the specification. The effect of the raised motif on the performance of the lens was not assessed. The inside surface of a wig-wag lens is moulded with many small indentations to focus the light. The quality of finish of these indentations on the lenses from Beech Hill was not as high as on modern lenses and this may have impaired the performance of the lens.

Figure 5: Close up of 'Bliss' lens fitted to one of the wig-wag units at the north side of the crossing

58 The effect of the lens on the light output of the red light units was assessed in the laboratory by replacing the 'Bliss' lens with the modern equivalent, taken from a new 50 W halogen wig-wag unit. The right-hand wig-wag lamp from the unit on the nearside of the road was selected for testing. The diameter of the 'Bliss' lens is less than the diameter of the modern lens and a temporary clamp arrangement was used to hold the new lens in front of the lamp. The luminous intensity of the combined lamp and lens was improved from 110 cd to 178 cd but still did not reach the 500 cd level required by the BRB 908 specification.

Infrastructure managers should determine which level crossings are fitted with 36 W road traffic light signal (wig-wag) units or with 'Bliss' lenses and draw up a time bound plan so that their replacement with LED units is done as soon as possible, those with 'Bliss' lenses being dealt with first.

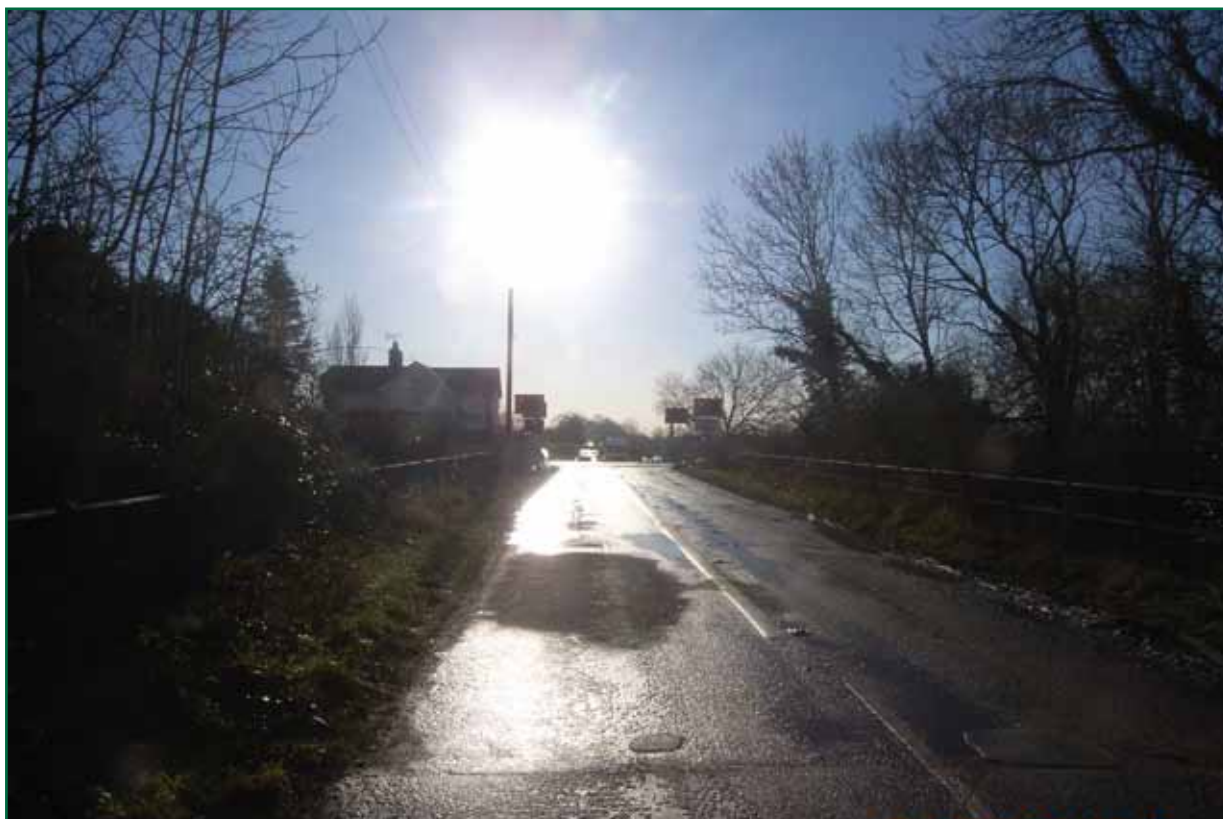
59 **The crossing barrier was not conspicuous against the background. This was exacerbated by the brightness of the background and glare from reflection off the wet road.**

60 The railway is raised above the general ground level at Beech Hill and the road is also raised on the approach to the crossing from the north. The combination of the low horizon and raised viewpoint approaching the crossing from the north side made the barrier difficult to discern against the dark background near the horizon in the conditions that prevailed at the time of the accident (figure 6). An electricity pole on the left of the road before the crossing may also have given the appearance of a raised barrier.

Figure 6: The approach to the crossing as seen from a point 45 metres back from it

- 2 *The purpose of this recommendation is to devise a method of assessing the risk of a bright background and glare preventing wig-wags, and other crossing equipment, from being seen and propose means of mitigating this (eg higher powered LED wig-wags, barrier skirts or other means of improving barrier conspicuity).*

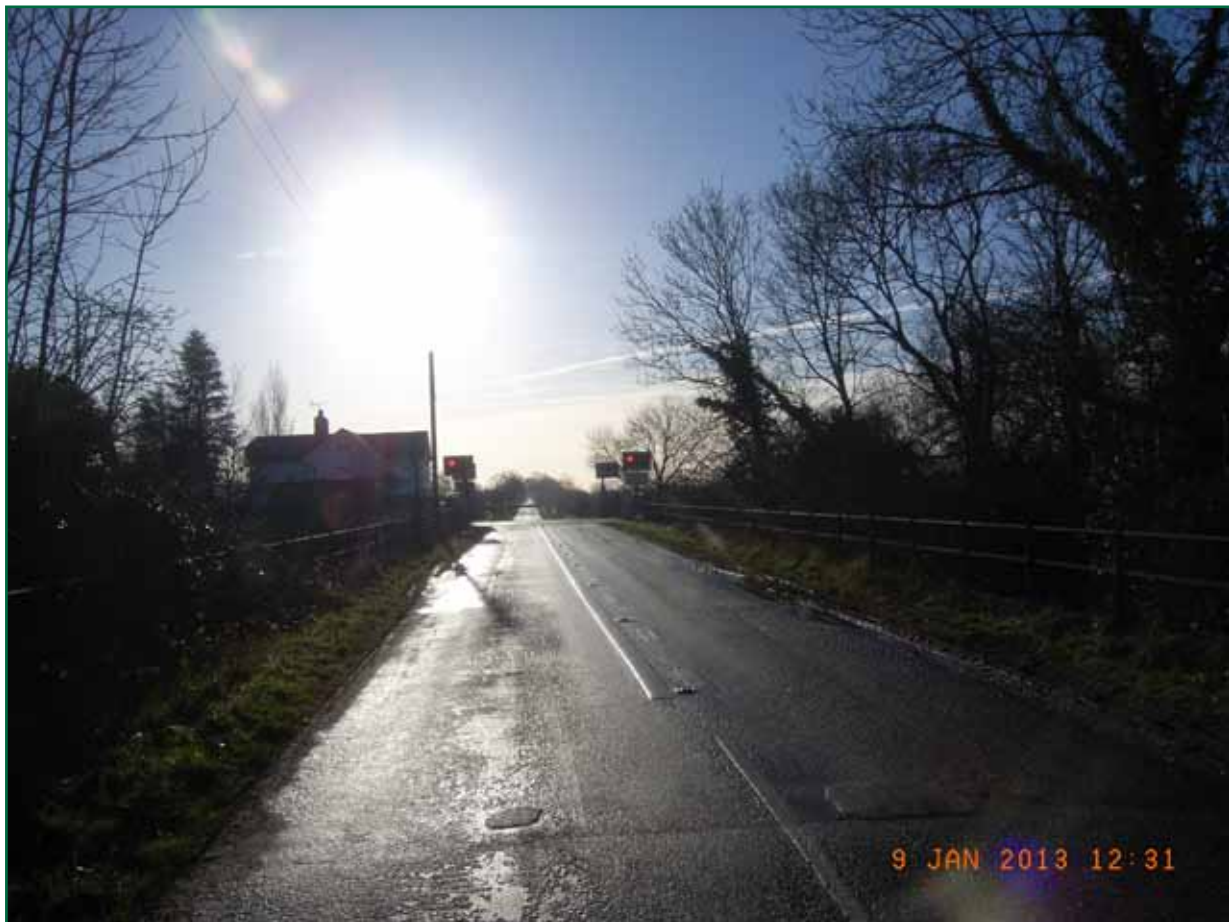
- 119 The picture in figure 7 was taken from the same place as figure 6; a point in the road 45 metres back from the nearside wig-wag, which is between the Highway Code stopping distances for speeds of 40 mph and 50 mph (36 metres and 53 metres respectively). The average speed for most vehicles over the crossing was 49 mph (paragraph 42). The position of the photographer in figures 6 and 7 was therefore at approximately the point at which a typical driver would start to brake for the crossing.

Figure 7: The view from the same point as figure 6, in similar conditions on 9 January 2013, with standard LED wig-wag light units

- 118 Network Rail replaced the 36 W wig-wag units at Beech Hill with LED units on 16/17 December 2012. The RAIB viewed the crossing in similar conditions to the day of the accident on 13 January 2013. Photographs were taken of the crossing while it was activated at the same time of day and from the same positions in the road as on the day after the accident. The exposure time of the photograph is short compared to the time of the flash cycle and it is possible that the 36 W lamps may not have reached full output at the instant of exposure. However, the photographs give an indication of the visibility of the crossing and wig-wags and confirm the observations made on the day after the accident (paragraph 43).
