Rail Accident Report

Collision between a train and a car at Beech Hill level crossing, near Finningley 4 December 2012

Report 17/2013 v2
September 2013

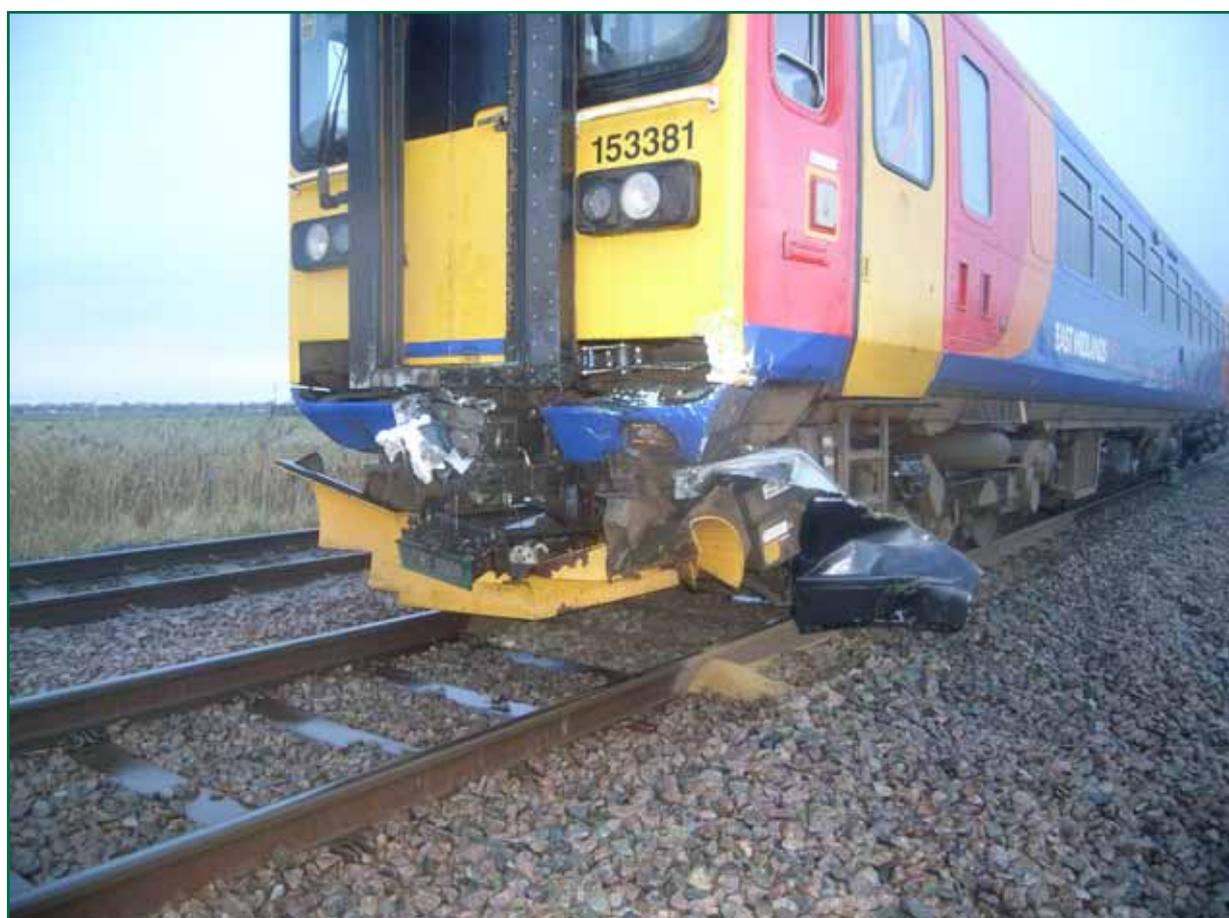
Figure 3: The train involved

- 28 The train driver could not see the car approaching the level crossing as his view of the road approach was obstructed by buildings and vegetation. He was looking towards a signal further up the line and was unaware of the car's encroachment onto the crossing as it was below his field of view. After the collision he went to apply the brake and found that it had already been applied automatically as a result of damage sustained by the train in the collision.

- 29 The train was not derailed and came to rest 479 metres from the crossing.

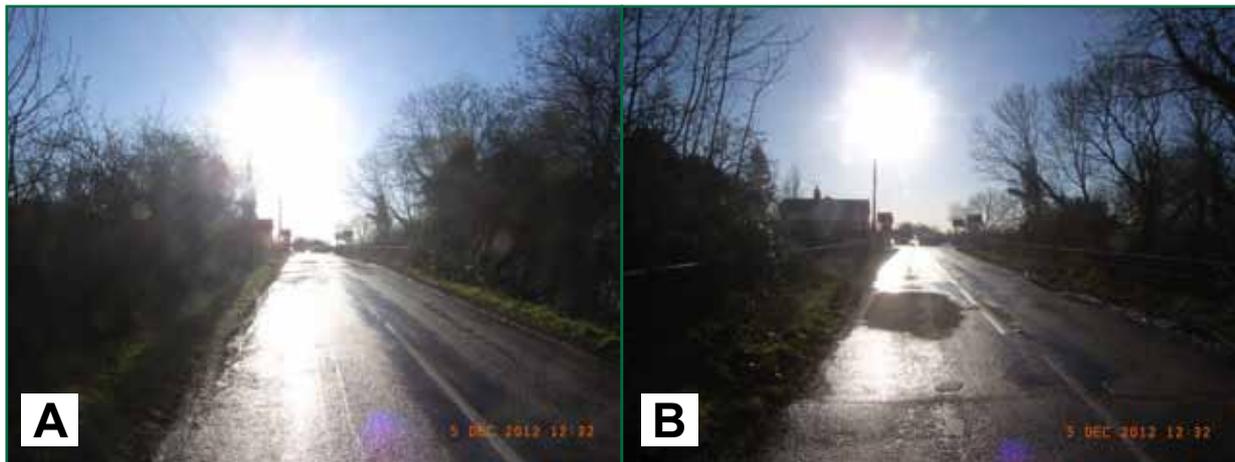
39 The sun was bright and low in the sky, and at the time of the accident was shining from behind the wig-wags towards the approaching car. The road surface was wet from rain earlier in the day and this led to *glare* from the sun reflecting back off the road. This had the effect of making the road surface up to, and beyond, the crossing appear shiny and apparently clear to drive over. Figure 6 shows this view in similar conditions the day after the accident.

Figure 4: The approach to the crossing in similar conditions at the same time of day on the day after the accident – (a) shows the view from 62 metres and (b) shows the view from 45 metres away

43 The crossing barrier was down, with the boom lamps lit and the wig-wag lights were flashing when the photographs of the approach were taken. The optical response of the camera may not match that of the human eye, however the photographs match the observations made by the RAIB inspector who was accompanied by several observers from Network Rail. That the crossing was activated was not readily apparent to any of those present when viewing the crossing from a range of distances between 129 metres and 45 metres. The wig-wag lamps became more clearly visible at distances closer to the crossing than 45 metres.

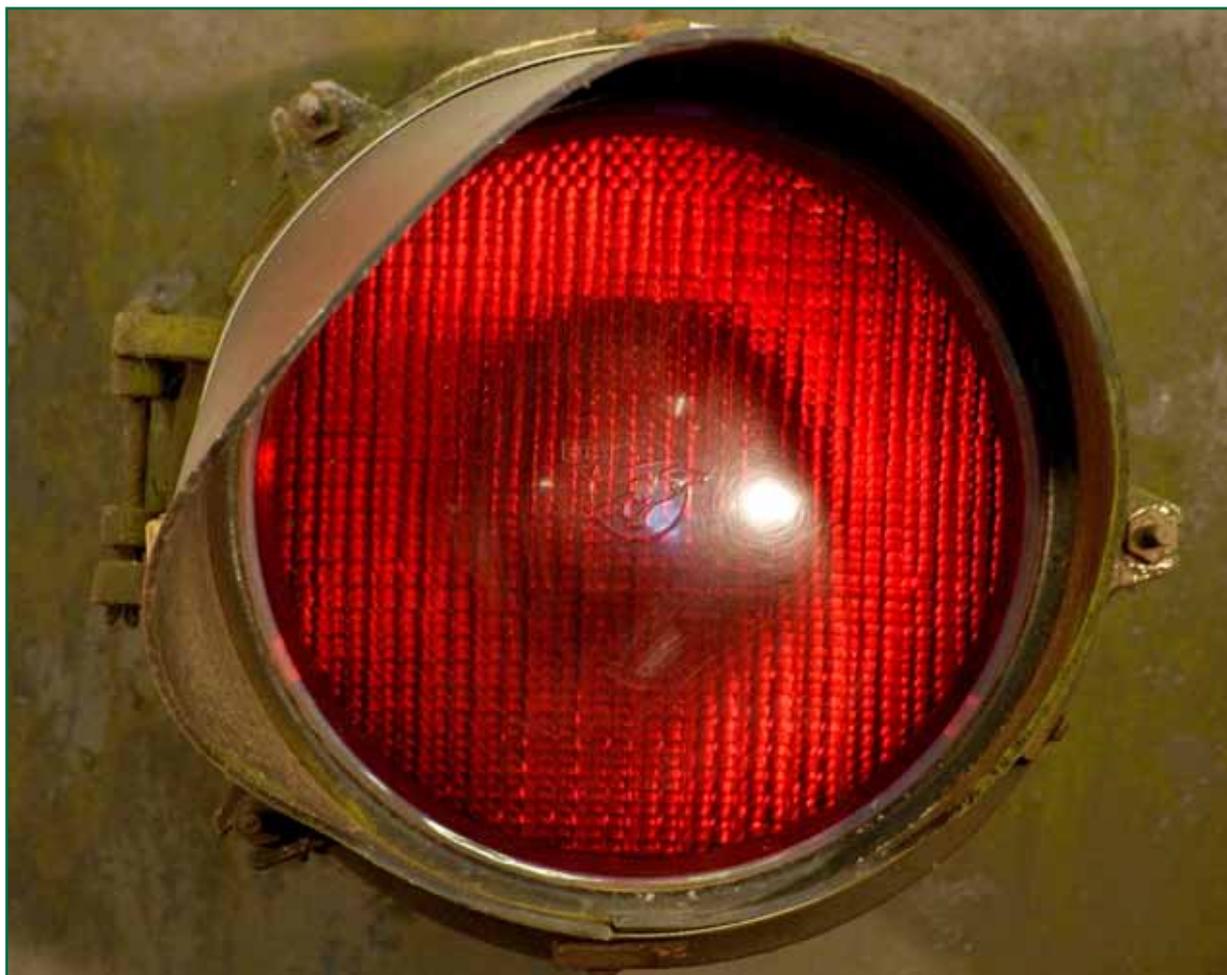
- 57 The lenses fitted to the wig-wag light units were marked with a raised motif of an eagle and the word 'Bliss' at their centre (figure 5). The markings are the trademark of the company which manufactured them, E.W.Bliss Eagle Signal Company. The BRB 908 specification requires that the external surface of the lens is completely smooth, so the lenses did not comply with the specification in this respect, though it is possible that these lenses might predate the specification. The effect of the raised motif on the performance of the lens was not assessed. The inside surface of a wig-wag lens is moulded with many small indentations to focus the light. The quality of finish of these indentations on the lenses from Beech Hill was not as high as on modern lenses and this may have impaired the performance of the lens.

Figure 5: Close up of 'Bliss' lens fitted to one of the wig-wag units at the north side of the crossing

58 The effect of the lens on the light output of the red light units was assessed in the laboratory by replacing the 'Bliss' lens with the modern equivalent, taken from a new 50 W halogen wig-wag unit. The right-hand wig-wag lamp from the unit on the nearside of the road was selected for testing. The diameter of the 'Bliss' lens is less than the diameter of the modern lens and a temporary clamp arrangement was used to hold the new lens in front of the lamp. The luminous intensity of the combined lamp and lens was improved from 110 cd to 178 cd but still did not reach the 500 cd level required by the BRB 908 specification.

- 65 The last annual maintenance and inspection visit prior to the accident was conducted on 11 July 2012 and the inspector noted only one non-conformance requiring corrective action (this stated that the site plan was out of date, rather than that the crossing did not comply with the plan). The list of checks to be carried out at the annual service included checking the alignment of the lights but not their level of light output. The list also included checking that '*the signal lenses are undamaged, clean and correctly orientated*'. The inspector noted that he had cleaned the lenses and that they satisfied this check. The list of checks did not include checking that the lenses met their specification. The lenses fitted at this crossing did not meet this requirement in that they had a raised manufacturer's name and logo at their centre (figure 5).

- 1 *The purpose of this recommendation is to replace, with LED units, all remaining 36 W wig-wags at level crossings, with those having 'Bliss' lenses a priority. Network Rail issued Special Inspection Notice SIN121 on 9 May 2013 to locate all such crossings on its infrastructure. This inspection is to be completed by 27 September 2013.*

Infrastructure managers should determine which level crossings are fitted with 36 W road traffic light signal (wig-wag) units or with 'Bliss' lenses and draw up a time bound plan so that their replacement with LED units is done as soon as possible, those with 'Bliss' lenses being dealt with first.

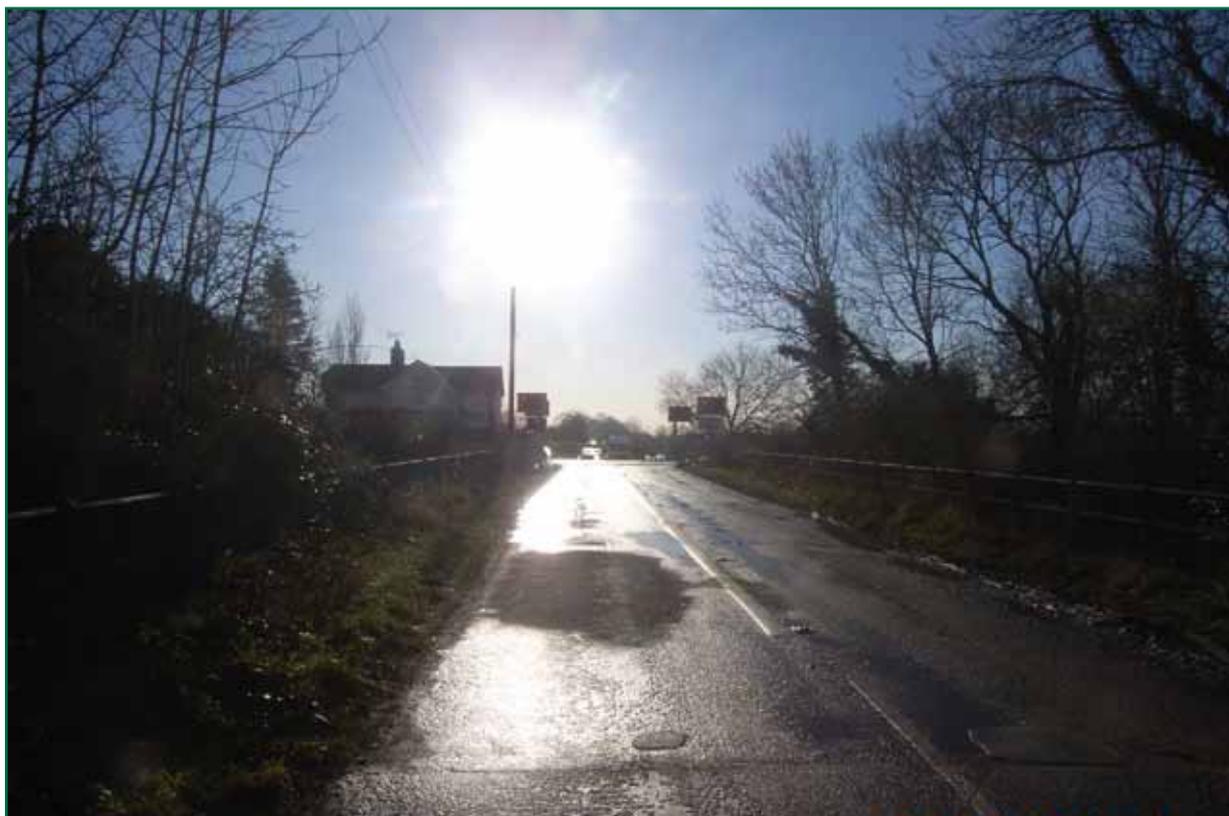
59 **The crossing barrier was not conspicuous against the background. This was exacerbated by the brightness of the background and glare from reflection off the wet road.**

60 The railway is raised above the general ground level at Beech Hill and the road is also raised on the approach to the crossing from the north. The combination of the low horizon and raised viewpoint approaching the crossing from the north side made the barrier difficult to discern against the dark background near the horizon in the conditions that prevailed at the time of the accident (figure 6). An electricity pole on the left of the road before the crossing may also have given the appearance of a raised barrier.

Figure 6: The approach to the crossing as seen from a point 45 metres back from it

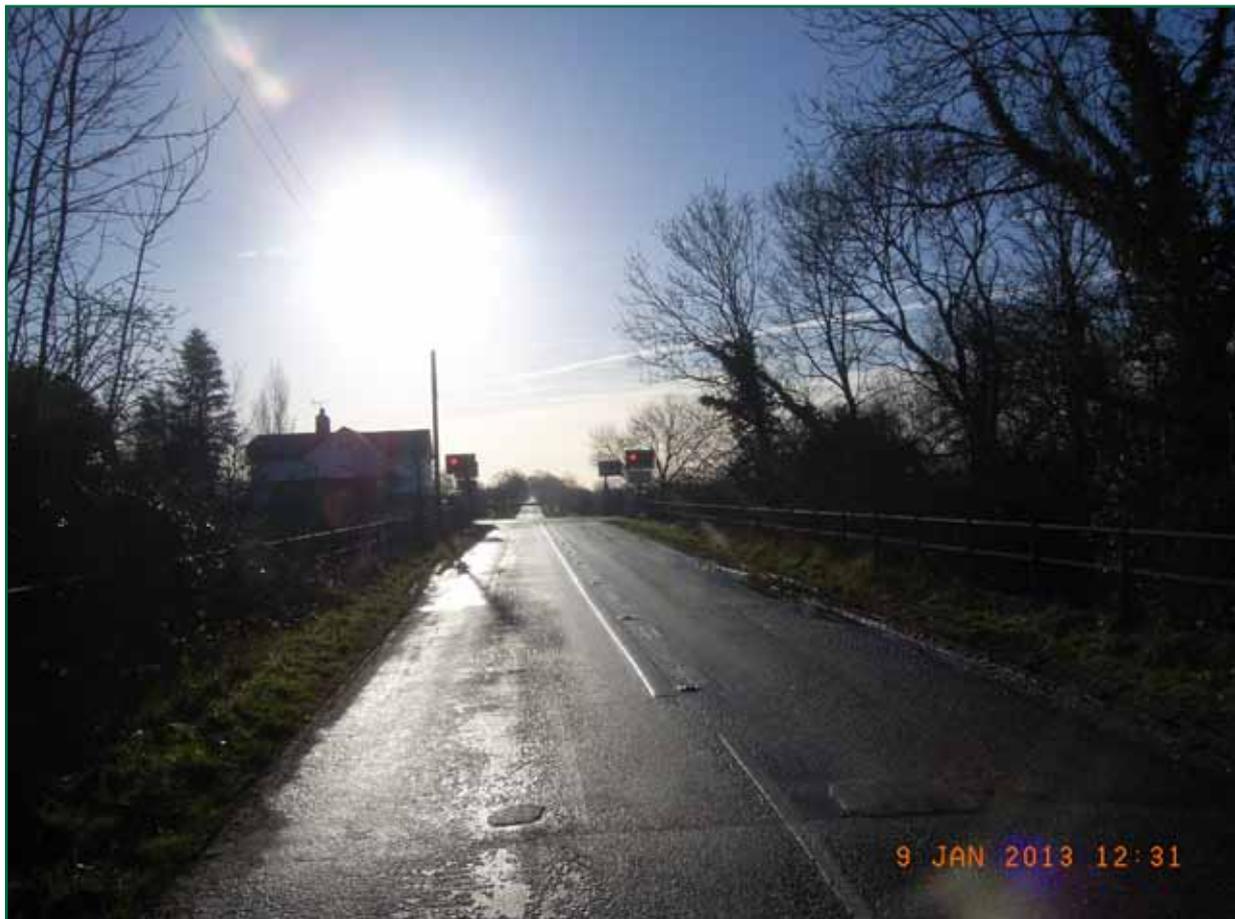
- 119 The picture in figure 7 was taken from the same place as figure 6; a point in the road 45 metres back from the nearside wig-wag, which is between the Highway Code stopping distances for speeds of 40 mph and 50 mph (36 metres and 53 metres respectively). The average speed for most vehicles over the crossing was 49 mph (paragraph 42). The position of the photographer in figures 6 and 7 was therefore at approximately the point at which a typical driver would start to brake for the crossing.

Figure 7: The view from the same point as figure 6, in similar conditions on 9 January 2013, with standard LED wig-wag light units

- 118 Network Rail replaced the 36 W wig-wag units at Beech Hill with LED units on 16/17 December 2012. The RAIB viewed the crossing in similar conditions to the day of the accident on 13 January 2013. Photographs were taken of the crossing while it was activated at the same time of day and from the same positions in the road as on the day after the accident. The exposure time of the photograph is short compared to the time of the flash cycle and it is possible that the 36 W lamps may not have reached full output at the instant of exposure. However, the photographs give an indication of the visibility of the crossing and wig-wags and confirm the observations made on the day after the accident (paragraph 43).
