Rail Accident Investigation Branch

Rail Accident Report

Accident at Charing Cross station 24 November 2012

Report 10/2013
July 2013

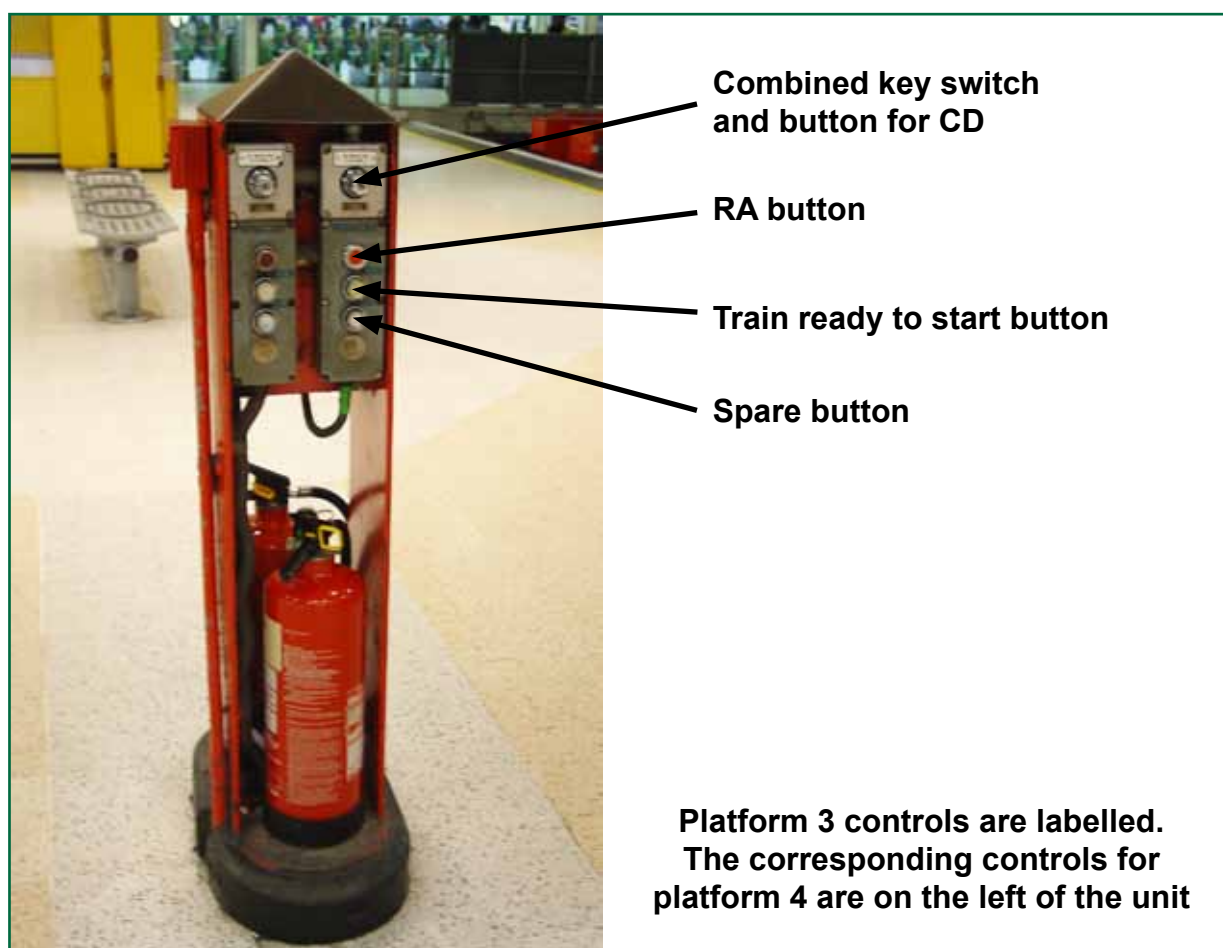
Figure 3: Dispatch controls for platforms 3 and 4 at Charing Cross

- 51 The customer service assistant operated the 'RA' control just before the person, who had been walking towards the exit, suddenly changed direction, moved quickly across the platform, and fell against the train. It was then impossible for the customer service assistant to do anything to prevent the departure of the train. The reaction of the driver to the 'RA' indication, the response of the train's systems to the driver's operation of the power/brake control handle, and the time required to release the brakes, means that there is normally up to seven seconds between the appearance of the 'RA' indication and the train starting to move.

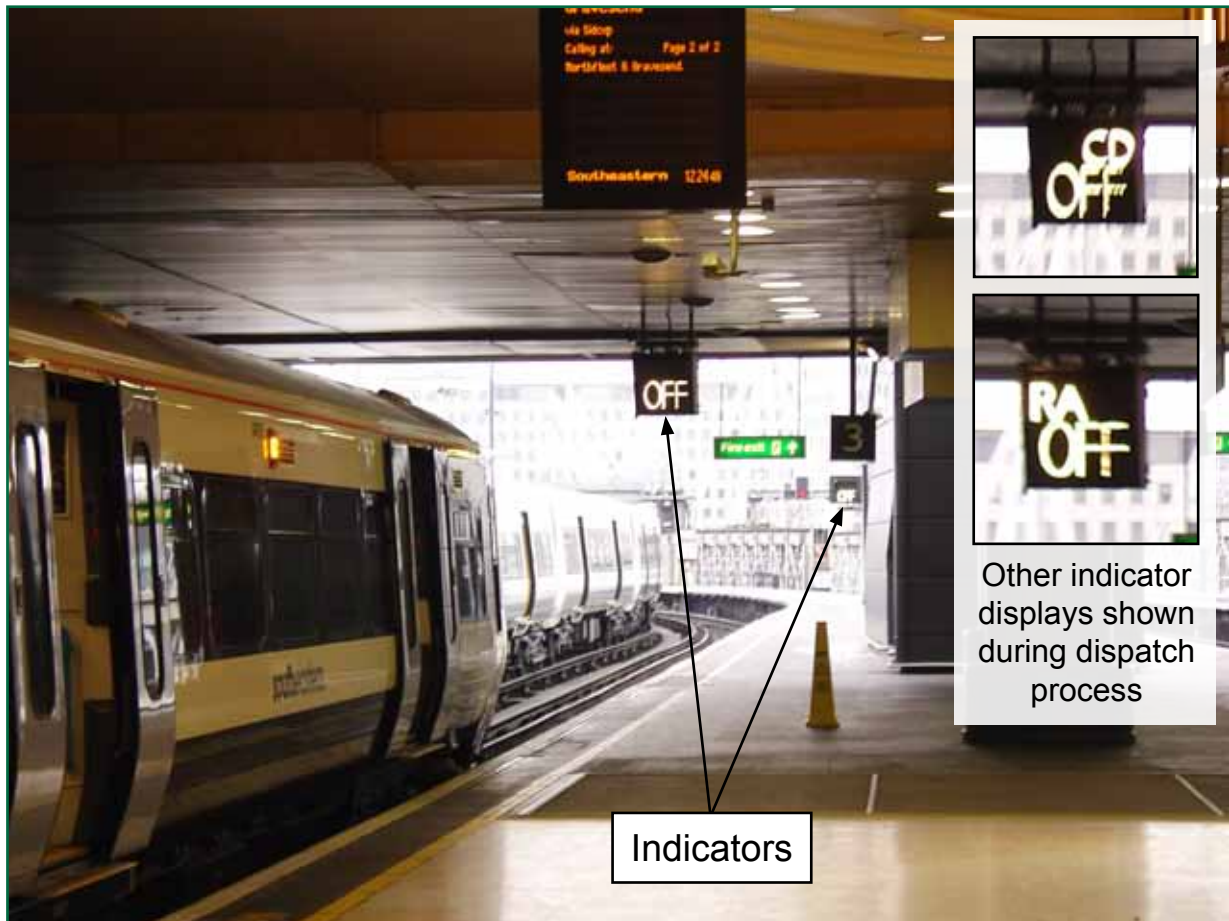
Figure 4: Dispatch indicators on Charing Cross platform 3

- 27 The indicators are positioned above the platforms, at locations where they are visible to the drivers of the various lengths of train that use the platforms. Each indicator consists of illuminated displays which show 'OFF' when the signal at the end of the platform is showing other than red, and are blank when the signal is showing red. Above the 'OFF' indication is a subsidiary indicator which can show blank, 'CD' or 'RA' (figure 4).

- 52 Once the 'RA' control has been operated, the platform staff have no ability to cancel it, and the indication remains illuminated until the train passes the signal at the end of the platform, at which time the signal returns to red and the 'OFF/RA' indication (figure 4) goes to blank.

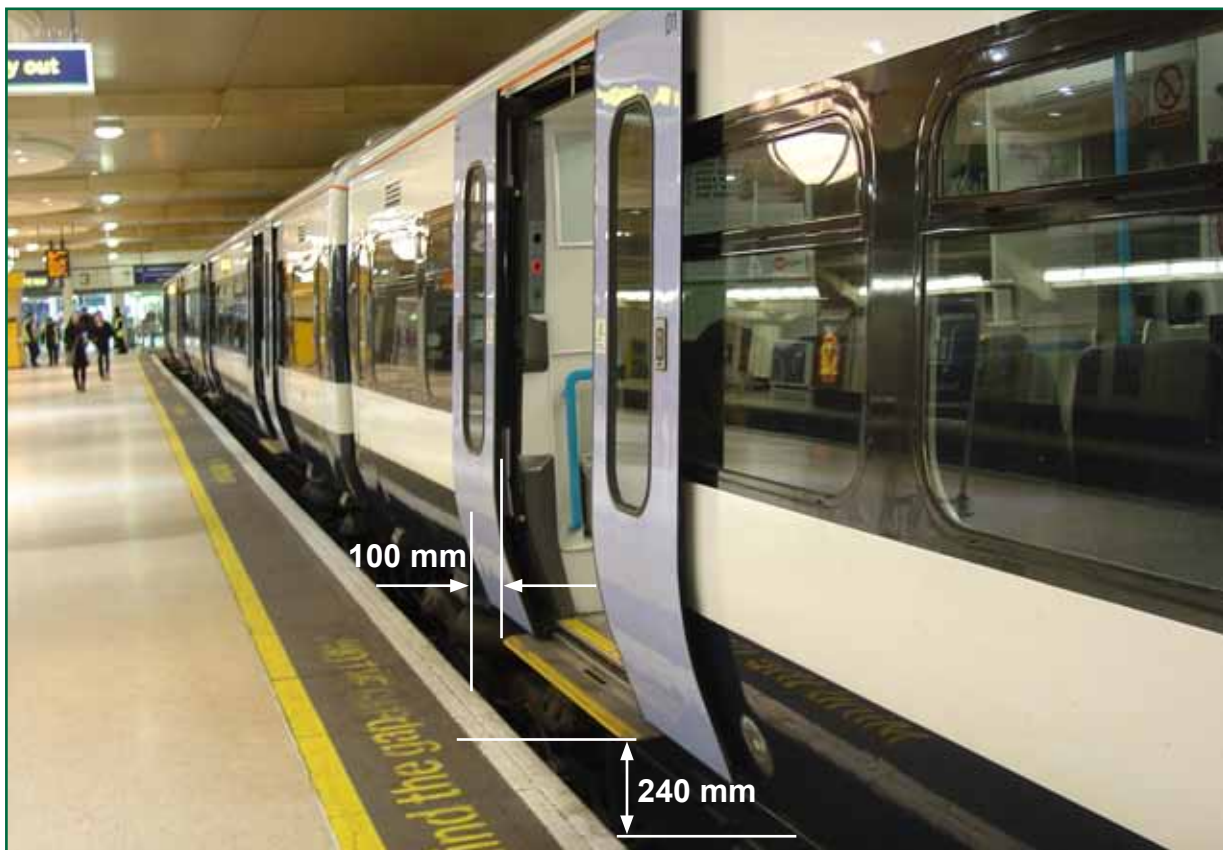
Figure 5: Class 465 train at Charing Cross platform 3

- 42 The RAIB examined a class 465 train in platform three at Charing Cross. Class 465/466 trains have protruding steps at each doorway (figure 5). When these trains are alongside platform 3 at Charing Cross, the edge of the step is 100 mm horizontally clear of the platform edge, and the surface of the step is 240 mm above the level of the platform (figure 5).
- 43 Between the doors, the gap between the platform edge and the body of the train is 360 mm wide (figure 6). Below the edge of the platform there is a recess about 300 mm deep, which, although it is partly obstructed by cables, can provide a refuge clear of the train for a fallen body.

- 44 The maximum stepping distance between platforms and trains is defined in Railway Group Standards⁶. This maximum dimension is intended to take account of considerations of safety and accessibility. At Charing Cross the step position for this type of train, relative to the platform, is compliant with the relevant standard (GI/RT7016) (figure 5 and table 1).

FOOTSTEP TO PLATFORM EDGE	Charing Cross platform 3 (mm)	Maximum permitted in standard (mm)
Platform edge to footstep: vertical	240	250
Platform edge to footstep: horizontal	100	275
Platform edge to footstep: diagonal	260	350

- 48 In view of the action that is reported as being taken by the railway industry in response to the James Street report (see paragraph 69), the RAIB is not making any recommendations in this report in relation to the management of the gap between the train and the platform.
