Rail Accident Investigation Branch

# Rail Accident Report

**Collision between a stoneblower and ballast  
regulator near Arley, Warwickshire  
10 August 2012**

Report 12/2013  
August 2013

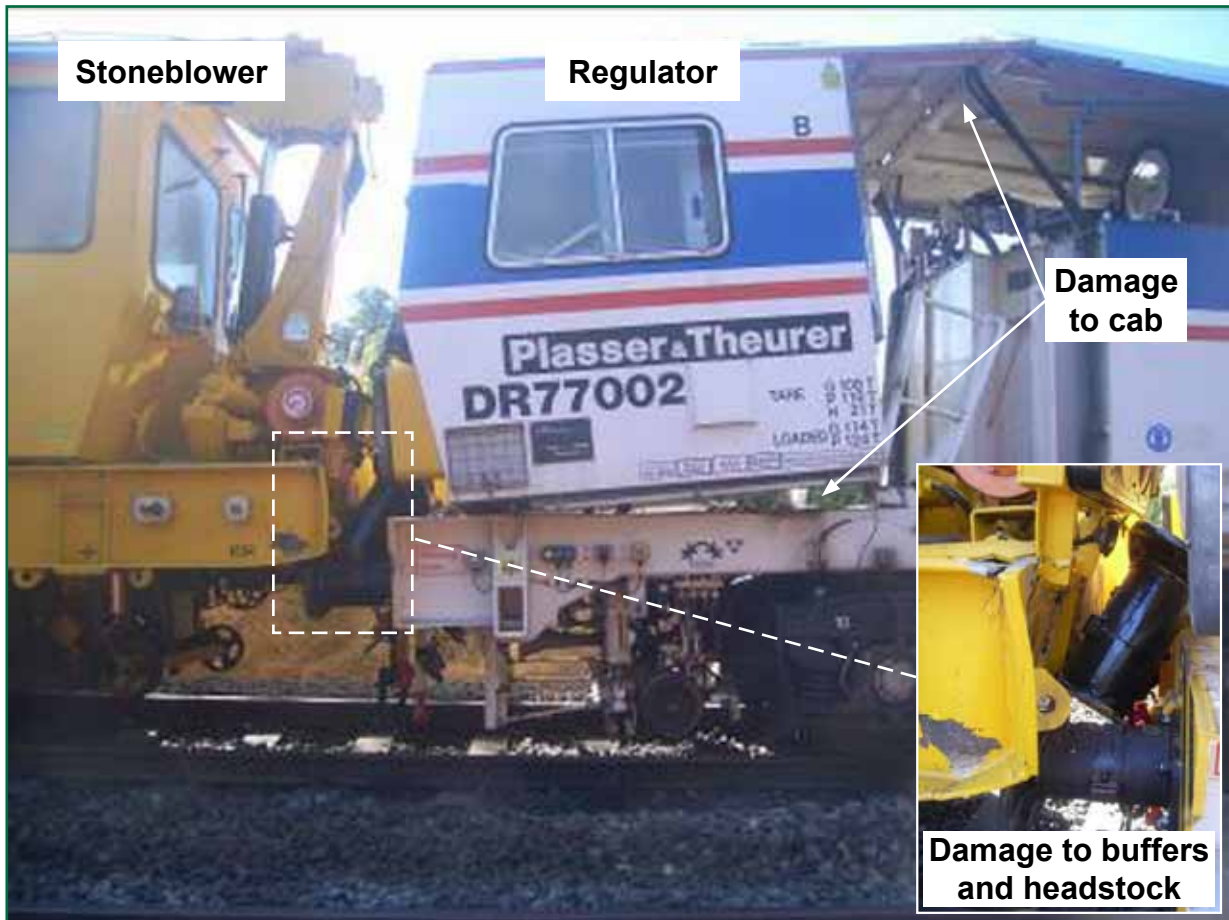
- 8 The stoneblower ran into the stationary regulator at approximately 22 mph (35 km/h), pushing the regulator forward by about 10 metres.
- 9 None of the four people on the regulator or the three people on the stoneblower was seriously injured. One person was treated in hospital for a minor injury but was not detained.
- 10 The stoneblower overrode the buffers of the regulator (figure 3) and the trailing wheels of its leading *bogie* were derailed. The stoneblower suffered significant damage to its underframe and was deemed beyond economic repair by its owner, Network Rail.
- 11 The rear cab of the regulator was deformed and partially displaced from its mountings (figure 3). The regulator was subsequently repaired and recommissioned for service.

Figure 3: Damage to stoneblower and regulator caused by the collision
