Rail Accident Investigation Branch

# Rail Accident Report

**Collision between a stoneblower and ballast  
regulator near Arley, Warwickshire  
10 August 2012**

Report 12/2013  
August 2013

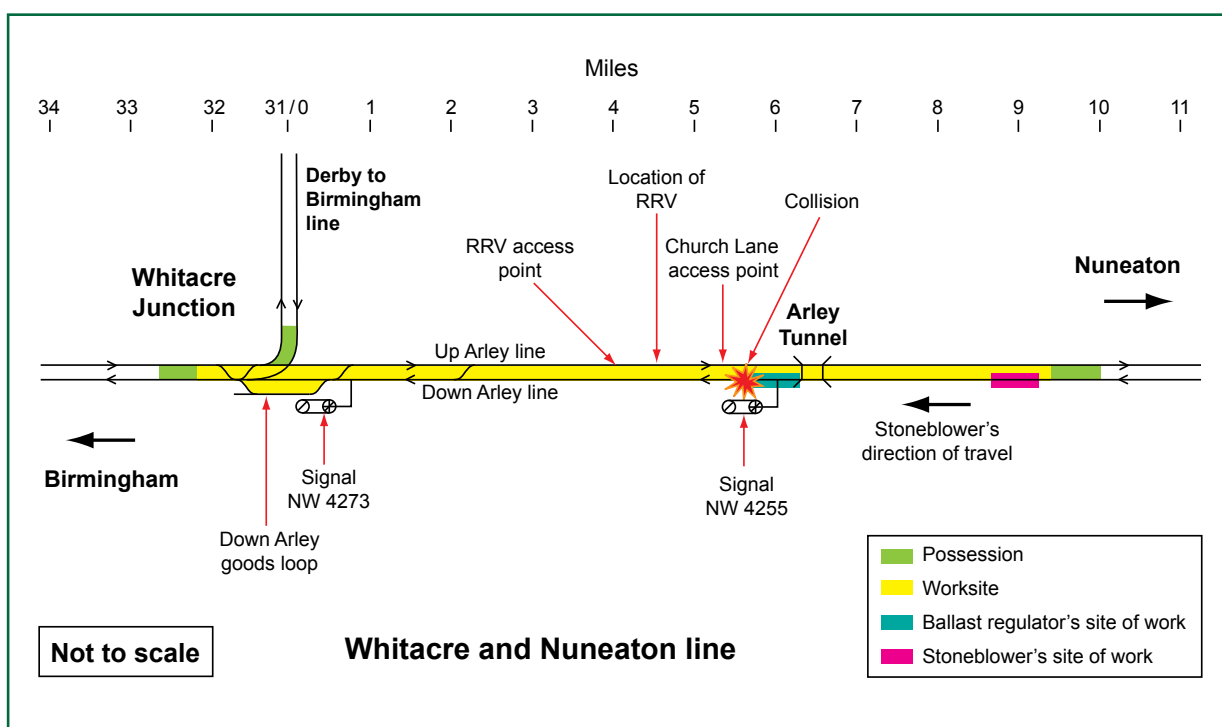
Figure 4: Schematic layout of possession and worksite
