# RAIB Bulletin 05/2012

## Train derailment near Letterston Junction, between Clarbeston Road and Fishguard, 12 July 2012

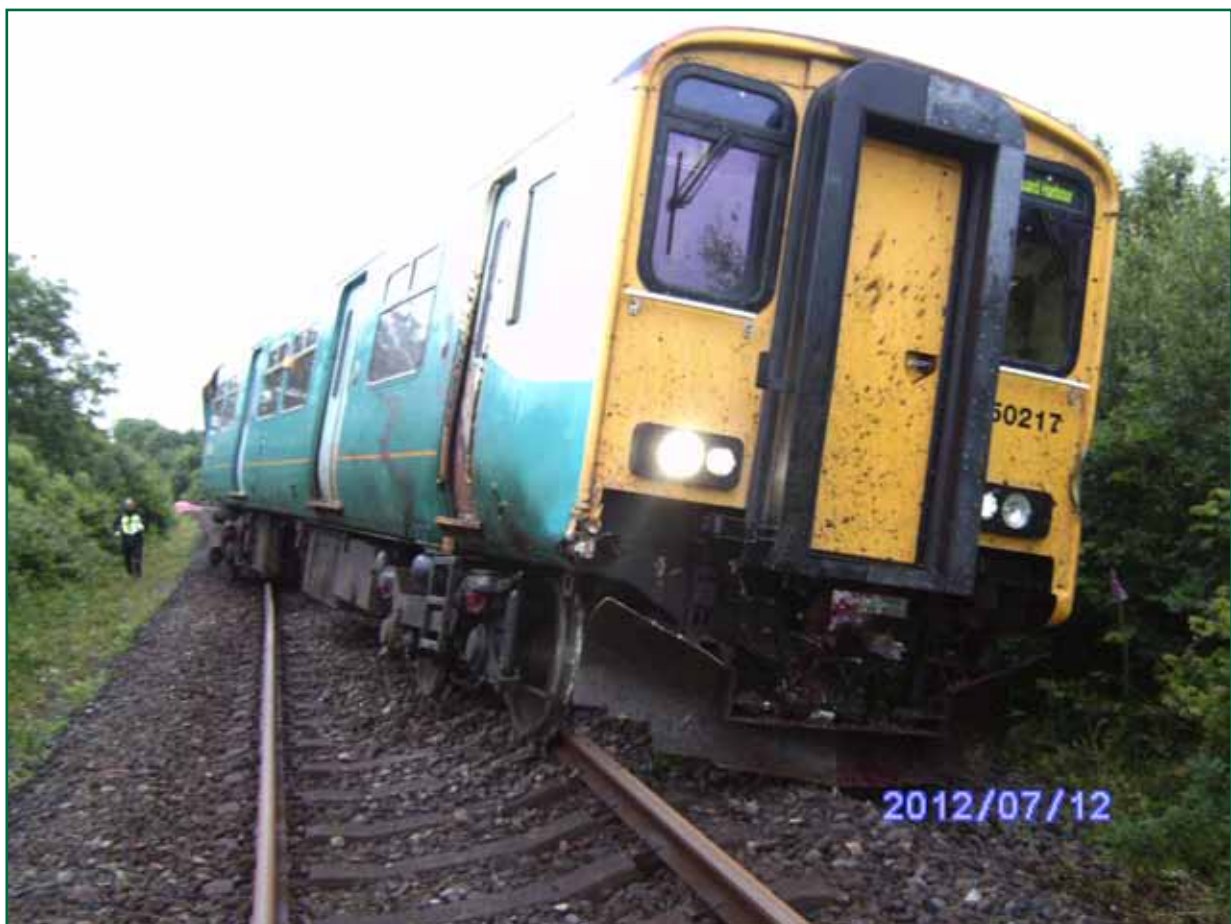
- 4 Seven cows and a calf were killed in the accident or had to be destroyed afterwards.
- 5 There was substantial damage to 60 metres of track, and minor damage to the train.

Figure 2: The train after the accident (courtesy of Network Rail)

- The derailment occurred because the train rode over the body of at least one cow, which lifted the wheels of the leading bogie off the line.
- Following the derailment the train decelerated rapidly. However, there was no disruption or damage in the passenger accommodation, and no injuries to the people on board.
