Rail Accident Investigation Branch

Rail Accident Report

Derailment of a freight train at Shrewsbury station, 7 July 2012

Report 08/2013
July 2013

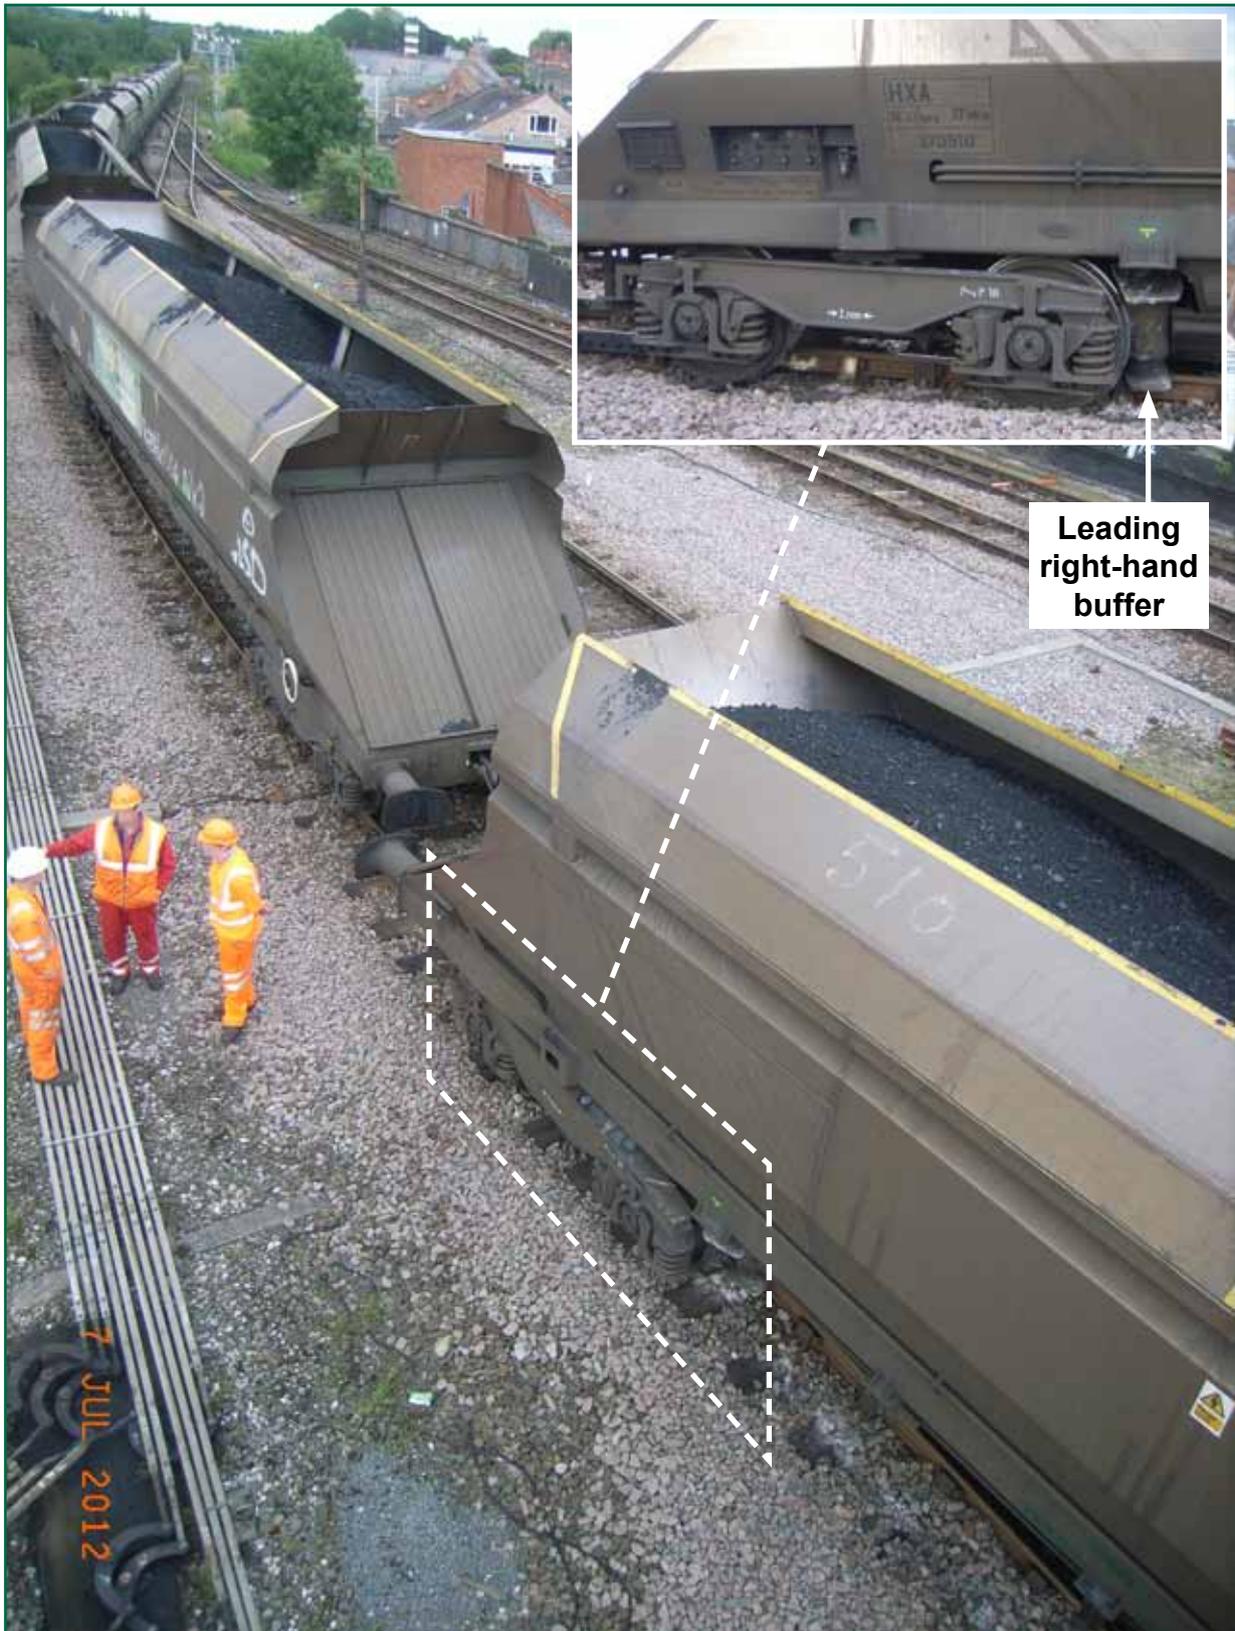
Figure 2: Wagon 370510 after the derailment

- 7 The leading bogie of wagon 370510 ran derailed for approximately 65 metres causing significant track damage in the process. The train was eventually stopped by a brake application initiated by the parting of the brake pipe between the 15th and 16th wagons. The *screw coupling* between these wagons remained intact.
- 8 There were no injuries as a result of the derailment. The derailed bogie of wagon 370510 was damaged. The leading right-hand *buffer* detached and became lodged between the trailing left-hand wheel of the derailed bogie and the wagon underframe (figure 2).

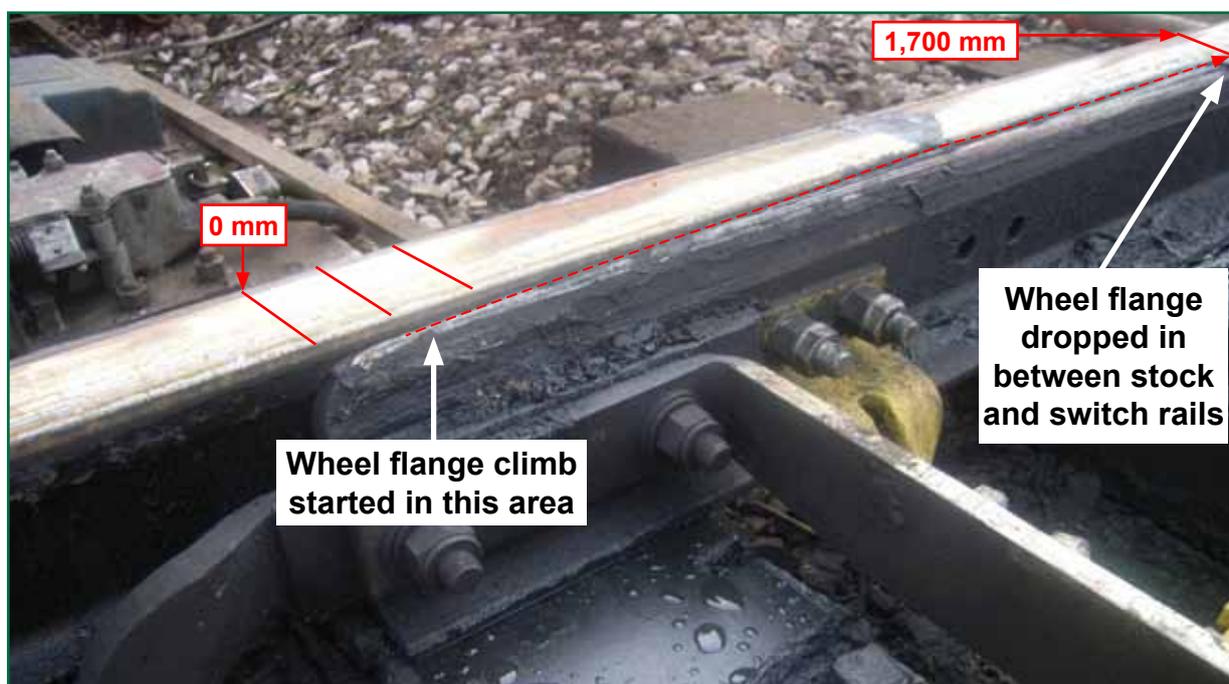
Figure 6: Toe of No. 75 points showing left-hand stock/switch rails and path of derailment

- 20 After the change of drivers, train 6M61 departed signal CJ106 at 14:12 hrs. The driver applied power and reached a speed of 8 mph (13 km/h) as the locomotive traversed No. 75 points. As the rest of the train was traversing the points, the speed gradually increased to 14 mph (22 km/h) which was the speed at which wagon 370510 entered the points. The marks left on the switch rail suggest that the *flange* of the leading left-hand wheel of wagon 370510 is likely to have started climbing the switch rail close to the toe of the points (figure 6).

- 21 It took approximately 1.7 metres before the wheel flange, having completely climbed over the switch rail, dropped between the stock and switch rails. After the train had travelled another 13 metres, the *On-Train Data Recorder* (OTDR) detected a drop in brake pressure which suggests that the brake pipe had parted leading to an automatic brake application¹. The train stopped 50 metres after this event with the trailing end of the locomotive in line with signal CB25 further along the line towards Crewe.

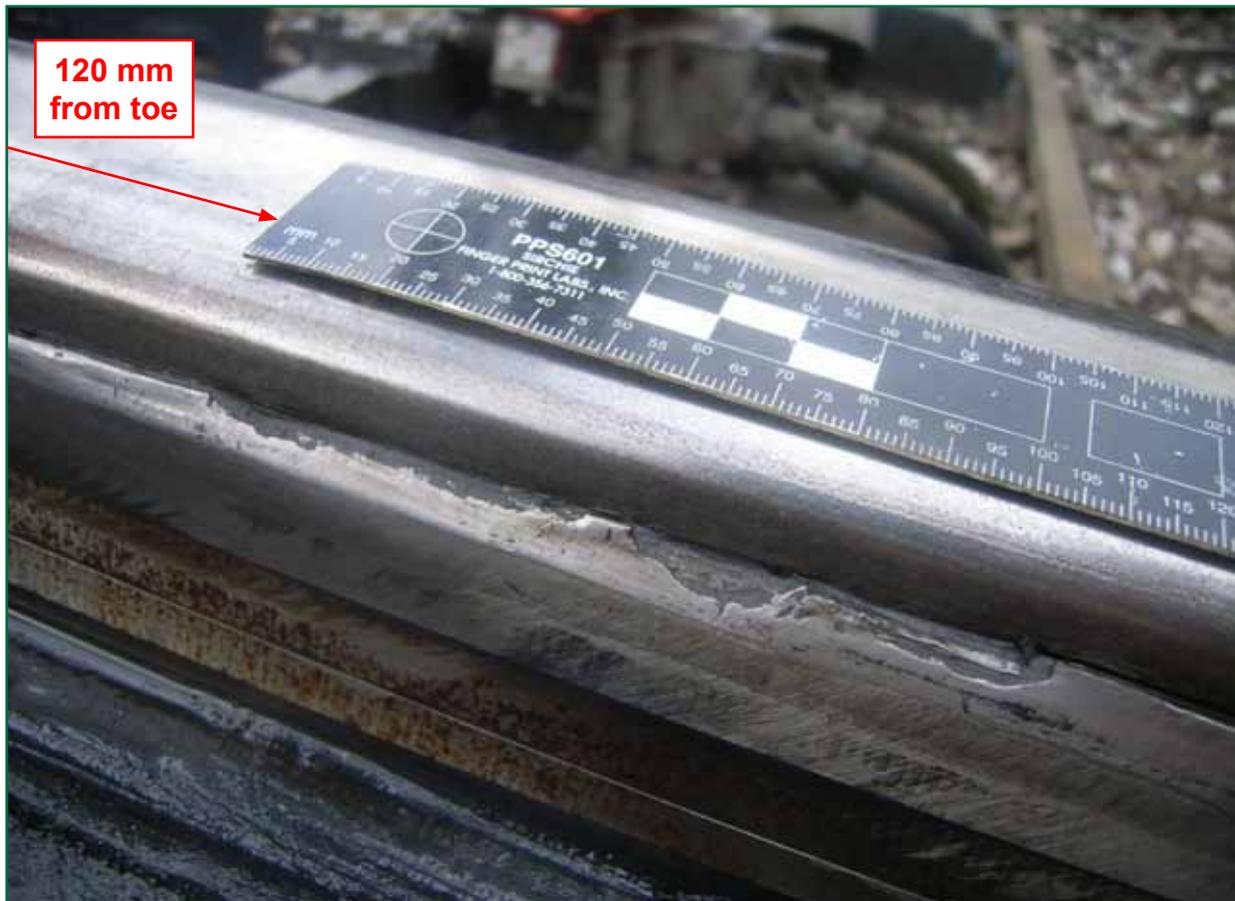
Figure 7: Left-hand switch rail damage

- 24 After the derailment at Shrewsbury and before any further rail traffic passed over them, the RAIB examined No. 75 points and found signs of wear and damage which are believed to have been there before the derailment. After removal of the grease and residue, the examination revealed that the left-hand switch rail was worn and damaged close to the toe of the points (figure 7). The switch rail damage started 120 mm from the toe of the points and continued for an additional 110 mm. The switch rail wear started close to the toe of the points (approximately 50 mm from the toe) and extended beyond the damage. The presence of grease obscuring the damage on the switch rail indicates that the damage is unlikely to be a consequence of the accident. The RAIB carried out a detailed inspection of No. 75 points against the requirements of TRK/053. The detailed inspection revealed that No. 75 points failed three out of the four checks for derailment hazards identified within the standard for this type of points. No. 75 points were therefore at risk of creating a derailment (see appendix B for more details about the results of this detailed inspection). Measurements carried out by the RAIB indicated that the first section of the switch rail, between 50 mm and 120 mm from the toe, in front of the damage, was compliant with TRK/053 despite the presence of wear.

- 27 The coefficient of friction considered in the analysis at the flange to switch rail contact ranged from 0.1 (lubricated conditions) to 0.3 (dry conditions). The simulation demonstrated that, for a coefficient of friction between 0.2 to 0.3, wagon 370510 was predicted to derail. The simulation indicated that the derailment was likely to initiate close to the toe of the points (50 – 120 mm from the toe) before the wheel reached the switch rail damage. In that area, the angle of contact between the flange and the worn switch rail was low enough to create conditions which would have increased the tendency for the flange to start climbing the face of the switch rail. However, the simulation also indicated that the damage was necessary to maintain the conditions over a distance sufficient to lead to a derailment. This suggested that the damage and wear were important factors in the derailment at Shrewsbury.

- 86 Since the derailment, No. 75 points have been replaced with vertical curved inset straightcut switches⁸. The alignment at the rail joint in front of the toe of the points has been reported as improved. Network Rail expects that these actions will result in a lower wear rate being experienced on these points and is monitoring these points accordingly. Network Rail is considering making similar modifications to other points in the vicinity which are similar to No. 75 points.

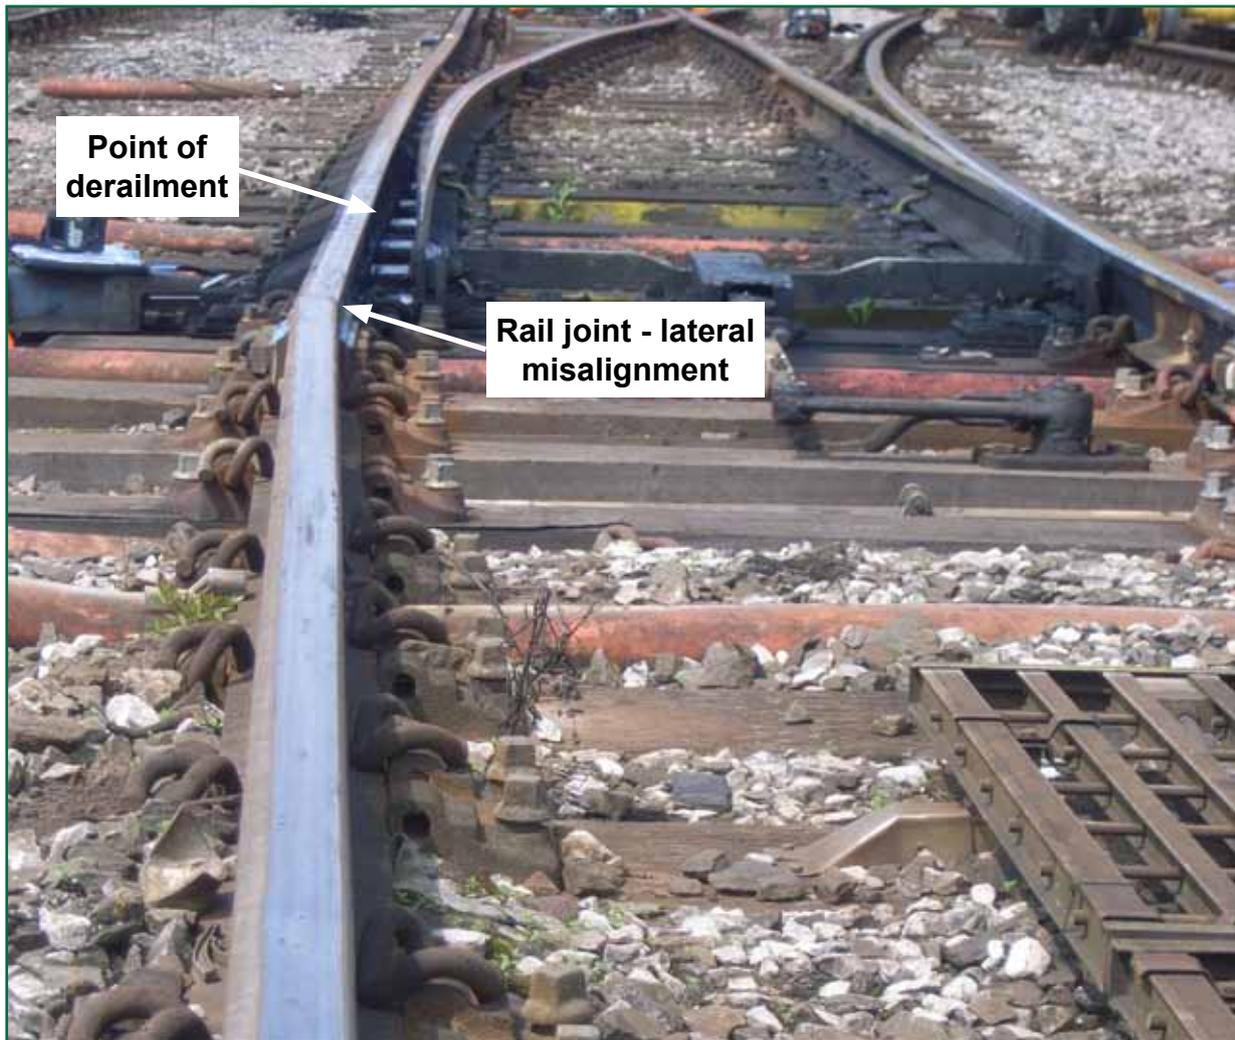
Figure 8: Track lateral alignment approaching No. 75 points

- 33 The left-hand stock and switch rails of No. 75 points had been renewed in July 2011 after having been in service for four years during which it had been subjected to two weld repairs following damage to the switch rail. In March 2012, eight months after having been renewed, the left-hand switch rail of No. 75 points was again in need of weld repair as the switch rail was damaged (the top of switch rail was *chipped*). In accordance with Network Rail's processes defined in TRK/053, the points were subjected to detailed inspections to TRK/053 before and after the weld repair. The records of these detailed inspections suggest that No. 75 points had been left in a safe condition following the repair.

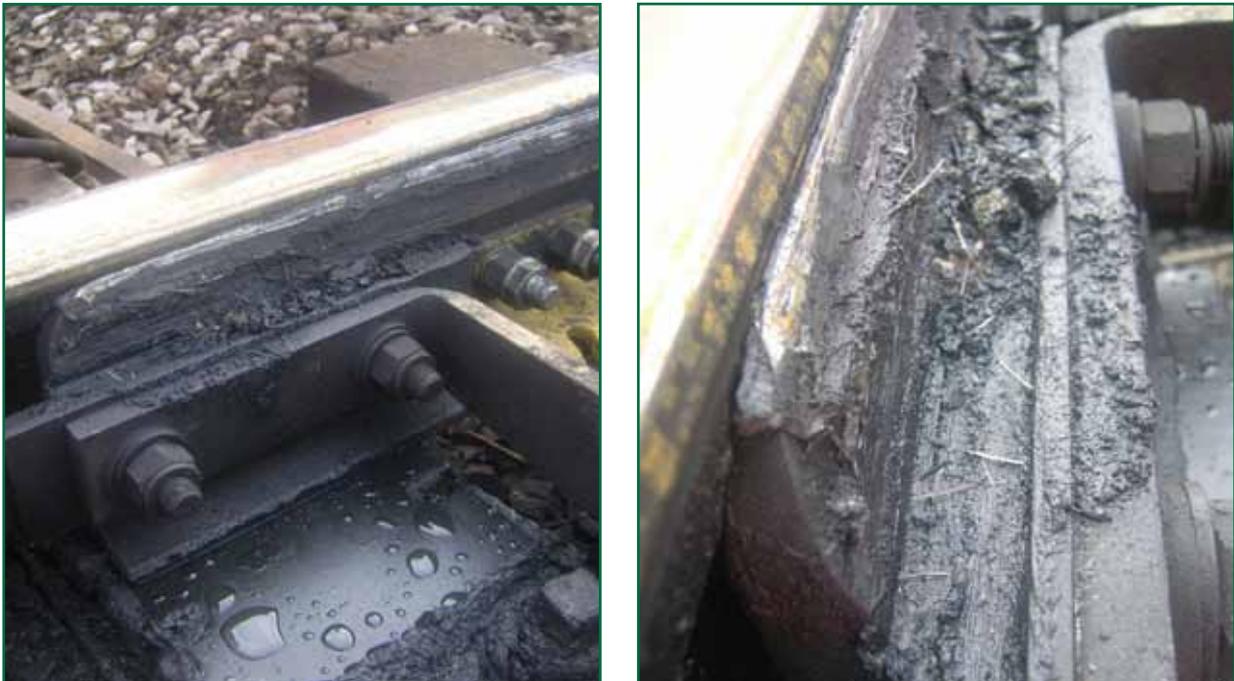
Figure 9: Left-hand switch rail at No.75 points immediately after derailment

- 57 It is possible that the damage to the switch rail occurred after the last basic visual inspection. The inspection of the points immediately after the accident identified fresh shards of metal, presumably from the switch rail, embedded within the grease at the base of the rail (figure 9). The size and appearance of these shards suggests that the creation of the damage could have been a fairly rapid process which could have taken place shortly before the accident (the presence of grease obscuring the damage on the switch rail indicates that the damage is unlikely to be a consequence of the accident). However, the more gradual nature of the wearing process suggests that the wear on the rails was already present at the time of the last supervisor's visual inspection and the last basic visual inspection.

- 74 The RAIB's inspection of the points that took place immediately after the accident indicated that the switch rail damage might have been obscured by grease at the time of the visual inspections (figure 9). There is no requirement in TRK/001 or TRK/053 to remove grease from points during a basic visual inspection or a supervisor's visual inspection. The requirement appears in TRK/053 only for a detailed inspection. It is therefore possible that grease was obscuring the damage to the switch rail during the visual inspections.
