Rail Accident Investigation Branch

Rail Accident Report

Derailment of a freight train at Shrewsbury station, 7 July 2012

Report 08/2013
July 2013

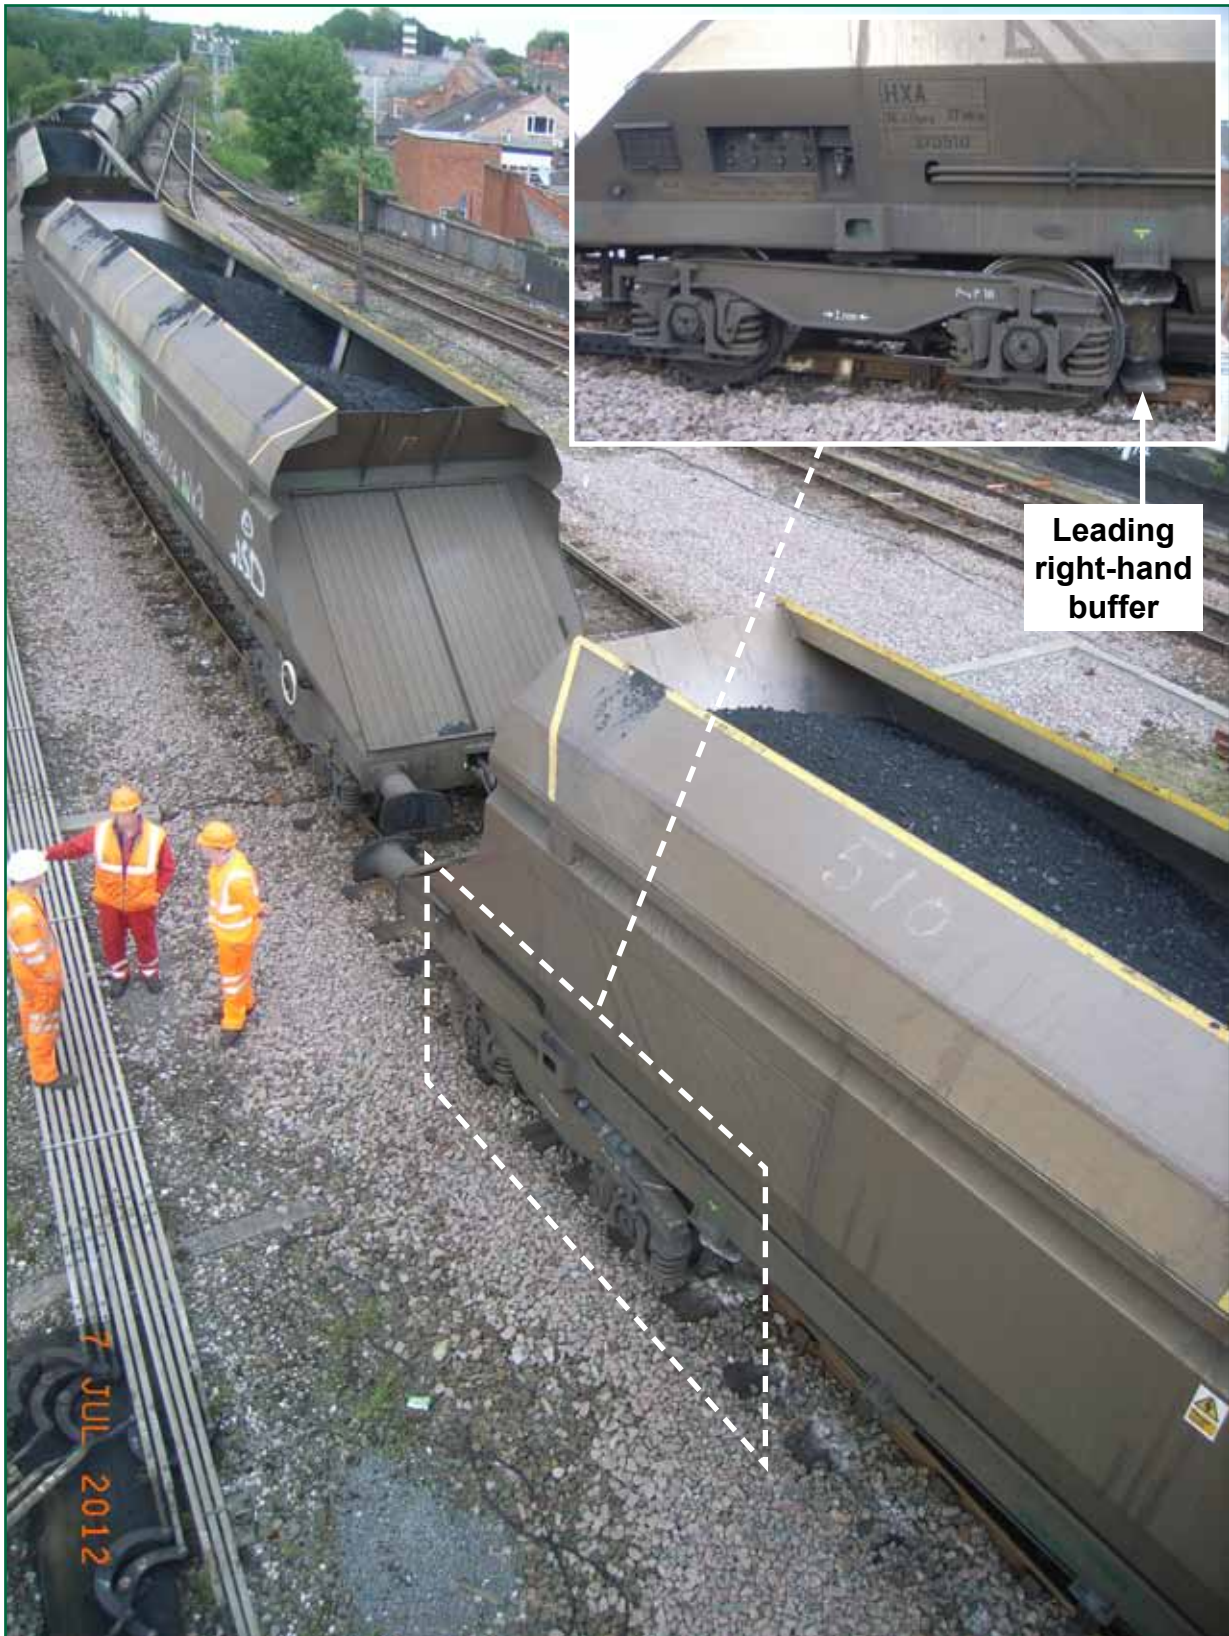
- 7 The leading bogie of wagon 370510 ran derailed for approximately 65 metres causing significant track damage in the process. The train was eventually stopped by a brake application initiated by the parting of the brake pipe between the 15th and 16th wagons. The *screw coupling* between these wagons remained intact.
- 8 There were no injuries as a result of the derailment. The derailed bogie of wagon 370510 was damaged. The leading right-hand *buffer* detached and became lodged between the trailing left-hand wheel of the derailed bogie and the wagon underframe (figure 2).

Figure 2: Wagon 370510 after the derailment

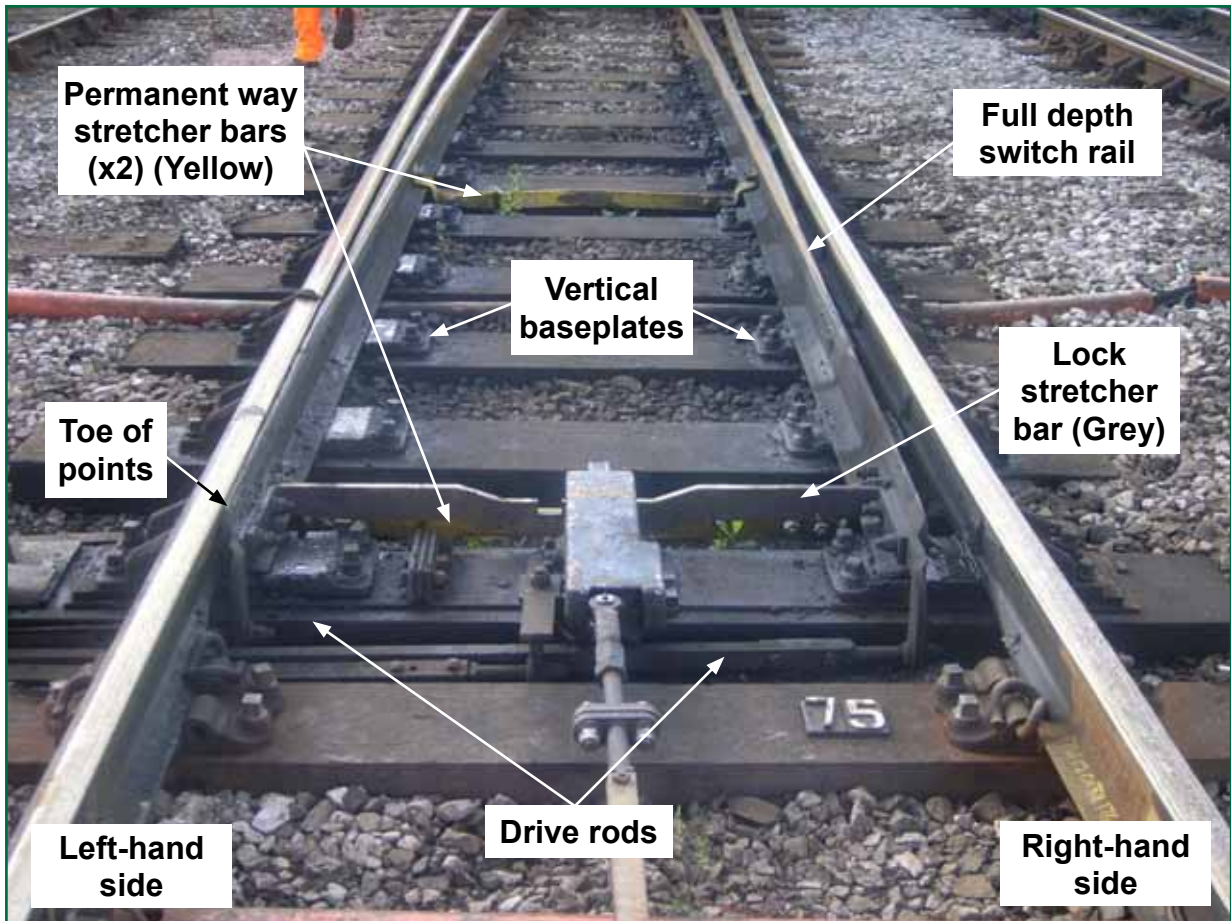
Figure 5: No. 75 Points

- 11 The down main line on the approach to No. 75 points is laid on a curve (130 metres radius at its tightest) on top of a bridge. Along the curve, the inner rail is fitted with a *check rail* which terminates 2.8 metres before the *toe* of the points. The track in the area is *jointed track* with the closest rail joint located approximately 1.7 metres before the toe of the points. Figures 4 and 5 show the track layout in this area. The rails on the approach to No. 75 points are laid on *vertical baseplates* except for the section of track between the end of the check rail and the toe of the points which were on *inclined baseplates*. No. 75 points are of the *B-type* with two *permanent way stretcher bars* and one *lock stretcher bar*. The *flat-bottomed rails* in No. 75 points are laid on vertical baseplates and the switch rails are *full depth*. There is no *supplementary drive*.

- 86 Since the derailment, No. 75 points have been replaced with vertical curved inset straightcut switches⁸. The alignment at the rail joint in front of the toe of the points has been reported as improved. Network Rail expects that these actions will result in a lower wear rate being experienced on these points and is monitoring these points accordingly. Network Rail is considering making similar modifications to other points in the vicinity which are similar to No. 75 points.

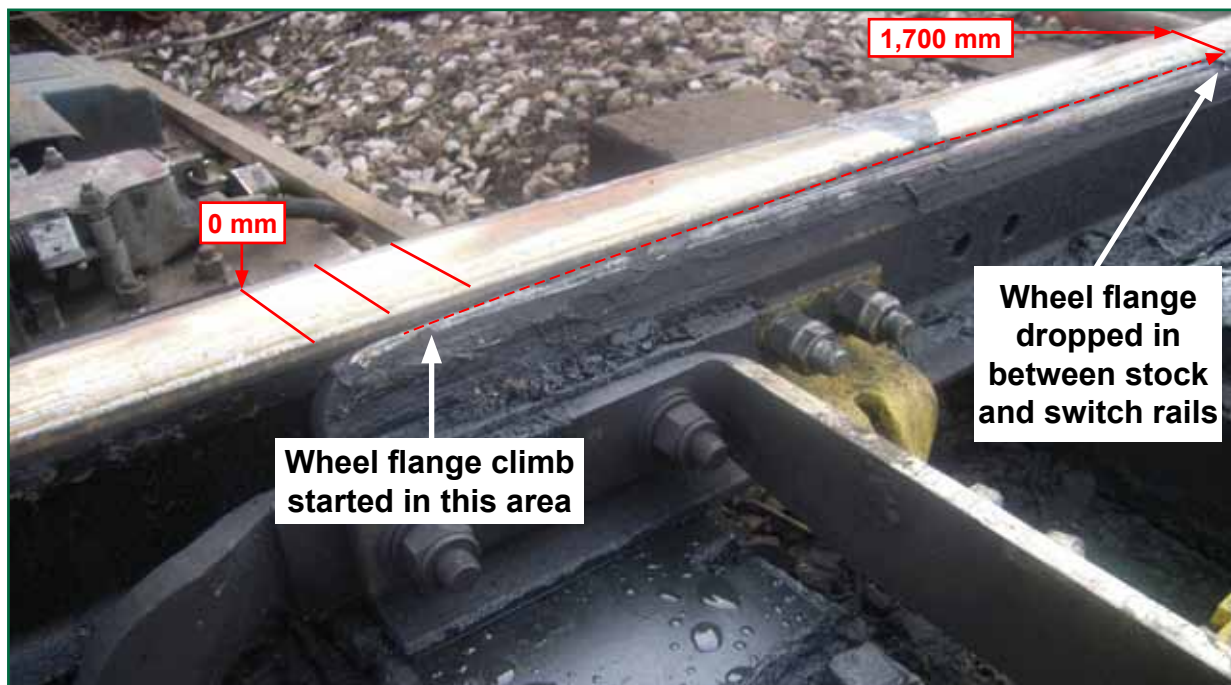
- 20 After the change of drivers, train 6M61 departed signal CJ106 at 14:12 hrs. The driver applied power and reached a speed of 8 mph (13 km/h) as the locomotive traversed No. 75 points. As the rest of the train was traversing the points, the speed gradually increased to 14 mph (22 km/h) which was the speed at which wagon 370510 entered the points. The marks left on the switch rail suggest that the *flange* of the leading left-hand wheel of wagon 370510 is likely to have started climbing the switch rail close to the toe of the points (figure 6).

Figure 6: Toe of No. 75 points showing left-hand stock/switch rails and path of derailment

- 21 It took approximately 1.7 metres before the wheel flange, having completely climbed over the switch rail, dropped between the stock and switch rails. After the train had travelled another 13 metres, the *On-Train Data Recorder* (OTDR) detected a drop in brake pressure which suggests that the brake pipe had parted leading to an automatic brake application¹. The train stopped 50 metres after this event with the trailing end of the locomotive in line with signal CB25 further along the line towards Crewe.

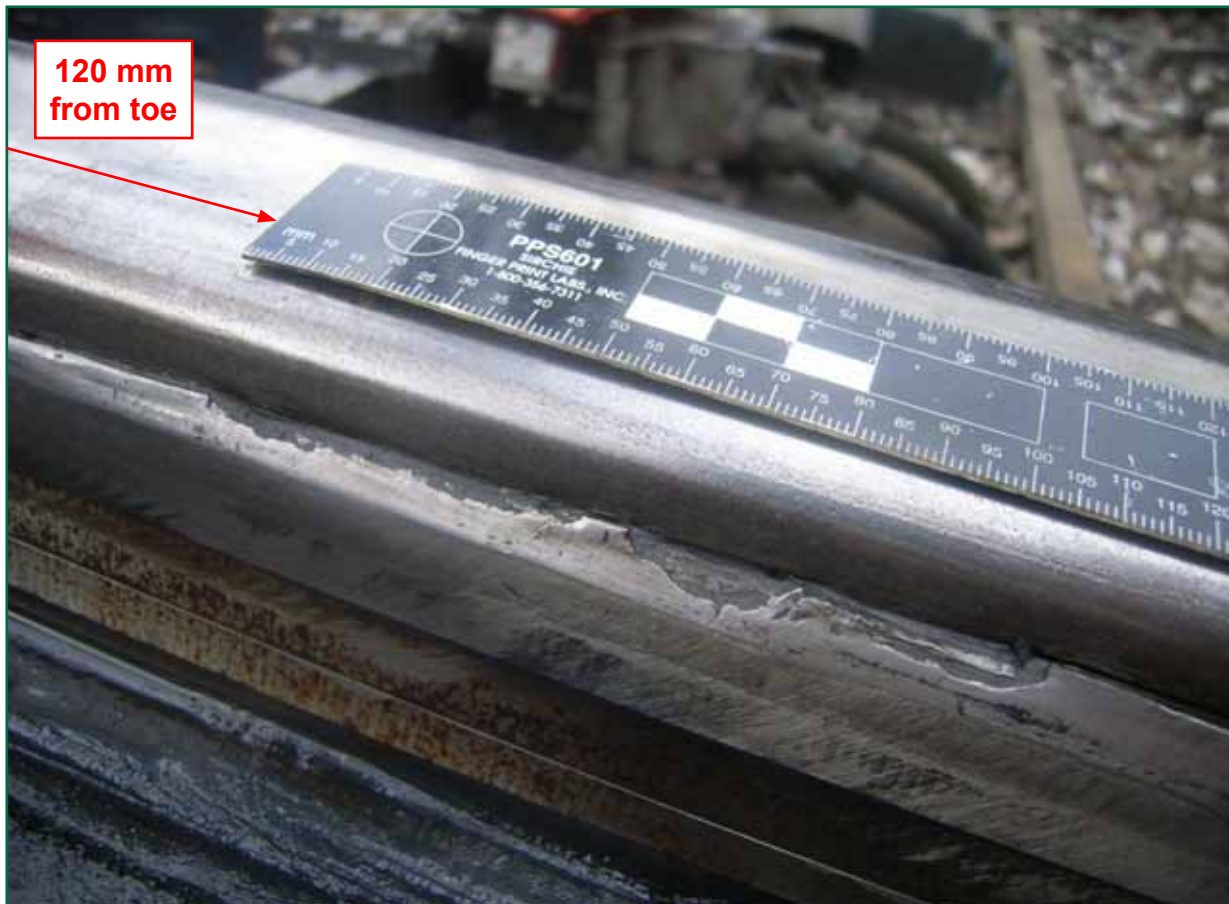
- 24 After the derailment at Shrewsbury and before any further rail traffic passed over them, the RAIB examined No. 75 points and found signs of wear and damage which are believed to have been there before the derailment. After removal of the grease and residue, the examination revealed that the left-hand switch rail was worn and damaged close to the toe of the points (figure 7). The switch rail damage started 120 mm from the toe of the points and continued for an additional 110 mm. The switch rail wear started close to the toe of the points (approximately 50 mm from the toe) and extended beyond the damage. The presence of grease obscuring the damage on the switch rail indicates that the damage is unlikely to be a consequence of the accident. The RAIB carried out a detailed inspection of No. 75 points against the requirements of TRK/053. The detailed inspection revealed that No. 75 points failed three out of the four checks for derailment hazards identified within the standard for this type of points. No. 75 points were therefore at risk of creating a derailment (see appendix B for more details about the results of this detailed inspection). Measurements carried out by the RAIB indicated that the first section of the switch rail, between 50 mm and 120 mm from the toe, in front of the damage, was compliant with TRK/053 despite the presence of wear.

Figure 7: Left-hand switch rail damage

- 27 The coefficient of friction considered in the analysis at the flange to switch rail contact ranged from 0.1 (lubricated conditions) to 0.3 (dry conditions). The simulation demonstrated that, for a coefficient of friction between 0.2 to 0.3, wagon 370510 was predicted to derail. The simulation indicated that the derailment was likely to initiate close to the toe of the points (50 – 120 mm from the toe) before the wheel reached the switch rail damage. In that area, the angle of contact between the flange and the worn switch rail was low enough to create conditions which would have increased the tendency for the flange to start climbing the face of the switch rail. However, the simulation also indicated that the damage was necessary to maintain the conditions over a distance sufficient to lead to a derailment. This suggested that the damage and wear were important factors in the derailment at Shrewsbury.

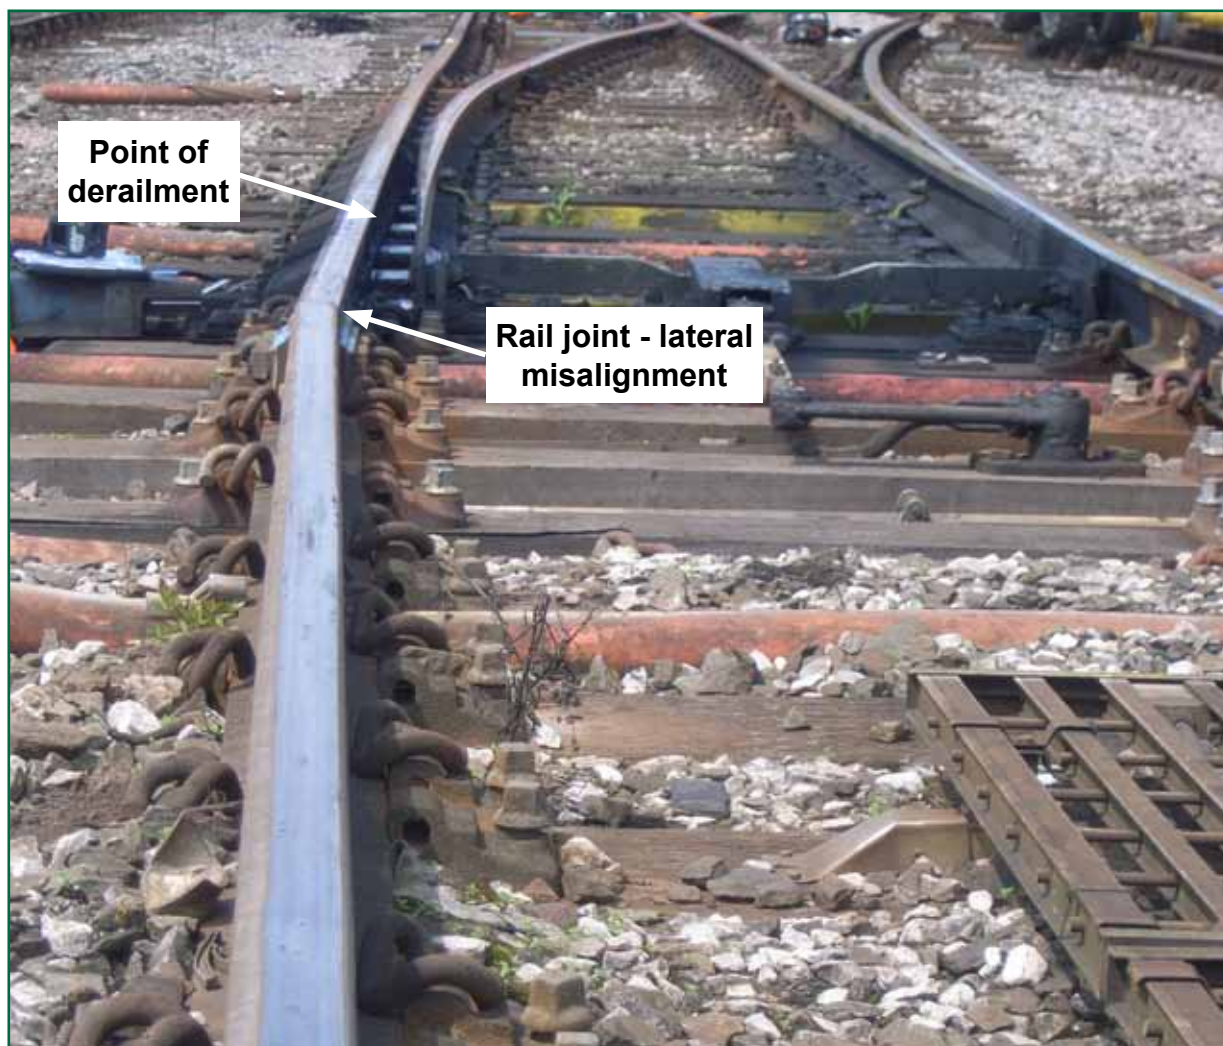
- 33 The left-hand stock and switch rails of No. 75 points had been renewed in July 2011 after having been in service for four years during which it had been subjected to two weld repairs following damage to the switch rail. In March 2012, eight months after having been renewed, the left-hand switch rail of No. 75 points was again in need of weld repair as the switch rail was damaged (the top of switch rail was *chipped*). In accordance with Network Rail's processes defined in TRK/053, the points were subjected to detailed inspections to TRK/053 before and after the weld repair. The records of these detailed inspections suggest that No. 75 points had been left in a safe condition following the repair.

Figure 8: Track lateral alignment approaching No. 75 points
