Rail Accident Investigation Branch

Rail Accident Report

**Train ran onto a washed-out embankment near
Knockmore, Northern Ireland
28 June 2012**

Report 14/2013
September 2013

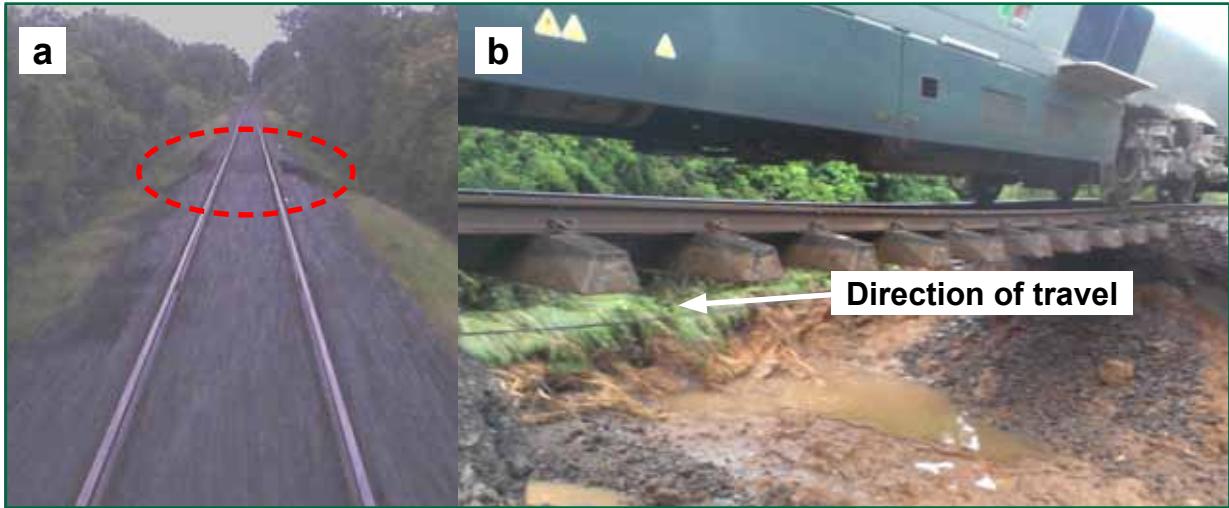
- 7 A *pilotman*, who was in the cab, saw the washed out embankment ahead (figure 2a) and warned the driver who applied the train's emergency brake. The train ran onto the unsupported rails and the leading vehicle came to a stand with one bogie on each side of the unsupported track (figure 2b).

Figure 2: (a) cab view of the washed out embankment and (b) the leading vehicle stopped over the washout (images courtesy of NIR)

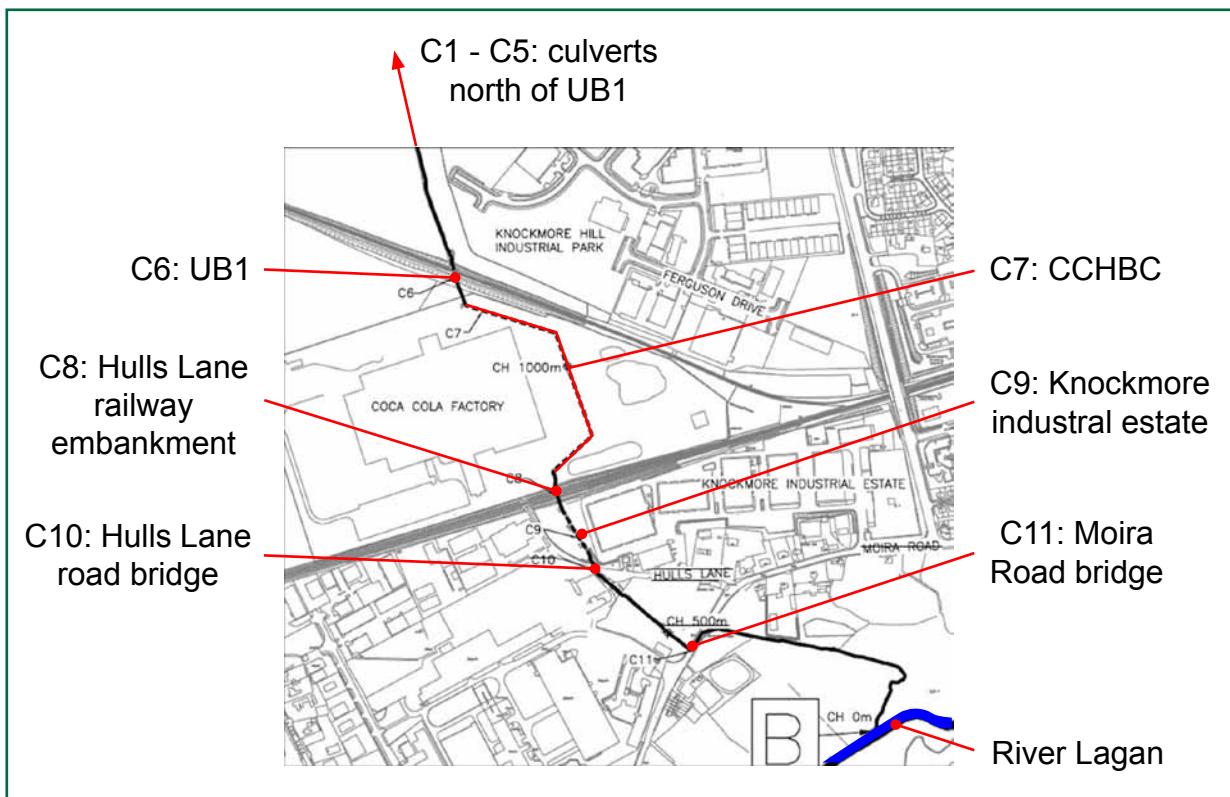
Figure 4: Culverts at and downstream of UB1 (courtesy of WDR & RT Taggart)

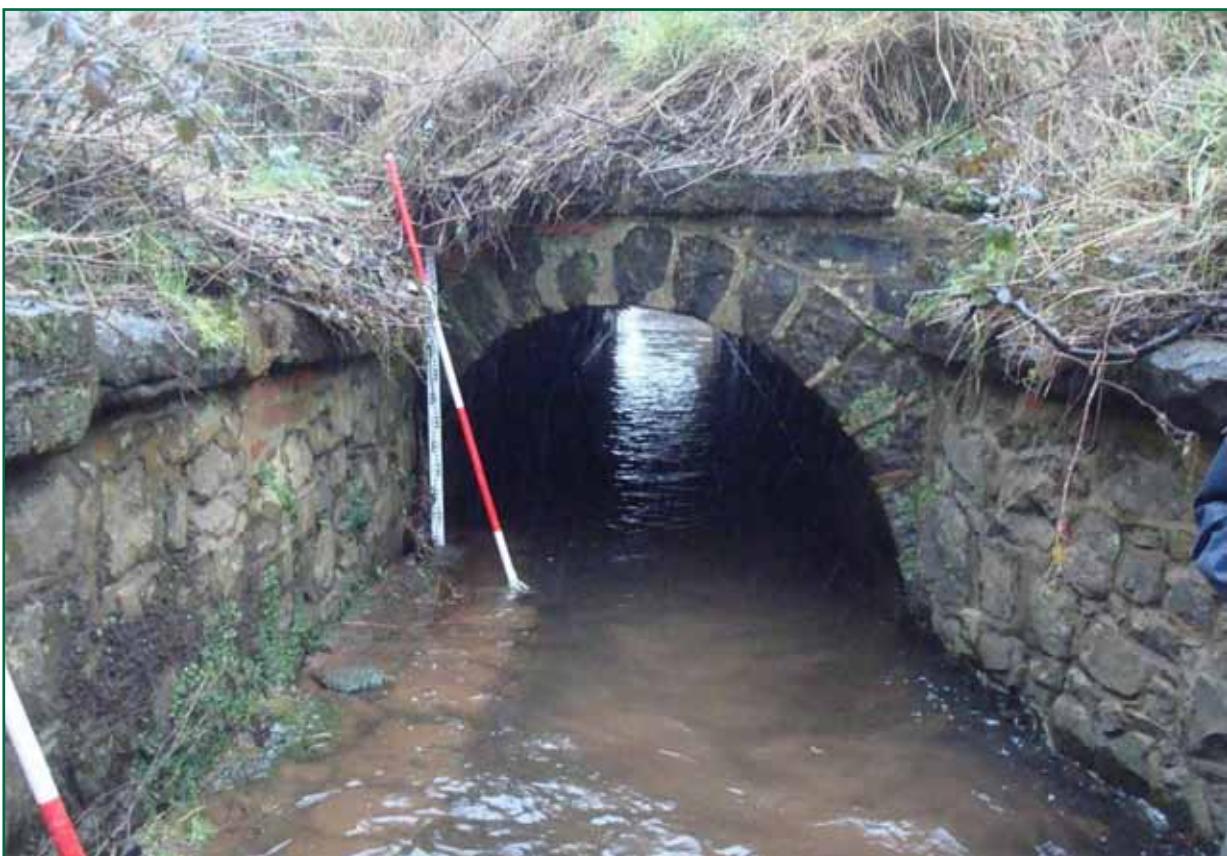
- 50 The culvert system on the Brokerstown stream was unable to cope with the water flows generated by the heavy rainfall, causing water to back up behind the railway embankment.
- 51 The brick arch culvert structure, UB1, is 38 metres long, with cross sectional dimensions, 1.8 metres high by 2.25 metres wide (figure 7). The Brokerstown stream flows from UB1 through a 40 metre long open section, to another culvert at the CCHBC plant, which is 390 metres long and has a series of bends in it (figure 4). This culvert has an inlet which is almost perpendicular to the watercourse and is protected by a *trash screen* (figure 8). Water then flows under the Belfast to Dublin main line though another culvert, (NIR bridge reference 02.278, shown as C8 in figure 4), before flowing through three other culverts and into the River Lagan.

Figure 7: Culvert UB1 inlet under Antrim branch line (image courtesy of URS)

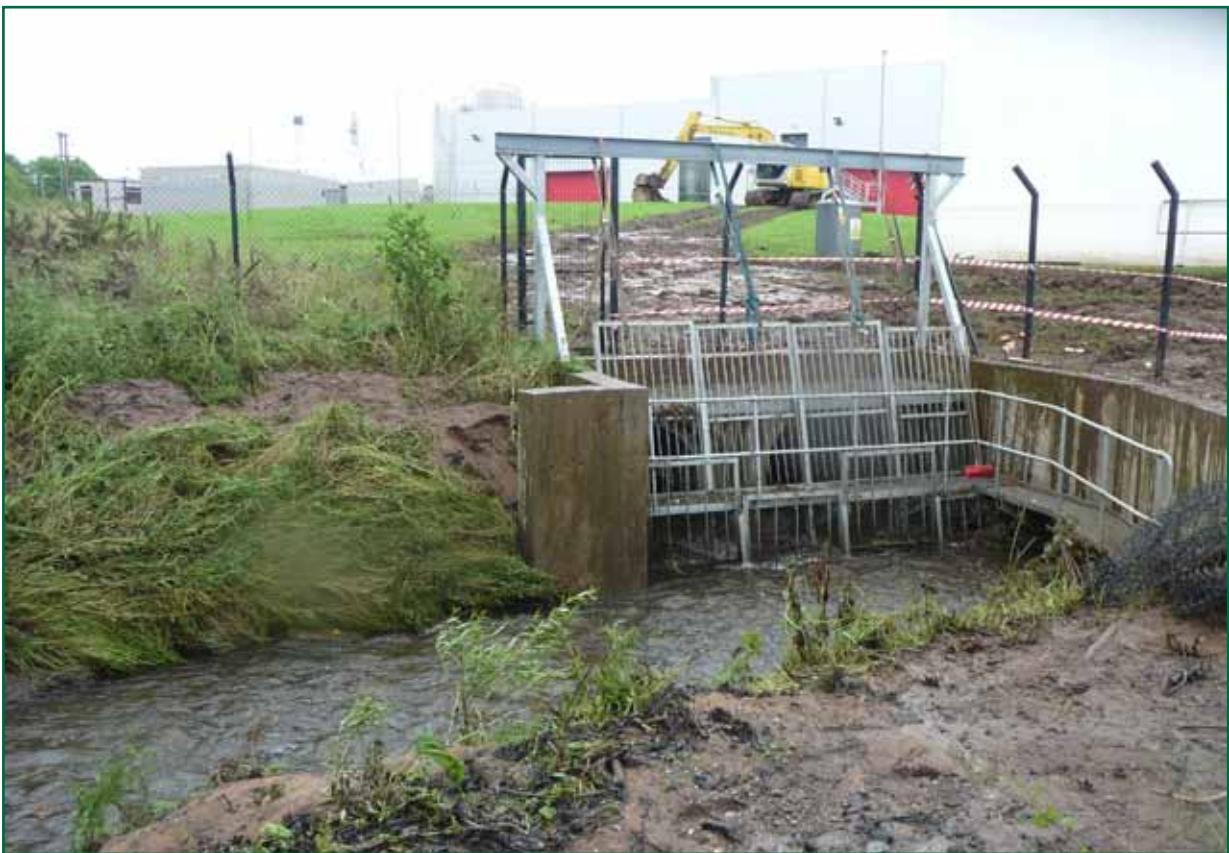
Figure 8: CCHBC culvert inlet with trash screen (image courtesy of URS)

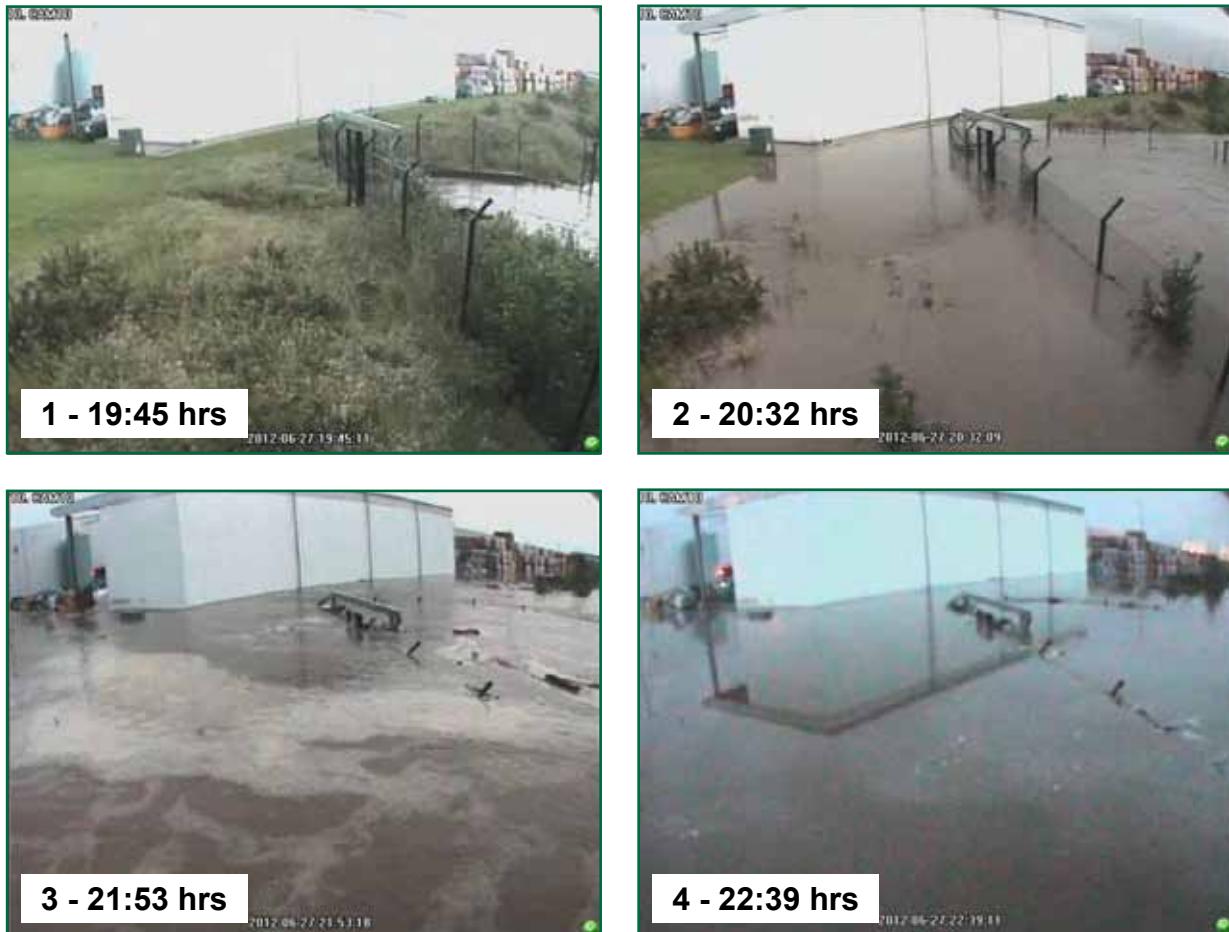
- 52 CCTV footage from a CCHBC camera aimed at the inlet to its culvert, showed the flood event developing on the CCHBC side of the boundary fence, between the plant and the downstream side of the railway embankment. A series of four still images taken from the footage are shown in figure 9.

- 53 By 19:45 hrs the inlet to the CCHBC culvert was completely submerged (ie the water level was higher than the top of the culvert inlet). By around 20:32 hrs, water had spilled over onto the adjacent land and had reached the plant itself. There is no CCTV footage which shows what was happening on the upstream side of the railway embankment at this time, but water would have been impounding on that side (figure 10) and its level would have been higher than on the downstream side in order to push water through UB1. Figure 9 shows that at around 21:53 hrs there was a sudden change in the pattern of water flow within the camera's field of view, and the simultaneous arrival of floating debris and an oily sheen. This was probably when the breach of the railway embankment occurred, releasing a large amount of water from the upstream side. The mechanism of embankment failure is discussed later at paragraph 62.

Figure 9: Flooding sequence at the adjacent CCHBC plant (images courtesy of CCHBC)

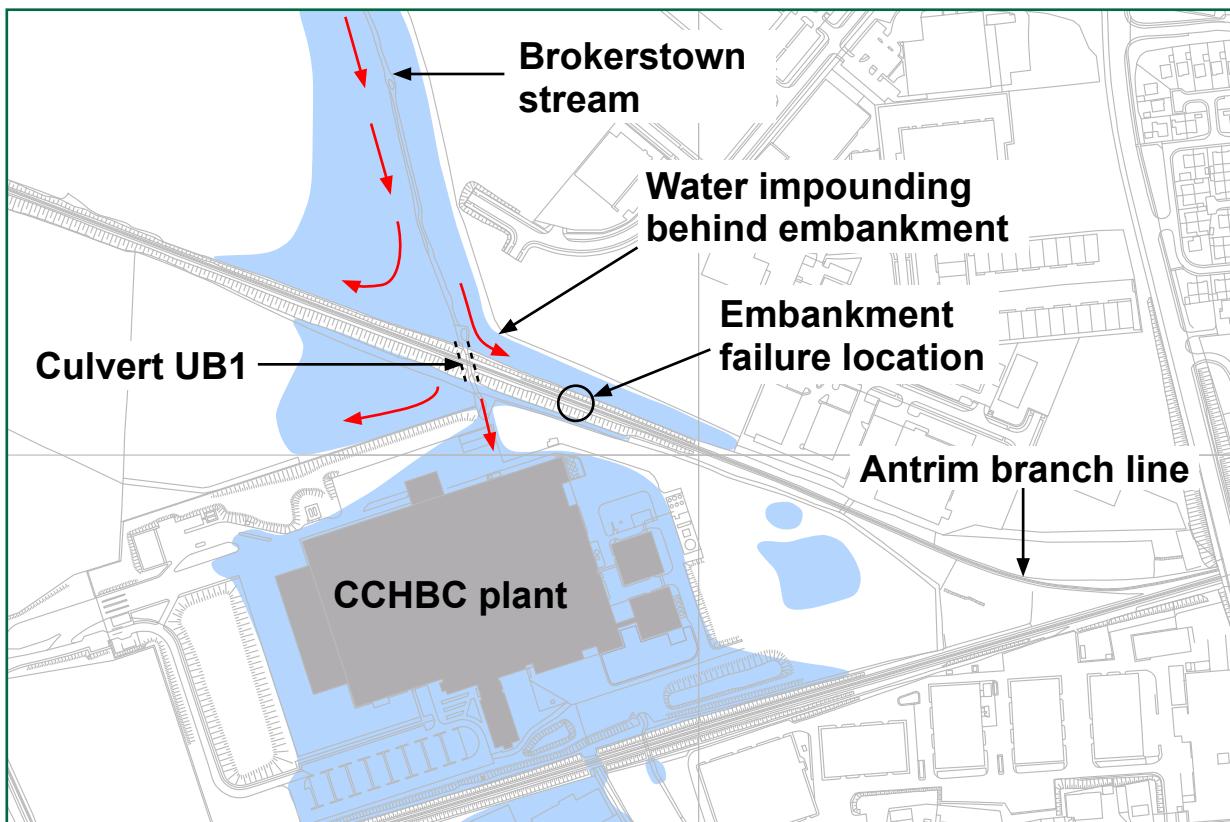
Figure 10: Schematic of water impounding behind the upstream side of the railway embankment

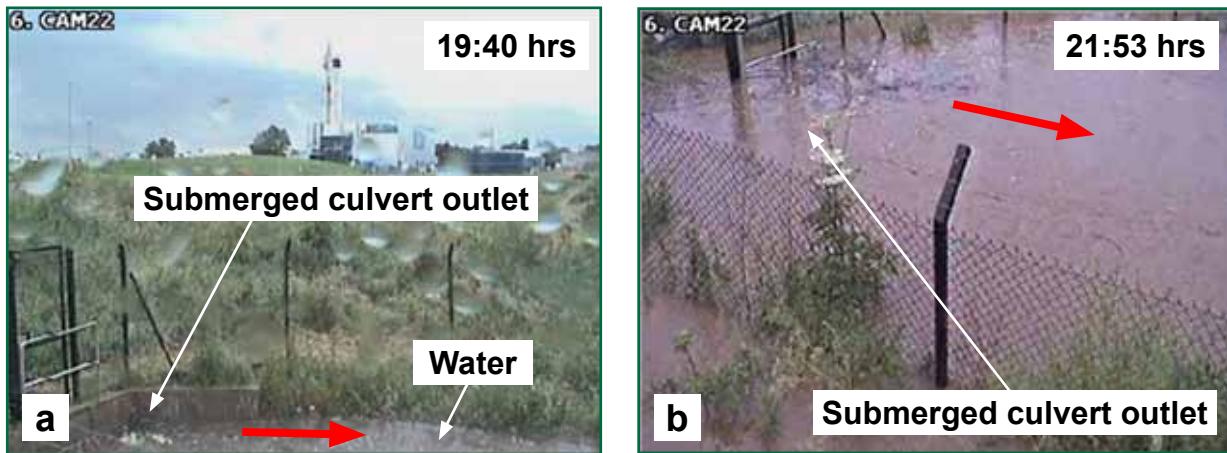
- 54 The CCTV footage from a camera aimed at the outlet from the CCHBC culvert shows that from around 19:40 hrs it was also completely submerged (figure 11). This indicates that culverts downstream of the CCHBC culvert were restricting flows through it. This in turn would have caused water levels to increase at the upstream end of the CCHBC culvert.

Figure 11: CCTV images of the CCHBC culvert outlet (images courtesy of CCHBC)

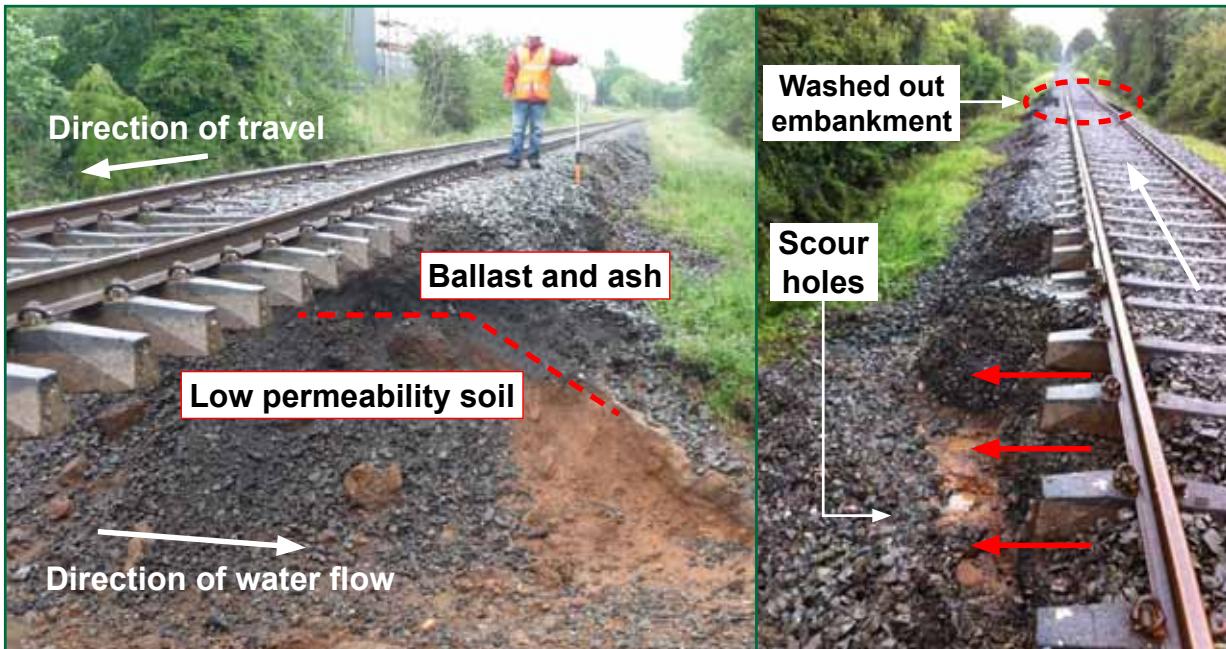
- 65 The photographs also recorded *scour holes* on the downstream side of the railway embankment, on the approach to the washout. These were formed as water seeped through the permeable upper layers of the track formation. The position of these scour holes provides an indication of the maximum water level on the upstream side of the embankment, which was around 1 metre below rail level.

Figure 12: Washed out embankment and scour holes on approach to the site (images courtesy of URS)

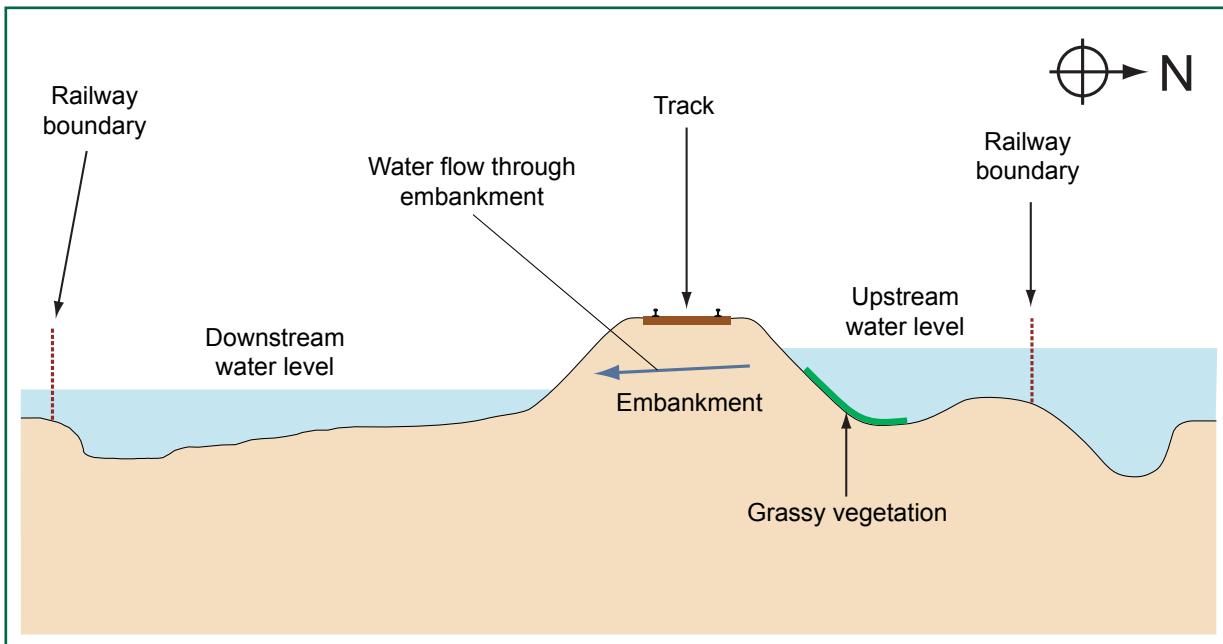
- 67 The difference in water levels across the embankment was caused by a greater flow of water arriving at the upstream side of UB1 than could be passed through the combination of UB1 and the downstream culverts, causing water to build up on the upstream side (figure 13). This water level difference would have provided a driving head to force water through the permeable upper layers of the embankment. When water levels were relatively low, it is likely that the embankment was effective as a dam because the embankment was relatively wide near its base, the grassy vegetation on the upstream face strengthened this surface, and the brown embankment core material offered a greater resistance to water seepage than the upper layers of ash and ballast.

Figure 13: Schematic cross section through embankment at the failure location, showing difference in water levels across it

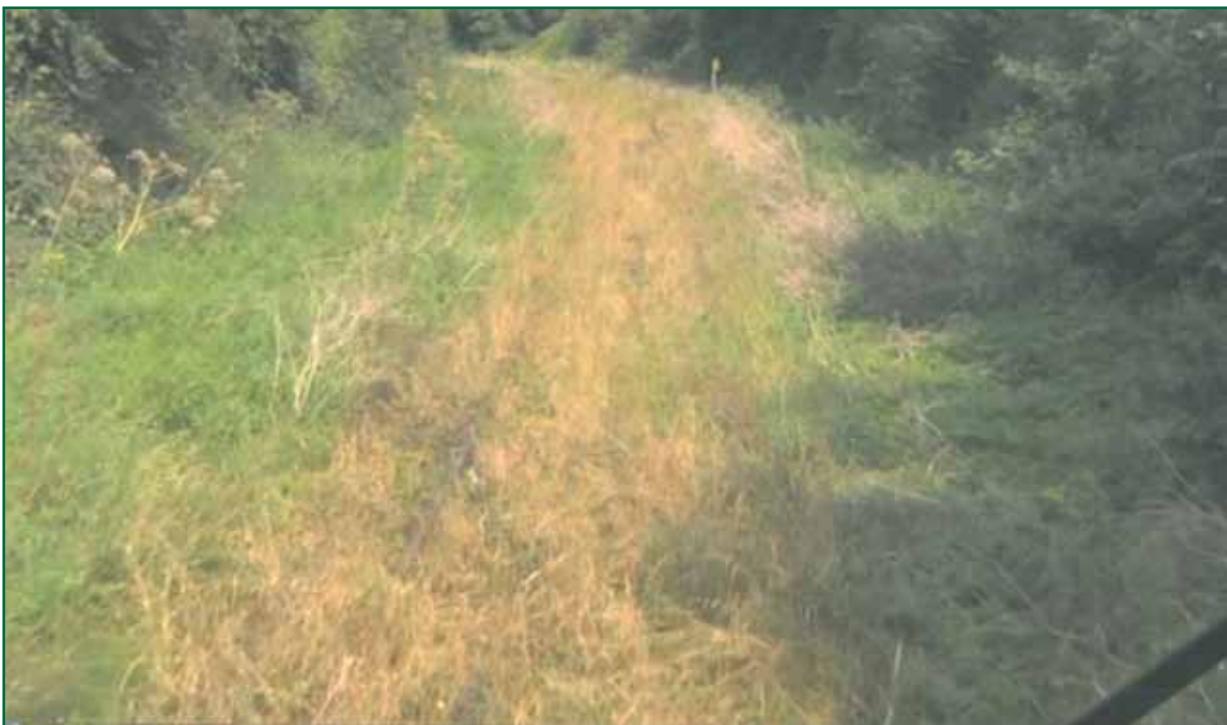
- 106 On 12 September 2012, the RAIB carried out a cab ride in a Class 4000 train along the Antrim branch line. It was noted that some short sections of the track were severely overgrown with weeds and in some locations one or both rails were not visible to the driver (figure 14).

Figure 14: A section of the Antrim branch line with excessive weeds and lack of visibility of the track, September 2012

- c. Some short sections of the Antrim branch line had been allowed to become severely overgrown with weeds, to the extent that one or both rails would not have been visible to track patrollers and drivers; (**paragraph 106, Recommendation 4**).
