RAIB Bulletin 04/2012

Blowback of a locomotive fire at Wood Green tunnel, London, on 27 May 2012

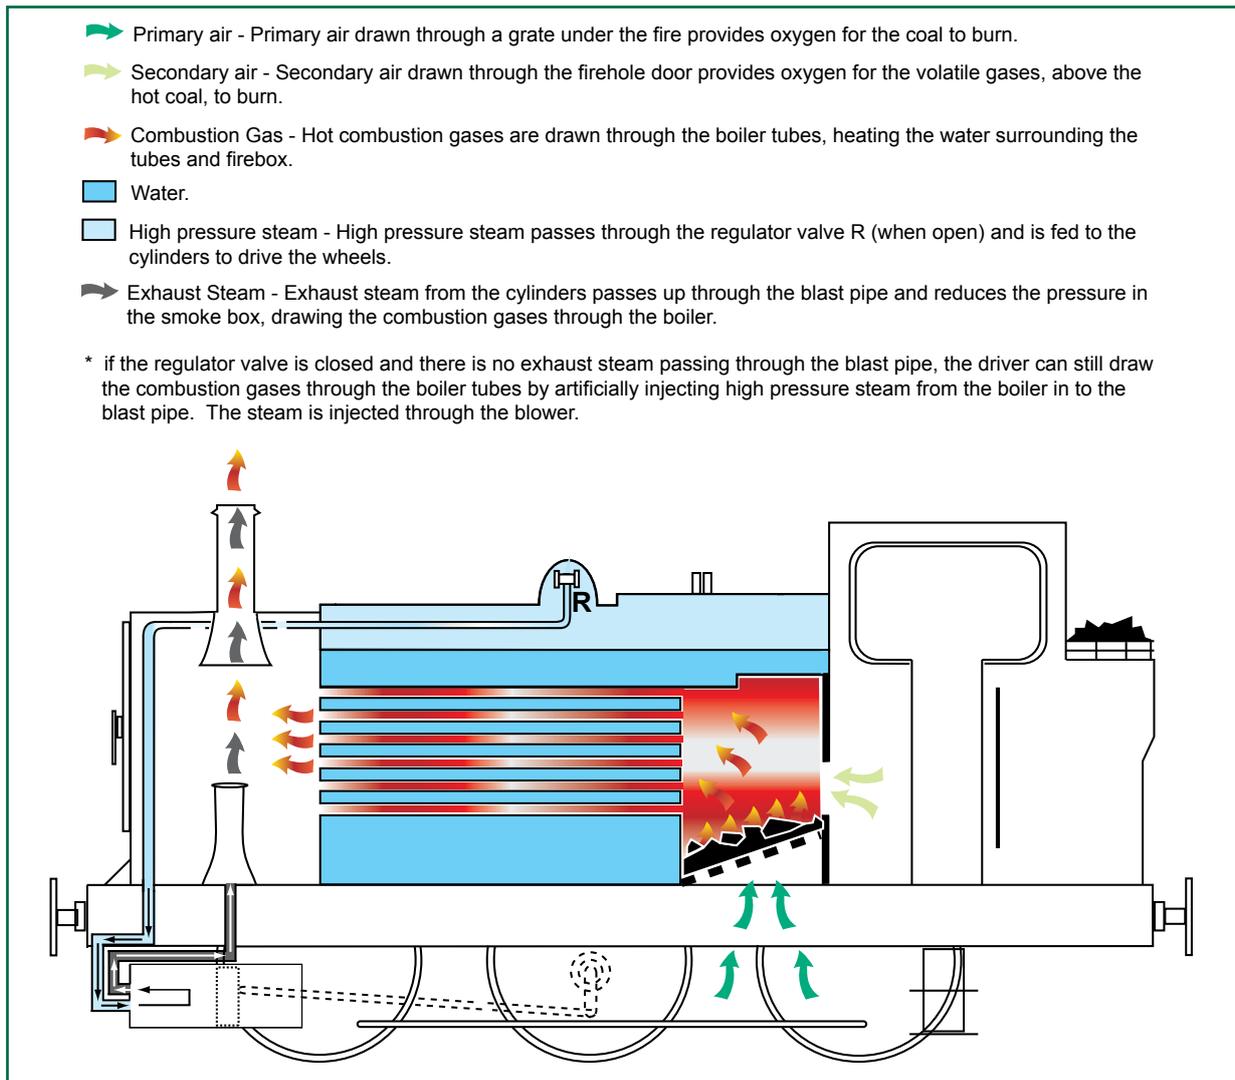
Figure 3: Diagram showing gas flows in a steam locomotive

- The diesel locomotive provided most of the power to move the train as it departed from Finsbury Park, but the driver of the steam locomotive applied a small amount of power because lubrication of the locomotive cylinders was reliant on steam passing through them. This demand for power caused the fire to burn more strongly because the exhaust steam in a steam locomotive is designed to create a vacuum in the smokebox which draws the hot gases from the fire through the boiler tubes (figure 3), thereby increasing the rate of burn of the fire. This in turn further heats the water and increases the boiler pressure. Four minutes into the journey, as the train was passing Alexandra Palace station, the locomotive fire had heated the water in the boiler to the extent that the boiler pressure was approaching its maximum allowed value and the safety valves were starting to operate.

⁵ The reason for opening the blower before entering a tunnel is to create a strong updraft in the chimney to counteract the pressure pulse in the air around the front of the train generated when it enters the tunnel. The magnitude of this pressure pulse depends on the size of the train in comparison to the size of the tunnel (the 'blockage ratio'); consequently it is much stronger in a single track bore tunnel, which was the type of tunnel the train entered at Wood Green.

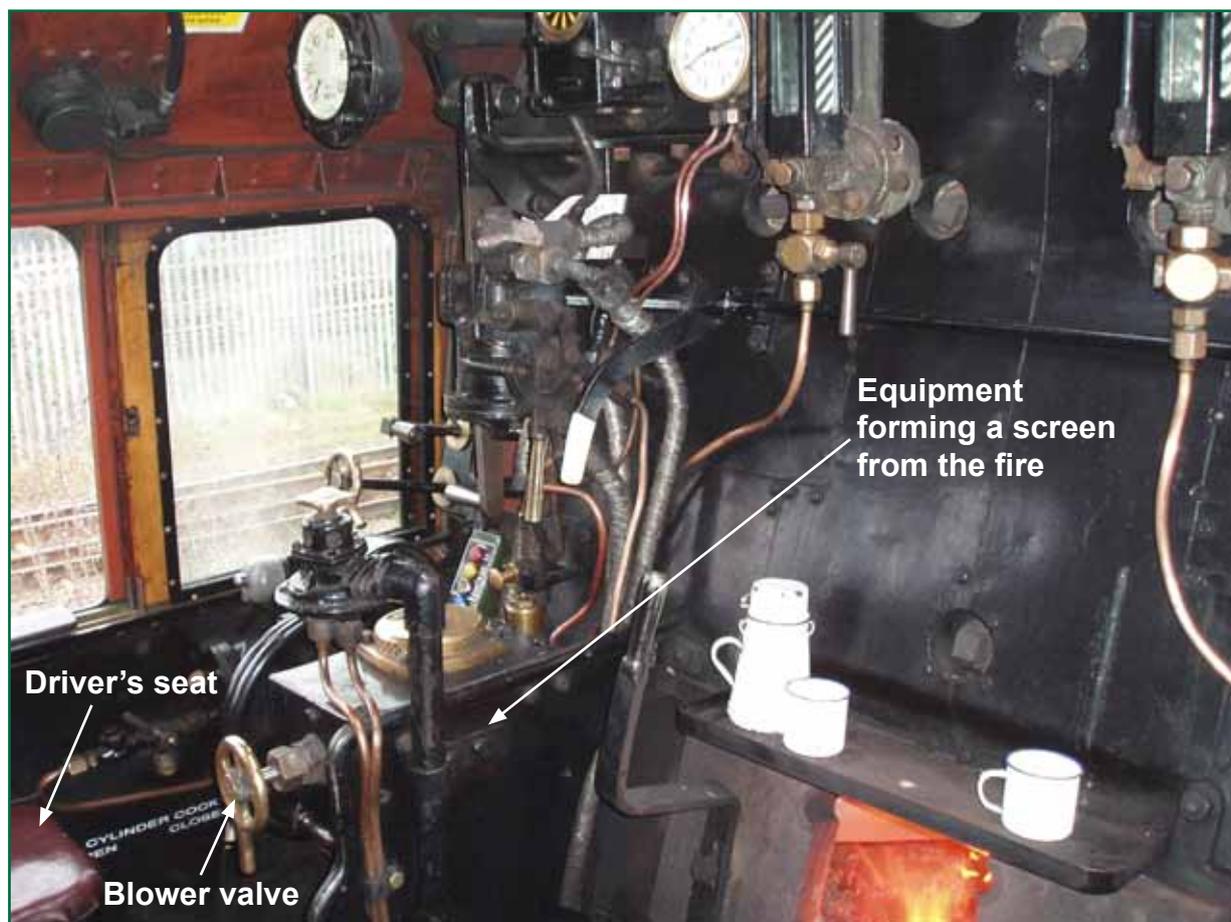
Figure 4: Cab interior of 70013 (courtesy of J. Street)

- 10 The fireman and the support crew member, who was standing behind the driver, tried to shelter from the flames. There were no controls within their reach that they could use to stop the blowback. The driver, who was partly shielded from the flames by some of the cab equipment (figure 4), fully opened the blower valve and this stopped the blowback while the locomotive was still in the tunnel.
