RAIB Bulletin 03/2012

Accident at Margam Yard, near Port Talbot 12 June 2012

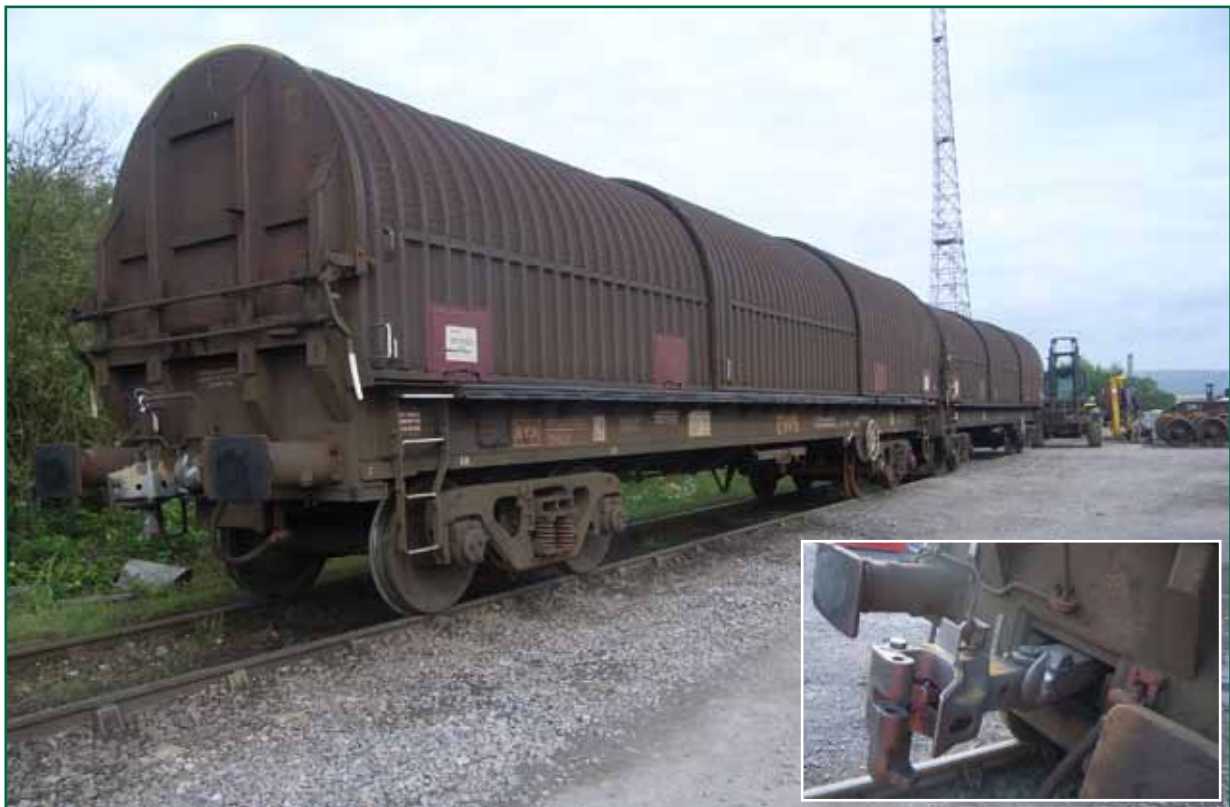
- 2 The wagons involved were of the BYA type with a buckeye coupler at each end (figure 1). These couplers are designed to engage automatically provided a locking pin has been raised on each coupler and the couplers, which can swing from side to side, are centred.

Figure 1: Incident wagons with buckeye coupler

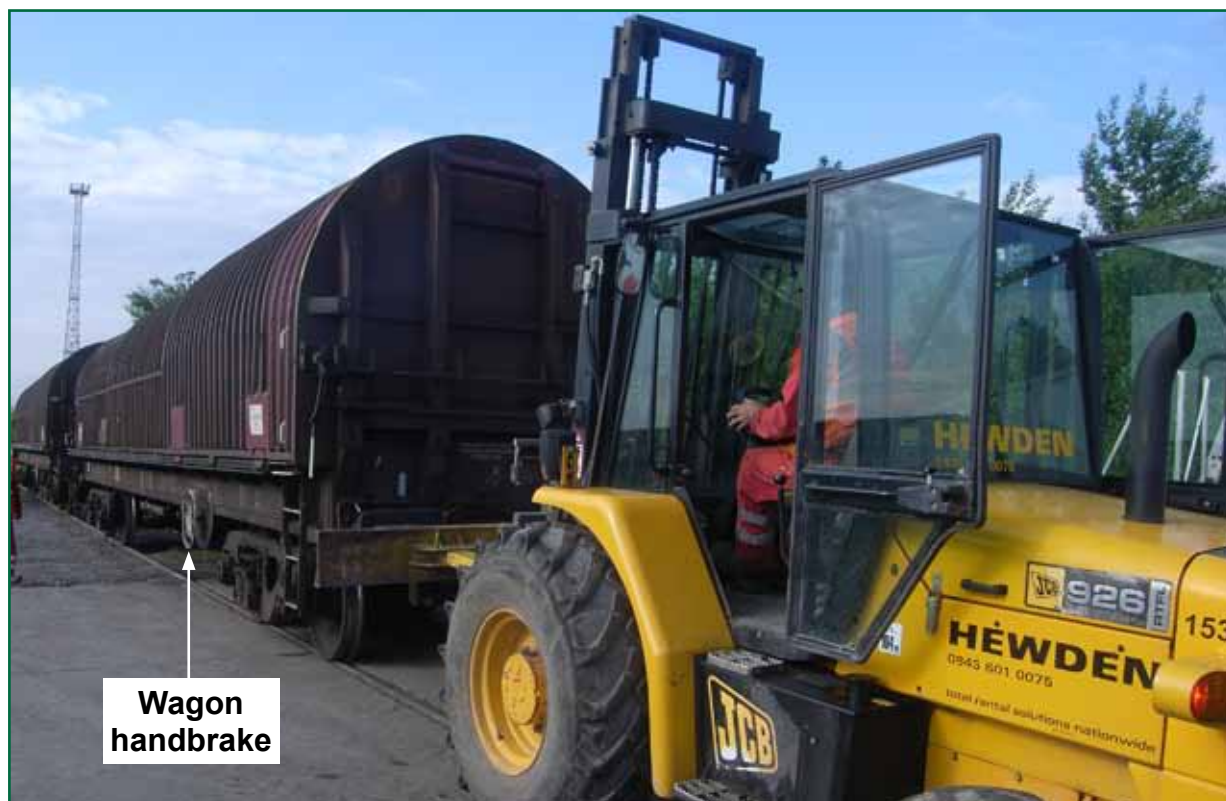
- 3 An adapted rubber-tyred forklift was used to push the wagons (figure 2). As was authorised by DB Schenker at this location, the forklift was not coupled to the wagons, the wagons' air brakes were inoperative and a member of staff walked alongside a wagon's handbrake to apply this as necessary.

Figure 2: Adapted forklift and wagon handbrake

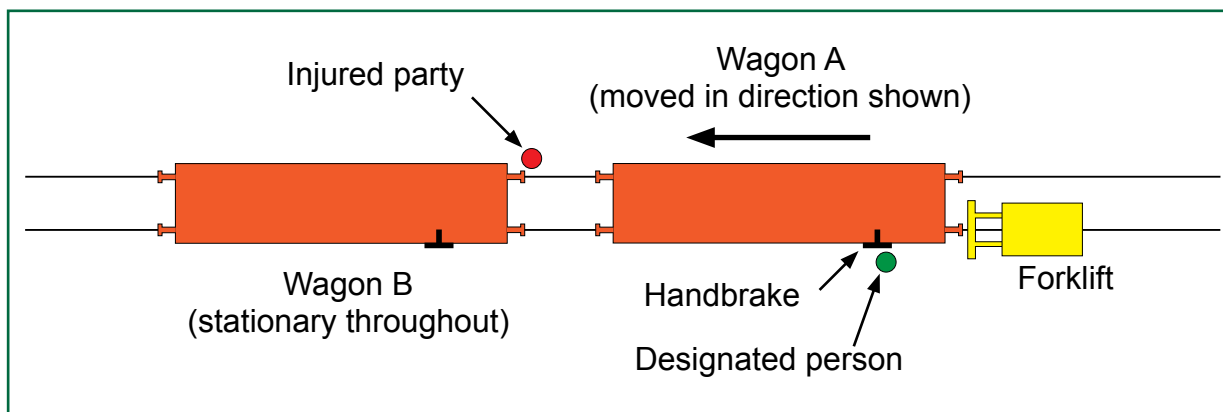
- 6 The accident occurred when two wagons were being coupled together (described in this bulletin as wagon A and wagon B, figure 3). After an initial attempt to couple the wagons failed because the couplers did not engage, the designated person and the injured party stepped between the wagons to realign the couplers. The designated person, located on the side of the siding from which he was able to give hand signals to the forklift driver, reported that he saw the injured party move to the opposite side of the siding and into a position clear of the impending shunting movement.

Figure 3: Plan showing situation immediately before the accident

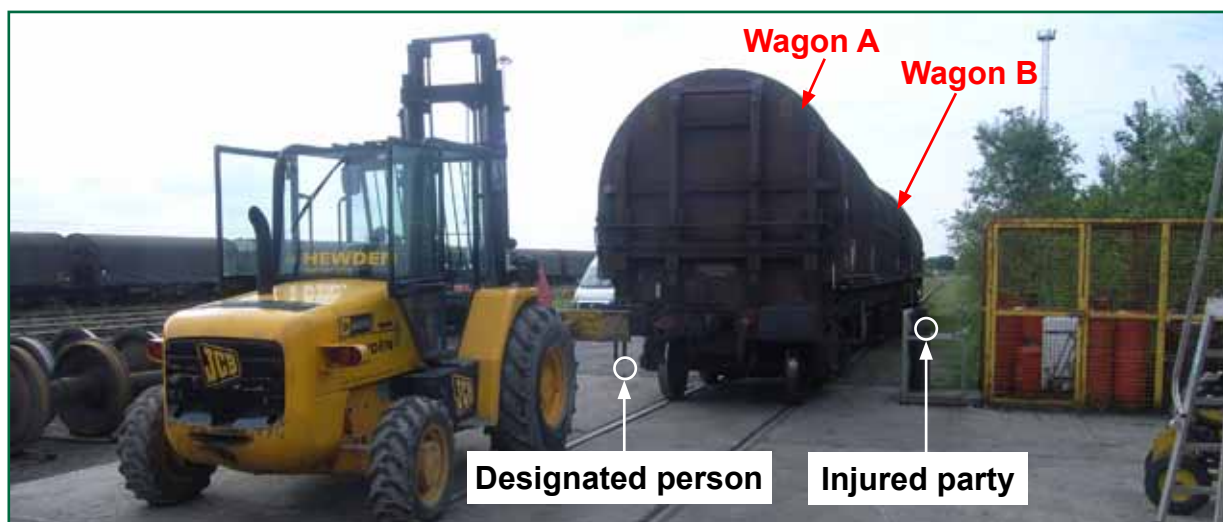
- 7 The designated person then walked along the siding to the handbrake of wagon A (figure 2), released the brake and instructed the forklift driver to push wagon A against wagon B (figure 4). While this was happening, and unknown to the designated person, the injured party moved into the gap between the wagons. The injured party was crushed between the buffers of the two vehicles when the forklift pushed the wagons together.

Figure 4: Reconstruction showing situation immediately before the accident

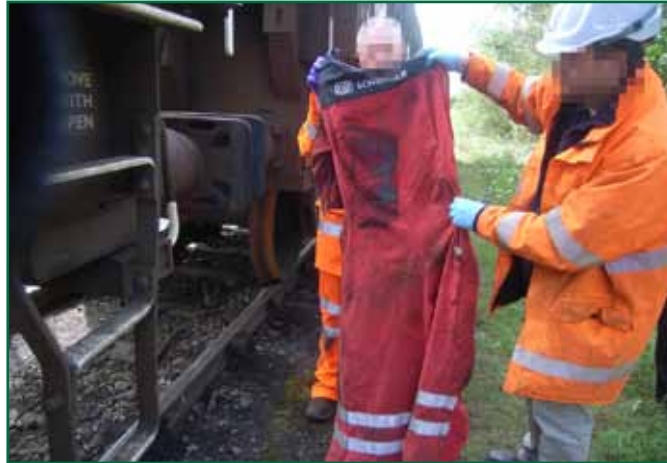
- 8 Witness evidence indicates that, before walking to the handbrake, the designated person had spoken with the injured party about the impending shunt move. The injured party had confirmed that he (the injured party) was clear of the wagons and that he understood the designated person was going to start a shunt move.
- 9 The injured party reports that he was standing clear of the shunting operation and watching both wagons until, very shortly before the wagons coupled, he moved to a position where he could concentrate on looking at the stationary wagon (wagon B). The grease mark on his overall (figure 5) shows that he was standing upright and very close to the track when he was crushed between the buffers. It is therefore probable that, when moving to concentrate on the stationary wagon, he misjudged his position or momentarily forgot about the moving wagon.

Figure 5: Grease mark from buffer on injured party's overall

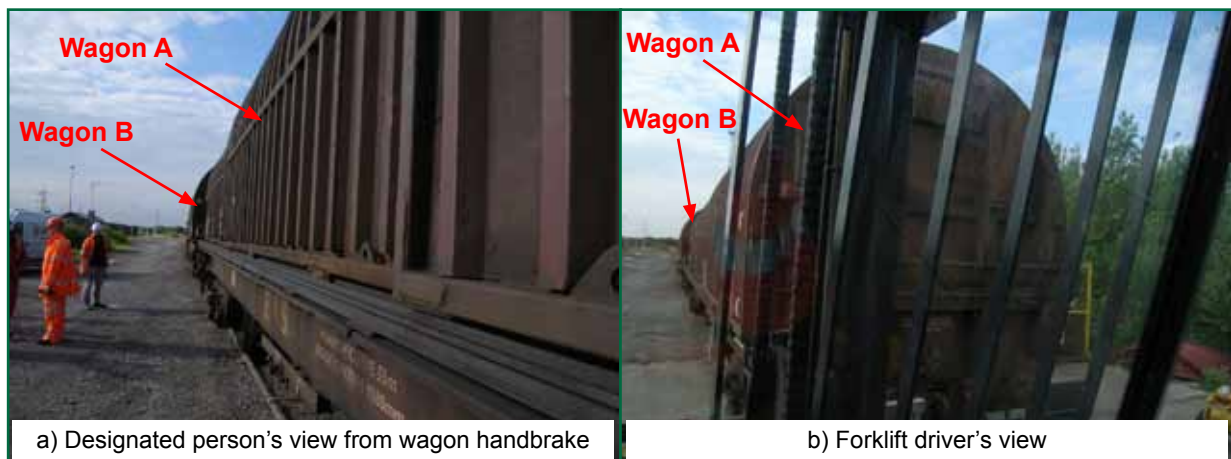
- 10 A reconstruction showed that, when walking to the handbrake and then standing at this position to instruct the forklift driver, the designated person could not see the area between the wagons (figure 6a). In addition, the forklift driver could not see this area (figure 6b).

Figure 6: Visibility when shunt move started

- 14 The RAIB has decided not to conduct a full investigation because it does not believe that this would identify any significant new lessons relating to railway safety. However, the accident reiterates the importance of ensuring that:
- staff must never go between vehicles unless they are absolutely sure that the vehicles will not move;
 - when working in a team, staff must never go between vehicles without reaching a clear understanding with the person controlling the movement of vehicles that it is safe to do so; and
 - shunting movements should involve only the minimum practical number of staff with other people remaining well clear of the movement.

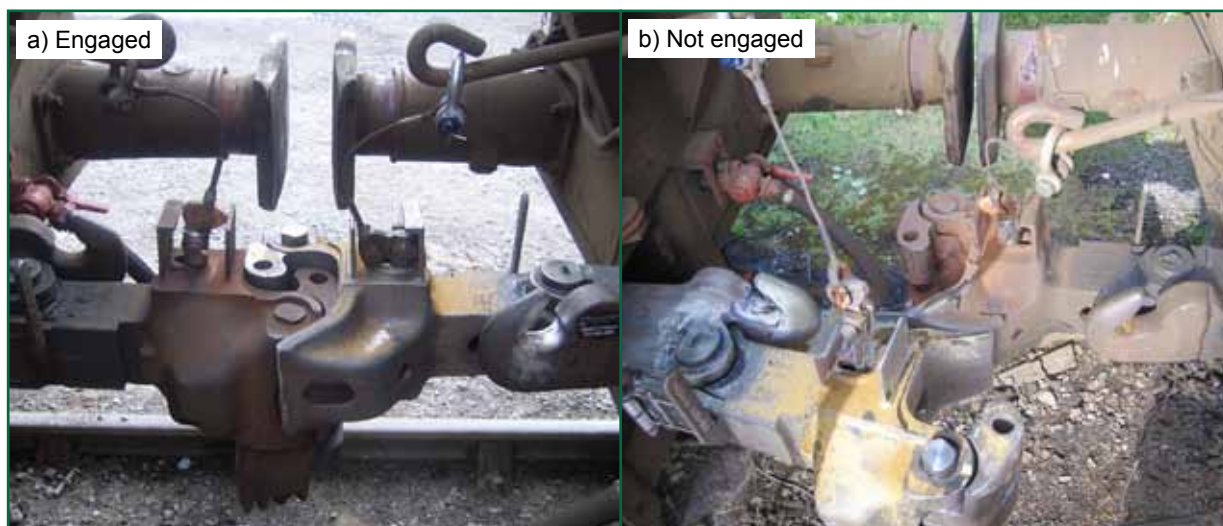
- 11 Inspection of the buckeye couplings showed that they had engaged correctly, with a gap of about 150 millimetres between the buffers, during the shunt move in which the injury occurred (figure 7a). If the couplers had not engaged, it is possible that they would have behaved in the way shown on figure 7b. If this had happened, the gap between the buffers would have been about 30 millimetres and it is unlikely that the casualty would have survived.

Figure 7: Buckeye coupling engagement
