Rail Accident Report

**Pedestrian struck by a tram at Sandilands tram
stop, Croydon
16 May 2012**

Report 03/2013
February 2013

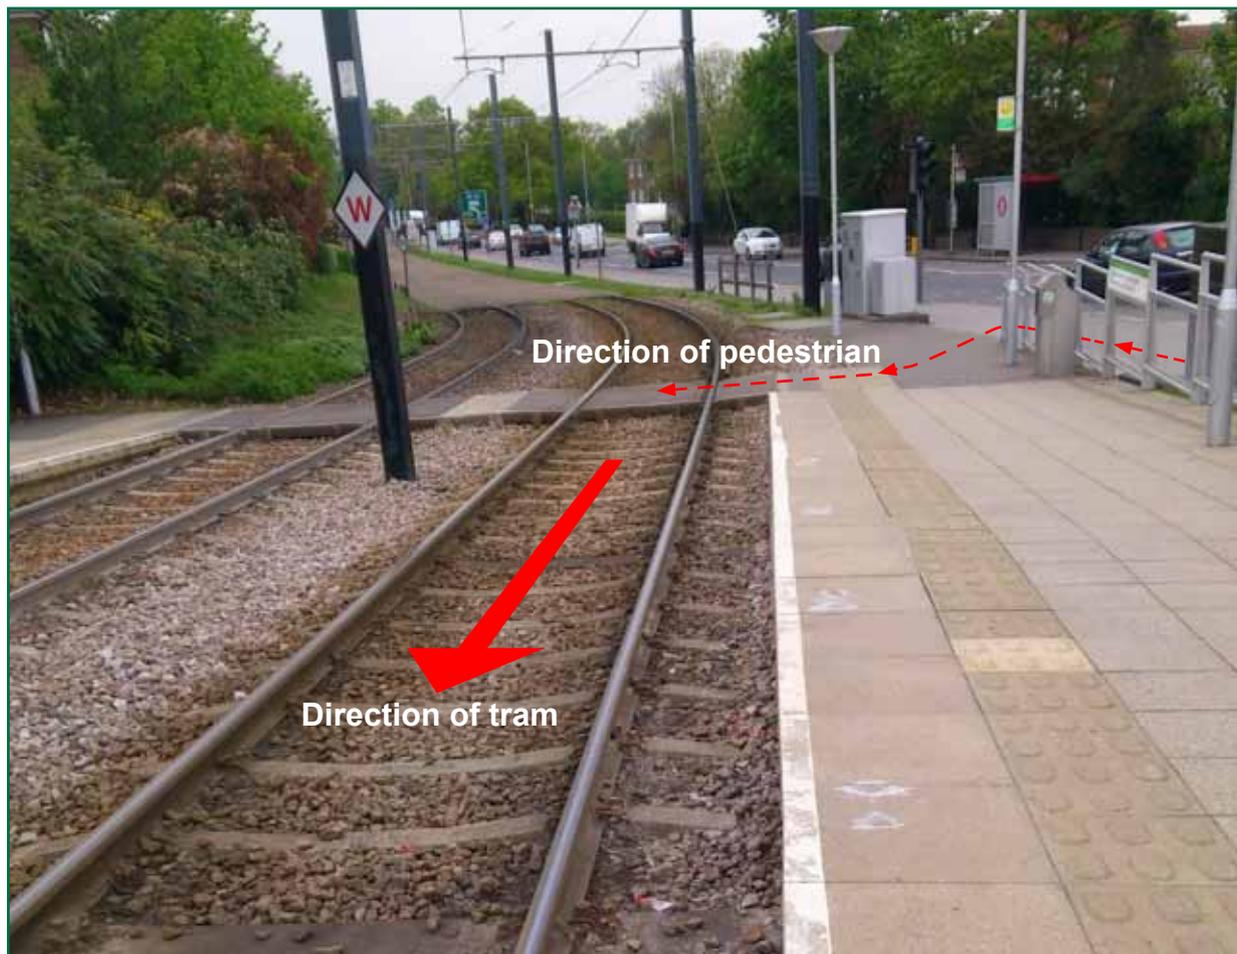
- 5 At approximately 09:44 hrs on Wednesday 16 May 2012, a pedestrian was struck by a tram as she crossed the tramway on a foot crossing at Sandilands tram stop in Croydon (figures 1 and 2).

- 6 The tram was travelling at 26 km/h at the time of the accident. The impact resulted in the pedestrian falling into the space between the platform face and the rail closest to the platform. She remained trapped in that position as the tram continued into the platform to its normal stopping point. The pedestrian was seriously injured.

Figure 2: Sandilands tram stop showing the crossing at the west end where the accident happened

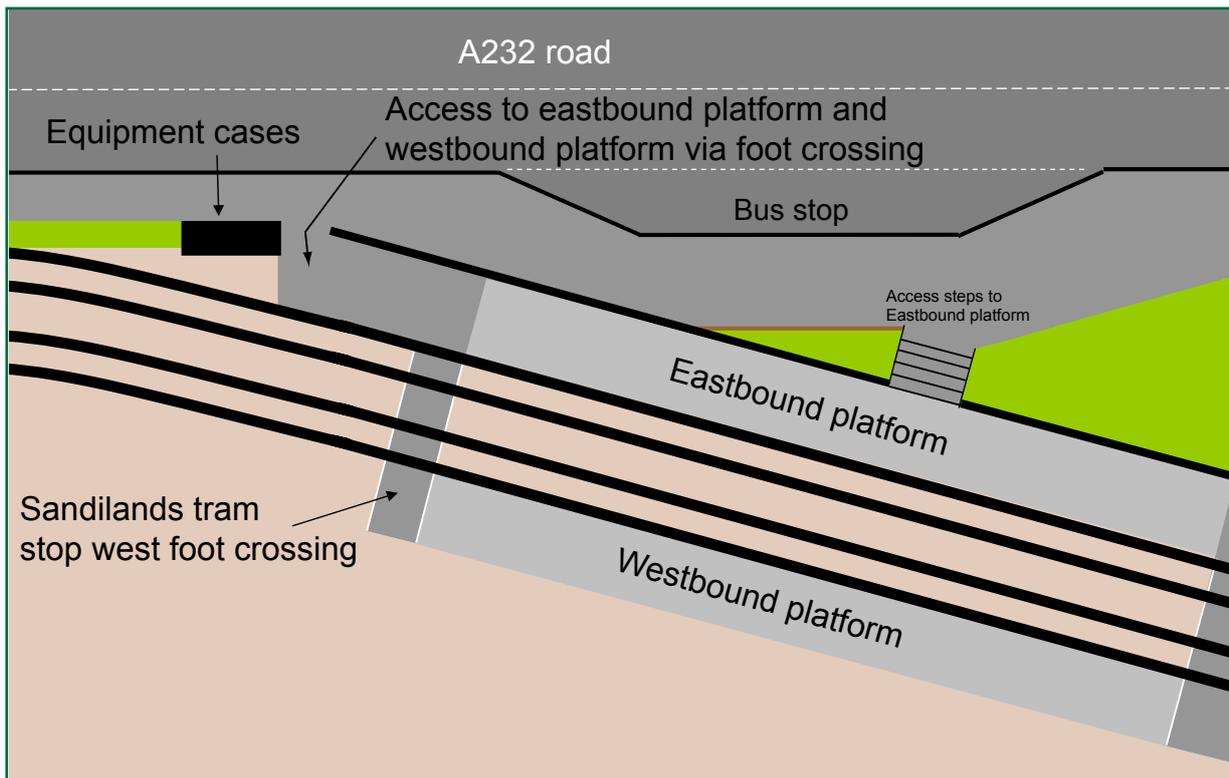
- 8 A fence separates the tram stop and the pavement, which are at different heights. Pedestrians going towards the platform and the foot crossing at the west end must walk a short distance on the pavement before reaching the entrance to the tram stop. At this point, it is necessary for them to turn back on themselves in order to reach the eastbound platform and the foot crossing to the westbound platform (figures 3 and 4).

Figure 3: Layout at Sandilands tram stop

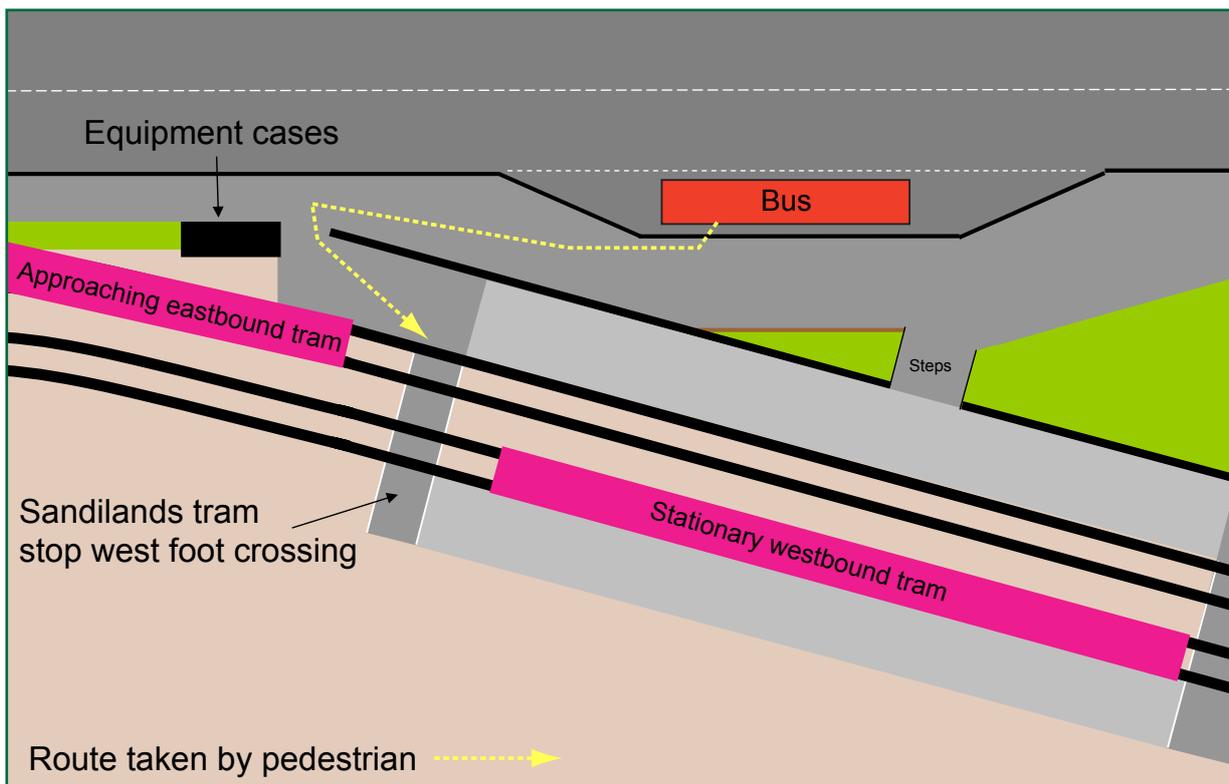
Figure 4: The pedestrian's route from a bus to the westbound platform at Sandilands

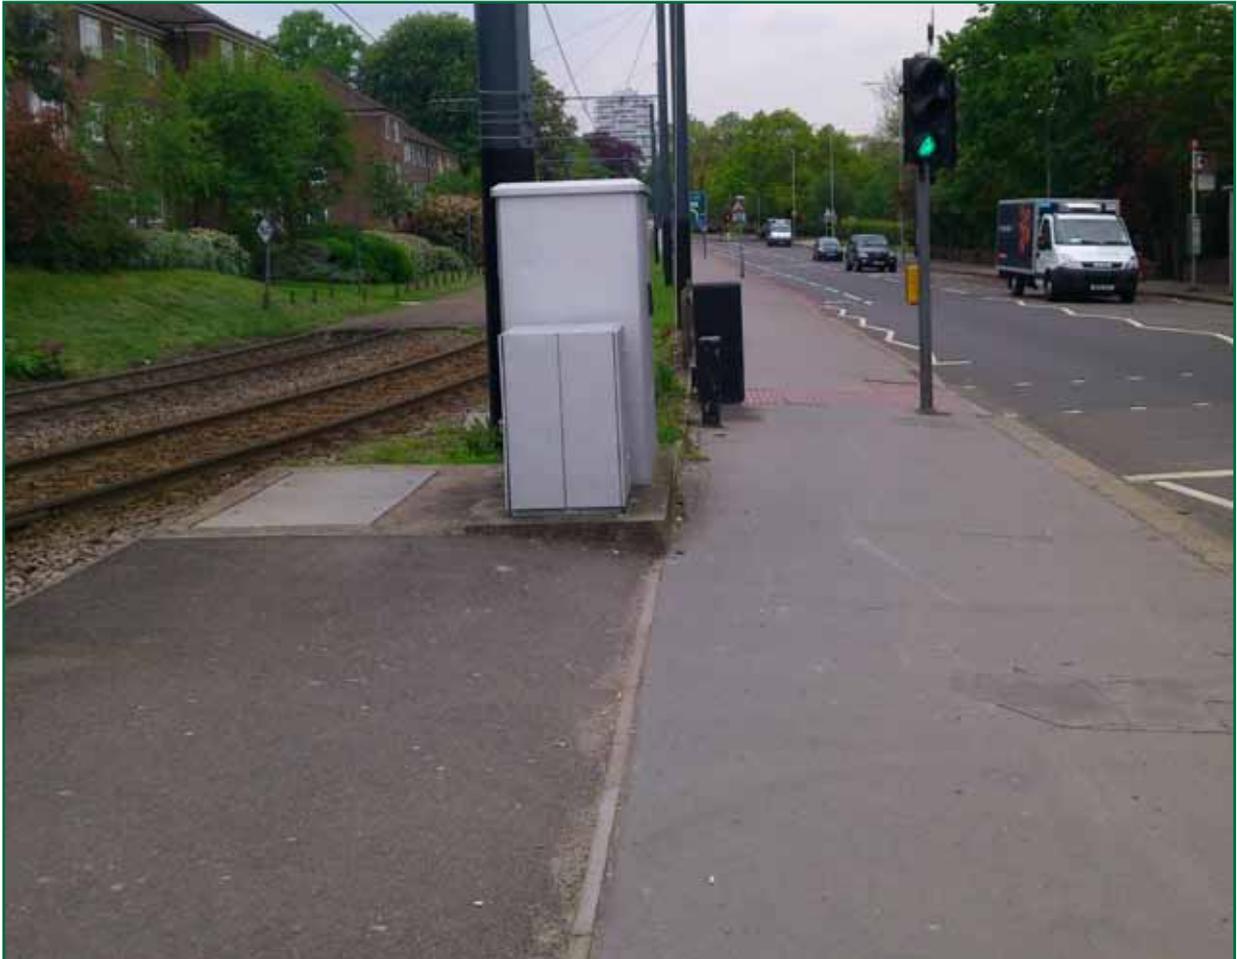
- 32 Paragraph 8 describes the route taken by pedestrians alighting from a bus to reach the entrance to the tram stop. As pedestrians walked towards the entrance, their view of approaching eastbound trams could be obscured by lineside equipment cabinets (figure 5), although this would not be the case if they walked close to the edge of the pavement. If they walked close to the fence separating the pavement from the platform, they were denied a view of approaching eastbound trams until they were approximately eight metres from the crossing. The RAIB has been unable to determine the exact position of the pedestrian as she walked along the pavement towards the entrance to the tram stop.

Figure 5: The obstruction to the pedestrian's view of approaching eastbound trams at Sandilands tram stop

- 87 London Tramlink did not identify the obstruction to a pedestrian's view of approaching trams that was caused by the equipment cases at the west end of Sandilands tram stop (paragraph 31), or the angle at which pedestrians could approach the foot crossing at the west end of the tram stop in relation to approaching eastbound trams.

- a. The pedestrian may not have been able to see the approaching tram as she walked from the bus stop to the entrance to the tram stop, because her view could have been obstructed by lineside equipment cabinets (**paragraph 31, Recommendations 2 and 3**).

- 2 *The intent of this recommendation is for London Tramlink to consider the need for removing the obstruction to pedestrians' view of approaching trams at Sandilands tram stop, to identify and take action as appropriate to deal with similar obstructions at other tram stops and to implement a process to prevent the installation of equipment in locations which are detrimental to pedestrian safety in the future.*

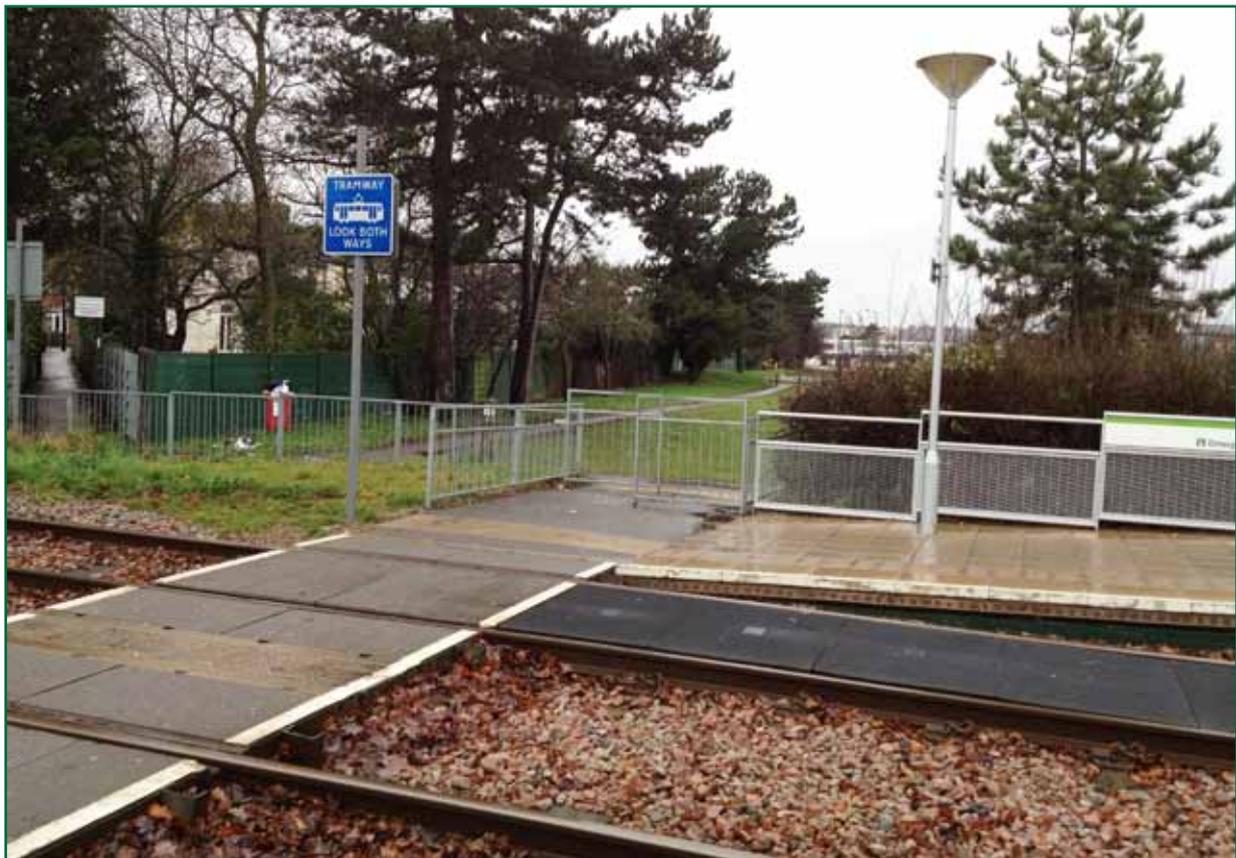
- 39 Following the accident at Arena, the concessionaire at the time, Tramtrack Croydon Ltd (paragraph 17), recognised the hazard of pedestrians approaching Arena tram stop with their backs to approaching trams and installed barriers which had the effect of encouraging pedestrians to approach the crossing at right angles, thereby making it easier for them to see trams approaching from either direction. Figure 6 shows the configuration of barriers that are currently in place at Arena tram stop; the barriers that were installed at Arena after the accident in August 2007 are shown in Figure 7 of the RAIB's investigation into another accident which occurred at Morden Hall Park footpath crossing in September 2008³.

- 40 Although Tramtrack Croydon Ltd recognised the specific hazard of the approach to the foot crossing at Arena tram stop, it did not carry out a review of other stops on the network where the same hazard existed, such as Sandilands, and similar mitigation was not applied elsewhere.

Figure 6: Barriers installed at Arena tram stop

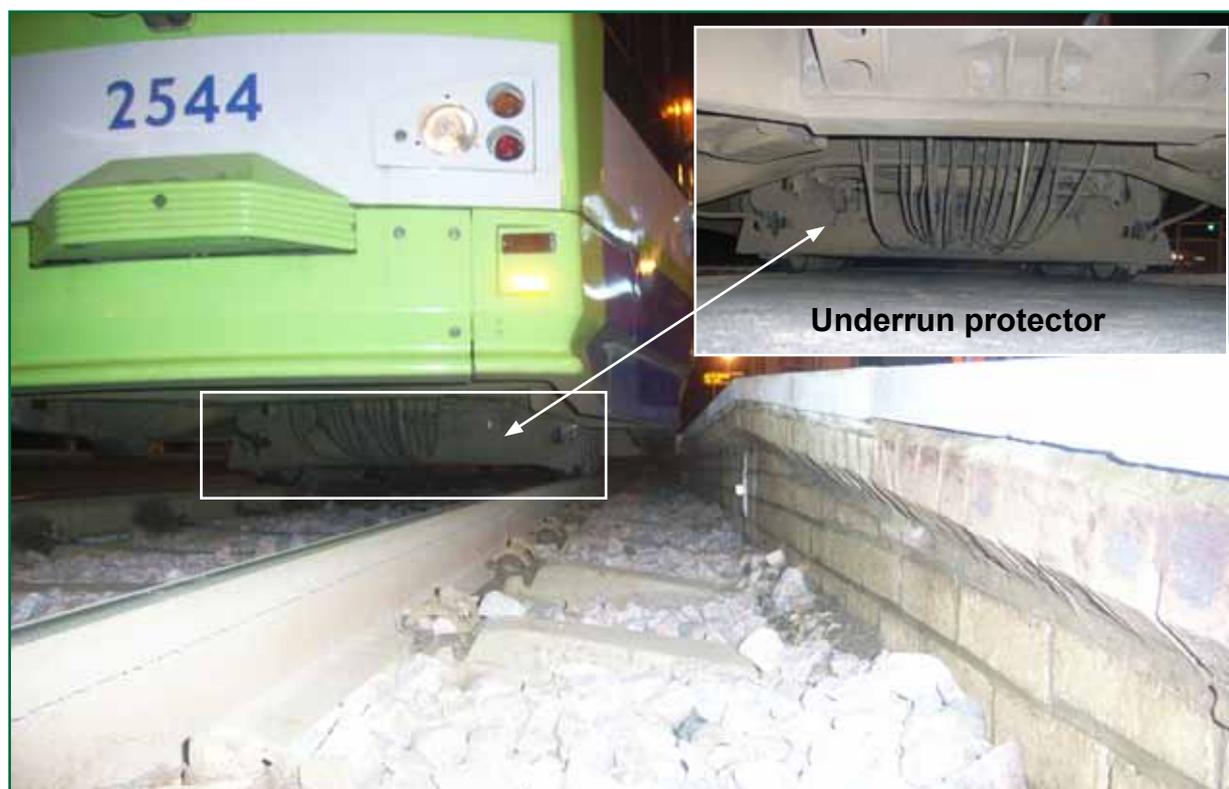
- 69 The underrun protector (figure 7) is a device located underneath the front of the tram that is intended to keep a pedestrian who has been struck by a tram from going underneath the wheels. For it to be effective, the clearance between the bottom of the underrun protector and the surface beneath it needs to be as small as possible, but allowing enough clearance to avoid it striking the ground in normal operation. Paving up to rail level at tram stops allows this clearance to be minimised; the use of ballast generally increases the clearance and thereby decreases the effectiveness of the underrun protector. At Sandilands, the clearance between the bottom of the underrun protector and the sleepers was 255 mm. Paving up to rail level would reduce it to around 105 mm, thereby increasing the likelihood of the underrun protector performing its function. The RAIB examined issues in relation to the design of tram underrun protectors in its investigation into a fatal accident at Piccadilly Gardens, Manchester on 5 June 2011¹⁰ and recommended that research should be undertaken into the potential for the reduction of injuries to pedestrians involved in front end collisions with trams.

Figure 7: Front of tram showing underrun protector

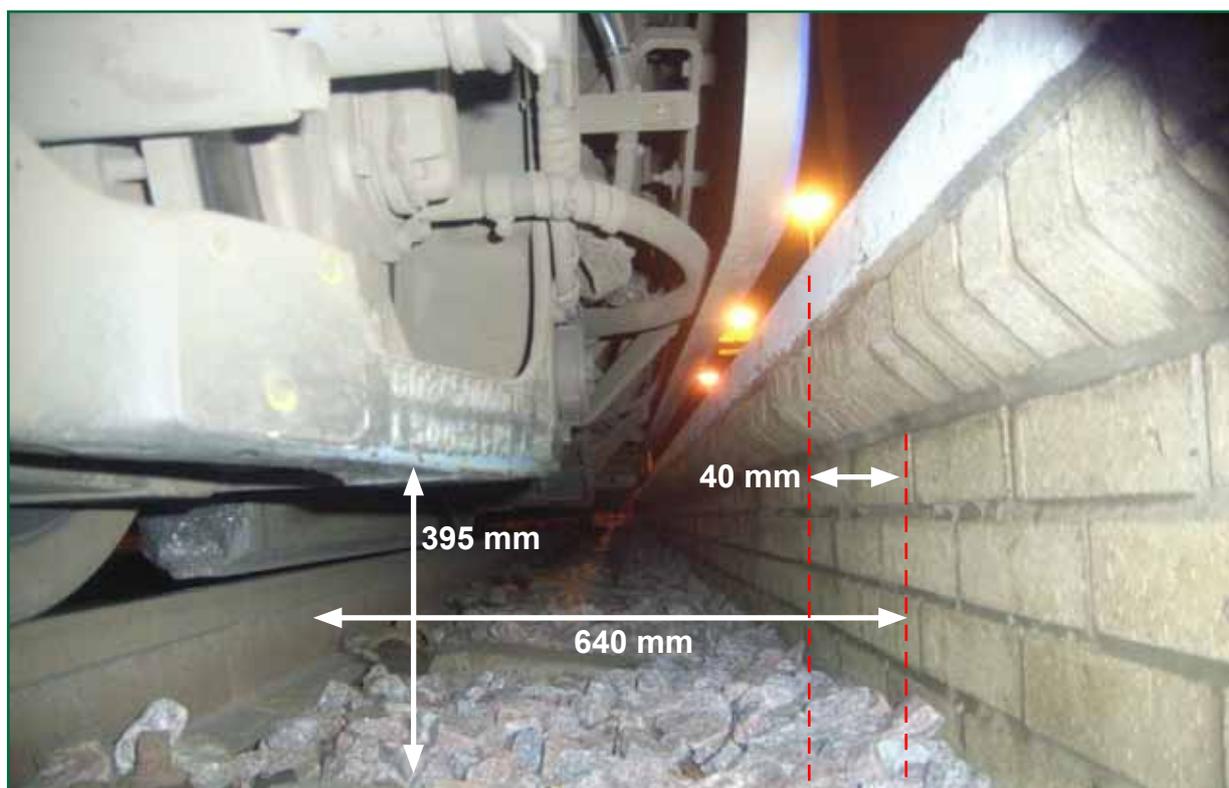
97 The size of the gap where the pedestrian was found after the tram had stopped is shown in figure 8. The limited space available meant that she was partly dragged by the tram, although the fact that she was only carried 17 metres beyond the crossing and not the full 40 metres traversed by the front of the tram, indicates either that the pedestrian was stationary for some of the time that the tram was moving or that she was being dragged at a slower rate than the tram was travelling.

Figure 8: Key dimensions in the gap between the platform face, platform-side rail and a tram

- 98 There are two reasons why the pedestrian survived the accident, both of which relate to the space available:
- The surface between the platform face and the rail comprised ballast which did not reach the height of the rail. Had the rails been set in slab up to rail height, the available vertical space would have been reduced by approximately 150 millimetres.
 - There was a recess under the platform, providing an additional 40 millimetres of horizontal clearance.
- 99 Paragraph 163 of ORR's guidance on the design of tram stops (paragraph 41) states:
- 'A recess below a platform coping is not required for tram platforms'.

- 3 *The intent of this recommendation is for ORR to re-evaluate its guidance to tram operators on optimising sight lines for pedestrians and tram drivers in the vicinity of foot crossings, physically guiding pedestrians as they approach foot crossings so that they are encouraged to look for approaching trams and the need or otherwise for recesses under tram stop platform and paving up to rail level through tram stops. The guidance should be amended in accordance with ORR's findings.*

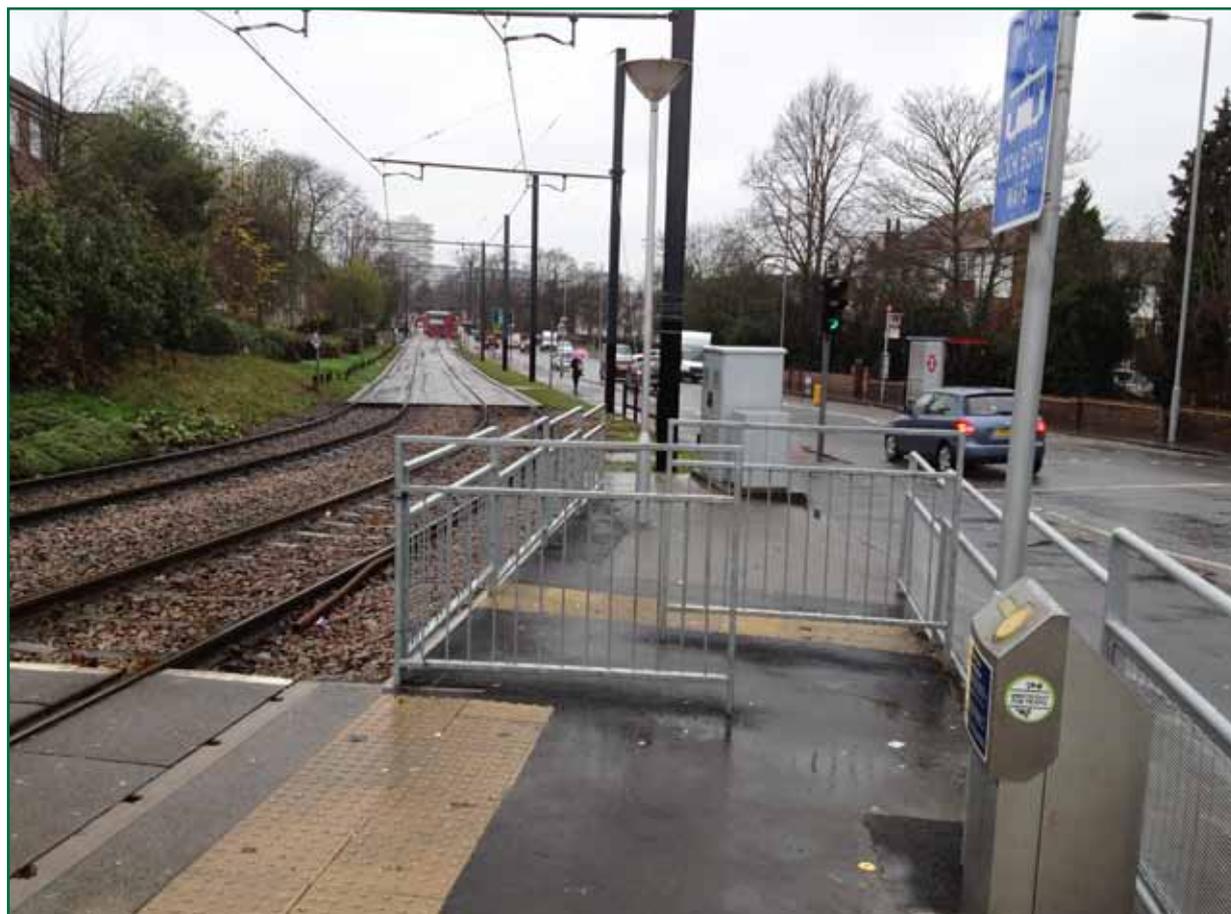
Figure 9: Revised arrangements for pedestrians, including a chicane, at the west end of the eastbound platform at Sandilands tram stop

- 121 A chicane has been installed at the Sandilands tram stop foot crossing, which has the effect of discouraging pedestrians from approaching the foot crossing diagonally and increases the likelihood that they will see a tram approaching from either direction (figure 9 and paragraph 115a).
