Rail Accident Investigation Branch

Rail Accident Report

**Fatal accident at Grosmont, North Yorkshire
Moors Railway
21 May 2012**

Report 23/2012
October 2012

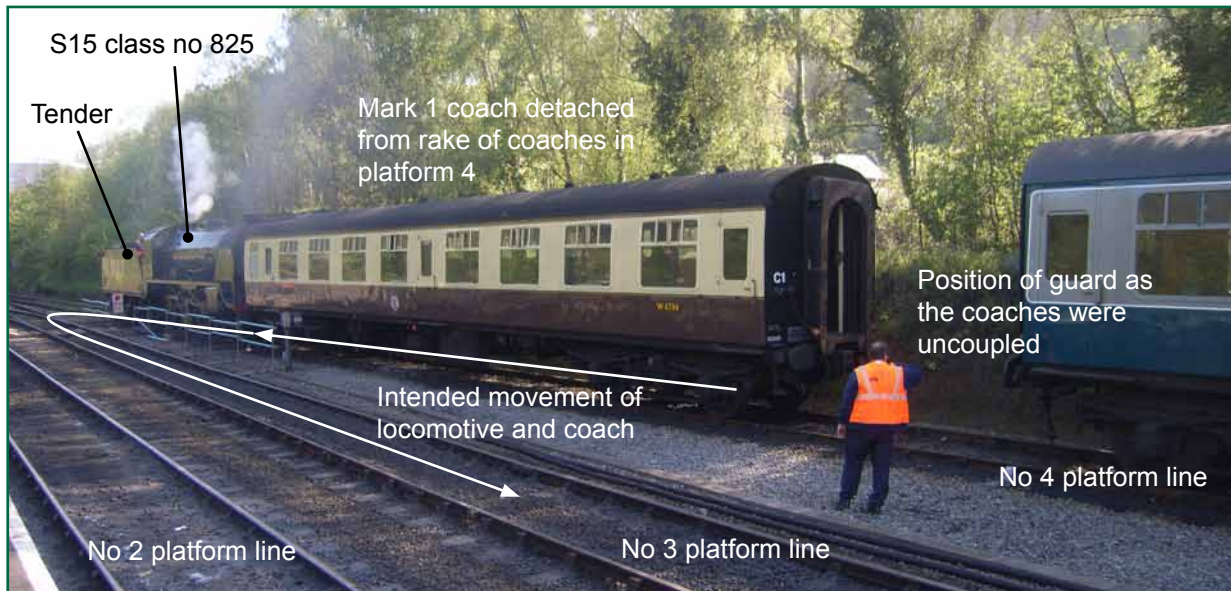
Figure 2: The accident site at Grosmont station showing a reconstruction by the RAIB of the accident circumstances

- 5 As one of the coaches was being drawn away by a steam locomotive, to be coupled to another rake of coaches, the locomotive changed direction and pushed the coach back towards where the uncoupling had just taken place. Meanwhile, the guard had gone between the coaches to complete the work arising from the uncoupling. The guard was trapped between the coaches and was fatally injured. Figure 2 shows the site of the accident.

- 43 **The immediate cause of the accident was that the guard was between vehicles during a shunt move when the locomotive and a coupled coach that were moving away unexpectedly changed direction.**

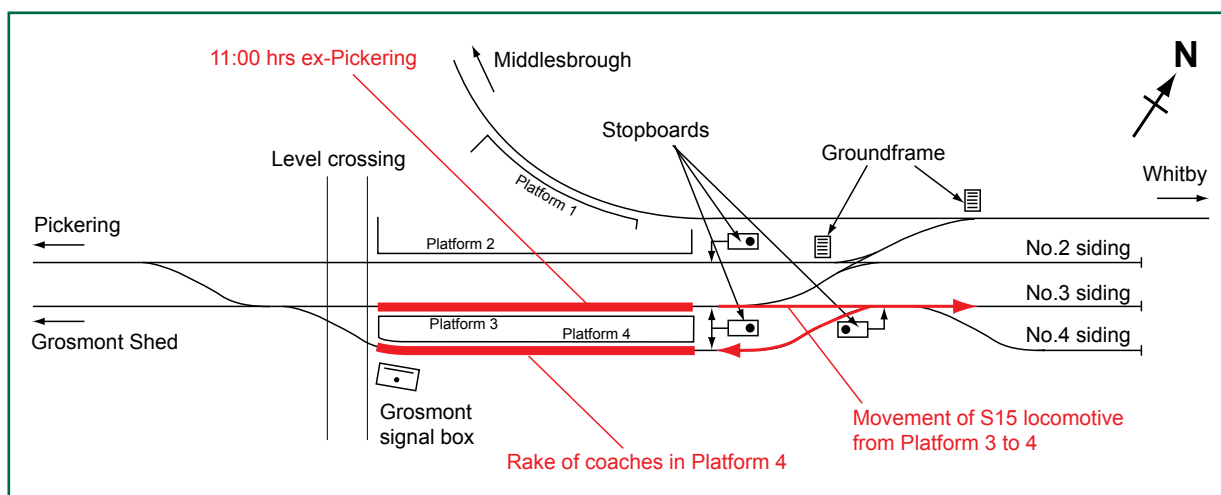
Figure 3: The track layout at Grosmont station

- 7 The station track layout at Grosmont (figure 3) consists of one platform to serve the Esk Valley line and three platforms to serve the NYMR. At the north end there are three NYMR sidings and a connection between the NYMR and the national network. Immediately south of the station there is a level crossing, followed by a short tunnel, and then the locomotive shed. Through the station, the gradient falls away at 1 in 126 towards Whitby.

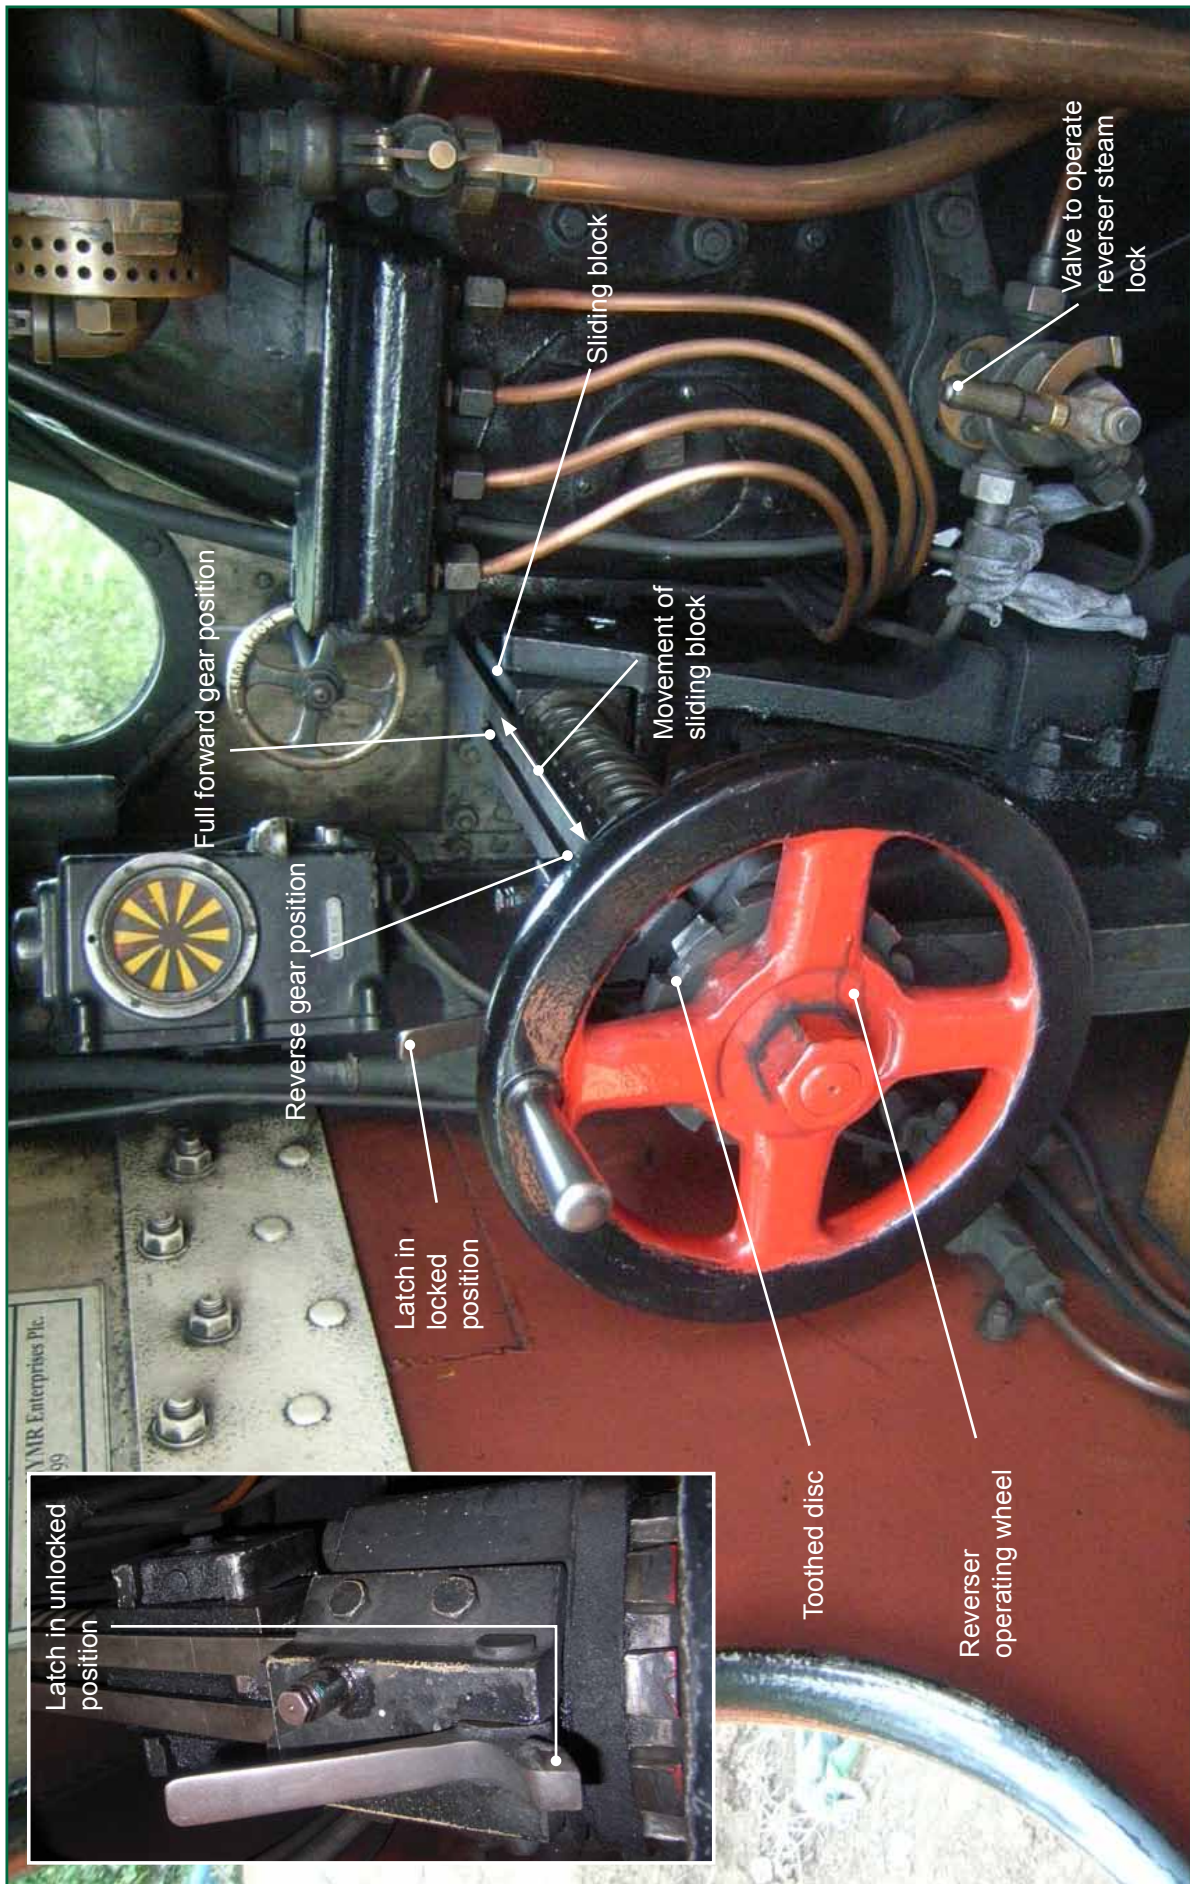
Figure 4: The screw reverser and its locking mechanism in the cab of S15 class locomotive no.825

- 11 In common with many other types of steam locomotive, the S15 locomotive is fitted with a *screw reverser* (figure 4) which the driver operates to alter the setting of the *valve gear*. The valve gear consists of a set of rods and links moved by the rotation of the locomotive's driving wheels, which in turn controls the admission and exhaust of steam to and from the locomotive's cylinders by opening and closing valves. Changing the setting of the valve gear can alter the direction of the locomotive from forwards to reverse (or vice versa) and alter the quantity of steam being admitted to the cylinders during each piston stroke. The S15 locomotive has two sets of valve gear; one on each side of the locomotive; the valve gear fitted to the right-hand side of the S15 is shown in figure 5.

- 13 Two locking devices are fitted to the S15 locomotive to prevent the reverser changing position when the locomotive is moving. These are a mechanical latch (figure 4), which is spring loaded with an over centre spring and, when operated, engages with a toothed disc fixed to the reverser shaft; and a steam operated lock. It is only necessary to use the mechanical latch during shunting movements, whereas during service running both locking devices should be used. Use of the mechanical latch alone in these circumstances would cause it to rattle resulting in wear and a noise distraction to the driver as a result of the higher forces when the locomotive is working at higher loads.

Figure 5: Valve gear fitted to S15 class locomotive no.825 with the locomotive in reverse gear

Background information

- 14 The personnel involved in carrying out the shunting move were all volunteer part-time staff. The locomotive was crewed by a driver and fireman who had brought the train from Pickering. The guard who undertook the shunting move had joined the train at Goathland (figure 1) and, following arrival at Grosmont, was due to work the 13:10 hrs train from Grosmont to Whitby.

- 70 Following the accident, the RAIB issued an urgent safety advice reminding operators of the need to lock screw reversers, and about safety while shunting (appendix B).

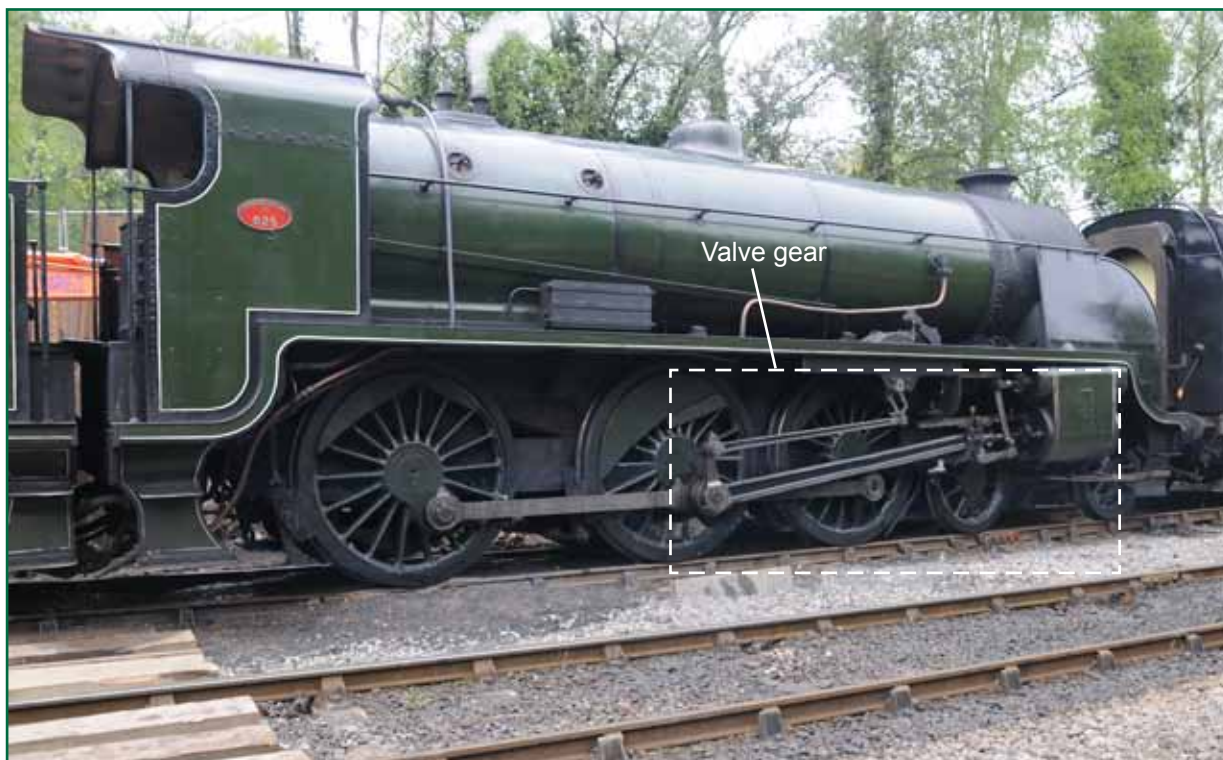
- 12 When the reverser is operated to alter the position of the valve gear from full forward gear towards mid-gear and then (if the locomotive is required to go backwards) into reverse (back) gear, its mechanism lifts one end of both radius rods, each of which is able to slide in its associated expansion link (figure 6). If the reverser is not restrained, the weight of the radius rods then acts to try and pull the valve gear to full forward gear, altering the position of the reverser. To prevent this movement, screw reversers are fitted with locking devices.
