Rail Accident Investigation Branch

# Rail Accident Report

**Fatal accident at Grosmont, North Yorkshire  
Moors Railway  
21 May 2012**

Report 23/2012  
October 2012

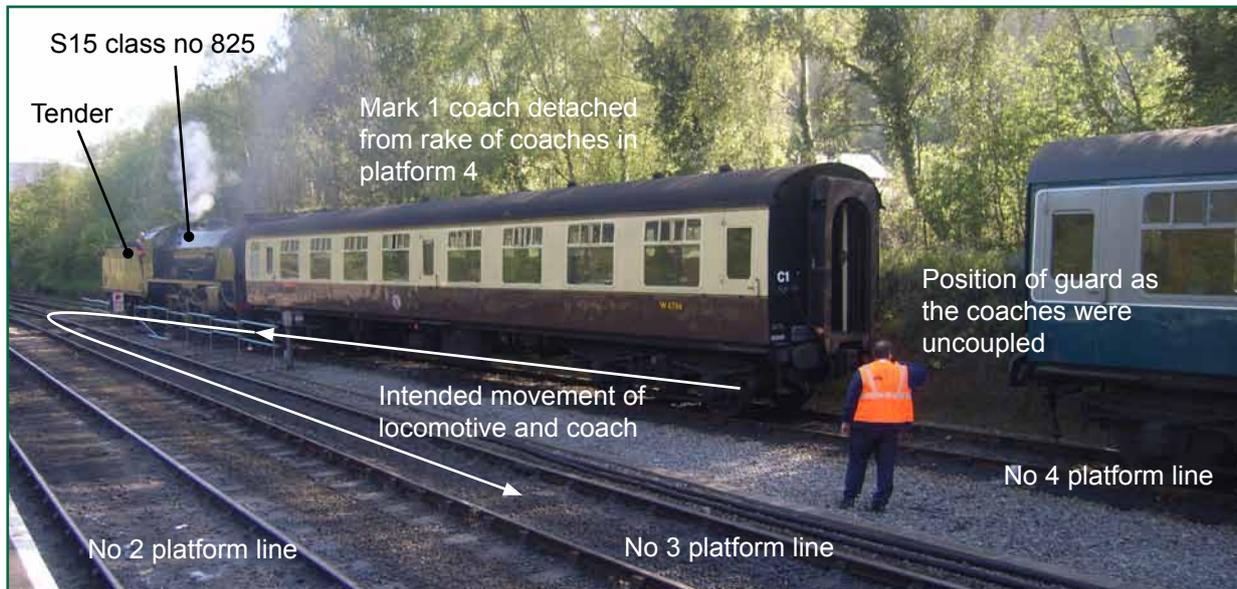
- 5 As one of the coaches was being drawn away by a steam locomotive, to be coupled to another rake of coaches, the locomotive changed direction and pushed the coach back towards where the uncoupling had just taken place. Meanwhile, the guard had gone between the coaches to complete the work arising from the uncoupling. The guard was trapped between the coaches and was fatally injured. Figure 2 shows the site of the accident.

Figure 2: The accident site at Grosmont station showing a reconstruction by the RAIB of the accident circumstances

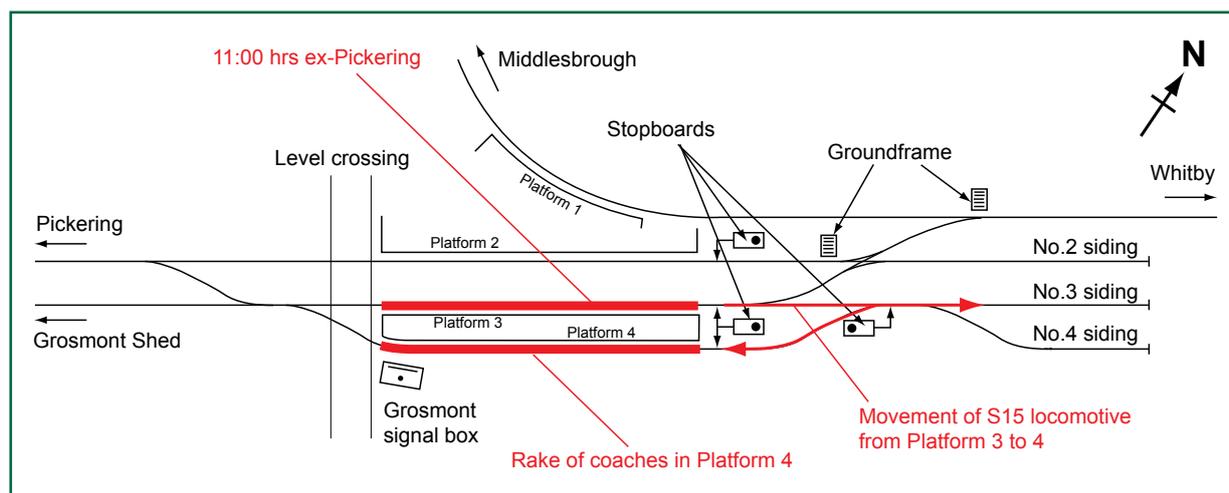
- 7 The station track layout at Grosmont (figure 3) consists of one platform to serve the Esk Valley line and three platforms to serve the NYMR. At the north end there are three NYMR sidings and a connection between the NYMR and the national network. Immediately south of the station there is a level crossing, followed by a short tunnel, and then the locomotive shed. Through the station, the gradient falls away at 1 in 126 towards Whitby.

Figure 3: The track layout at Grosmont station

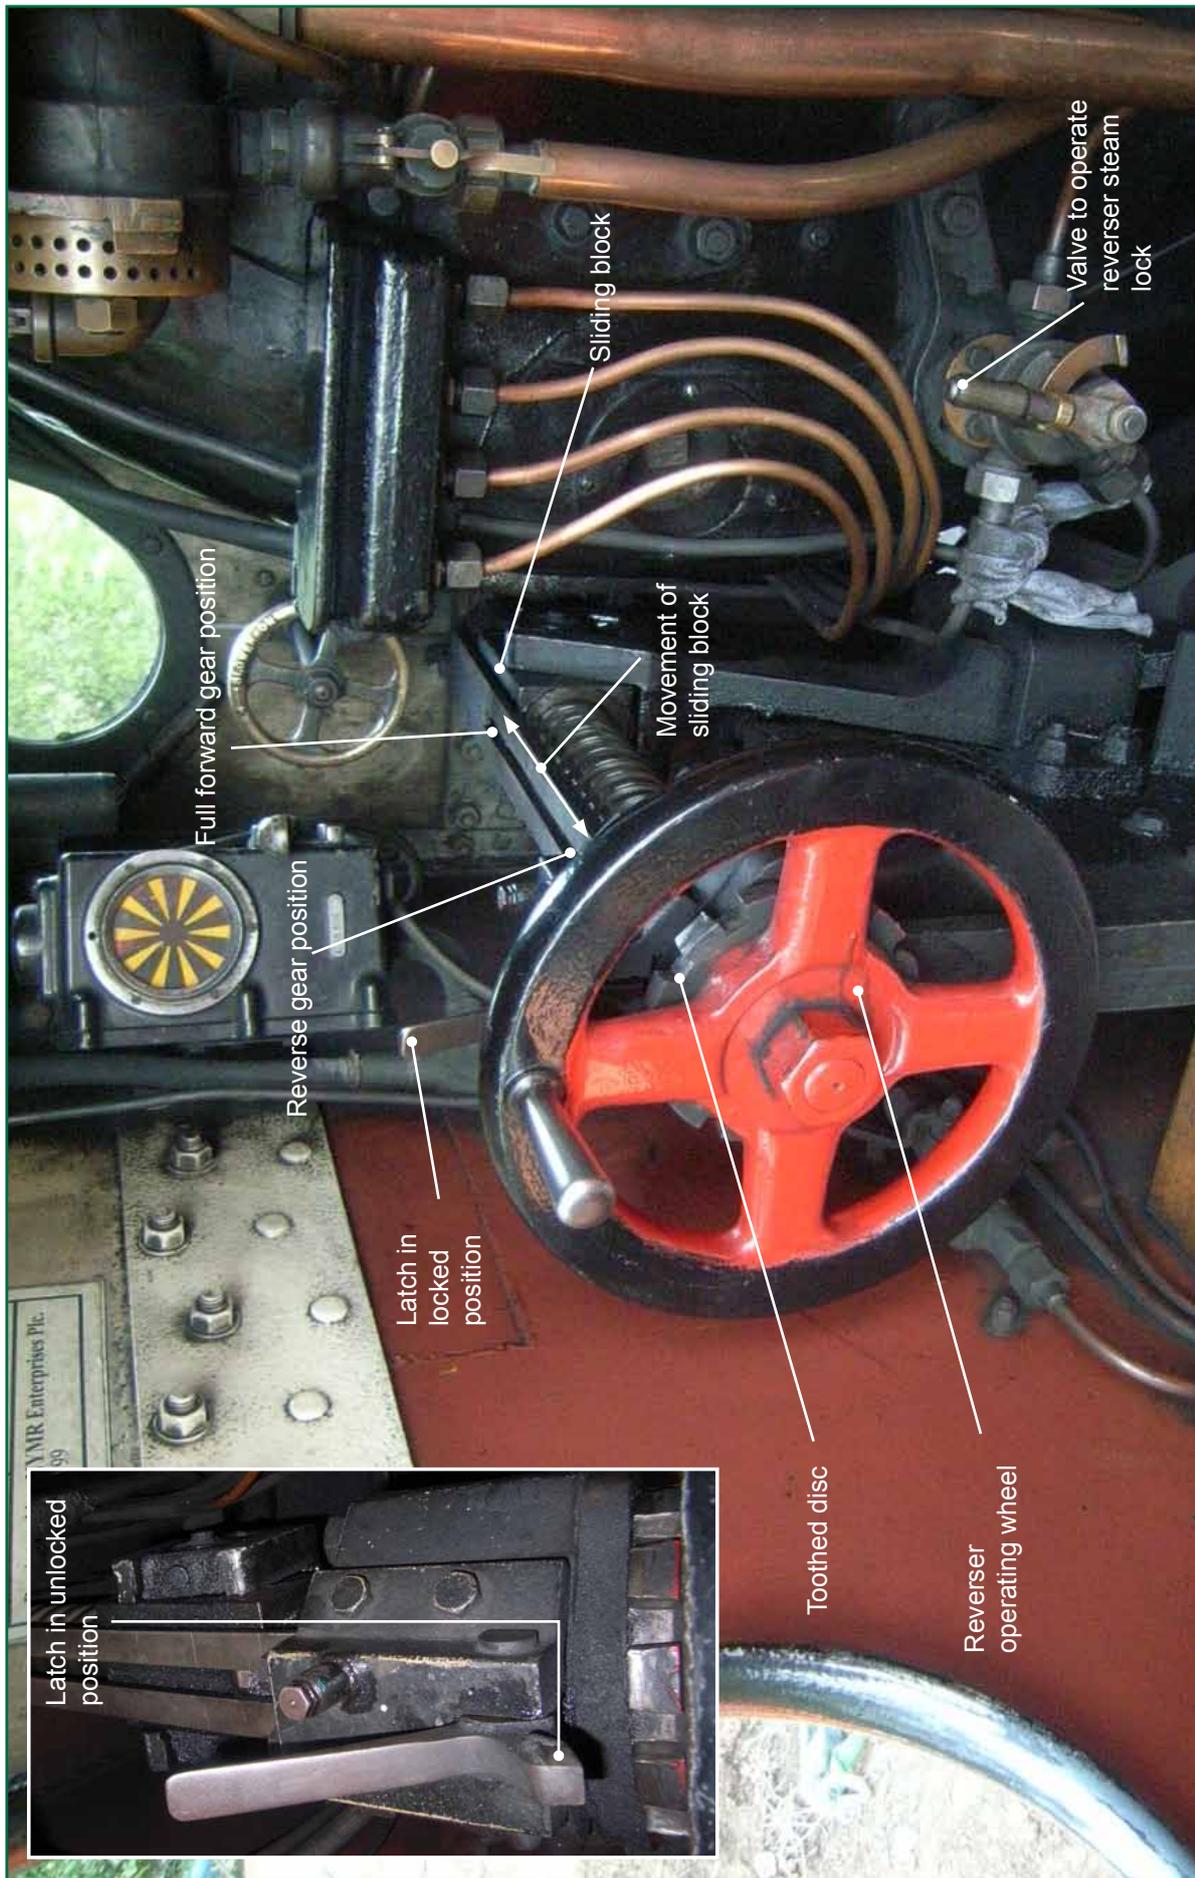
- 11 In common with many other types of steam locomotive, the S15 locomotive is fitted with a *screw reverser* (figure 4) which the driver operates to alter the setting of the *valve gear*. The valve gear consists of a set of rods and links moved by the rotation of the locomotive's driving wheels, which in turn controls the admission and exhaust of steam to and from the locomotive's cylinders by opening and closing valves. Changing the setting of the valve gear can alter the direction of the locomotive from forwards to reverse (or vice versa) and alter the quantity of steam being admitted to the cylinders during each piston stroke. The S15 locomotive has two sets of valve gear; one on each side of the locomotive; the valve gear fitted to the right-hand side of the S15 is shown in figure 5.

- 13 Two locking devices are fitted to the S15 locomotive to prevent the reverser changing position when the locomotive is moving. These are a mechanical latch (figure 4), which is spring loaded with an over centre spring and, when operated, engages with a toothed disc fixed to the reverser shaft; and a steam operated lock. It is only necessary to use the mechanical latch during shunting movements, whereas during service running both locking devices should be used. Use of the mechanical latch alone in these circumstances would cause it to rattle resulting in wear and a noise distraction to the driver as a result of the higher forces when the locomotive is working at higher loads.

Figure 4: The screw reverser and its locking mechanism in the cab of S15 class locomotive no.825

Figure 5: Valve gear fitted to S15 class locomotive no.825 with the locomotive in reverse gear

### Background information

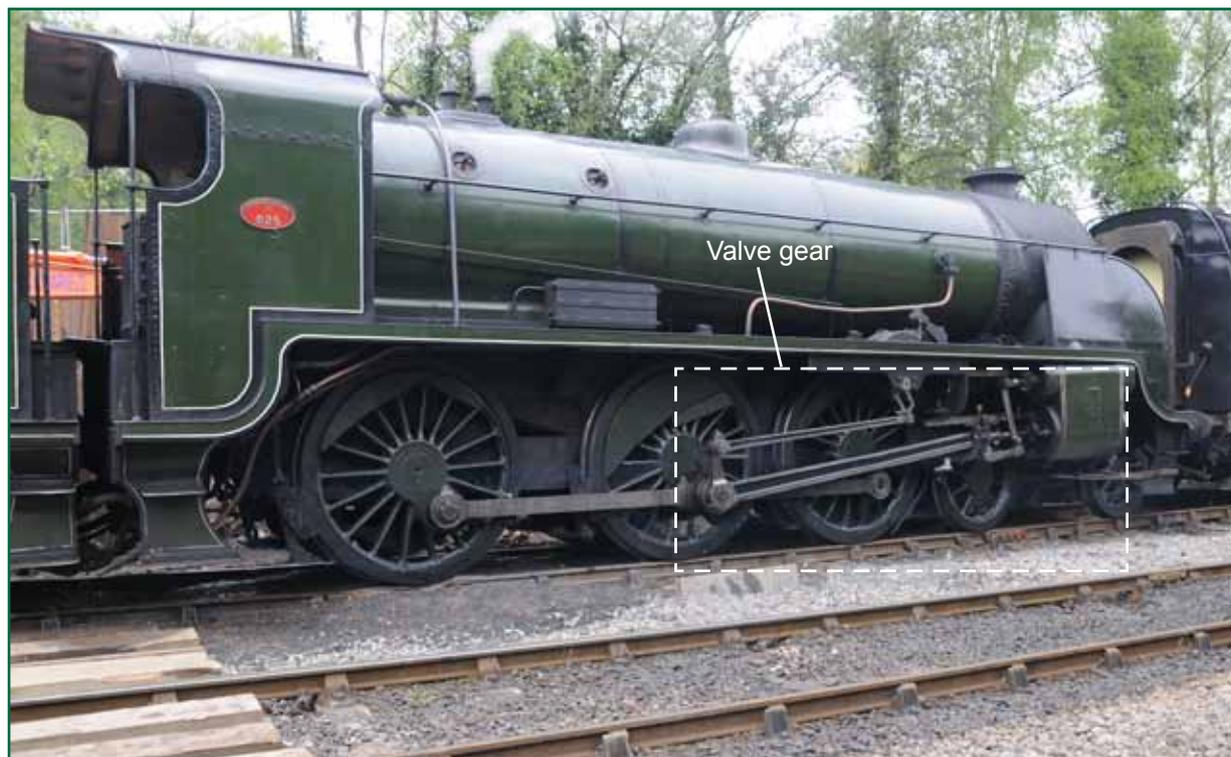
- 12 When the reverser is operated to alter the position of the valve gear from full forward gear towards mid-gear and then (if the locomotive is required to go backwards) into reverse (back) gear, its mechanism lifts one end of both radius rods, each of which is able to slide in its associated expansion link (figure 6). If the reverser is not restrained, the weight of the radius rods then acts to try and pull the valve gear to full forward gear, altering the position of the reverser. To prevent this movement, screw reversers are fitted with locking devices.

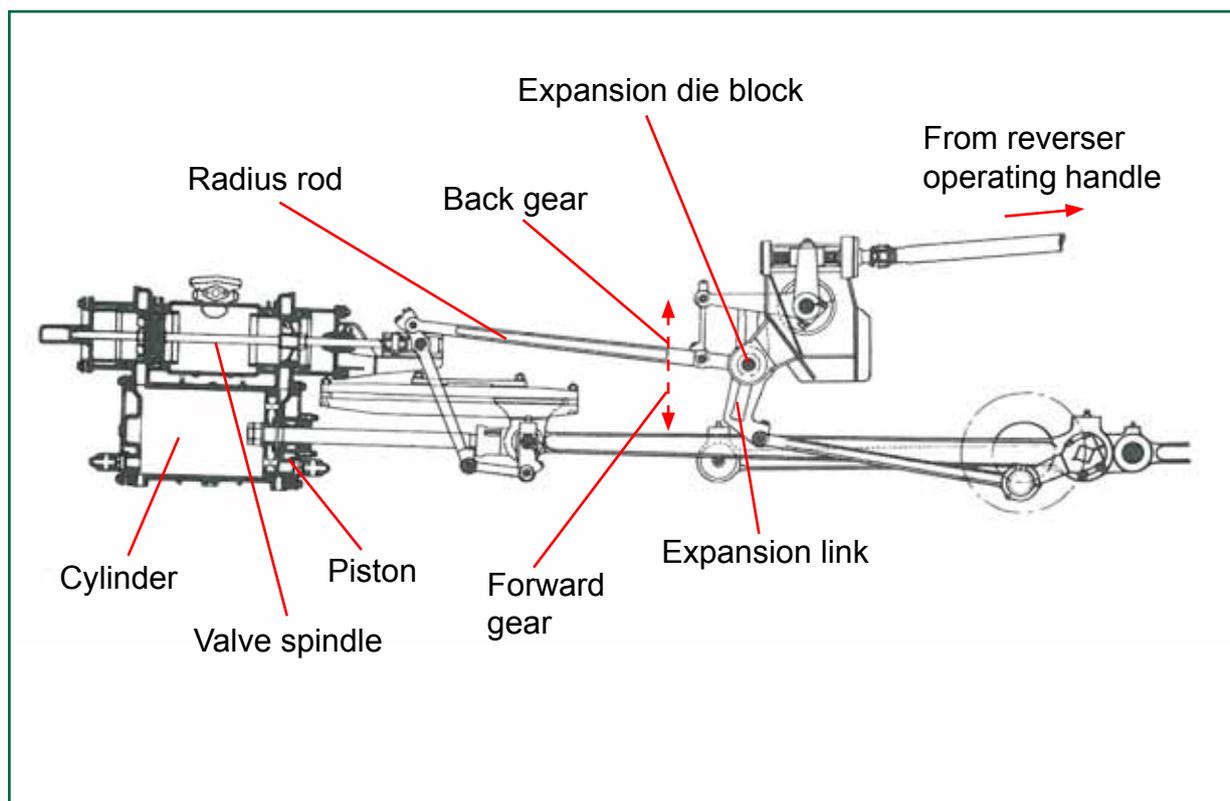
Figure 6: Diagram of typical valve gear (as fitted to S15 class locomotive no.825) shown in the mid-gear position
