Rail Accident Investigation Branch

# Rail Accident Report

**Signal passed at danger at Stafford**  
**26 April 2012**

Report 16/2013  
September 2013

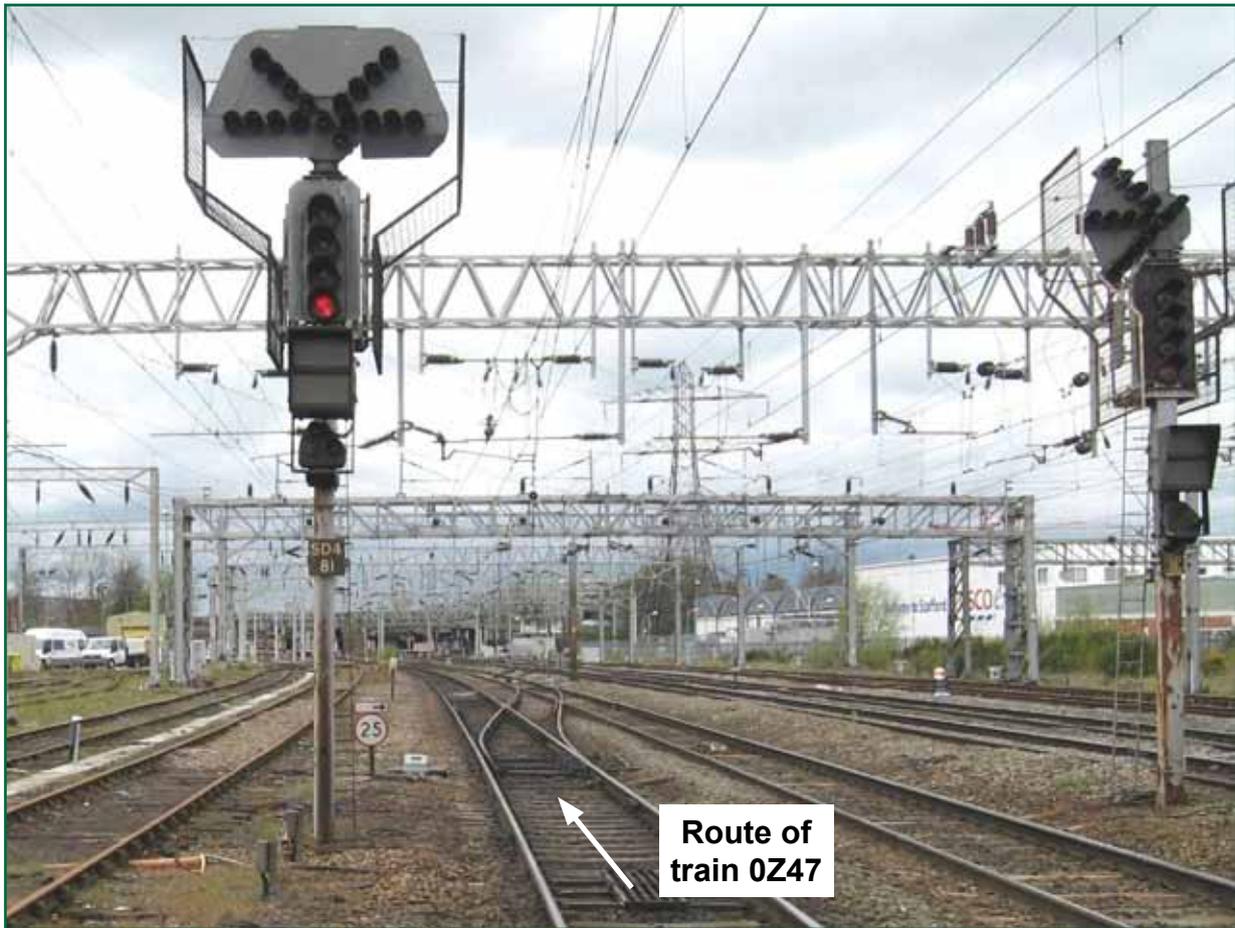
Figure 2: Signal SD4-81

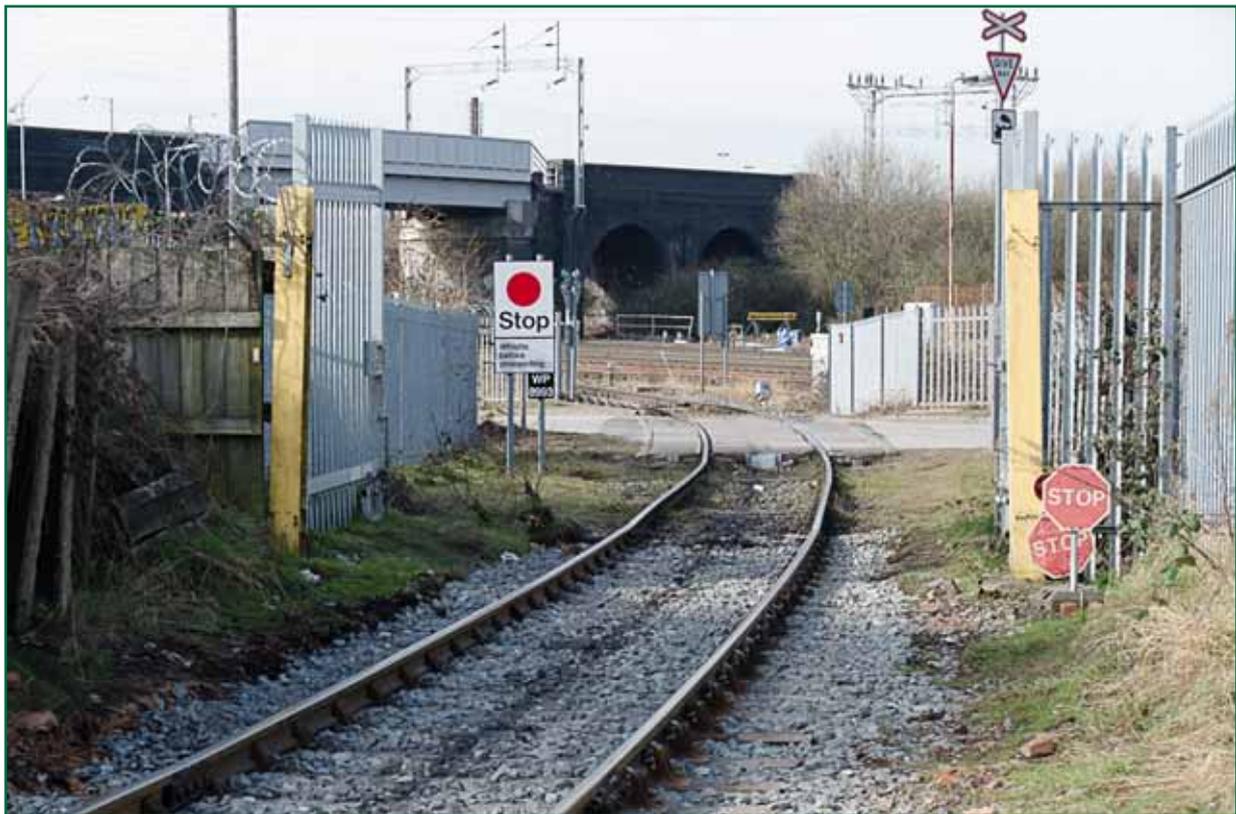
Figure 5: Approximate location where the DSD was isolated, prior to entering Network Rail infrastructure

26 Although the depot manager had repaired the DSD, it failed again and was isolated by the technician on board the locomotive, in the vicinity of the gates just before the locomotive crossed the boundary between Washwood Heath depot and Network Rail's main line infrastructure, figure 5. Module TW5 of the *Rule Book* does not permit a train to enter service if the DSD is defective. The locomotive's *national radio network* (NRN) radio also failed at Duddleston Junction, after the driver and technician changed ends to reverse the locomotive immediately following departure from the depot. The driver did not stop and report the failure of either of these safety systems to the signaller as required by Module TW5 of the *Rule Book*.

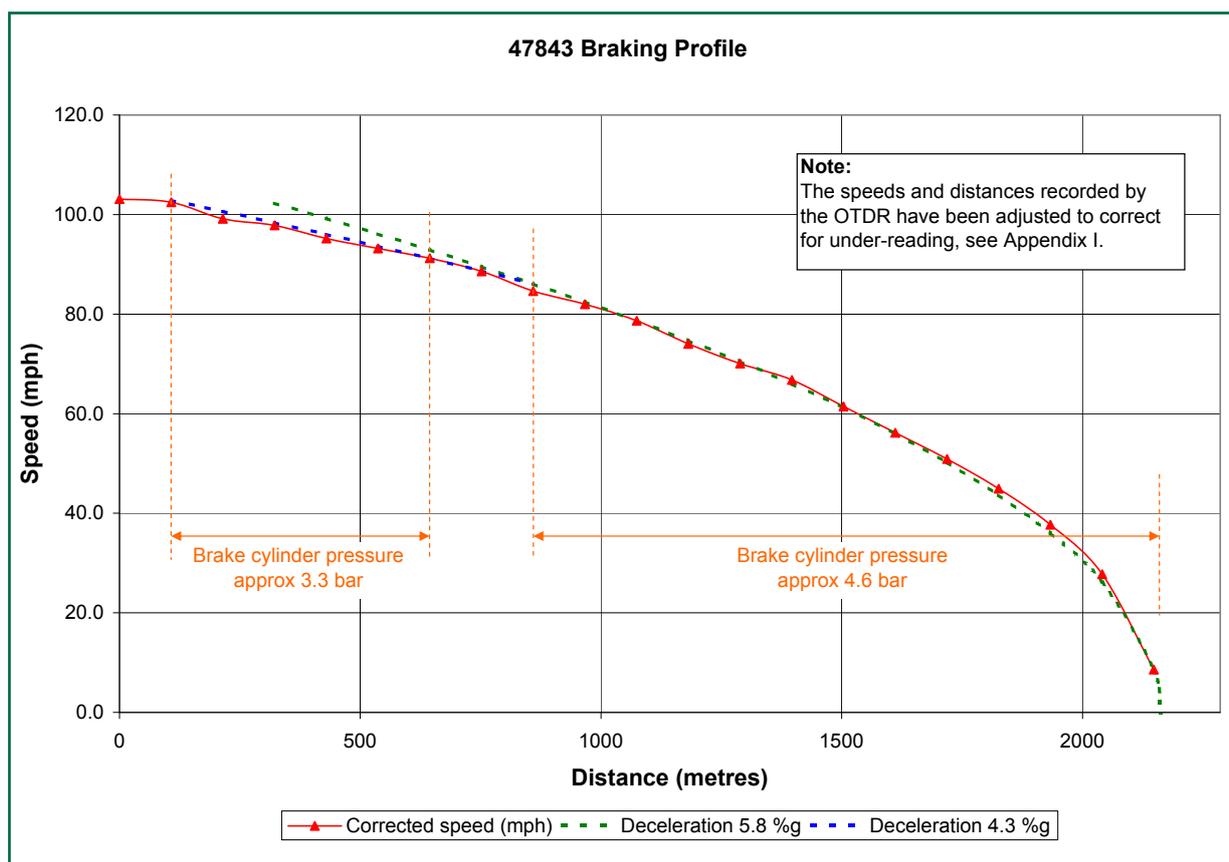
Figure 7: 47843 braking profile

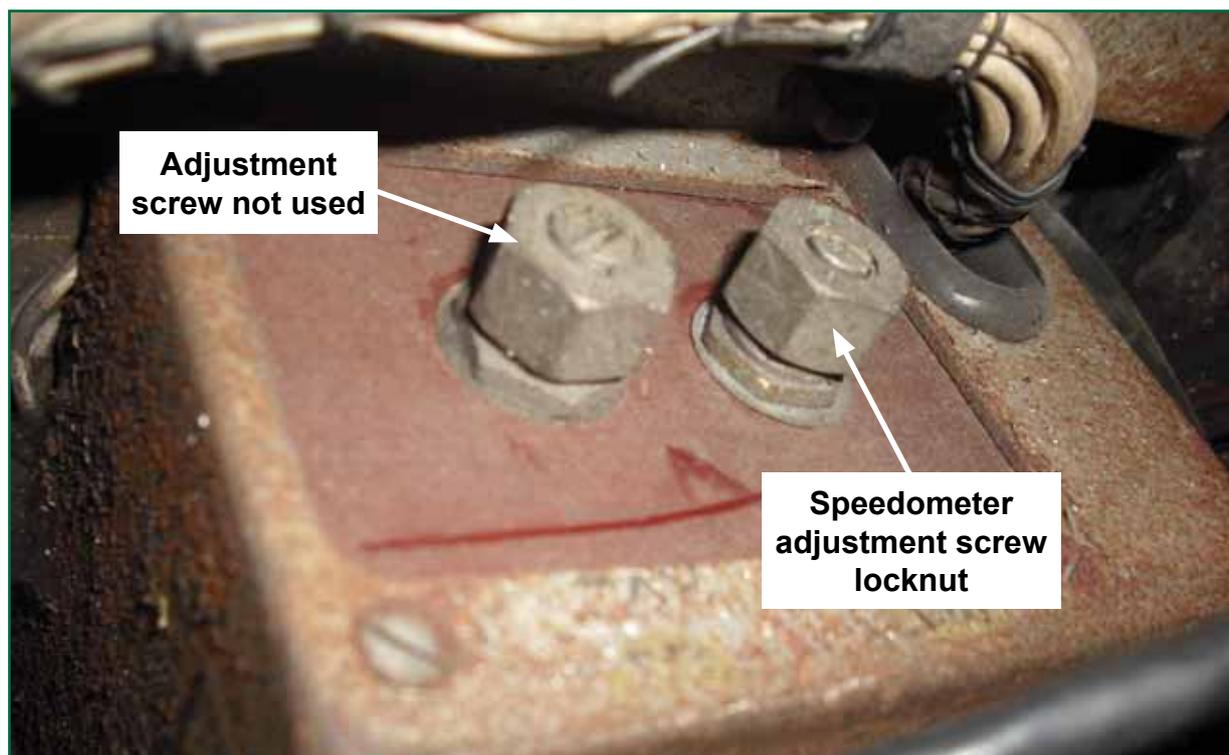
- 59 RTL subsequently tested the speedometer at Crewe on 14 May 2012 and found that it was under-reading by 13%. It had previously been calibrated on 17 September 2009, as part of the locomotive's last scheduled B exam (see appendix B), at which time no adjustment had been necessary<sup>13</sup>. Since that date, the locomotive had spent the majority of its time carrying out shunting and train heating<sup>14</sup> duties at Crewe: records provided by RTL indicate that, until its hire by DCR on 24 March 2012, its main line duties had consisted of two return trips from Crewe to Warrington and one from Crewe to Derby.

- 60 Representatives of RTL and DCR reported that when they examined the locomotive at Crewe, they found that the locknut on one of the adjustment screws on the speedometer equipment box was loose and that the screw itself showed signs of recent adjustment (figure 8). This screw provides a coarse adjustment of the speed displayed by the speedometer; its condition apparently explains the discrepancy of 13% in the speed displayed, although it would not have caused the alleged sticking of the speedometer (paragraph 27). The RAIB has been unable to establish why or when the locknut on the adjustment screw had been undone.

Figure 8: Close up of the coarse adjustment screw for the speedometer on 47843 (courtesy RTL)

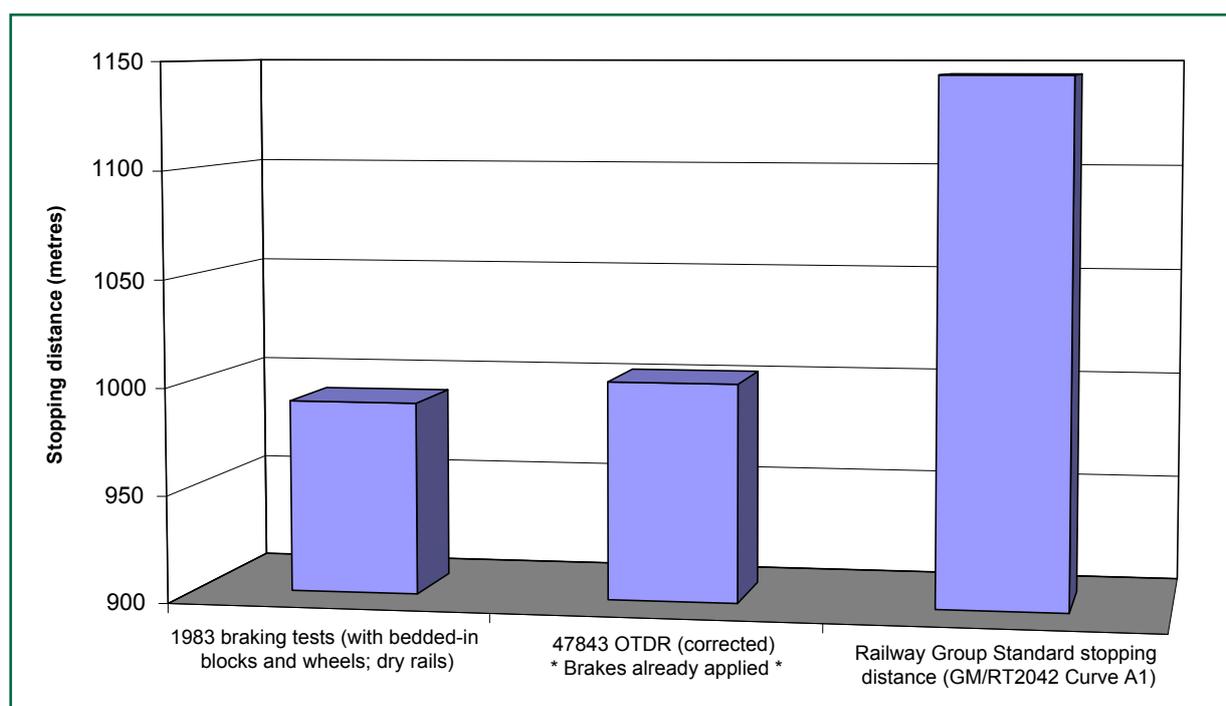
- Cast iron brake blocks exhibit different coefficients of friction depending on the starting speed of a brake application: the higher the initial speed, the lower the coefficient of friction throughout that particular brake application. This means that the stopping distance of the locomotive, if it had started braking at 75 mph (121 km/h), would have been less than the distance required to stop from 75 mph while braking from 103 mph (166 km/h).

Figure 9: Comparison of stopping distances from 75 mph (121 km/h)

68 The RAIB has concluded that the braking performance of the locomotive was broadly as effective as that of the class 47 locomotive tested by British Rail in 1983, and that it would have complied with the relevant standard (curve A1 in GM/RT2042). It was therefore not causal to signal SD4-81 being passed at danger on 26 April 2012. The condition of the brake blocks is discussed at appendix H.

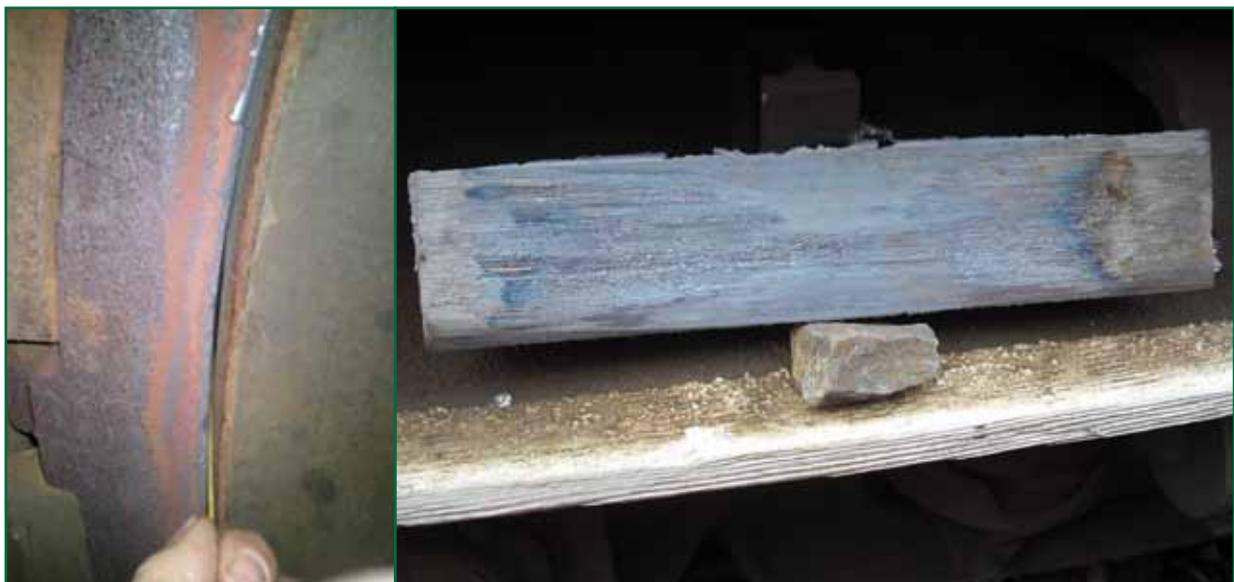
- H1 In the immediate aftermath of the incident of the SPAD incident at Stafford on 26 April 2012, arrangements were made for an independent engineer from URS to examine the brakes on the locomotive. The URS report concluded that second hand brake blocks had been fitted to the locomotive, with the result that only 57% of the friction surface was in contact with the wheels (paragraph 66). The principal evidence cited in support of this hypothesis was that the internal diameter of the blocks' friction surfaces appeared to be smaller than the external diameter of the wheels. Figure H1a shows the gap between the centre of one of the brake blocks and the wheel tread, which was observed before locomotive 47843 was moved from Stafford. Figure H1b is typical of photographs taken by RTL at Crewe on 14 May 2012, and shows a brake block after removal from the locomotive; the centre of the block is 'blued' (defined at Appendix B) due to overheating. This is the part of the block that was not in contact with the wheel in Figure H1a. The URS hypothesis does not account for the recent bluing, scoring and burring which is evident in the centre part of the brake block.

- H2 Advice given to the RAIB by Interfleet Technology, Railway Brake Services and a train operator with relevant experience suggests that the condition of the blocks is probably attributable to a sustained high-speed application of the locomotive's brakes; this is consistent with the opinion of the locomotive's owners, RTL. A possible mechanism for the damage to the inside face (the friction surface) of the brake block is that, during such a brake application, the friction surface experiences an extreme temperature, whereas the mounting point on the outside of the block acts as a heat sink. The temperature gradient through the brake block causes the inside face to expand more than the outside, and therefore tends to flatten its curved shape; on cooling, the block contracts again. The energy needed to stop a vehicle from 103 mph (166 km/h) is 189% of that needed to stop it from 75 mph (121 km/h); this energy must be dissipated by the brakes. The light wear at the ends of the block is likely to have been caused by the subsequent use of the locomotive's brakes when it was moved from Stafford to Crewe after the incident.

Figure H1a and H1b: Brake blocks from locomotive 47843, when examined after the incident (courtesy URS and RTL)
