Rail Accident Investigation Branch

Rail Accident Report

**Dangerous occurrence involving an engineering train at Blatchbridge Junction, near Frome,
19 March 2012**

Report 15/2013
September 2013

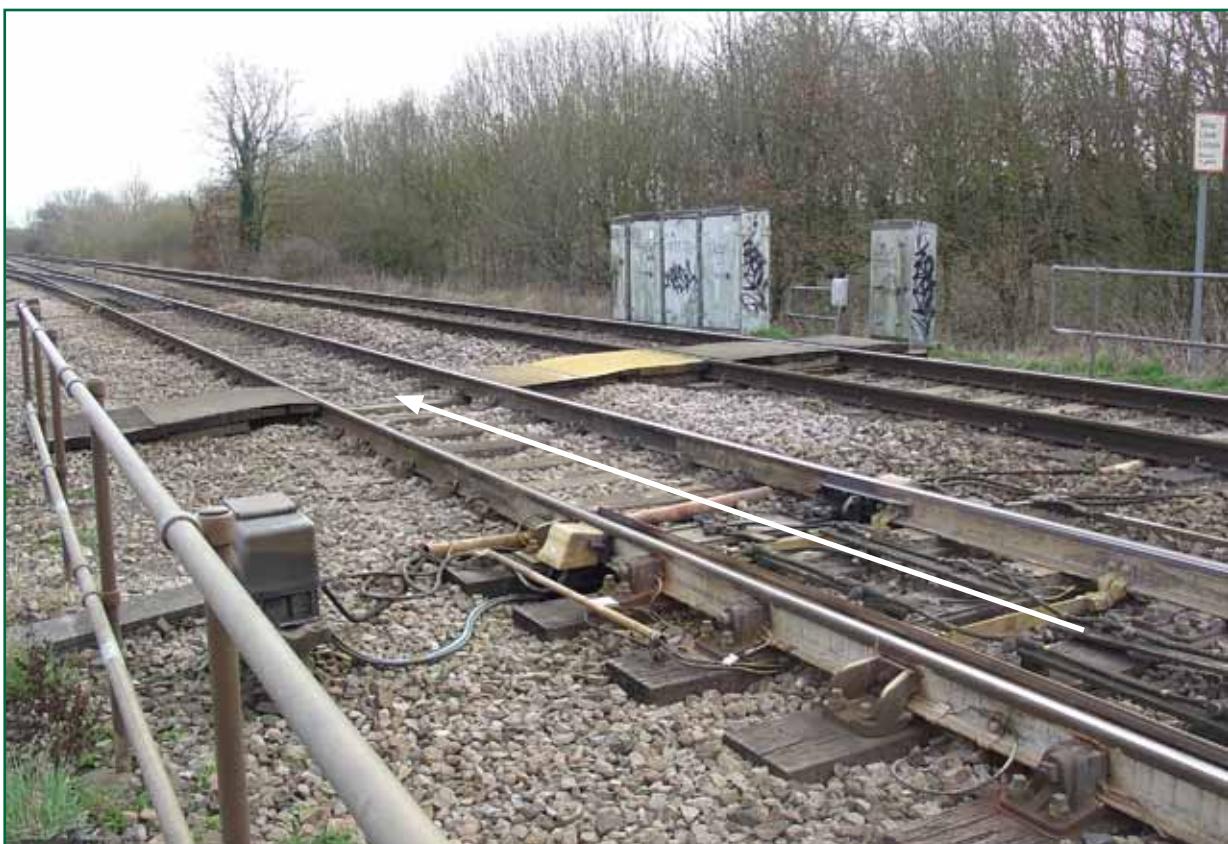
- 31 Approaching Blatchbridge Junction, the P3 control cab became detached from the supporting structure and fell onto the track beneath the train. The control cab continued to slide along the surface of the rails partially restrained by electrical cables and the brake hose. Timbers forming part of the foot crossing at Blatchbridge Junction were damaged as the detached control cab passed over it (figure 6).

Figure 6: Blatchbridge Junction and the partially destroyed foot crossing (path of train 6Y33 indicated by white arrow)

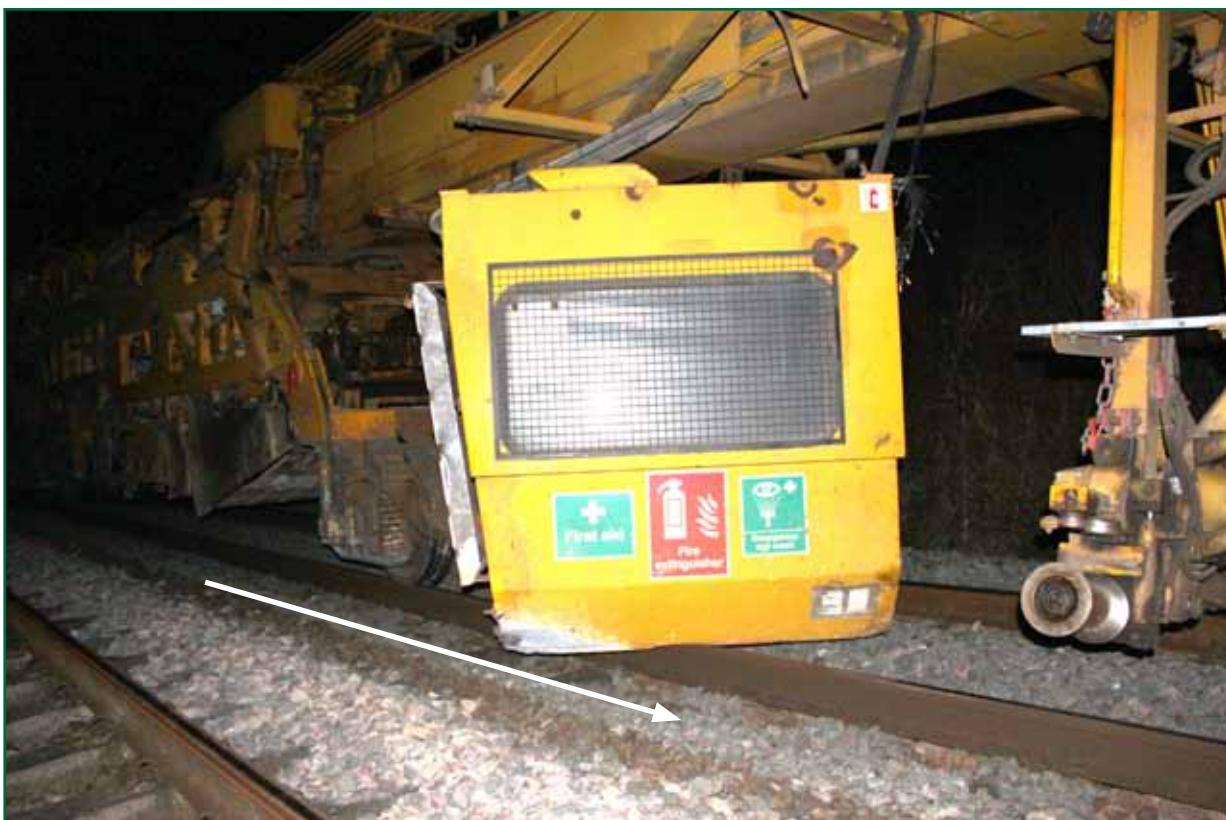
Figure 7: The detached control cab (path of train 6Y33 indicated by white arrow)

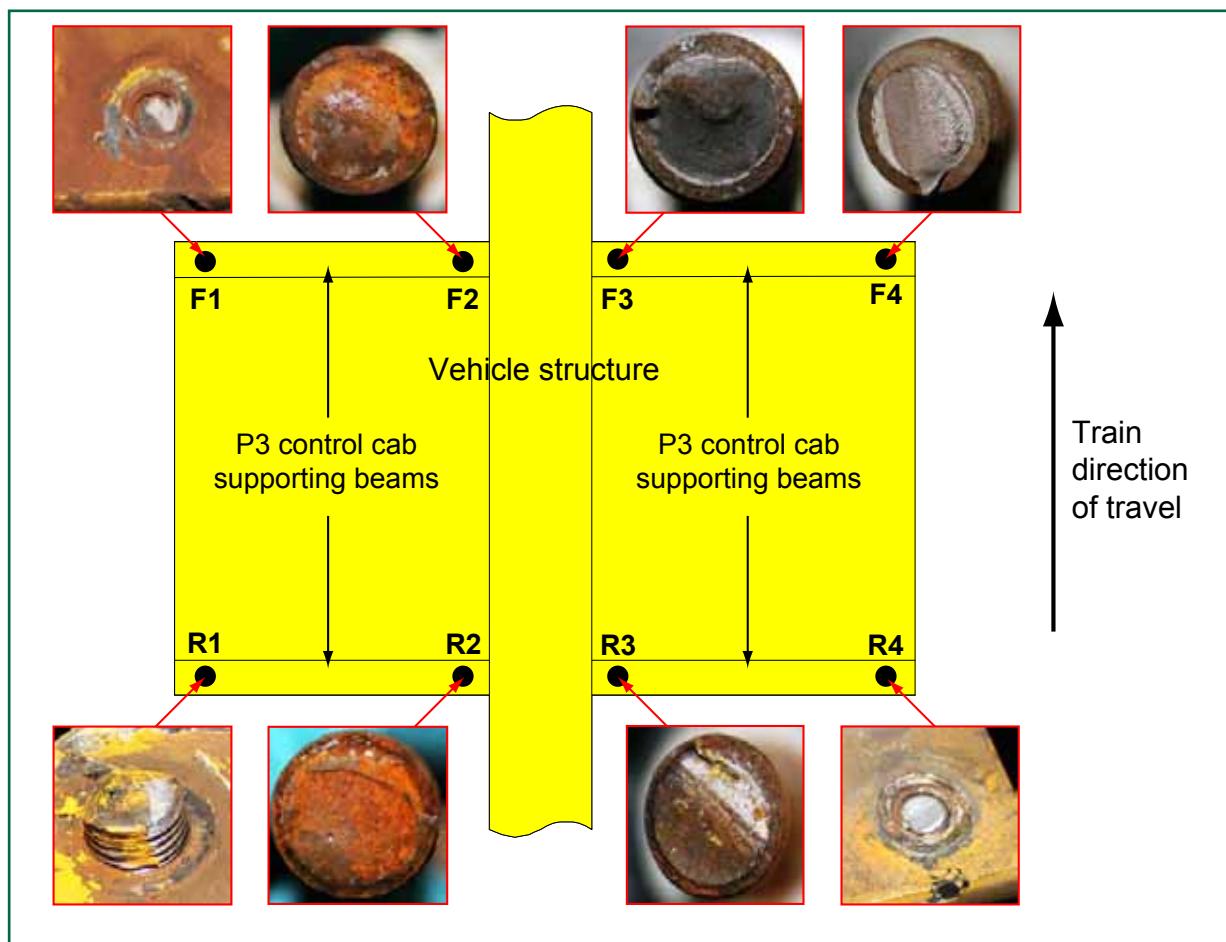
- 40 The RAIB examined the detached control cab at the site of the incident before it was moved clear of the track. All eight bolts had failed at the interface between the bottom of the flexible rubber mount and the top of the cab roof. Figure 9 and table 1 show the condition and type of failure exhibited by each of the eight bolts within the cab's flexible mountings.

Figure 9: Bolt condition and location

Bolt	Failure mode of bolt (based on metallurgical analysis)
F1	Rapid rate fatigue failure leading to final failure by overload.
F2	Slow rate fatigue failure.
F3	Some evidence of fatigue cracking with the final failure by overload.
F4	Rapid-rate fatigue failure.
R1	The fractured face of this bolt was damaged during the incident. There is evidence of overload failure on part of the undamaged surface of the fracture. The top half of bolt R1 was not found after the incident.
R2	Slow-rate fatigue failure.
R3	Slow-rate fatigue failure.
R4	Overload failure.

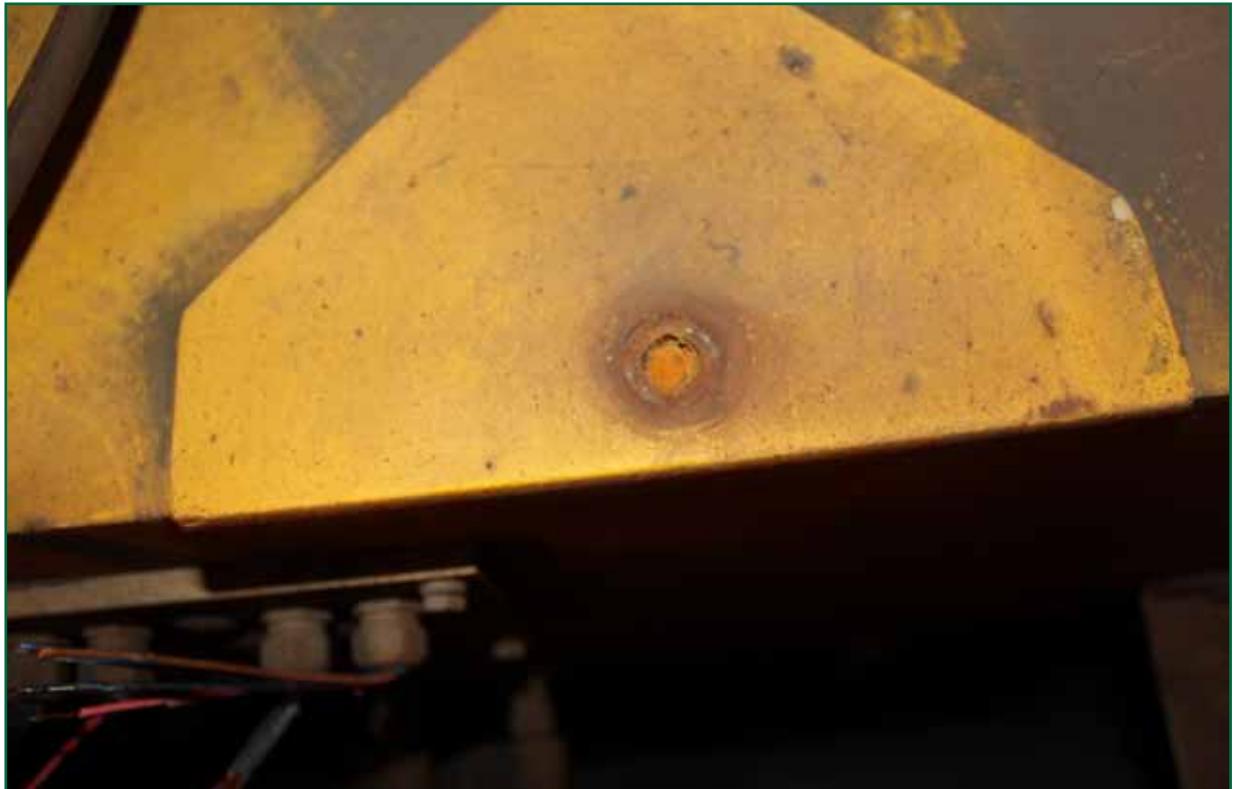
- 41 The fracture faces of bolts F2 and R2 had rusted over, indicating that these two bolts were probably the first to fail and had done so some time before the incident (figure 10). Bolts F3, F4 and R4 exhibited overload failure and are most likely to have failed shortly before the control cab detached (figure 11). The remaining three bolts, F1, R1 and R3 exhibited evidence of pre-existing fatigue failure with final failure caused by overload as the cross-sectional area of the bolt diminished (figure 12).

Figure 10: Lower section of bolt F2 (inserted into cab roof) showing rusted-over fracture face

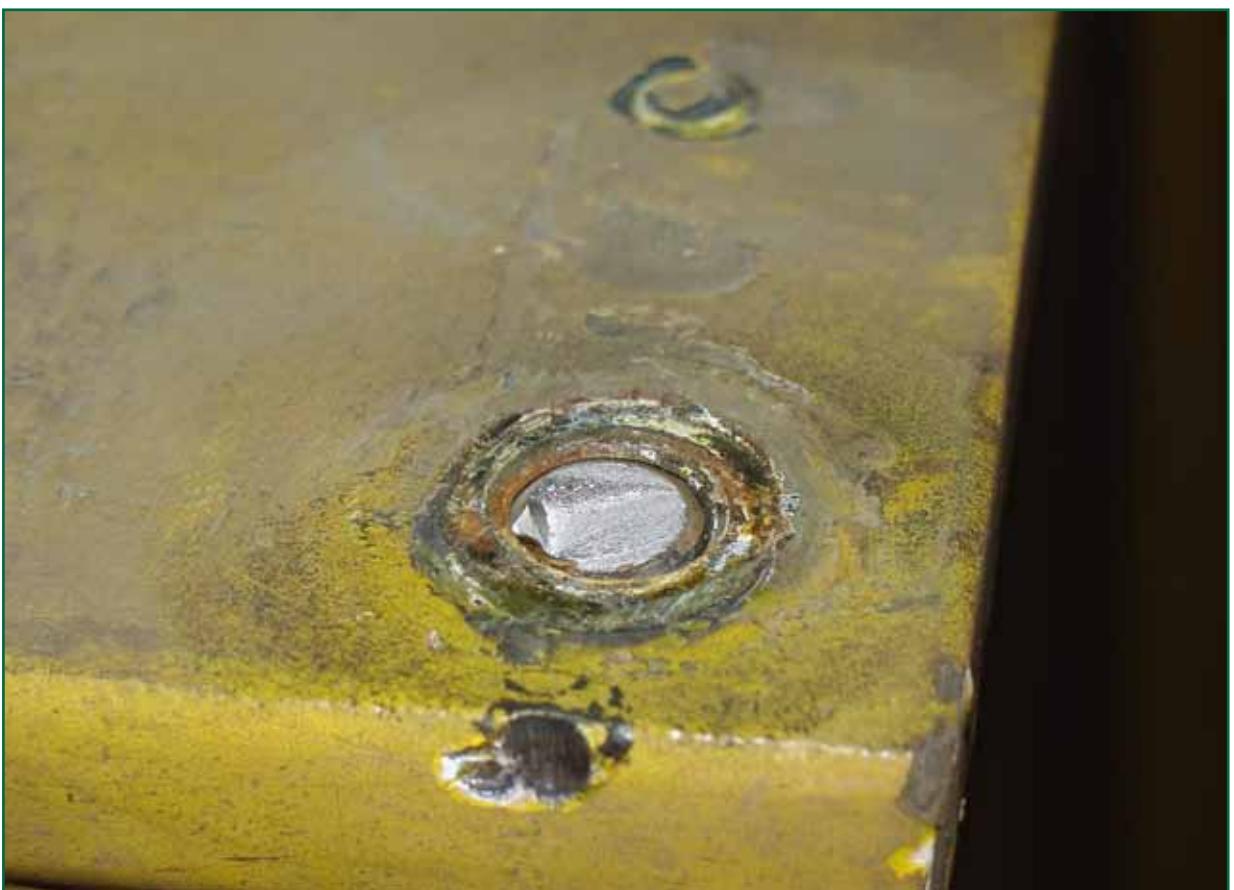
Figure 11: Lower section of bolt R4 (inserted into cab roof) showing clean-break indicating overload failure of the bolt

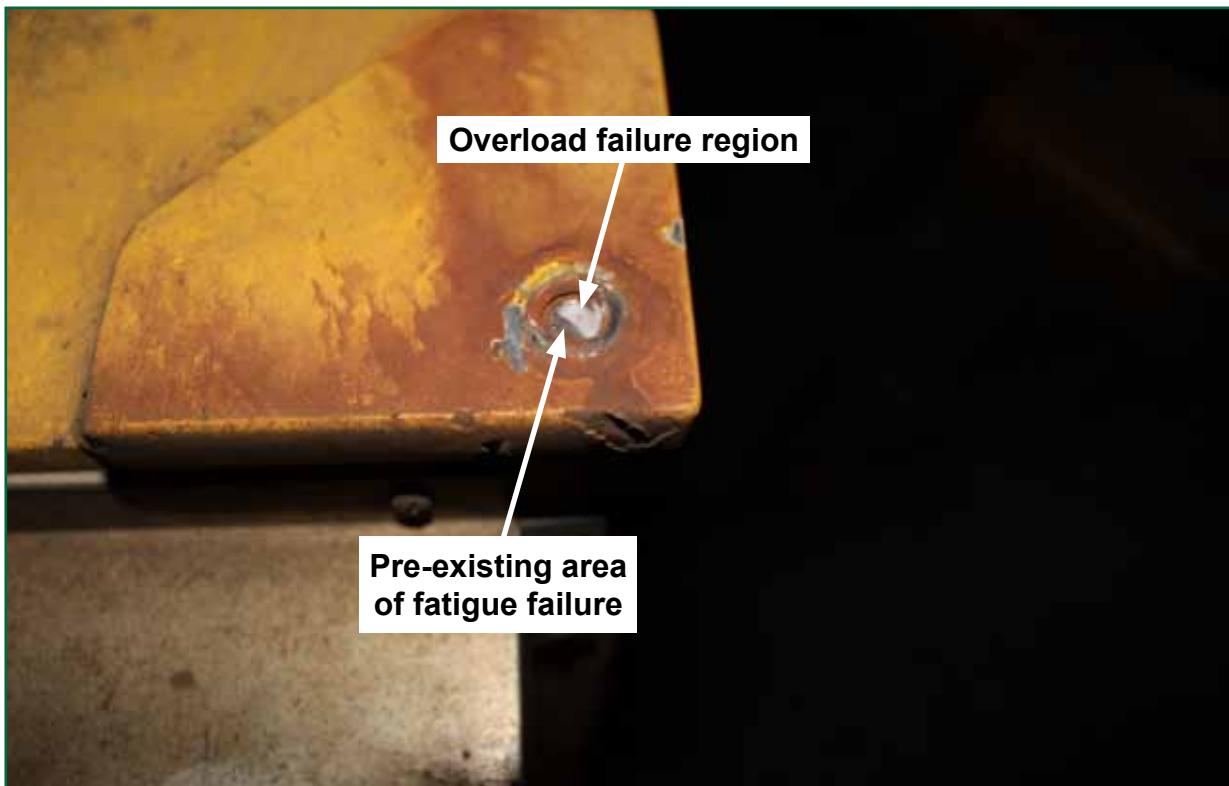
Figure 12: Lower section of bolt F1 (inserted into cab roof) showing evidence of pre-existing fatigue and final overload fracture

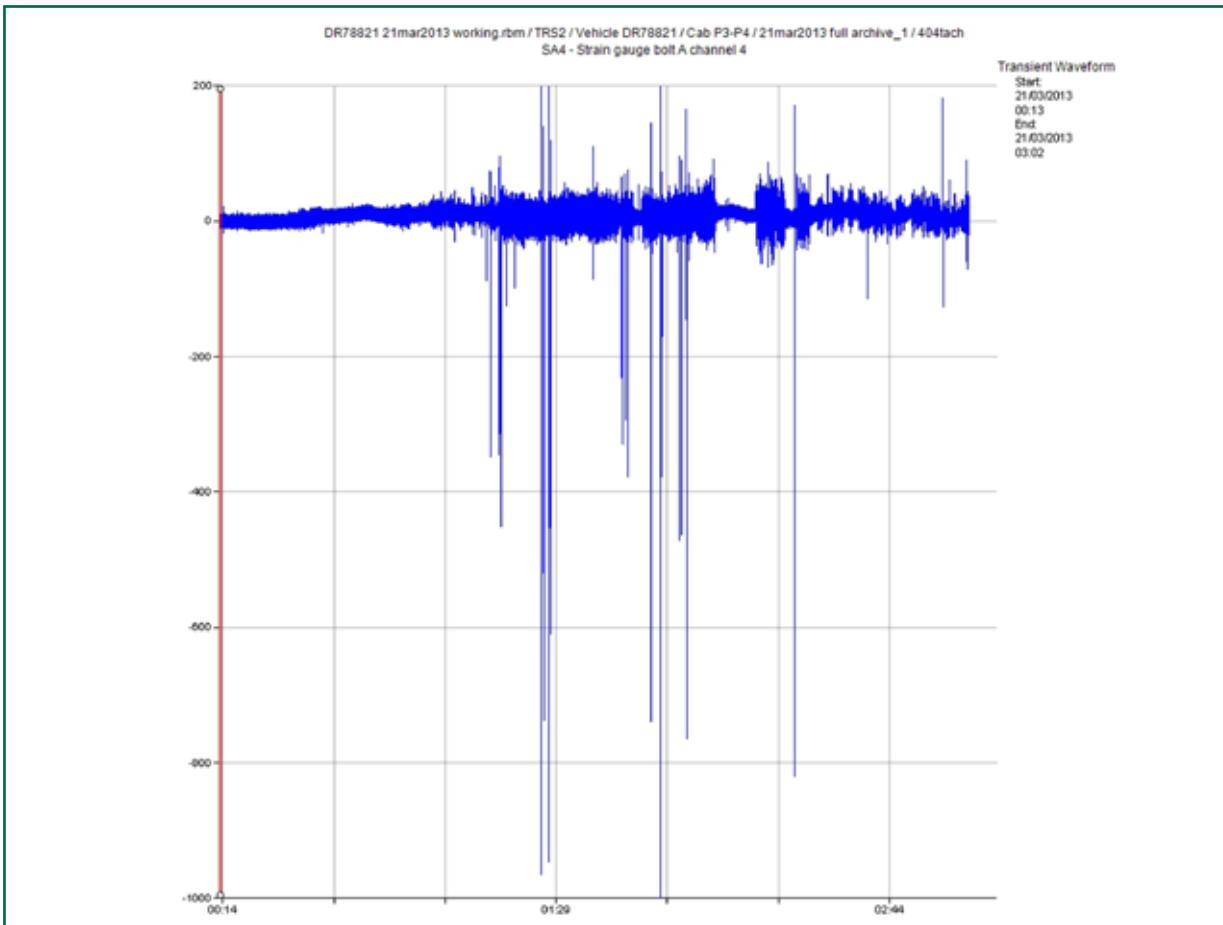
Figure 13: Strain signal plot for bolt at position F4

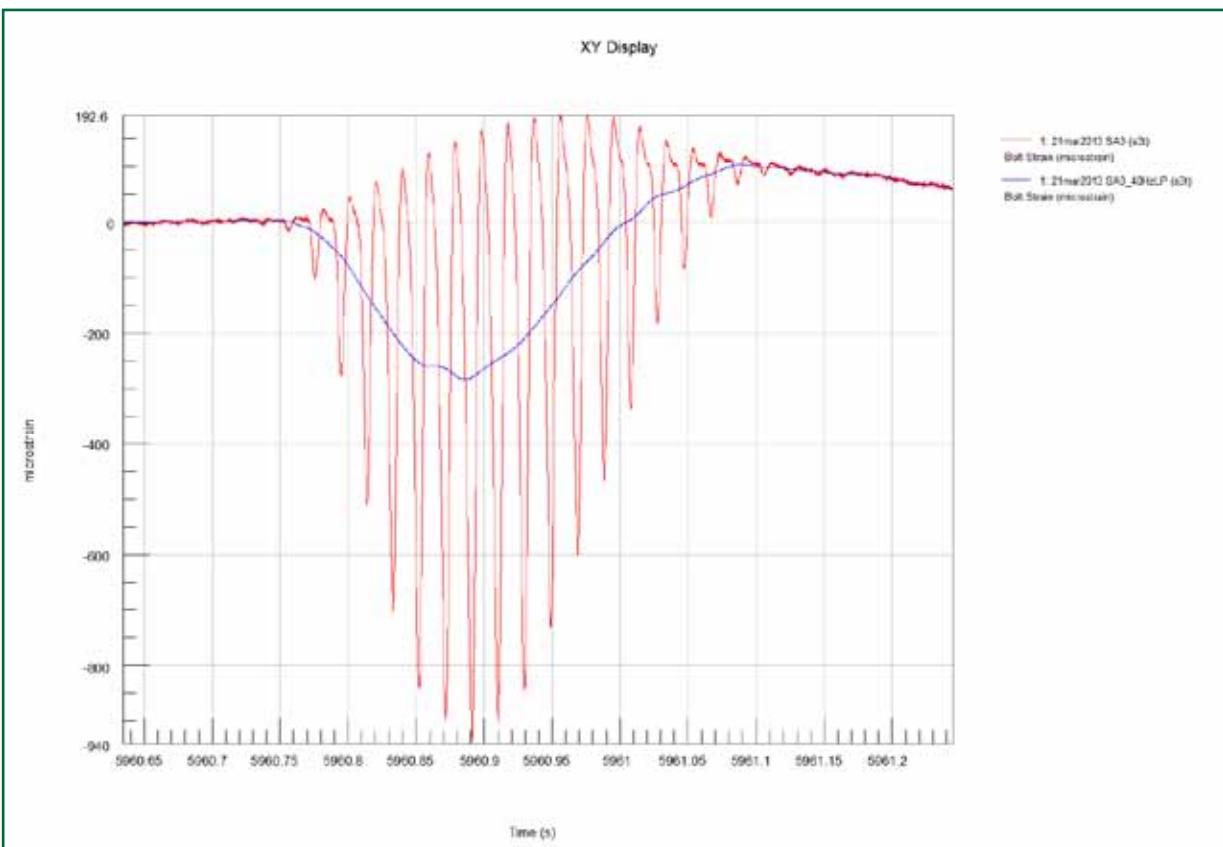
Figure 14: High strain event (blue line) and oscillating 50 Hz stress (red lines)

- 53 The frequency of the alternating current power supply to the strain gauges was 60 Hz, so it could not have been the cause of the observed 50 Hz oscillation. To understand if some other *electromagnetic interference* was being recorded, rather than genuine strains, a ‘dummy’ strain gauge was fitted to the cab. This dummy strain gauge was fitted to a metal block located close to the strain gauged bolts but structurally disconnected from the mounting structure. This meant that the dummy strain gauge would only detect any false strains caused by electromagnetic interference. Data collected during the second working shift was analysed and this showed that the dummy strain gauge had not recorded any activity when compared to the eight strain gauges mounted on the bolts. This indicated that the data collected during both working shifts had not been corrupted by electromagnetic interference, and were real. The cause of the high strain events has not been determined (see paragraphs 56 to 59).

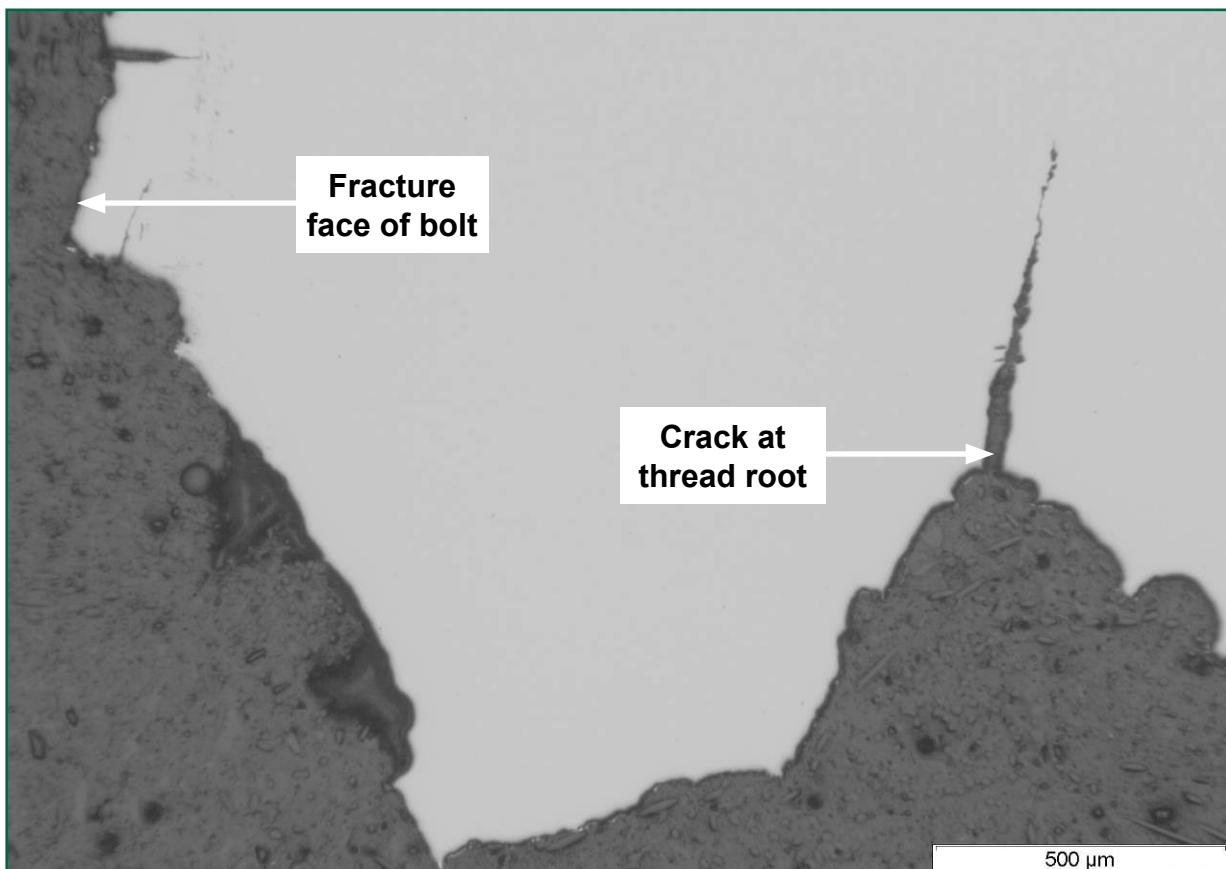
- 61 The metallurgical analysis (paragraphs 43 and 44) of the failed bolts from the P3 control cab and the used bolts from the smaller P2 cab on the P95/1 UK and the used bolts from the P3 cab of the P95/2 UK found that they were all severely corroded. When this corrosion was cleaned off the failed P3 cab bolts, there was evidence of cracking at the end of the threaded region (figures 16 and 17). The metallurgical analysis did not identify any irregularities at the thread roots, such as defects during the manufacture of the bolts, and so the most likely starting point of the fatigue failure was from a point at the bolt thread root affected by corrosion. Bolts F2, R3 and R2 appeared to have failed by fatigue from the *thread root* at a relatively slow rate. Bolt F4 showed signs of fatigue failure from the root, but this had occurred relatively rapidly in a small number of cycles. Although the majority of bolt F3 had failed by rapid overload, there were signs of fatigue cracks in the root of the bolt thread.

Figure 16: Cross sectional evidence of fatigue cracking and corrosion of the teeth of bolt F2 (picture courtesy of SERCO)

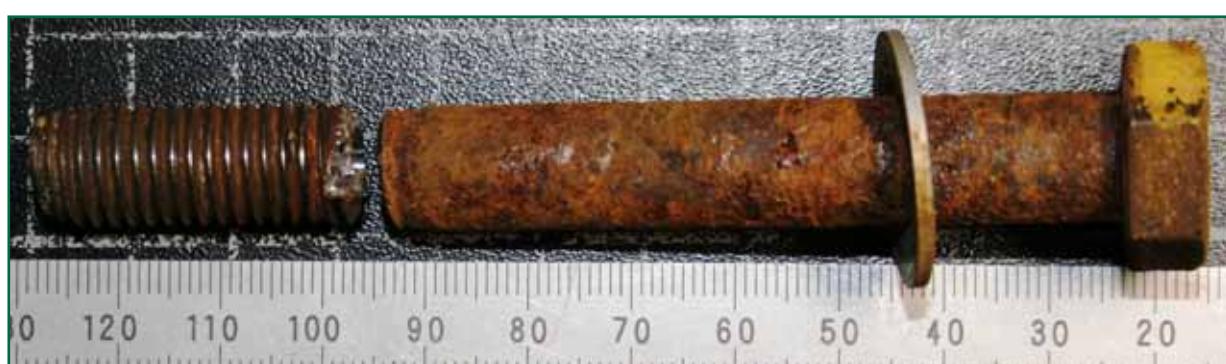
Figure 17: Corrosion on bolt R3

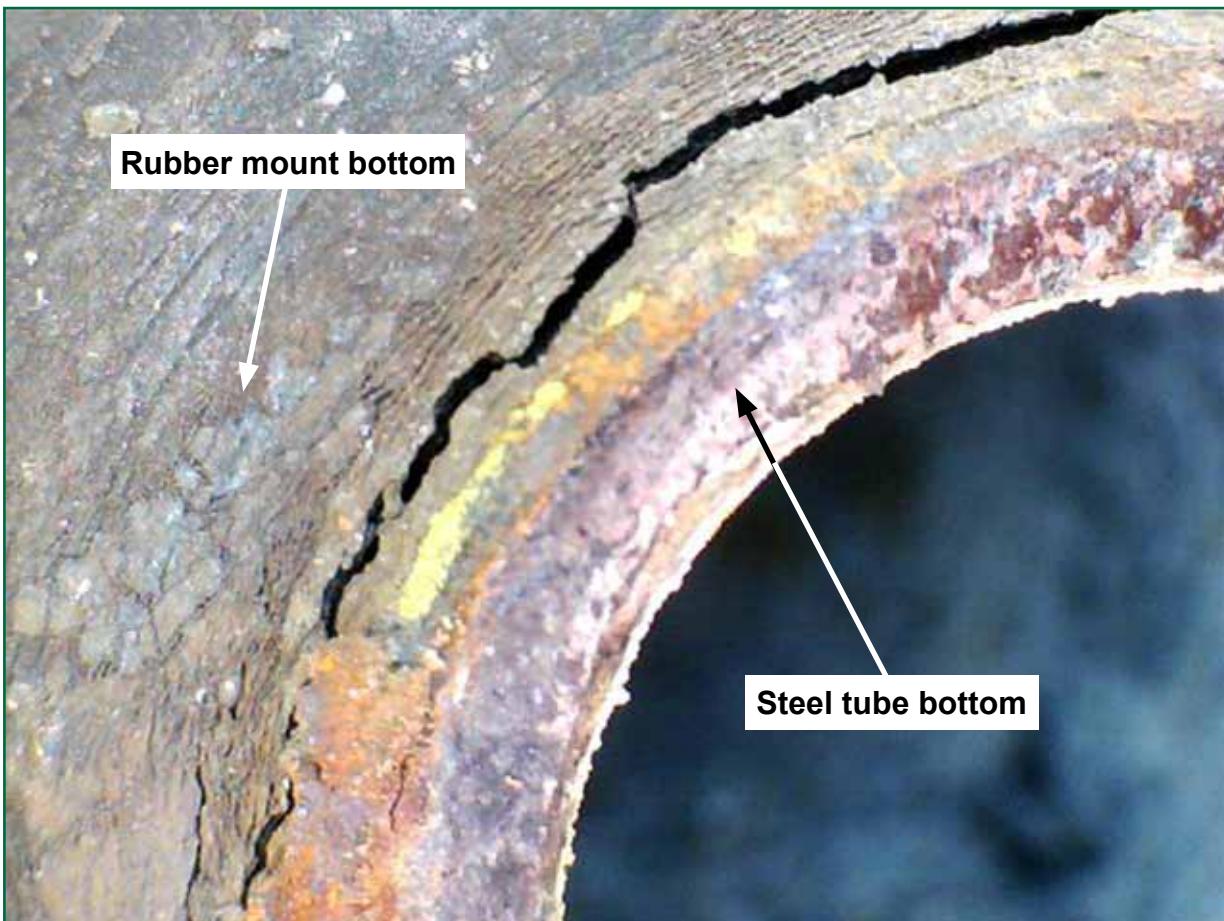
- 62 The corrosion on the threads was most likely to have been caused by moisture ingress through capillary action at imperfections around the interface between the bottom of the flexible mount (which was not designed to seal against the P3 cab) and the cab roof (figure 8). Bolts that had corrosion along their shanks, right up to the bolt heads, may have been exposed to moisture ingress from the interface between the bolt head and the top of the flexible mount, once the bolt had failed and the joint was no longer tightly clamped. Although the bolts were zinc plated for corrosion protection, contact between the threads of the bolt and the threaded hole of the cab roof appears to have removed this protection (figure 19 insert). It is also possible that the corrosion protection was imperfect at the thread roots. In either case, unprotected metal could have been exposed to moisture, allowing corrosion to develop and fatigue cracks to initiate from some of the corrosion pits in the presence of service stresses (paragraphs 50 to 54) until the affected bolts eventually fractured.

Figure 18: Imperfections of the steel tube and the bottom face of the rubber mount allowing moisture to reach the bolt threads

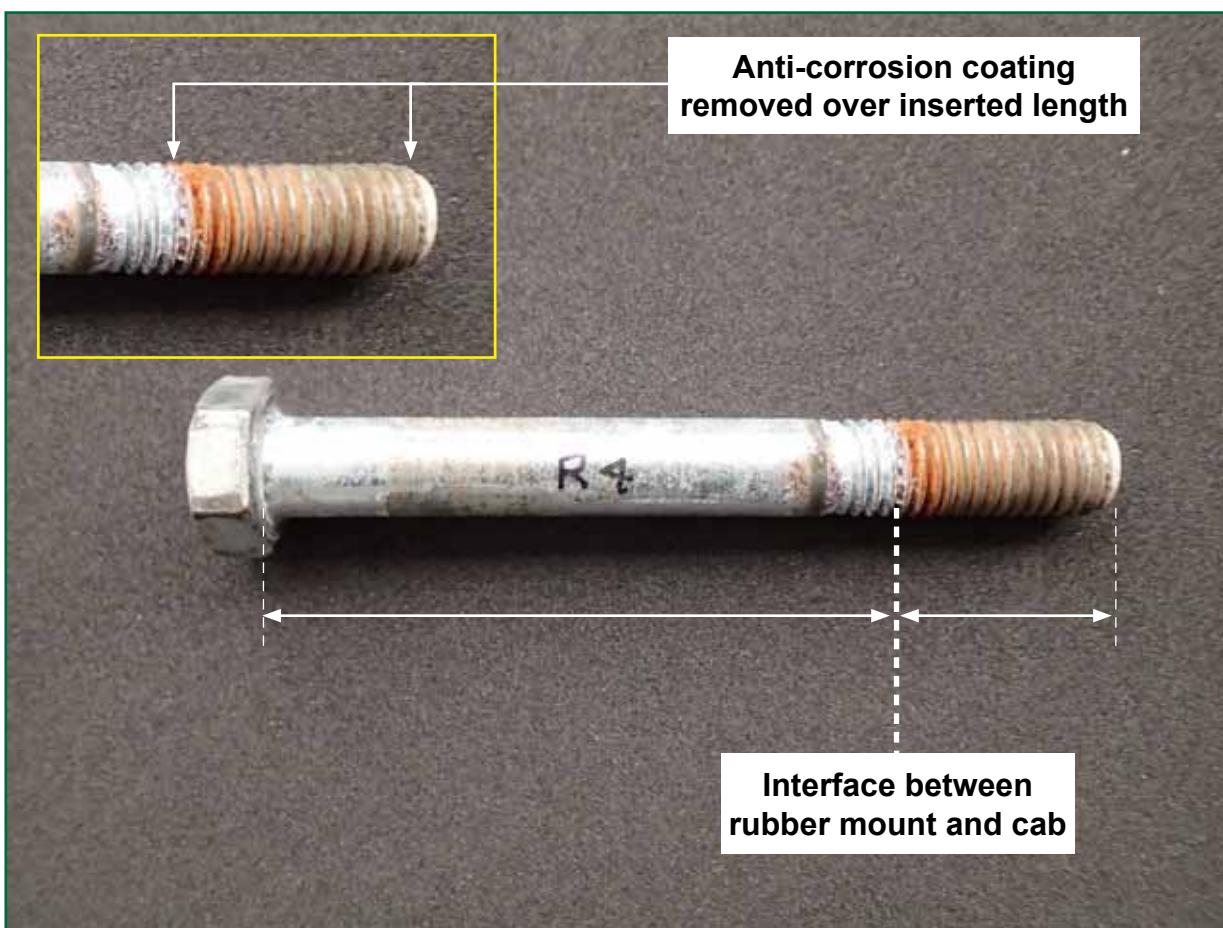
- 63 The RAIB inspected the new P3 cab bolts that had been installed after the incident at Blatchbridge Junction, rubber mountings and contact areas during a visit in April 2013, around 12 months after the P3 cab had been rebuilt and refitted to the P95/1 UK. Corrosion was already evident on the replacement bolts. The area of corrosion was near the top of the bolt threads at the point where the failed bolts had previously corroded. Since installation, the bolts had been regularly checked to make sure they were correctly torque tightened. There was little evidence of corrosion of the bolt shank or the bolt head or washer. This indicates that moisture was reaching the bolt at the interface between the bottom of the rubber mount and the cab roof surface. Figure 19 shows replacement bolt R4. The length inserted into the blind hole in the cab was 28 mm which corresponded to the length exhibiting signs of corrosion. The worst corrosion corresponded to the interface between the bottom of the rubber mount and the cab roof surface. At this point corrosion was clearly visible for 3 to 4 turns down the threaded length of the bolt with lighter corrosion propagating further down the threaded length.

Figure 19: Bolt R4 removed for inspection with evidence of corrosion forming at the interface between the rubber mount and cab roof surface. Inset: anti-corrosion coating removed by the action of inserting the bolt into the blind hole.

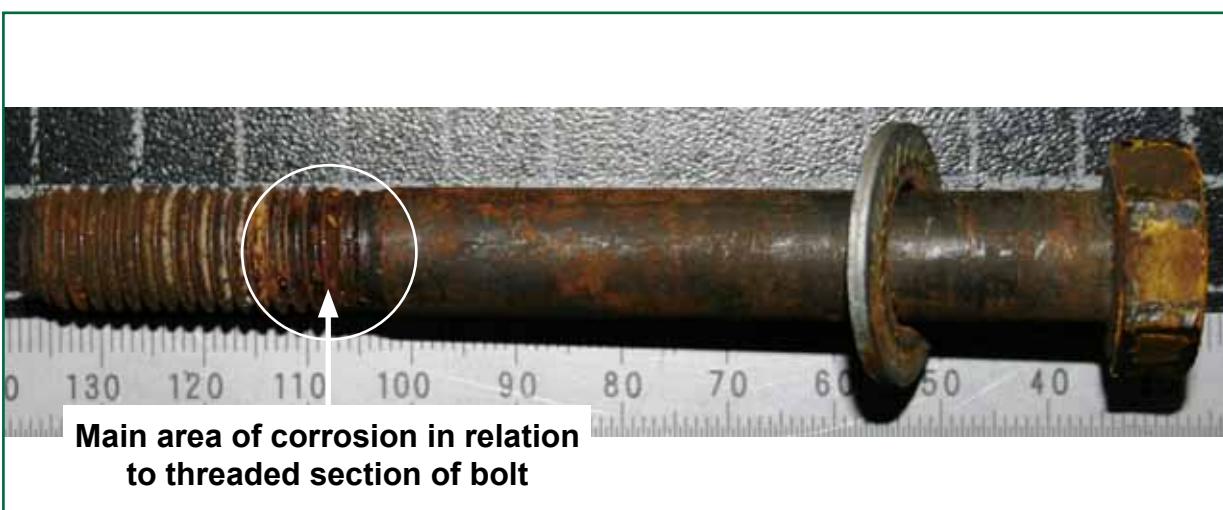
- 64 Six used bolts were also analysed (paragraph 43) for comparison with the failed bolts from the P3 control cab. Four came from the smaller P2 control cab on the P95/1 UK, and two from the P3 control cab on the P95/2 UK. All the used bolts showed evidence of corrosion around the top of the threaded region. The location of the corrosion was identical to that seen on the failed bolts from the P95/1 UK P3 control cab that has identical, but fewer (four) flexible mountings (figure 20).

Figure 20: Location of corrosion seen on the used bolts from the smaller P2 cab from the P95/1 UK

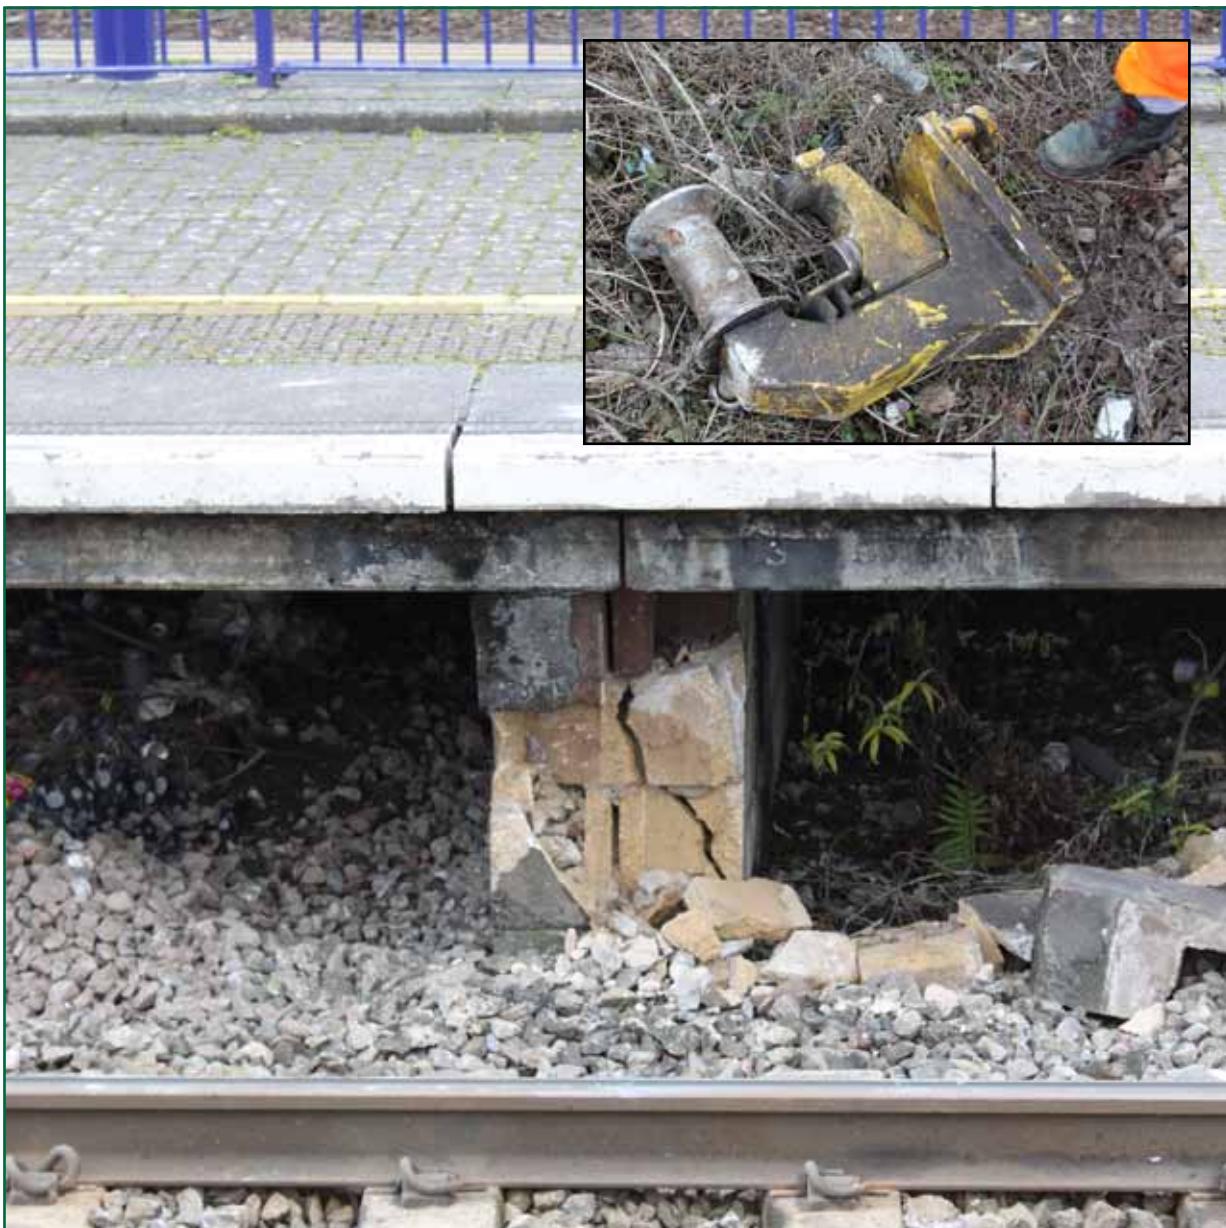
- 69 The clamp became detached because there was no positive locking mechanism fitted to prevent the clamp moving into an unsafe position, and there was no requirement to check that the clamp was correctly stowed prior to the machine entering service.

Figure 21: The damaged brick platform support at Thatcham station and the detached clamp (inset)

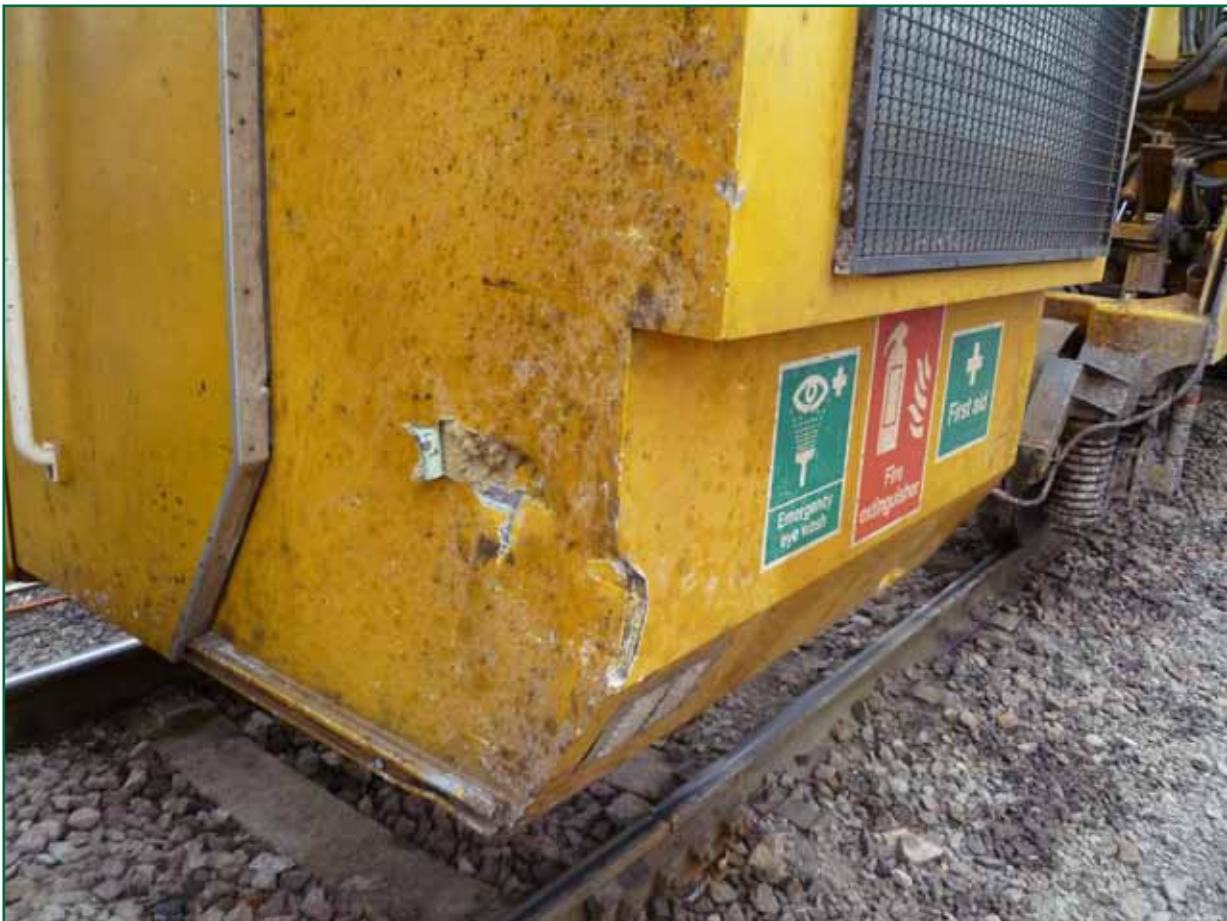
Figure 22: The damaged leading left edge of the P3 control cab following impact from the detached clamp on 26 January 2011

- 75 Paragraph 71 explains that the impact between the clamp and P3 cab may have caused movement within some of the flexible mount assemblies as a result of the applied forces overcoming bolt grip. Figure 22 indicates that the damage to the P3 cab looked superficial in nature. It was not until the cab was rebuilt following the incident at Blatchbridge Junction that a deformed cross member was found, which indicated that the impact force could have been significant (figure 23).

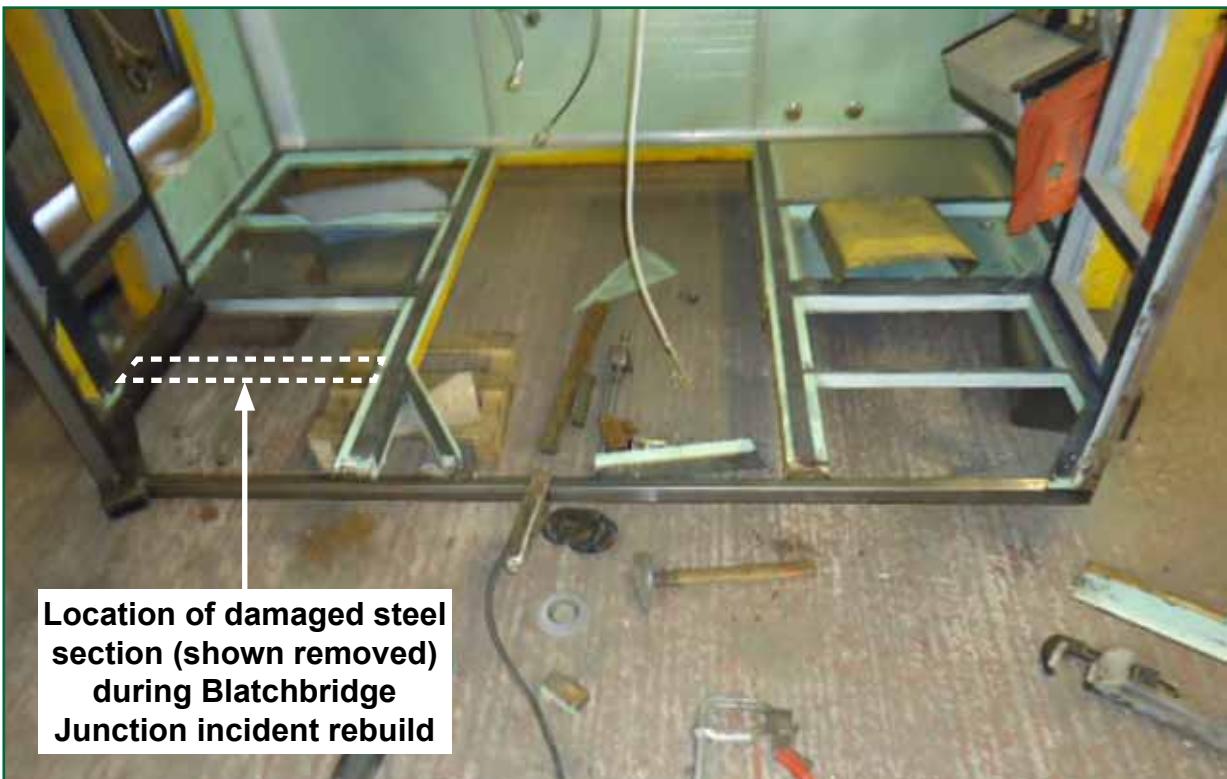
- 70 Following the incident at Blatchbridge Junction on 19 March 2012, the P3 control cab had to be rebuilt. When the body panels were removed, a 40 mm x 40 mm x 2 mm steel cross member was found to be deformed. There was no evidence that the P3 cab had been involved in any other collisions or impacts before or since the incident at Thatcham, and so this deformation had almost certainly been caused by the impact with the clamp on 26 January 2011. It was estimated that the cross member had deformed by no more than 50 mm (figure 23).

Figure 23: Damaged steel section removed for replacement during re-build of the P3 cab after the incident at Blatchbridge Junction. The front of the cab is lying face down in this image.
