Rail Accident Investigation Branch

Rail Accident Report

Derailment at Bletchley Junction, Bletchley 3 February 2012

Report 24/2012
November 2012

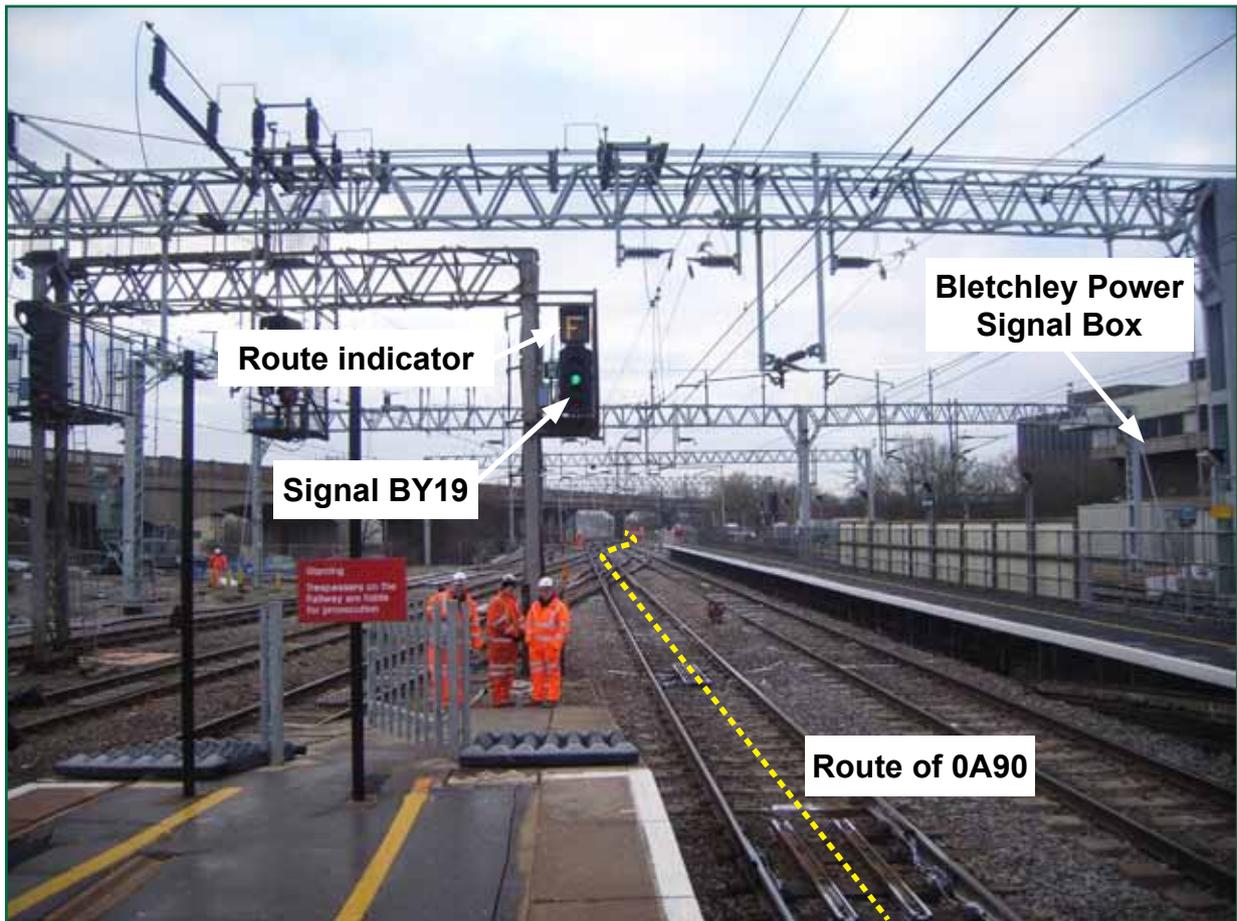
Figure 2: Daylight view of signal BY19 showing a proceed aspect and the route indicator illuminated for a move from the up slow line to the up fast line

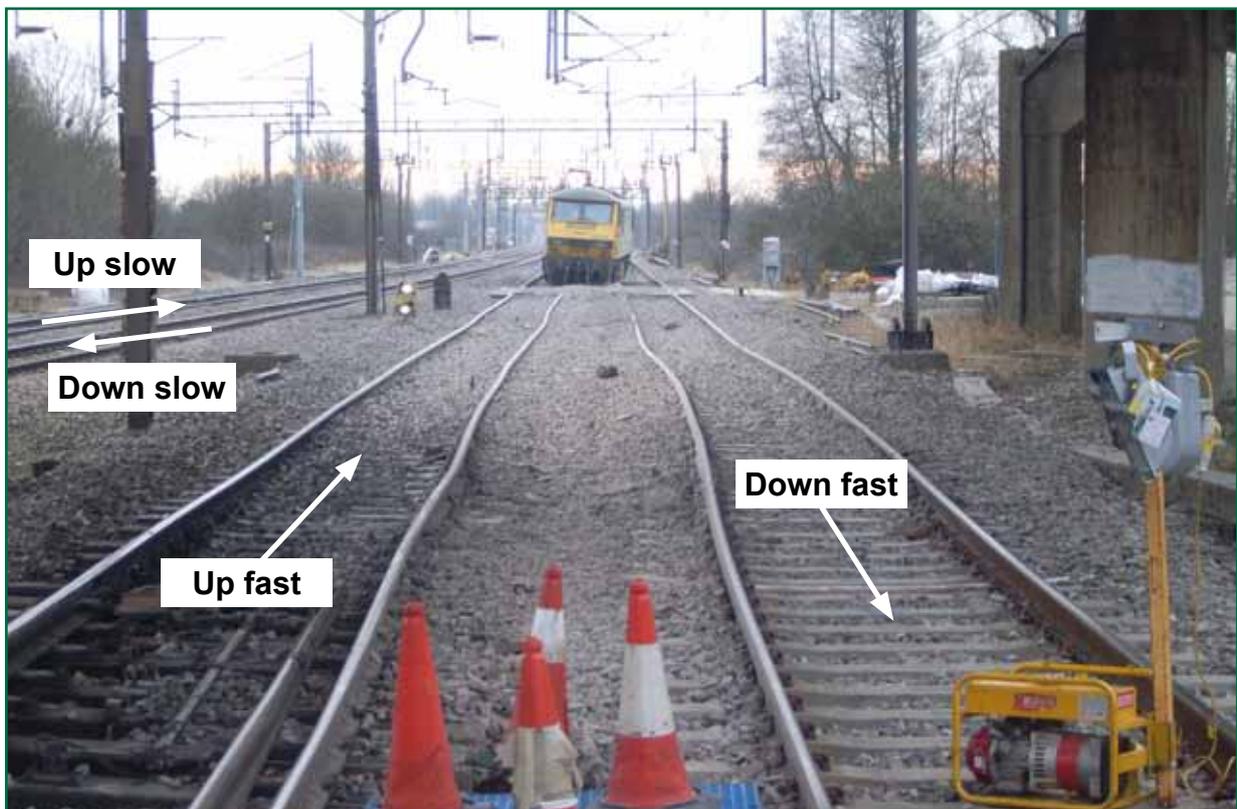
- 6 The driver responded correctly to the sequence of signal *aspects* displayed on the approach to the signal that protected Bletchley Junction, signal BY19. As the locomotive approached it, this signal cleared to a green proceed aspect with a letter 'F' showing in the *route indicator*. This advised the driver that he was to be switched to the up fast line (figures 2 and 4). However, the driver accelerated the locomotive in the belief that he was continuing on the up slow line rather than continuing at slow speed for the diverging move.
- 7 The locomotive derailed as it negotiated the diverging route while travelling at 65.5 mph (105.4 km/h) (figure 3). It should have been travelling at no more than 15 mph (24 km/h).
- 8 The driver received minor injuries. The locomotive's underframe, the track and overhead line equipment were all significantly damaged.

Figure 3: The derailed locomotive no.90046 following the accident

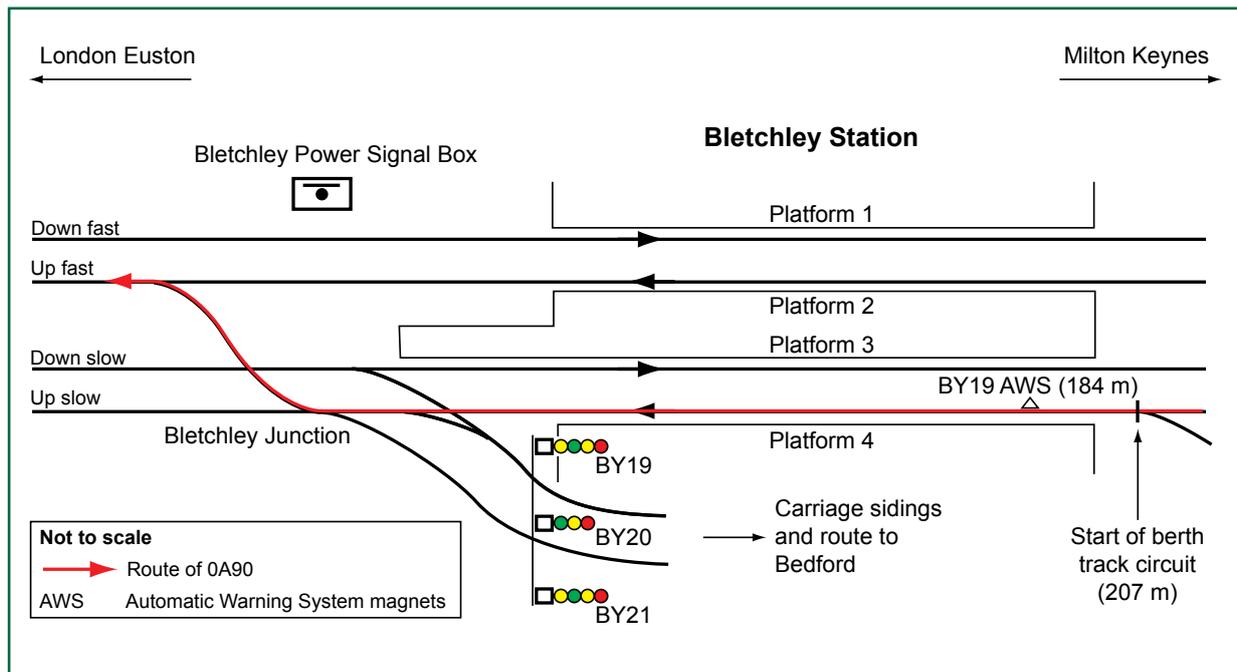
- 11 The maximum permitted speed of trains using Bletchley Junction to cross from the up slow line to the up fast line is 15 mph (24 km/h). As with other changes of permissible speeds, this is indicated by a sign at the junction. The purpose of the sign is to inform drivers and to supplement their route knowledge, which is the primary means of ensuring that permissible speeds are not exceeded. Drivers are trained and examined on route knowledge so that they should be aware of signalling and track layouts, permissible speeds, and other route features such as gradients.

Figure 4: Track layout of Bletchley Junction (distances shown are from BY19 signal)

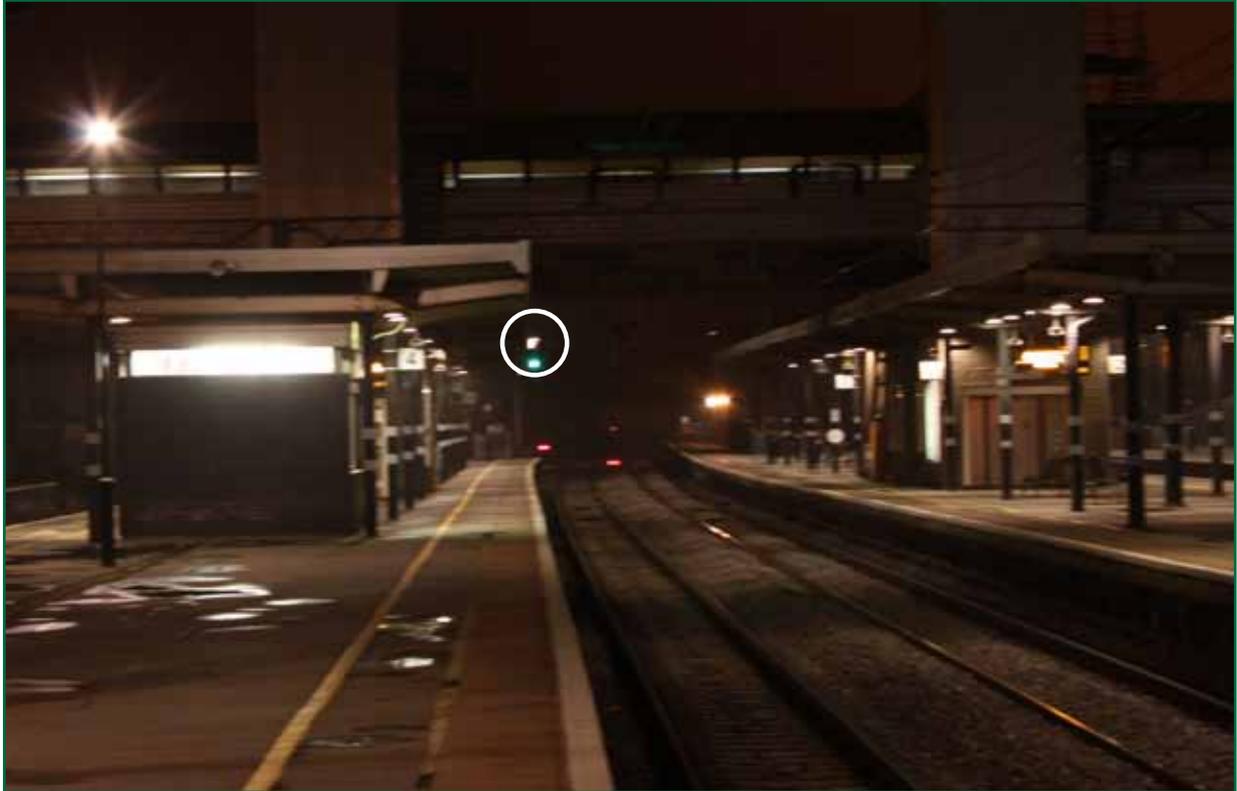
- 87 Position light junction indicators (paragraph 46) are significantly brighter than the alphanumeric type fitted to signal BY19, and their physical form (figure 6) gives a clearer indication that a diverging route is to be taken. Had one been fitted to signal BY19 rather than the alphanumeric indicator, it would probably have appeared to be more prominent in the driver's view. Therefore, it is possible that had a position light junction indicator been fitted, the driver of train 0A90 would have perceived it and been alerted to the fact that he was taking the diverging route.

- 88 The RAIB commissioned an examination of the sighting of signal BY19's route indicator and identification of any human factors issues that could cause errors. The approach view of the route indicator was found to be satisfactory, being free of obstructions and with sufficient time for a driver to see and interpret its meaning. No human factors issues were identified that would have increased the probability of errors being made. Figure 9 shows a night time view of signal BY19, with the 'F' illuminated, from its associated automatic warning system magnets.

Figure 9: Night time view of signal BY19, with the 'F' indication illuminated, from the automatic warning system magnets

- 2 *The intention of this recommendation is that, at potentially high risk diverging junctions, such as those where the approach speed is 60 mph (96 km/h) or greater and requiring a reduction in speed of a third or more, the risk from a train overspeeding on a diverging route following the clearance of the junction signal under approach control conditions is reduced. Different or additional mitigation may be justified depending on the level of risk identified; this may include replacement by position light junction indicators; replacement of junction indicator by one in modern equivalent form; alteration to signalling controls etc.*
