RAIB Bulletin 01/2012

Track worker struck by a passing train near North Kent East Junction, 2 February 2012

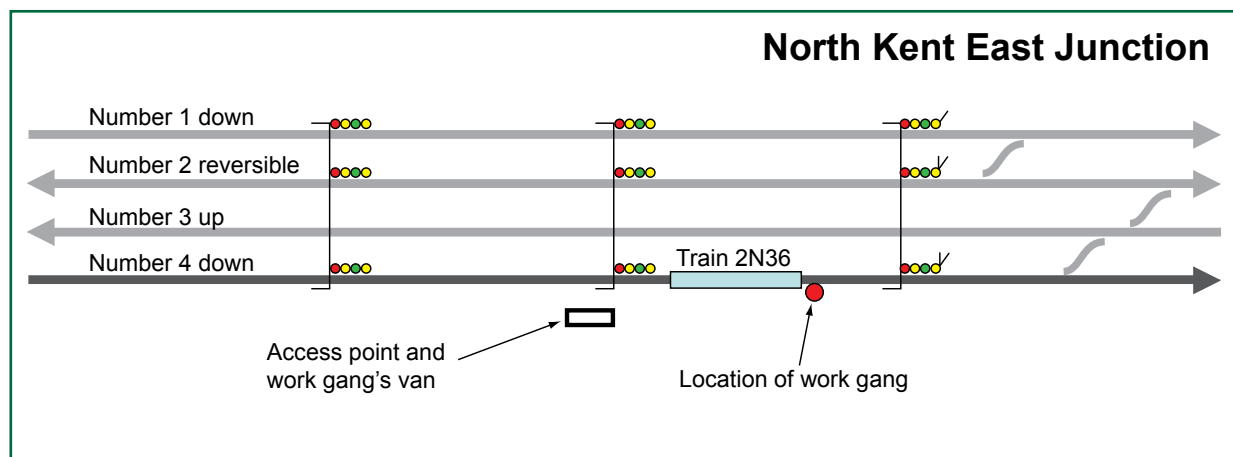
Figure 1: Simplified layout of the approach to North Kent East Junction showing the location of the work gang, and the approach of train 2N36 (not to scale).

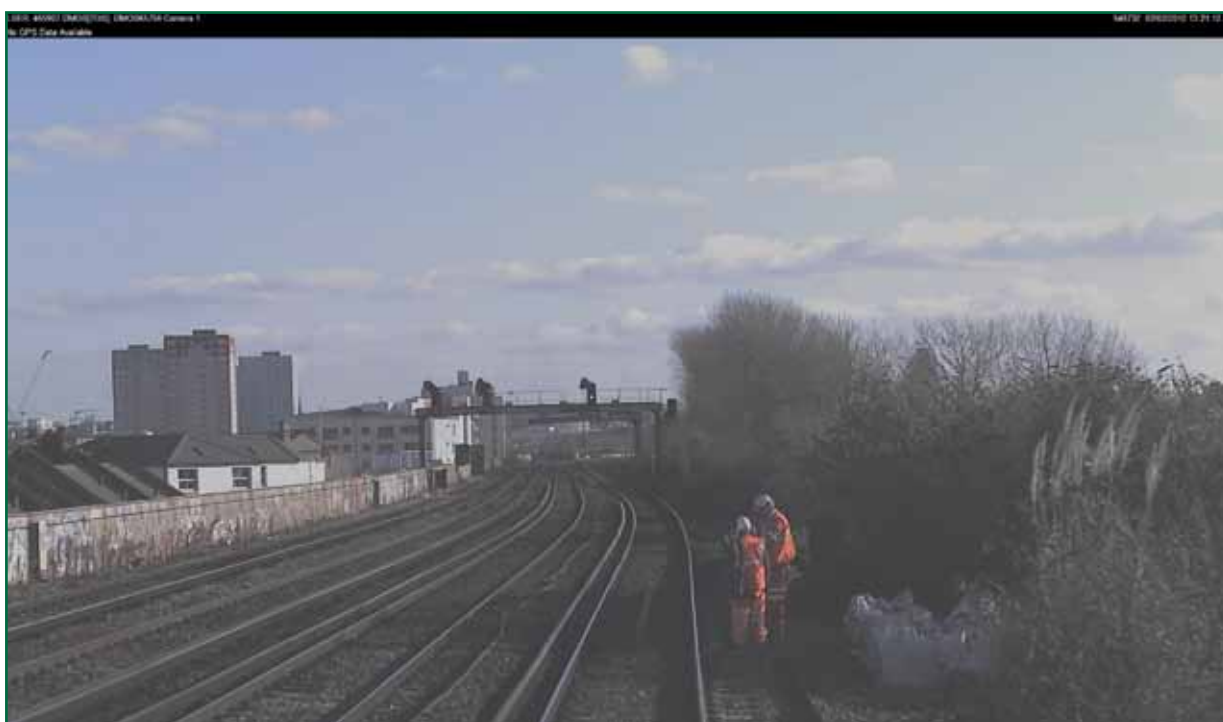
- 5 When the two rail weld inspections were complete, the COSS and supervisor moved into the cess and began to discuss the inspections that they had to undertake at the next location at Honor Oak Park. The cess is an area adjacent to the railway tracks. It does not always provide a safe place to stand clear of passing trains. The lookout realised the rail weld inspections had been completed and walked over to the COSS and supervisor. He positioned himself with his back to the direction from which trains would approach along number 4 down line. His equipment bag was hanging on the lookout flag poles that he was holding over his left shoulder (figure 2).

Figure 2: Forward facing CCTV image from train 2N36. The lookout has his back to the approaching train. The COSS is positioned to the right of the lookout. The supervisor is just beyond the COSS and cannot be seen in this image.
