Rail Accident Investigation Branch

Rail Accident Report

Fatal accident at James Street station, Liverpool 22 October 2011

Report 22/2012
October 2012

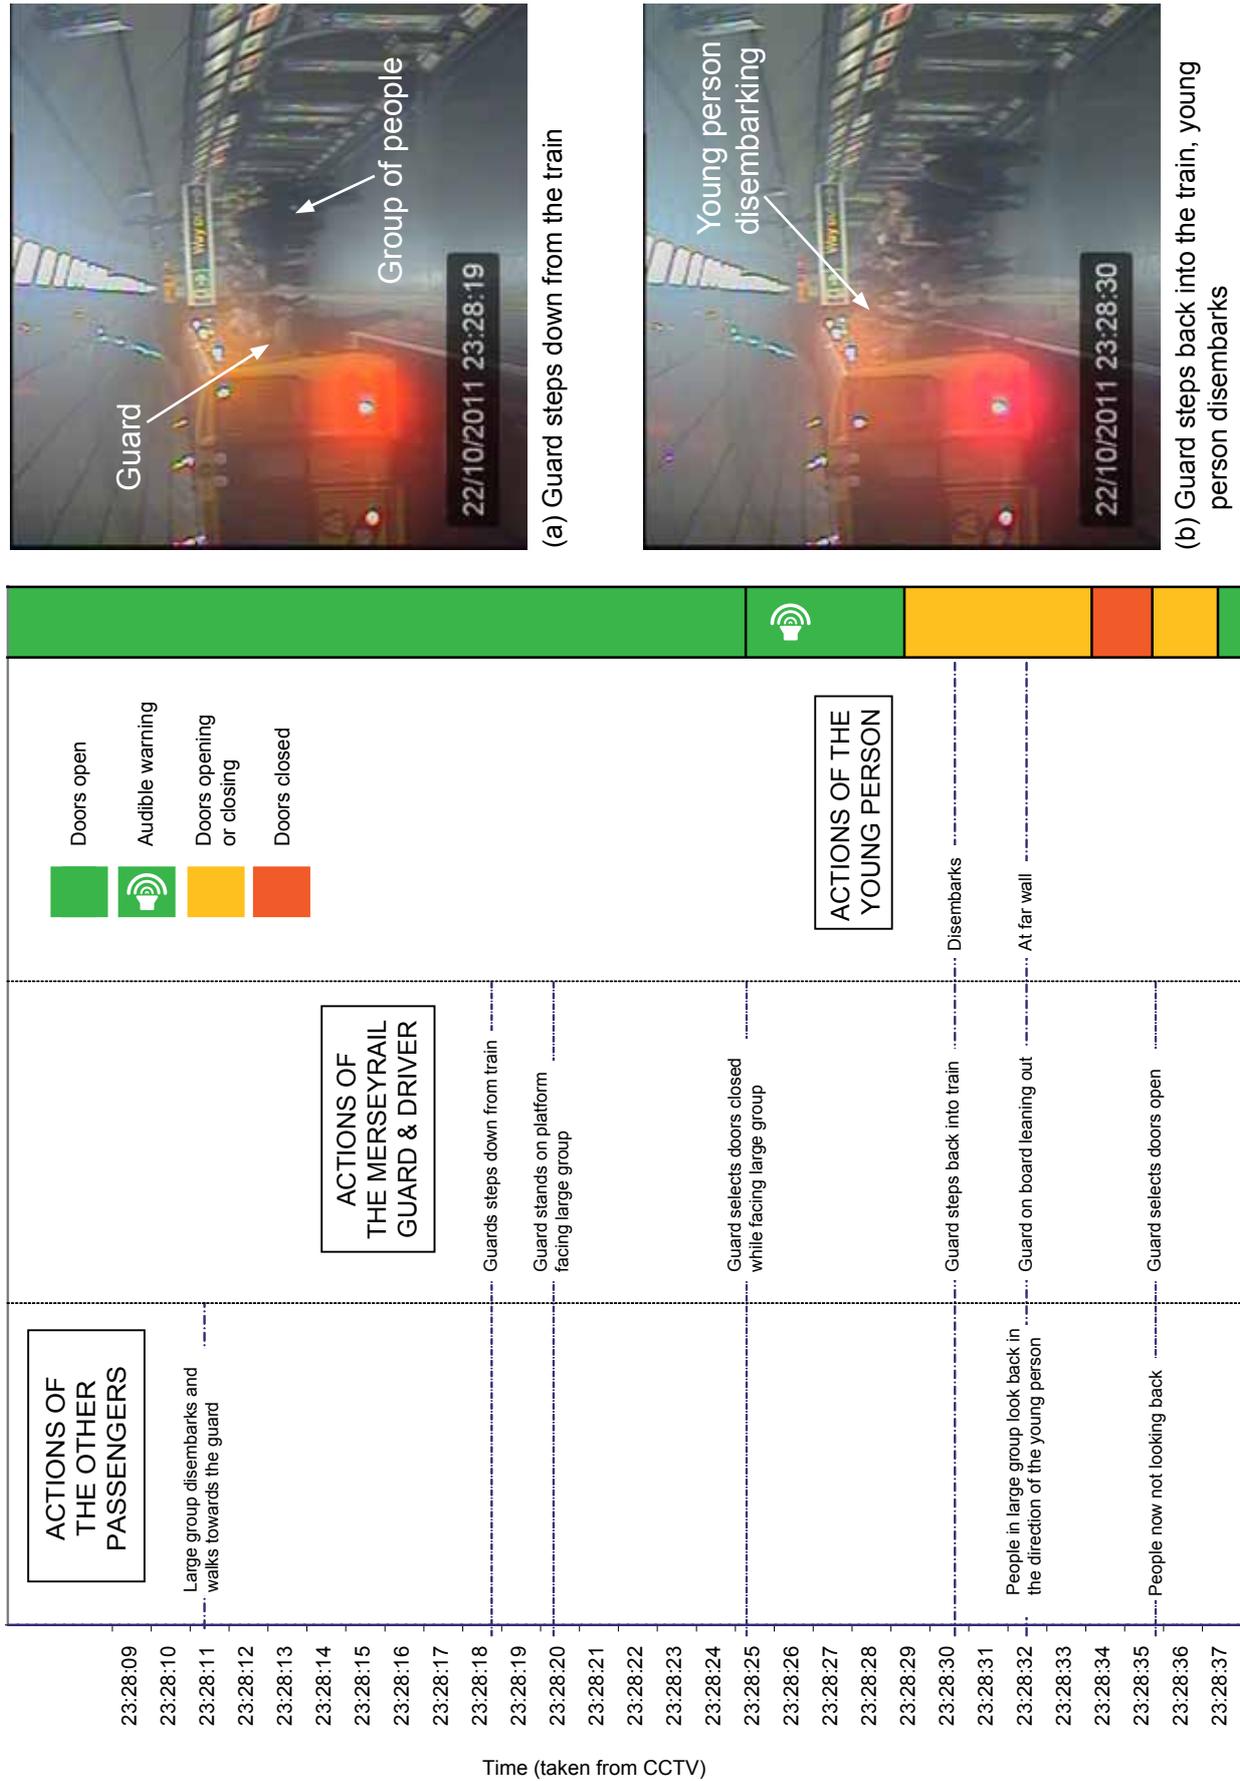
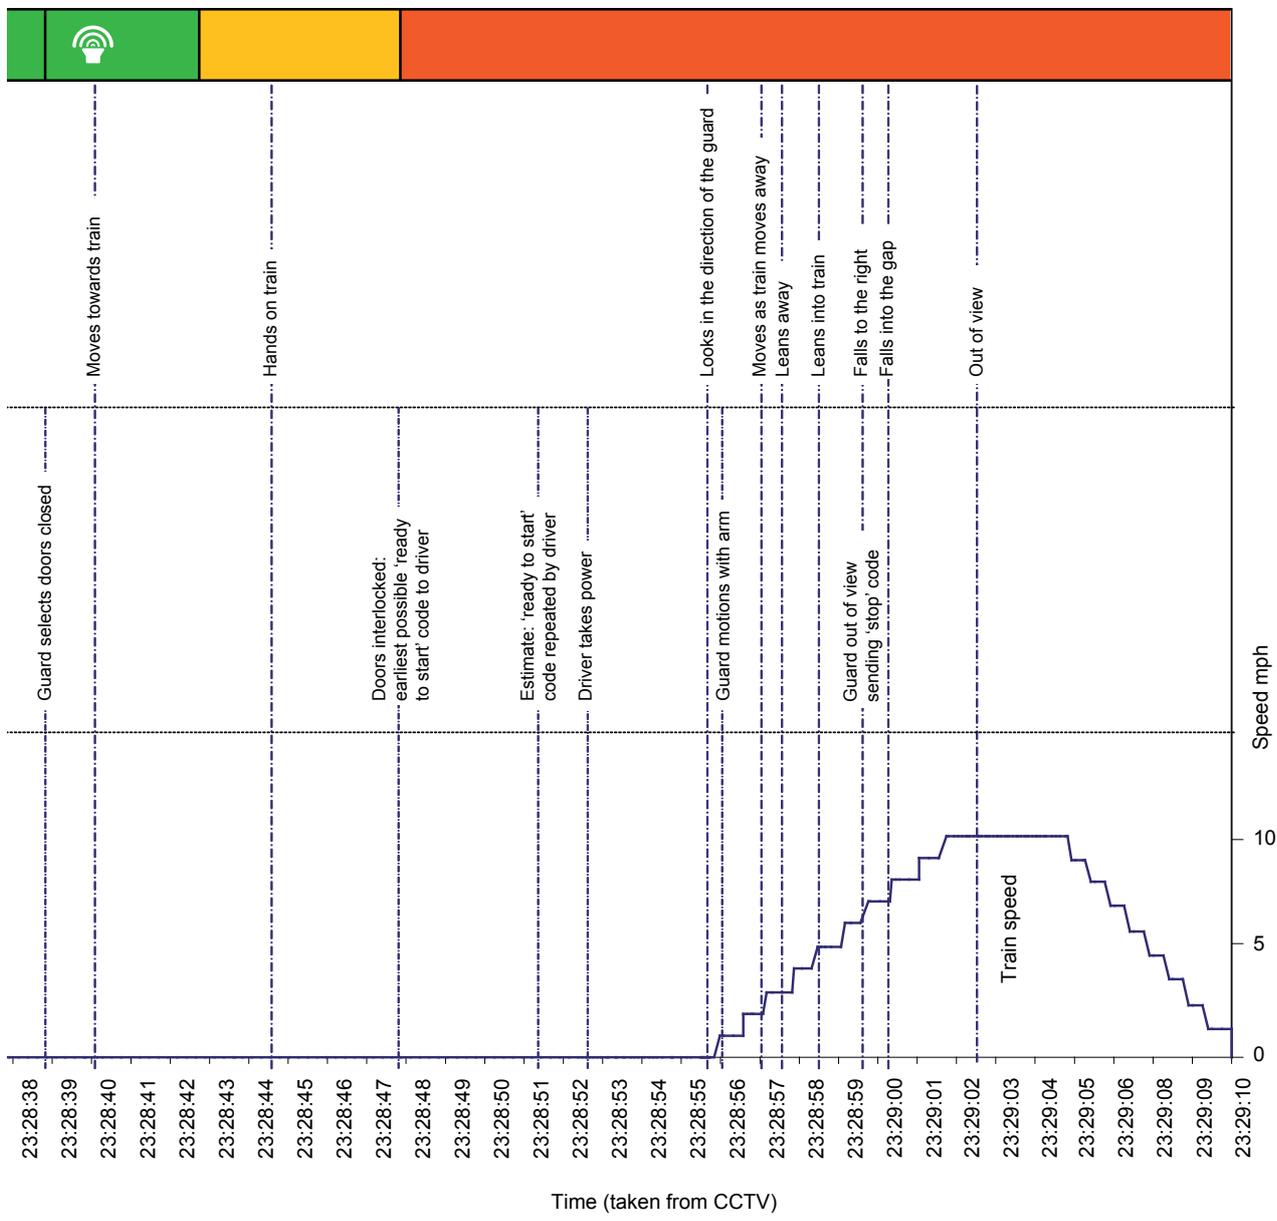
Figure 5 (continued): Timeline of events recorded by the video camera on platform 1 and the train's data recorder

- 10 A large group of passengers left the train's centre vehicle and walked in the direction of the guard who stepped down from the train and faced in their direction (figure 5a). Between 40 and 50 passengers remained on board the train. The guard remained standing on the platform facing the large group as he pressed the door close button, which initiated the door close sequence and sounded audible warning devices for approximately four seconds.

- 11 Immediately the audible warnings stopped the passenger doors started to close, the guard stepped back into the train, the young person disembarked and went straight to the tunnel wall (figure 5b). At this time many of the large group of passengers turned to look in the young person's direction as they walked along the platform, possibly because she and her friends were shouting to one another at a level loud enough to be heard by the train driver in her cab.

- 14 The young person turned to look in the direction of the guard as the last person in the large group left the platform through the exit opposite the guard's door. The guard stated that he warned the young person to stand back and platform video camera footage shows that he gestured with his arm for her to move away from the train (figure 5d) but she continued to lean against it.

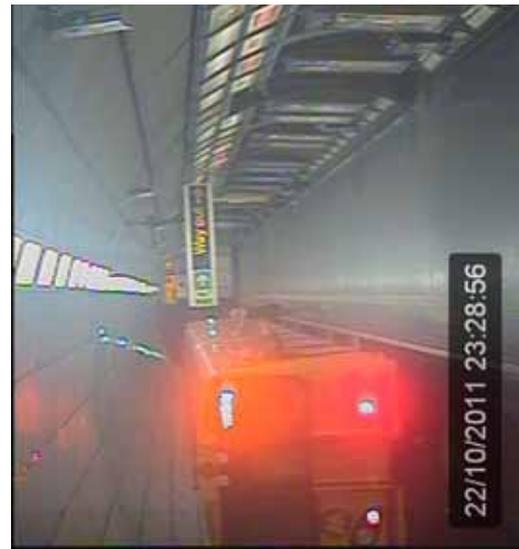
(d) Guard warns the young person to stand back

- d. By the time the guard warned the young person to stand back she had been leaning against the train for approximately eleven seconds. It is not known when the guard saw her during this time or, if he saw her, whether he delayed taking action in the expectation that she would move away. Platform video camera footage shows him warning her to stand back in the moments before the train departs and it is likely he did this because he thought that it would be immediately effective and because he had no direct and immediate way to stop the train (**paragraph 39, Recommendation 1b**).

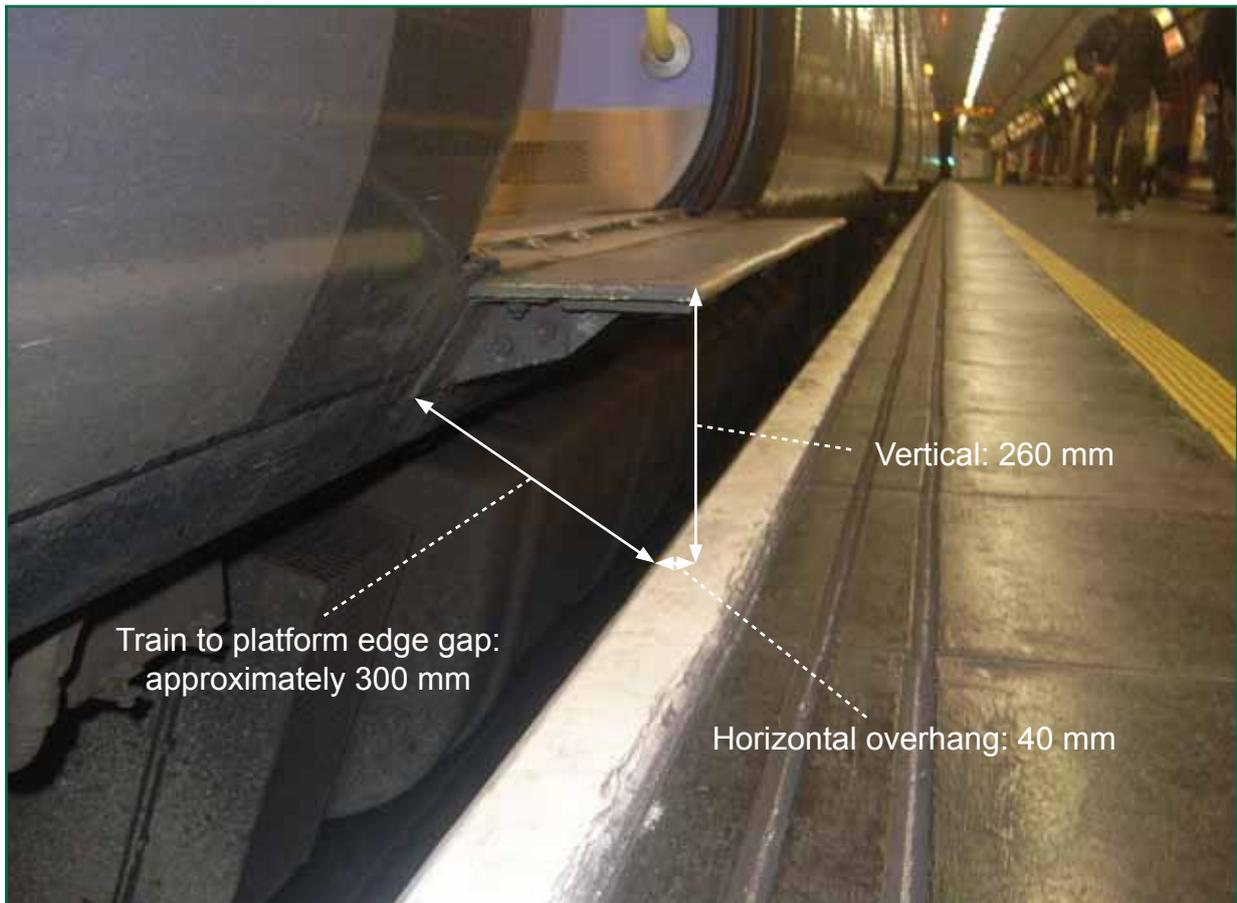
Figure 10: The train to platform edge gap and measurements to the footstep

The platform edge gap was wide enough for her to fall through and onto the track

The gap can be made much smaller on platforms with straight, level track served by trains of uniform size and suspension that do not pass through at speed. All these conditions prevail at James Street station platform 1.

FOOTSTEP TO PLATFORM EDGE	James Street platform 1 measurements (mm)	Industry maximum dimensions (mm)	Comparison with requirements
Platform edge to footstep: vertical	260	250	Does not comply but reducing the dimension to 250 mm would have little effect on the platform edge gap
Platform edge to footstep: horizontal	40 (overhang)	275 (gap)	Complies
Platform edge to footstep: diagonal	Not applicable due to overhang	350	Not applicable
Platform edge gap	Approximately 300	No requirement	No requirement

Merseyrail, in consultation with Merseytravel, Network Rail and other relevant industry bodies, should evaluate equipment and methods that reduce the likelihood of a person falling through the platform edge gap. Platform edge gap fillers and vehicle body side panels should be included in the evaluation, the outcome of which should be a plan to implement measures when appropriate to do so, for example when trains or the infrastructure are changed, improved or replaced.

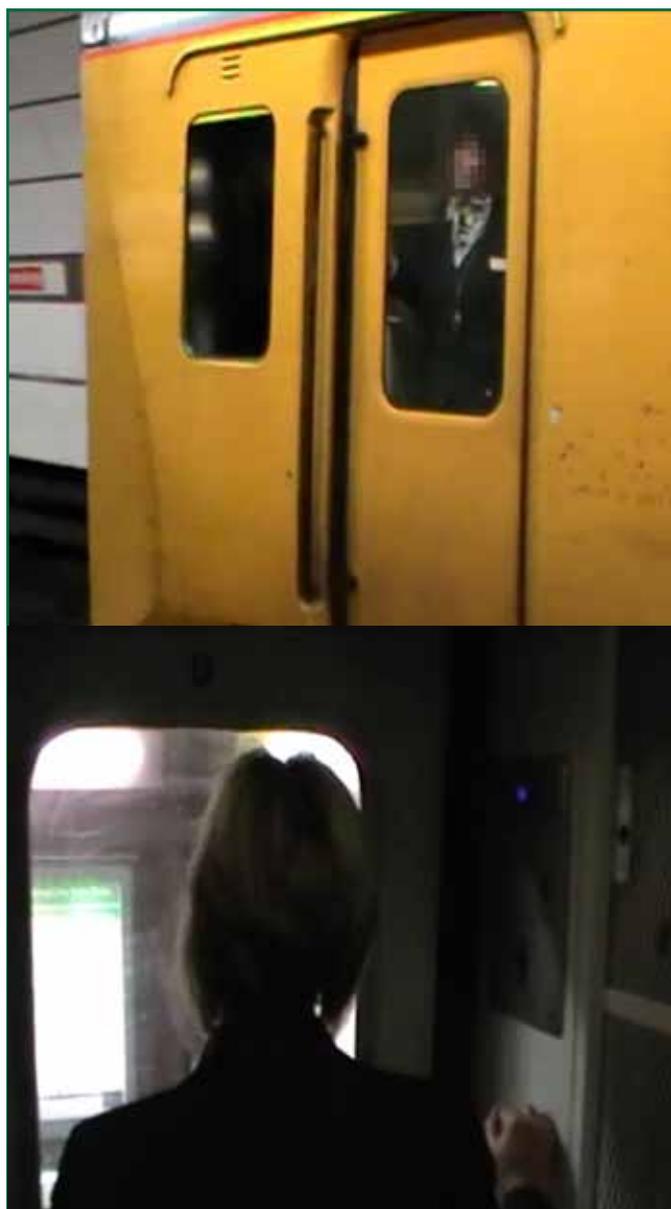
Figure 12: A guard viewing James Street station platform 1 from behind a closed door

- 24 The RAIB used Merseyrail's video of best practice train dispatch to the published procedure to calculate that approximately 12 seconds passes between the guard boarding the train, waiting for the adjacent door to close, sending and receiving the 'ready to start' code and the train moving out of the station. This is a period of time during which serious accidents may occur because a guard may not be able to see and react to events at the platform/train interface because of the narrow field of view through the door's fixed window (see figure 12).

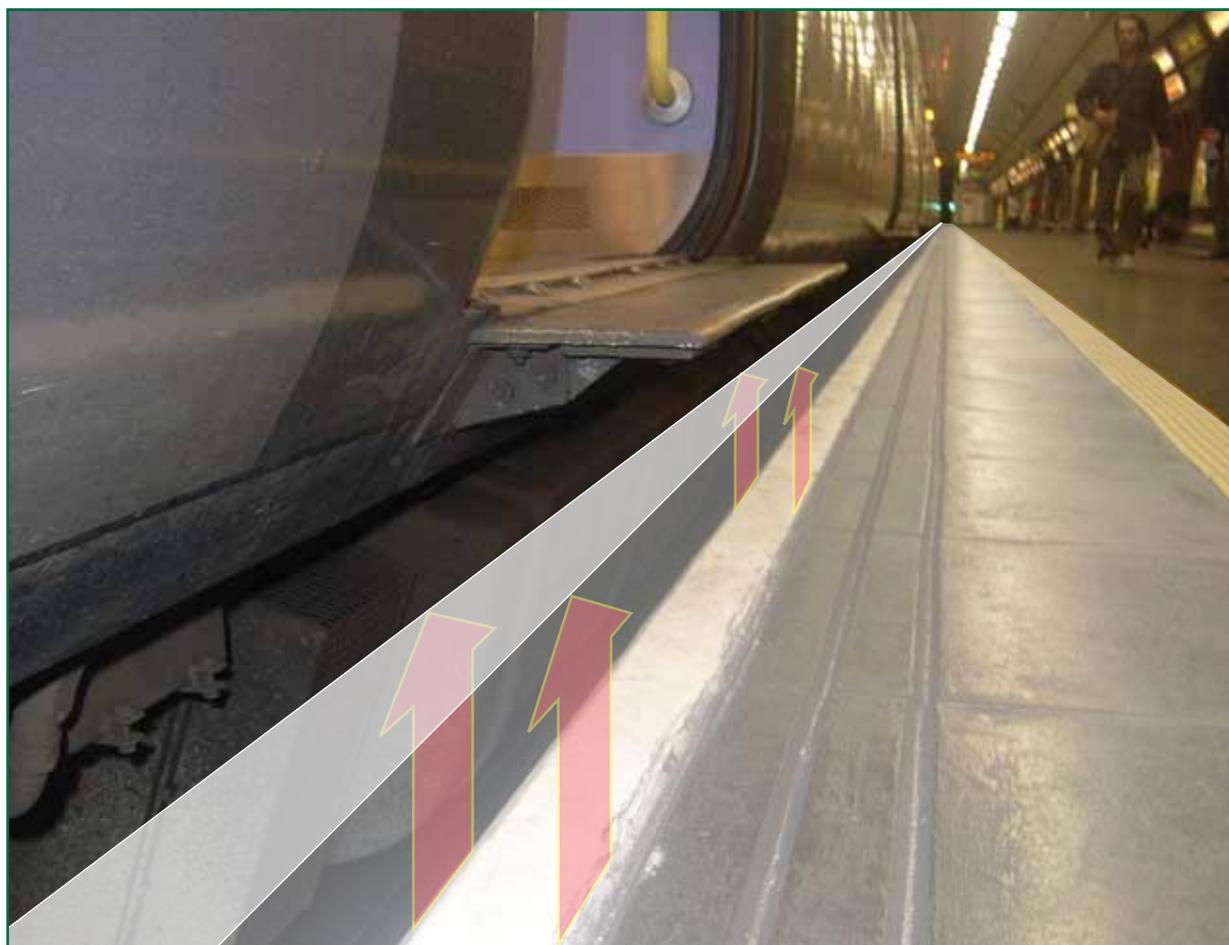
Figure 25: The James Street platform edge gap, shown reduced by raising the platform

- iii. Adapting the infrastructure. Figure 25 shows a platform edge gap reduced by raising the platform edge. Figures 26 to 28 show the gap reduced by fitting gap fillers to the platform face. The gap fillers are made from blocks with rubber prongs: the prongs are able to support a person's weight vertically and deflect horizontally without damaging themselves or the trains that pass and contact them. The gap can also be reduced by moving the track closer to the platform, moving the platform coping stones closer to the track or both.
