Rail Accident Investigation Branch

Rail Accident Report

**Fatal accident at Mexico footpath crossing (near
Penzance)
3 October 2011**

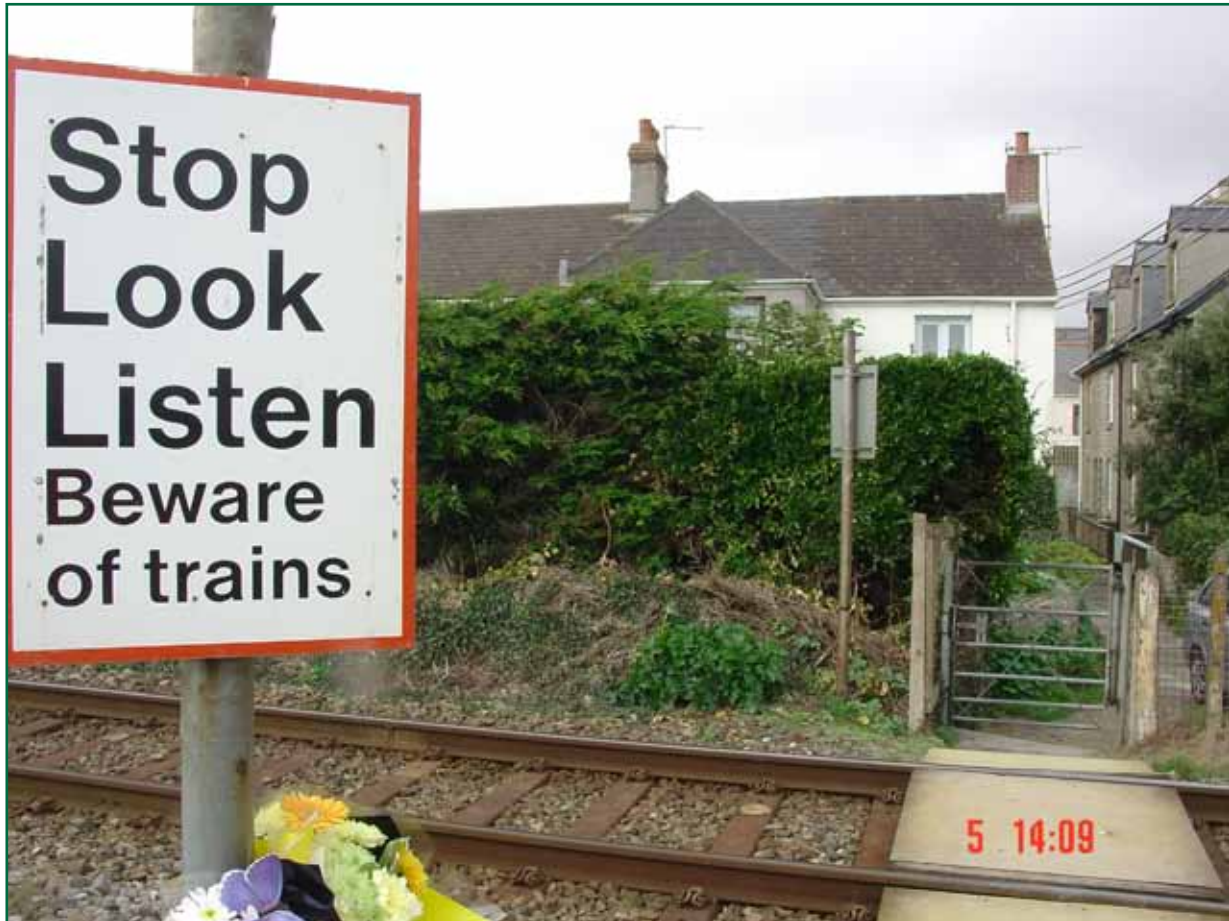
Figure 5: Signage at the crossing (view taken from south side)

- 14 The crossing is equipped with self-closing metal gates on the north and south sides and signs which instruct users to stop, look and listen and beware of trains; see figure 5. The signs correspond with the template for non-vehicular crossings contained in the Private Crossings (Signs and Barriers) Regulations 1996.

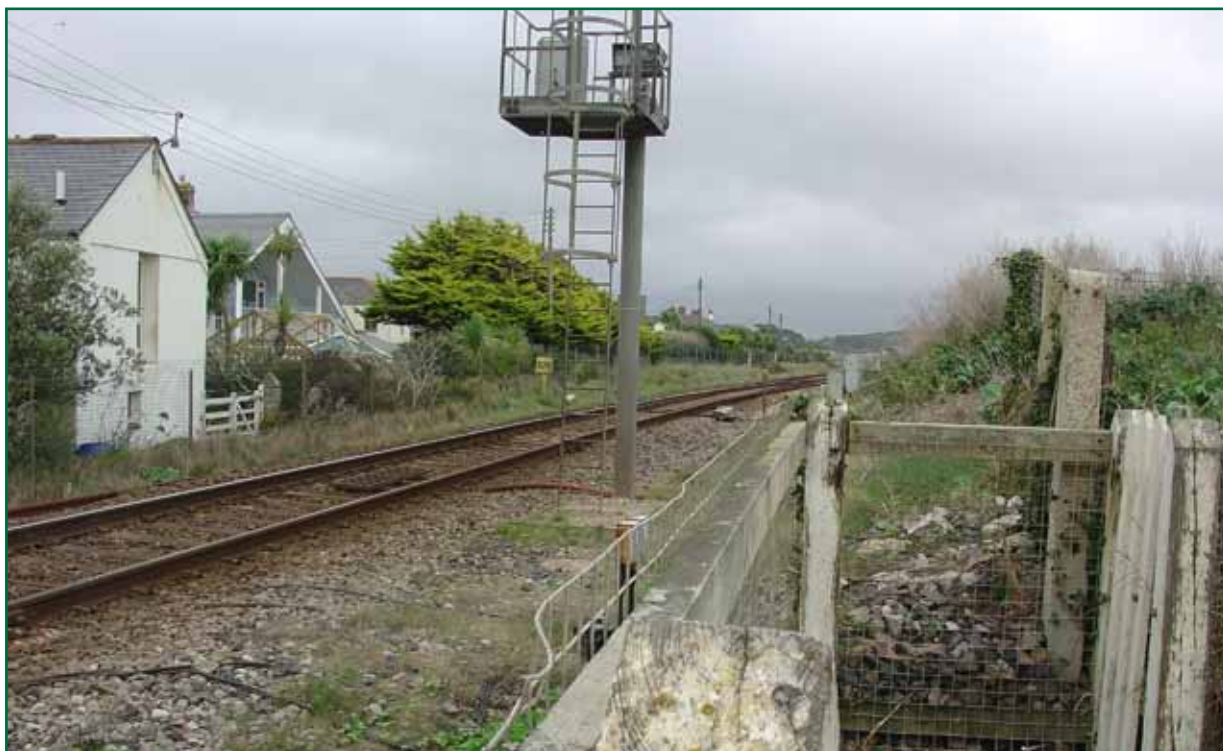
Figure 6: View east from the gate on the south side of the crossing (4.25 metres from the nearer rail)

- 34 From all three locations, the crossing user's view to the east is partially obstructed by an equipment case and the signal post, but an approaching train can still be seen because of its height and width in relation to the structures. This is discussed later in the report (paragraph 65 and figure 10).

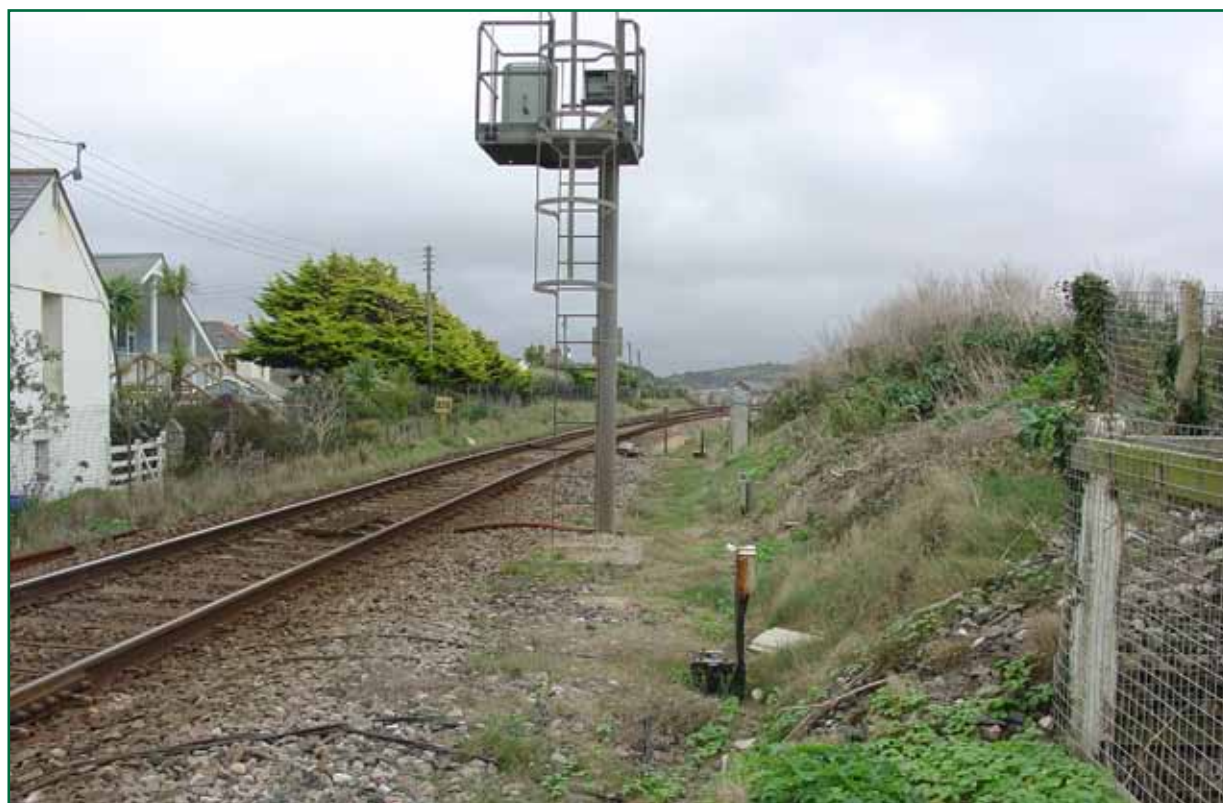
Figure 7: View east from a position alongside the sign on the south side of the crossing (3.40 metres from the nearer rail)

- 32 The sign which instructs users how to cross safely was located between the gate and the track at a distance of 3.40 metres from the nearer rail. At this location, the view to the east for a user is marginally better than that from the gate; see figure 7.

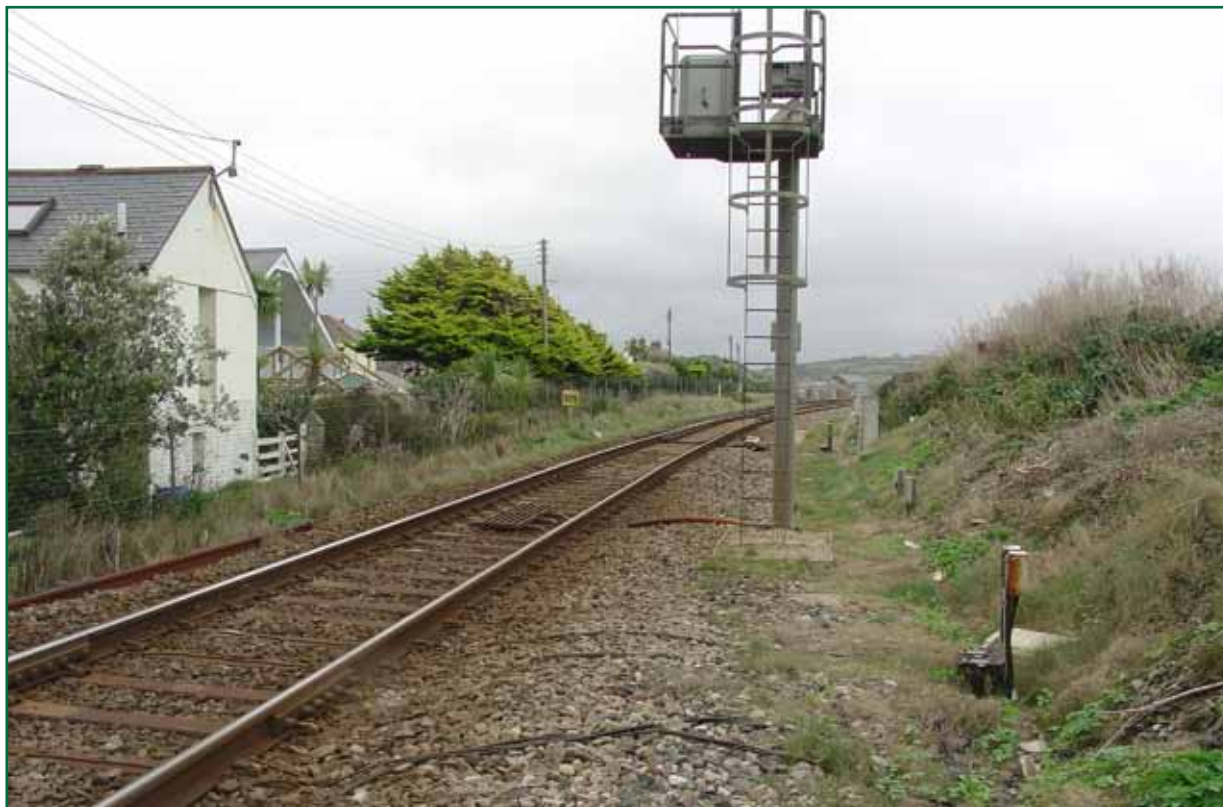
Figure 8: View east from a position on the south side of the crossing (2 metres from the nearer rail)

- 33 When assessing *sighting distances* at level crossings, it is Network Rail's practice in its Western route (which includes Mexico footpath crossing) to take measurements from a position two metres from the nearer rail; see figure 8. This corresponds with the minimum distance defined in the guidance from the Office of Rail Regulation (table 1). At two metres from the nearer rail, a user can see further to the east than is possible from 3.40 metres.

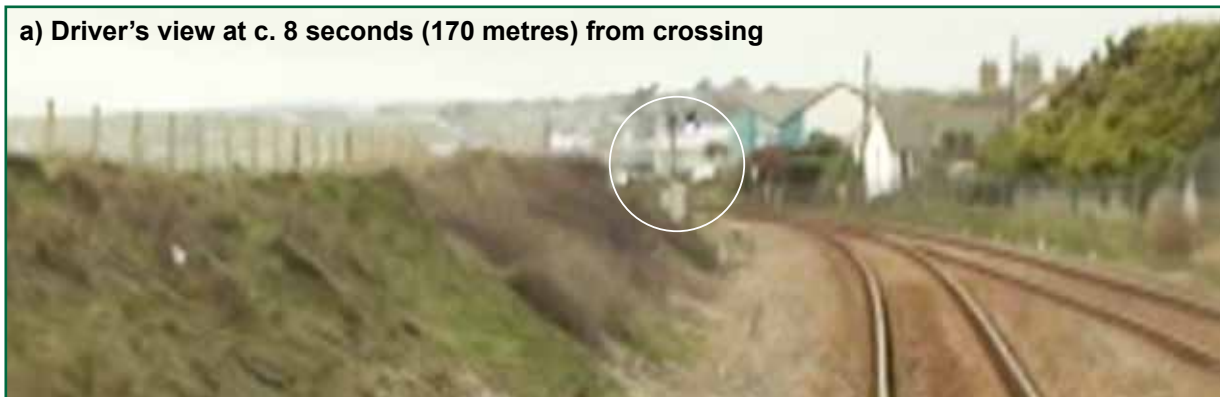
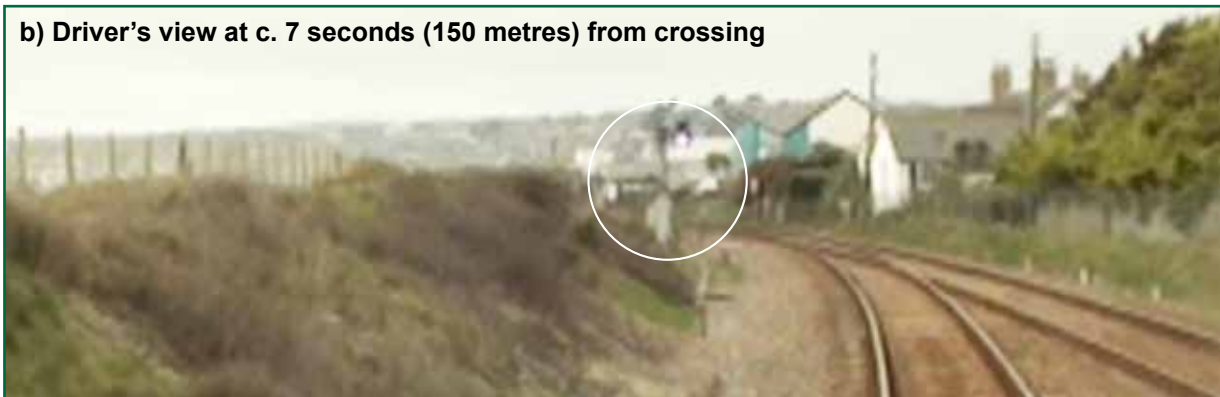
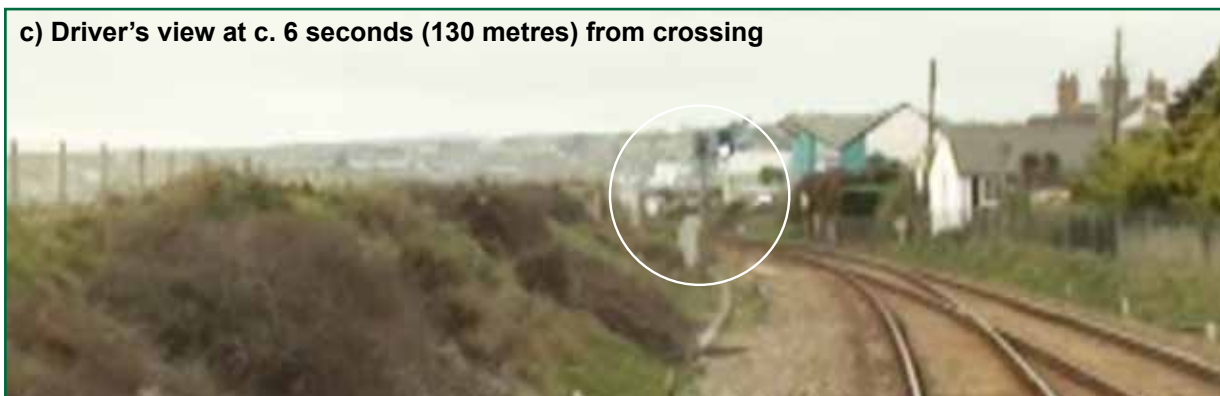
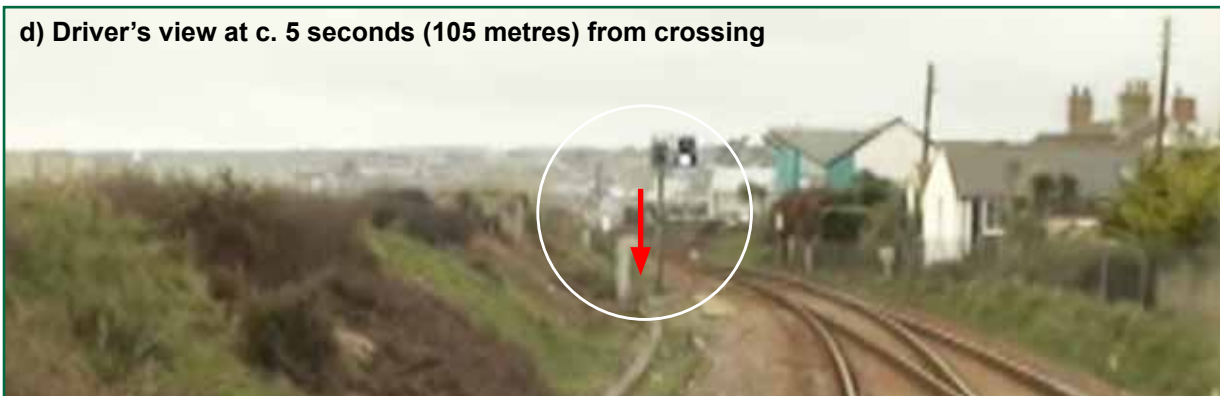
Figures 9a to 9d: The train driver's view approaching Mexico footpath crossing (source RAIB video). It can be seen that the driver's view of the area (circled) immediately to the left of the crossing (the location where Mrs Nicholls was most likely to have been standing and arrowed in figure 9d) was initially obscured by the signal and the equipment cases, and it is not until the train is approximately five seconds from the crossing that the relevant area becomes visible to the driver. Note that the green signal that can be seen clearly in the photograph is mounted to the right of the post that comprises part of the obstruction to the driver's view.

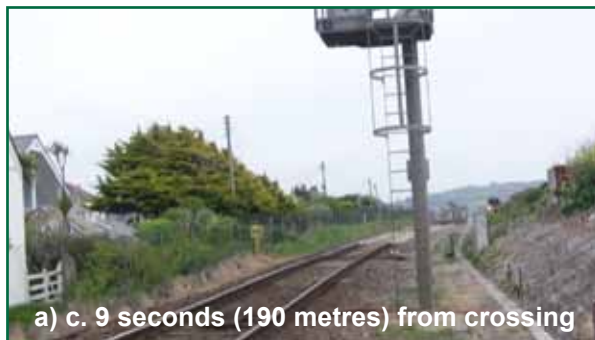
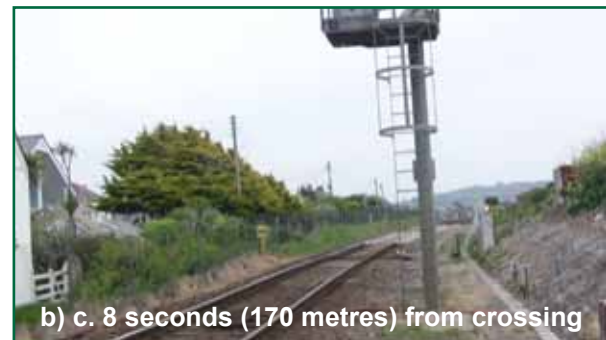
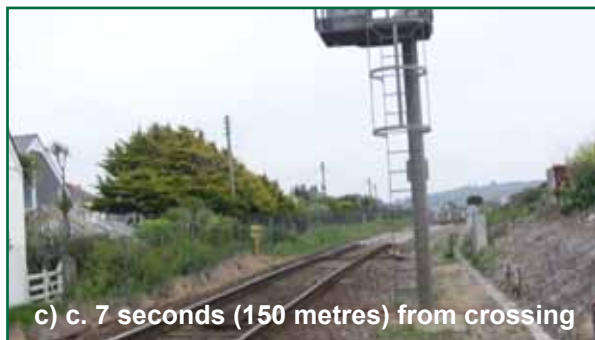
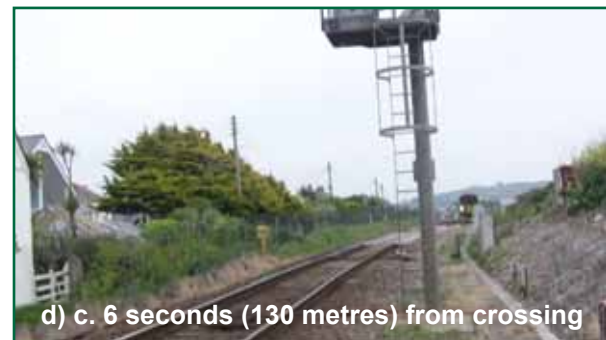
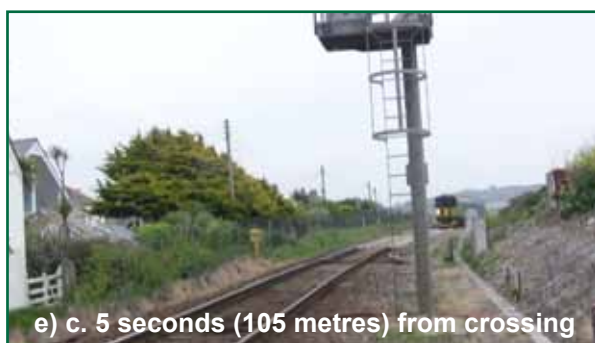
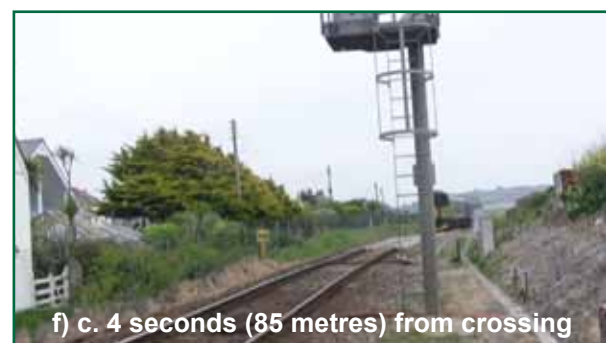
- 65 Figures 10a to 10f show that although the train is visible when it is around nine seconds running time from the crossing, the lower half of the train is obscured by two equipment cases for a period of around one second as it moves towards the crossing. The marker light which helps a pedestrian to distinguish the train as it approaches is obscured at this point, although the upper half of the front of the train and the side of the train are still visible. These findings are valid for someone looking from a position of 1.45 metres above ground. The RAIB noted that when the same train is viewed from 1.6 metres above ground (current Network Rail practice), the period of time over which the marker light disappears is shorter. This is because the roof of the equipment case is pitched and the higher the viewpoint, the narrower the obstruction to the user's view of the marker light (for a tall person, there would probably be no obstruction at all). The signal post also obscures the marker light, but at this point the train is closer and the period over which the marker light disappears is shorter.

Figures 10a to 10f: Views from the south side of Mexico footpath crossing towards a train approaching from the east taken at 1.45 metres above ground level and at 2 metres from the nearer rail. The images show that although part of the train is always in view, the distinctive marker light at the front of the train is temporarily hidden by the equipment cases at 7 seconds from the crossing and by the signal post at 4 seconds from the crossing.
