Rail Accident Investigation Branch

# Rail Accident Report

**Person trapped in doors and pulled along platform at King's Cross station, London  
10 October 2011**

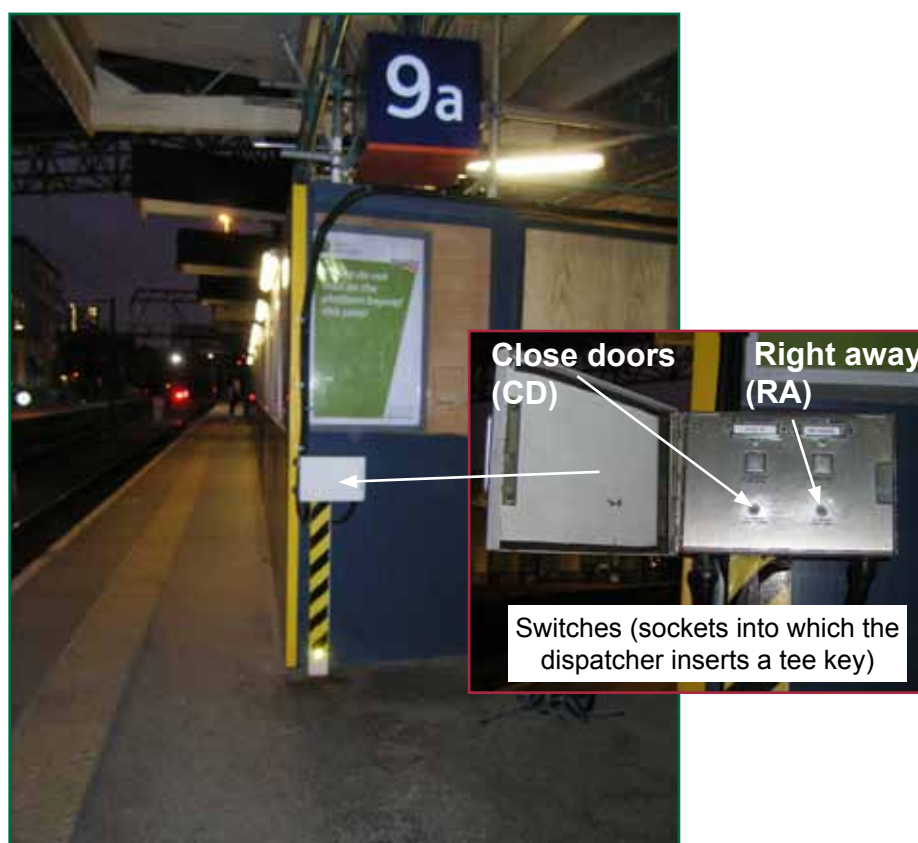
Figure 2: Dispatch point with CD/RA controls mid-way along platform 9

- 23 The dispatcher was standing at the dispatch point midway along platform 9, about 60 metres from the incident door and about 2 metres from the platform edge (figure 2). The distance to the incident door was significantly less than the 160 metres maximum viewing distance advised in RSSB publication RIS-3703-TOM<sup>5</sup>. Although there were few people on the platform, the group of people not intending to board the train were between the dispatch point and the incident door. This meant that the dispatcher did not have a clear view of passenger A and the incident door (figure 3). If the group had not been present, it is possible that the position of passenger A's body would still have prevented the dispatcher seeing her trapped hand.

- instructing dispatchers to position themselves, and move where necessary, so that they can get an unobstructed view of the whole side of the train;
- moving CD/RA control positions to a location with an improved view of the side of the train, or providing a wireless hand set for operation of these indicators;
- using public address systems to ask passengers to move away from the train; and
- use of closed circuit television (CCTV) or mirrors to assist dispatchers.

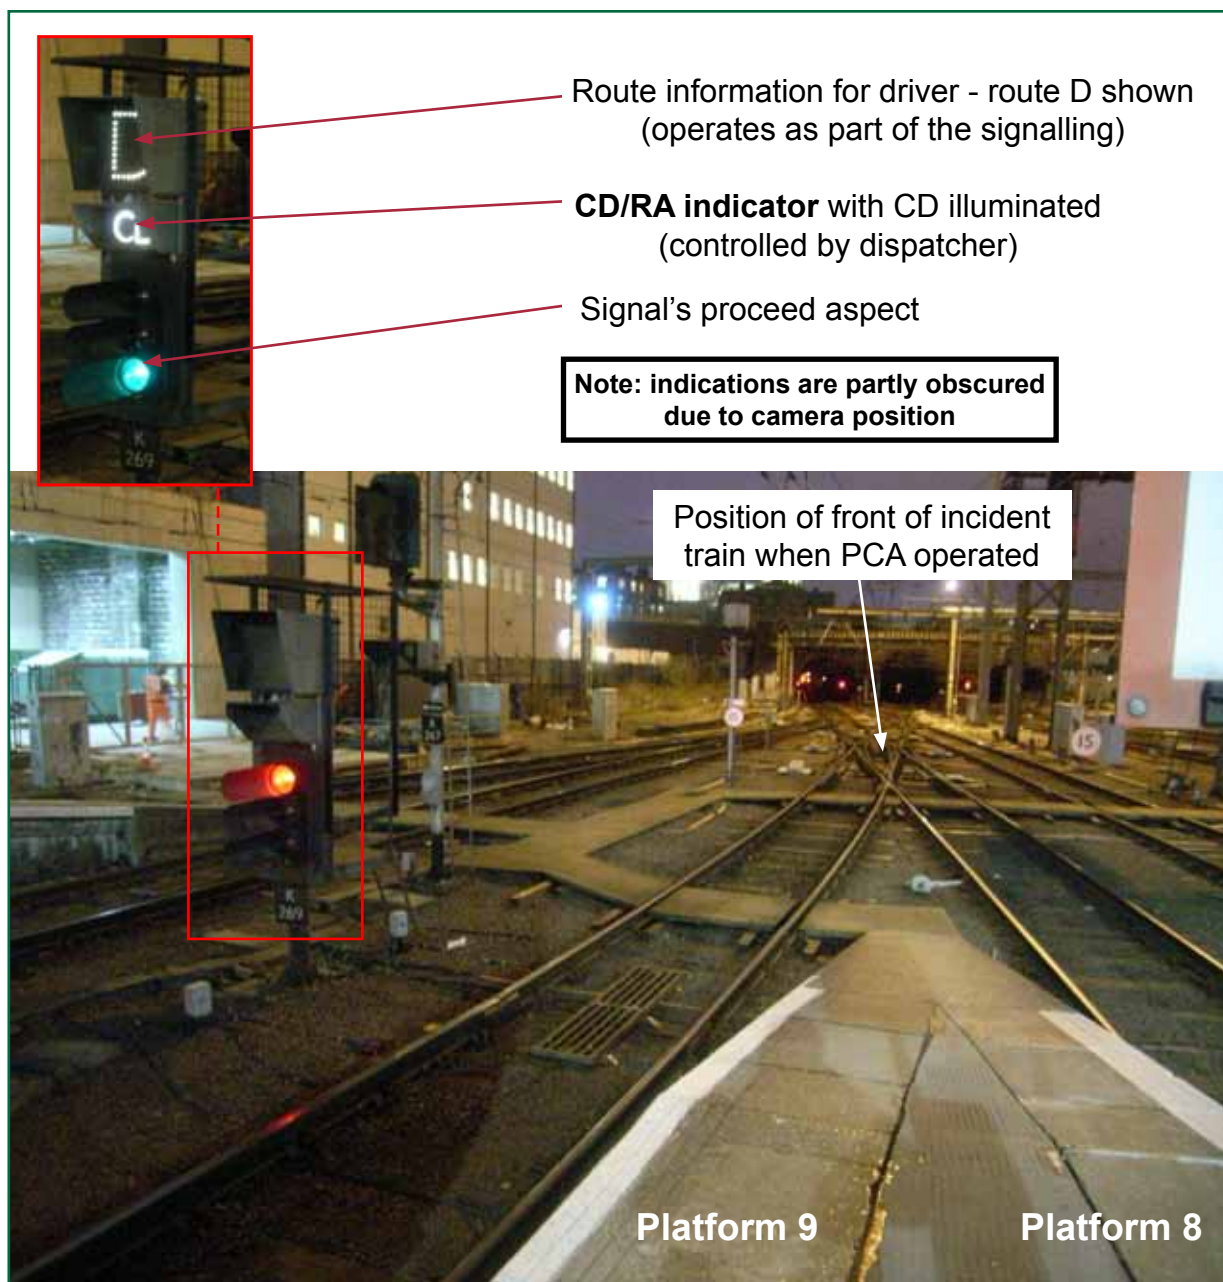
Figure 4: CD/RA indicator and trackwork used by trains leaving platform 9

- 46 When the PCA was operated, the front of the train had left the platform and was running on to the points at the exit from King's Cross station (figure 4). The driver assumed that there was a problem inside the train. He decided that an immediate brake application was inappropriate because this would delay evening peak services, and because the train would have stopped over points, a location where, according to his training, it would be difficult to provide assistance to passengers.

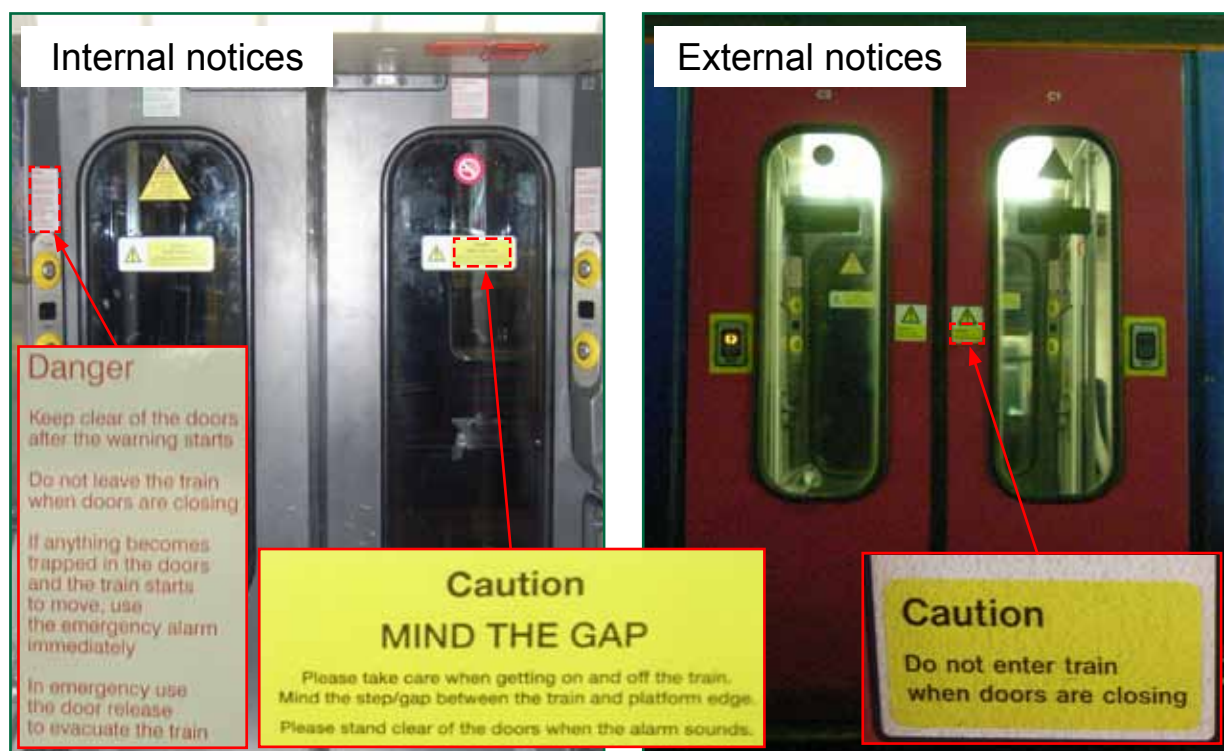
Figure 5: Typical safety notices on Class 365 train doors

19 Train operators have, for many years, recognised the risks of delay and possible injury associated with people and objects becoming trapped in sliding doors. Notices describing the proper use of sliding doors, or warnings against improper use, are found in proximity to most sliding doors on trains. Typical notices fixed around Class 365 doors are shown in figure 5.

- 50 FCC intends to run another poster campaign covering the risks associated with passengers attempting to board trains after the doors start to close. It also proposes wider use of public address systems to educate passengers about the correct use of train doors.
