Rail Accident Investigation Branch

# Rail Accident Report

## **Collision between a train and a tractor, White House Farm User Worked Crossing 25 September 2011**

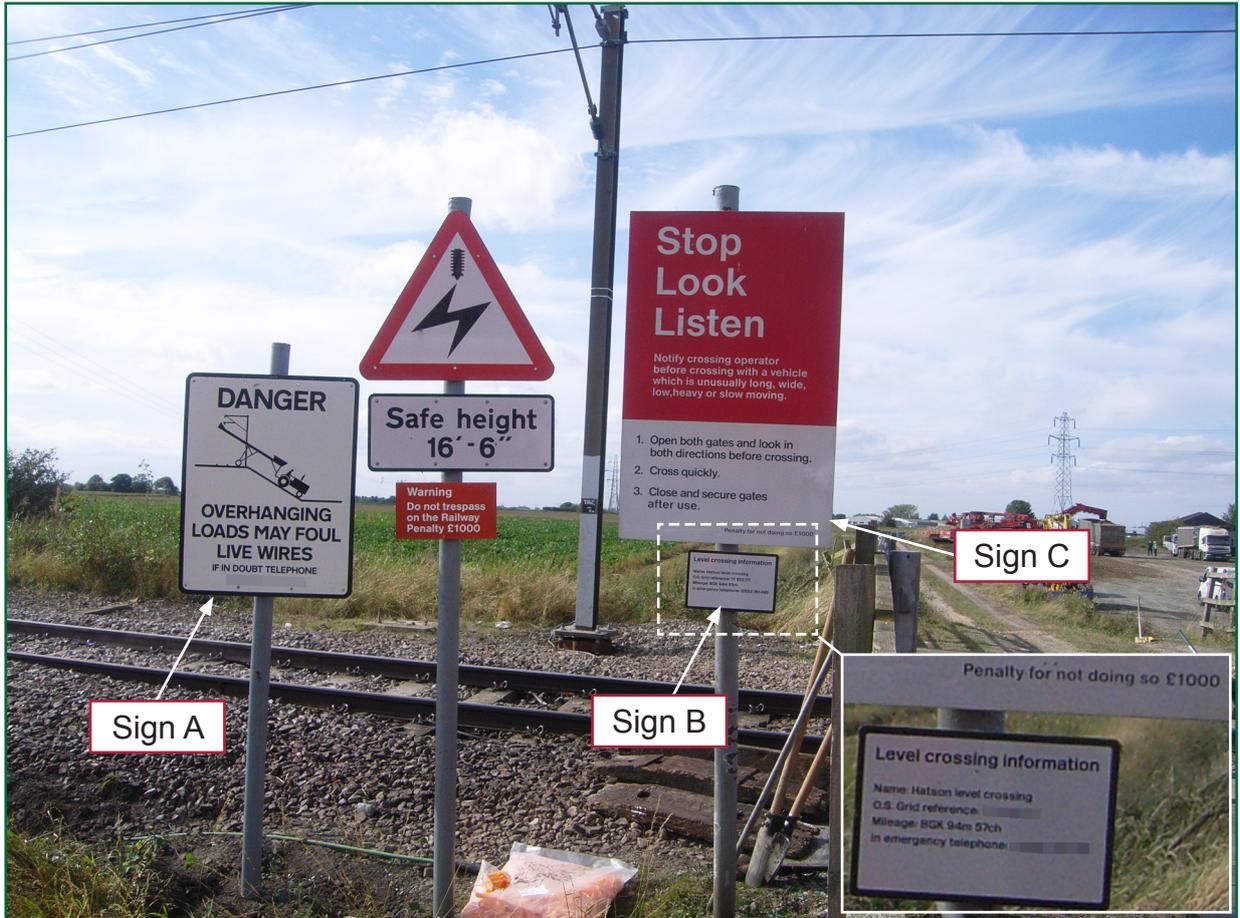
- 7 Signs at the crossing included two telephone numbers. One was for drivers of vehicles with overhanging loads who were required to call if they were in doubt as to whether their load might foul the overhead lines (sign A in figure 3). This telephone number connected the user with Network Rail's control centre for the Kings Lynn route. The other telephone number was for emergency use and connected the user with the signaller at Kings Lynn (sign B in figure 3). Drivers of vehicles that were unusually long, wide, slow, heavy or slow-moving were required to 'contact the operator' (sign C in figure 3), although there was no indication of which of the two telephone numbers was the right one to use.

Figure 3: Signs at White House Farm UWC

- 50 Five different signs were provided at the crossing (figure 6). Two different phone numbers were also provided, but a user could not tell from the signs who would respond. There was a reference to contacting the operator for drivers of designated vehicles (paragraph 7), without any indication of which phone number to use.

- 51 The number of signs is confusing and the signs lack useful information. The Rail Safety and Standards Board is currently undertaking a research project, 'T983 - Research into signs at private level crossings'. The scope of the research includes determining the instructions, messages and/or warnings that should be conveyed to users of level crossings on private roads, and on private land, to ensure that they carry out the required actions correctly and safely.

- Re-assessed sighting distances at White House Farm UWC and found that they are not compliant. Network Rail intends to install telephones at the crossing to provide users with a direct means of communication with the signaller before they cross (paragraph 64a).
- Restored the telephone number which had previously been out of use (paragraph 64d).
- Updated its records regarding the authorised user at White House Farm UWC (paragraph 64e).

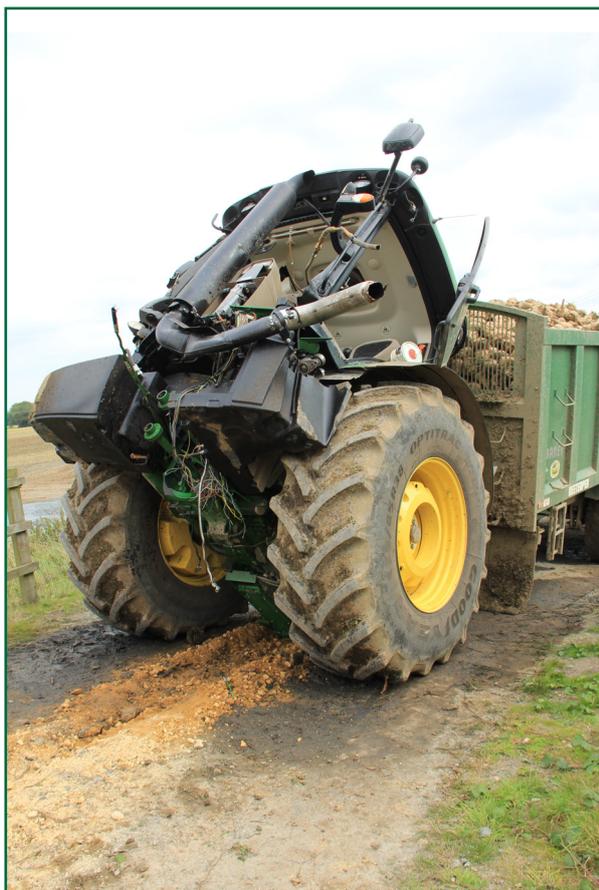
- 17 The driver of the train vacated the cab shortly before the train struck the tractor. The impact between the train and the tractor caused the front of the tractor to be separated from the driving cab (figure 4). The tractor driver remained in the cab of the tractor, but suffered a broken collarbone, lacerations and bruising.

Figure 4: The cab section of the tractor (trailer still attached)

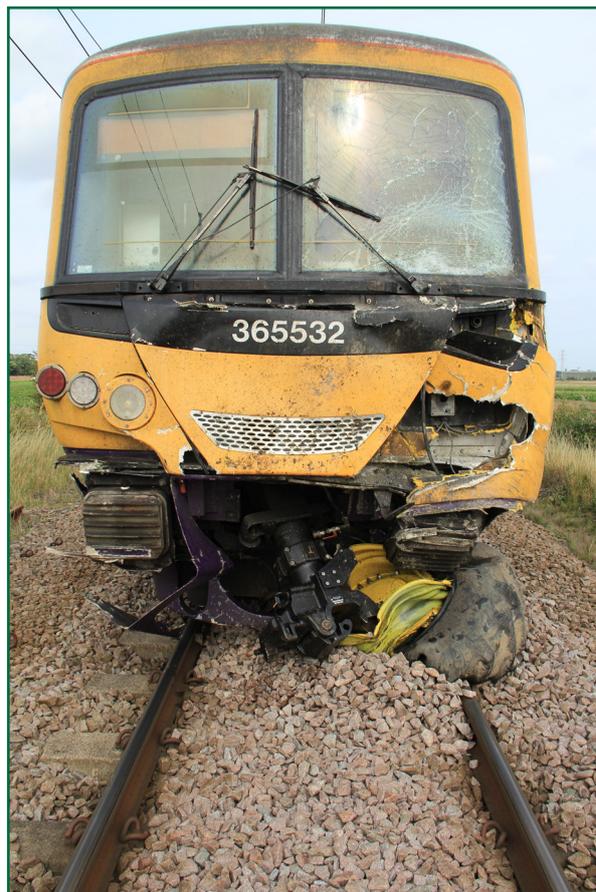
- 18 Debris from the front half of the tractor became lodged under the train (figure 5). In the aftermath of the collision, the second wheelset on the train was derailed, but the train remained upright and in line, stopping approximately 320 metres from the crossing. There were 41 passengers and a Revenue Protection Inspector on the train. None were injured.

Figure 5: Debris under the front of train 1T60

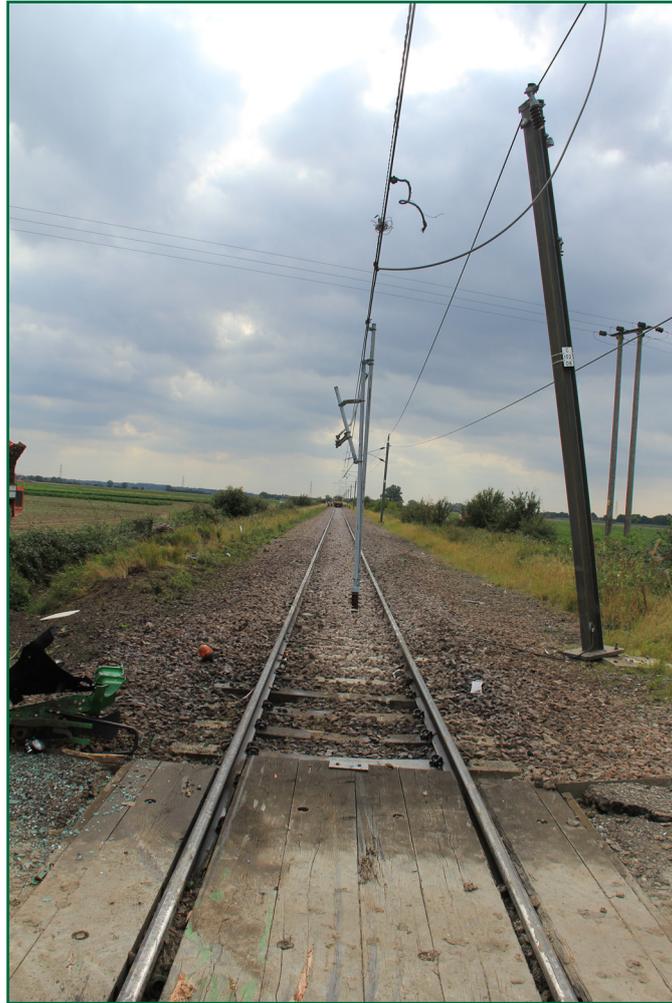
- 20 A solid metal counterweight (weighing approximately 1100 kilograms) on the front of the tractor was detached in the collision and it struck and dislodged a stanchion supporting the overhead line equipment which supplies traction current to trains. The power lines were left hanging near the track (figure 6). It was necessary for the equipment to be isolated and earthed before passengers could be evacuated from the train. The evacuation did not start until approximately 13:00 hrs.

*Figure 6: Damage to overhead line stanchion and equipment caused by counterweight from tractor*

- 39 There was a need to earth the dislodged overhead line equipment (paragraph 18) before evacuation could commence. The nearest staff competent to undertake earthing were at Cheshunt, almost 100 miles, and around two hours' drive, away. By the time that they had been deployed, travelled to Kings Lynn and applied the earthing equipment, almost three hours had elapsed since the accident.

- 40 Network Rail has no staff in the Kings Lynn area trained in earthing, although MOMs are trained to undertake switching of the overhead line equipment and to remove objects from the overhead line. If local staff had been on-hand, earthing could have been accomplished earlier. Passengers could have been evacuated as soon as coaches for their onward transit were available. The coaches were in place 90 minutes after the accident and evacuation might therefore have been accomplished approximately 75 minutes earlier than was achieved on 25 September 2011. It should also be noted that delays in earthing can impede fire-fighting operations as fire crews will normally seek assurance that the overhead line is earthed before applying water to a fire or working in close proximity to electrical conductors.

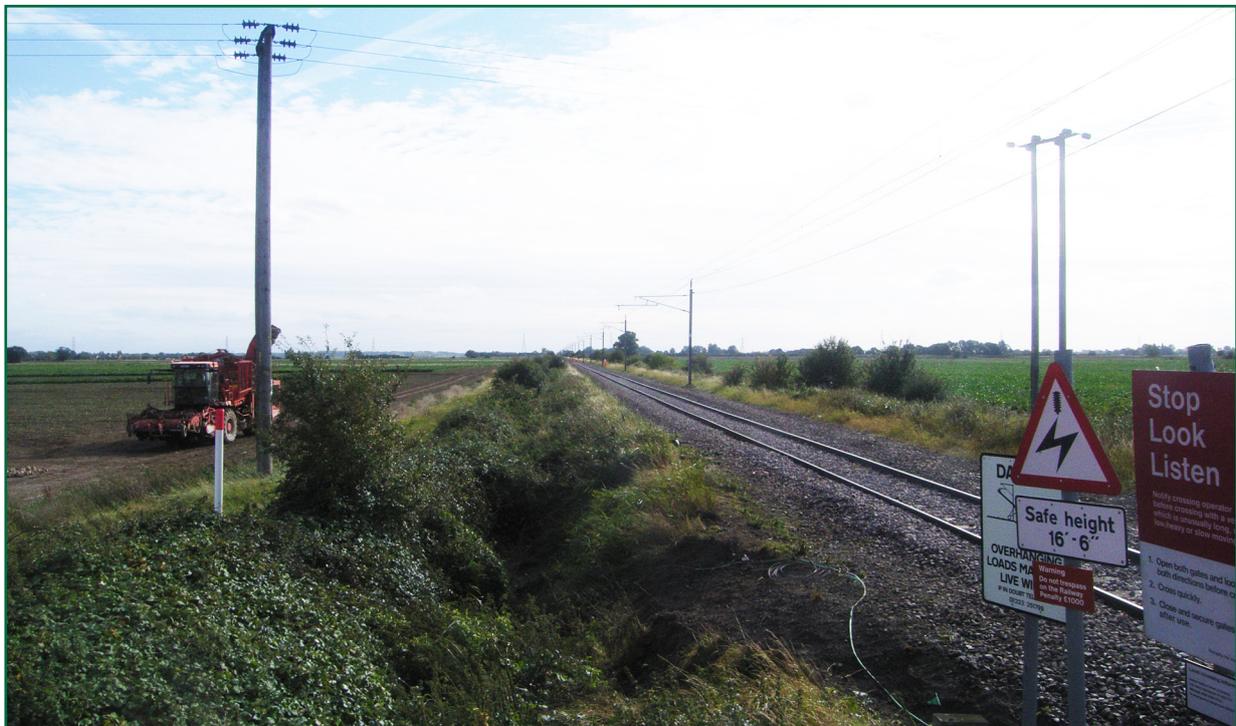
- 47 This makes a significant difference to sighting distances (figure 7). The crossing gate and signage are located 2.6 metres from the nearer rail on the up (east) side of the crossing. Network Rail had estimated the sighting distance towards Watlington to be 1388 metres from this point<sup>12</sup>. The RAIB observed that the sighting distance changed significantly if measured from a point further back from the crossing, for example:

- 475 metres when viewed from a position 3.2 metres from the sign/gate (5.8 metres from the nearer rail); and
  - 317 metres when viewed from a position 5 metres from the sign/gate (7.6 metres from the nearer rail).

- 48 The front of a tractor similar to the one involved in the accident on 25 September 2011 is approximately 3.7 metres from the driver's position. For the purposes of illustration, if the tractor driver were to stop with the front of the tractor approximately two metres from the nearer rail (as is likely if the driver is looking for trains), the sighting distance towards Watlington would be around 500 metres; equivalent to a sighting time of around 12 seconds for a train approaching at 90 mph (145 km/h).

Figure 7: Sighting from White House Farm UWC towards Watlington at 5.8 metres from the nearer rail on the east side of the crossing from a height similar to that of a person sitting in a tractor. Sighting from a point further back would be significantly impaired by the vegetation to the left of the line.
