Rail Accident Investigation Branch

Rail Accident Investigation: Interim Report

**Partial failure of a structure inside Balcombe
Tunnel
23 September 2011**

Report IR1/2013
January 2013

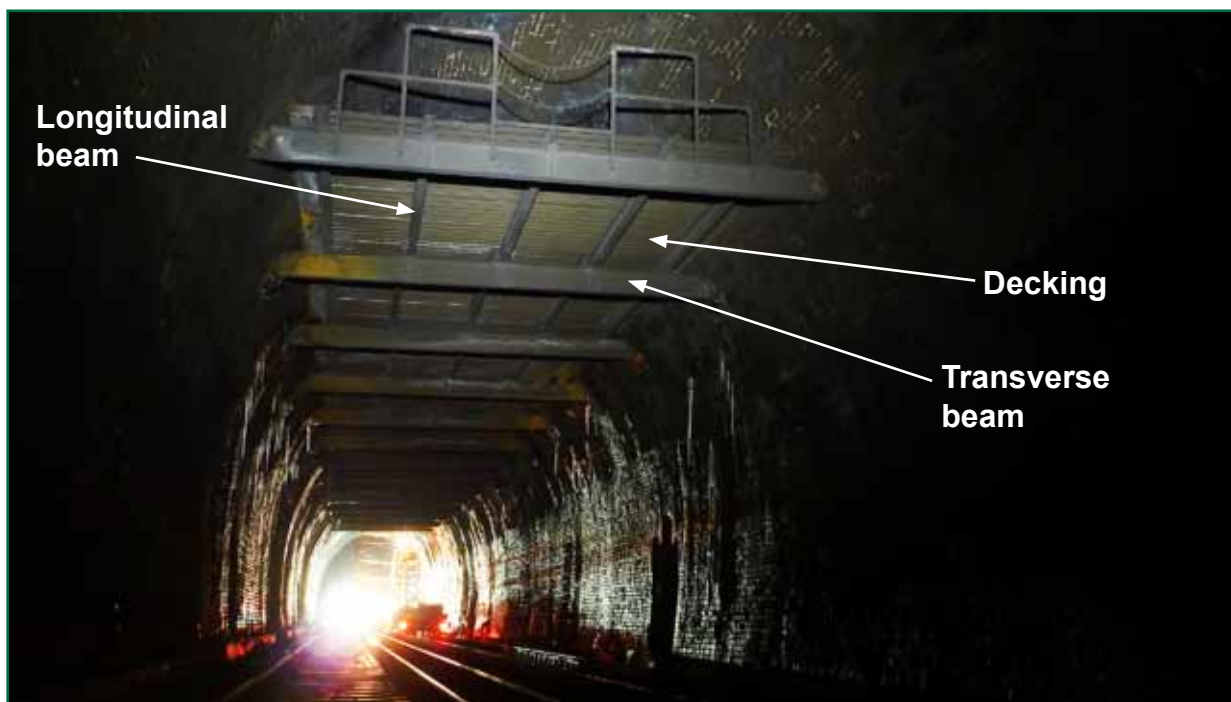
- 7 The water catchment tray involved in this incident (figure 2) was installed in 1998/99 and was 72 metres long. (It was shortened after the incident.) It comprises a deck, supported by longitudinal beams which in turn rest on transverse beams. The transverse beams are about six metres long and are located at four metre intervals. The beams are bolted to brackets supported by studs which are grouted⁴ into holes drilled in the tunnel brickwork, two on each side of the beam end (figure 3).

Figure 2: Water catchment tray structure

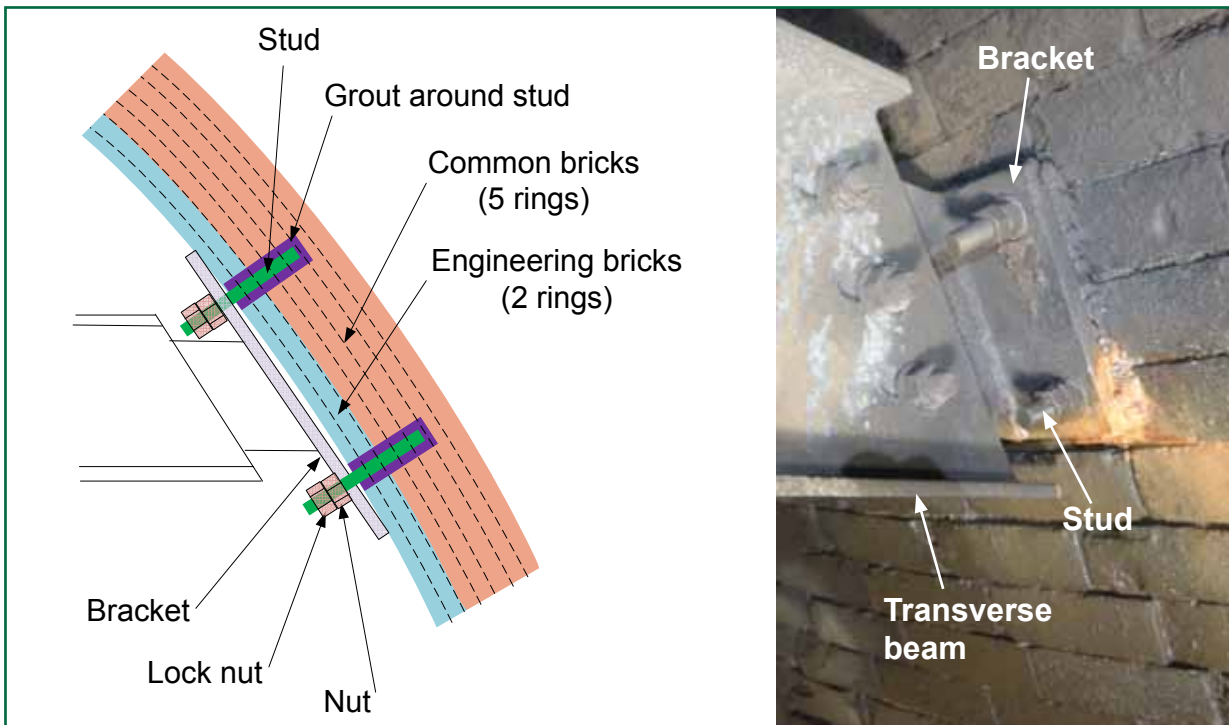
Figure 3: End fixing detail (photo courtesy of Amey)

- 10 It is probable that the studs were displaced as the structure vibrated due to the aerodynamic (wind) forces caused by passing trains. This was probably because, for reasons explained below, some studs were not adequately bonded to the brickwork by grout.
- 11 Post incident testing has shown that the grout used to fix the studs into the brickwork did not bond with the engineering bricks⁵ which form the innermost rings of brickwork (figure 3). This testing also showed that, in some locations, the grout was only poorly bonded to the remaining brickwork.
- 12 Witness evidence suggests that a volume of grout used around each stud had been pre-calculated. Post incident testing showed that
- grout was missing along parts of some studs;
 - some grout had escaped into gaps where mortar had been lost from the brickwork; and
 - some holes had been drilled longer than the nominal length.

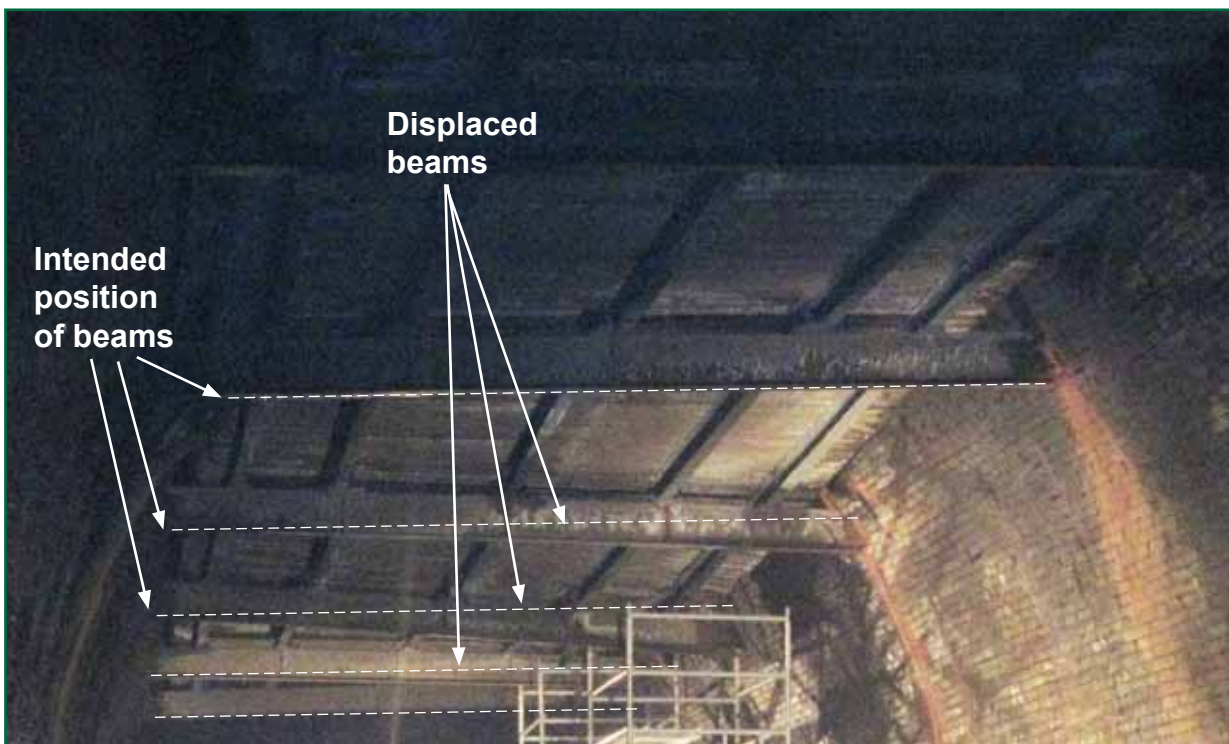
- 8 Following the train crew's earlier report a Network Rail inspection on 23 September established that, on one side of the tunnel, three adjacent transverse beams were detached from the tunnel wall. At these locations, the beam ends had dropped about 0.5 metres (figure 4). The beams were not fouling the path of a train but there was risk of them moving until they did so. The beam ends had become detached because the four studs at each beam end (a total of 12 studs) had fallen from the tunnel wall.

Figure 4: Deflected structure (photo courtesy of ORR)

23 Network Rail undertook emergency repairs to the defective part of the structure before train services resumed on 24 September 2011. Subsequently the defective part of the structure has been removed and additional support brackets have been installed under all similar water catchment trays in Balcombe tunnel. Network Rail has established that there are no other similar structures on their infrastructure.

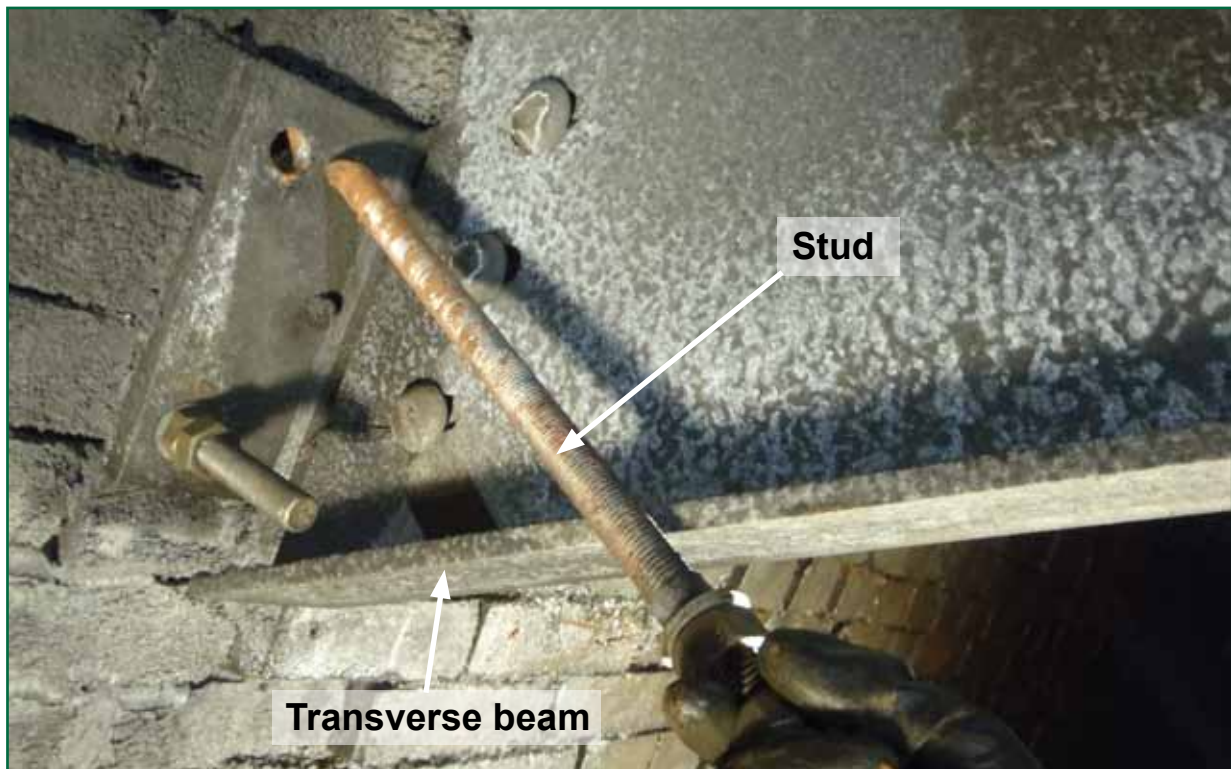
- 9 All similar beam ends supporting water catchment structures in the tunnel were also inspected on the 23 September with the exception of ten beam ends which could not be inspected because they were close to the displaced beams. This inspection showed that, in addition to the 12 studs missing at the detached beam ends, at least six other studs were missing, at least five were loose, and nuts were loose or missing on at least 29 other studs (figure 5).

Figure 5: Loose stud outside incident area removed by hand during inspection on 23 September 2011 (photo courtesy of Amey)
