Rail Accident Investigation Branch

# Rail Accident Report

**Incident involving a runaway track maintenance  
trolley near Haslemere, Surrey  
10 September 2011**

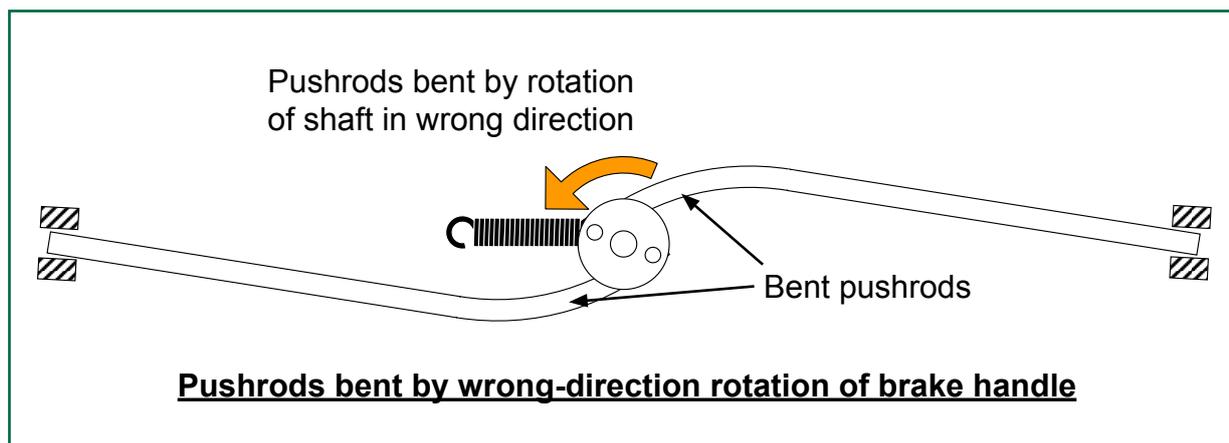
- D5 If the handle is pushed in the wrong direction, the brakes remain applied. If the handle is forced further in this direction, the pushrods, which are made from steel tubing, can start to bend and wrap themselves around the camshaft (figure D5). Damage consistent with this mechanism was observed on six of the seven LT1000P trolleys examined after the incident, figure D6. Bending of the pushrods in this way probably occurred incrementally due to trolley operators mistakenly applying too much force to the brake handle in an initial attempt to release the brakes, before realising that the handle should be pushed in the opposite direction. If the damage had occurred over a short period, it is likely that the operators would have noticed the sudden changes in the positions of the brake handle and put the trolleys into quarantine.

Figure D5: View of the brake linkage showing bending of brake pushrods

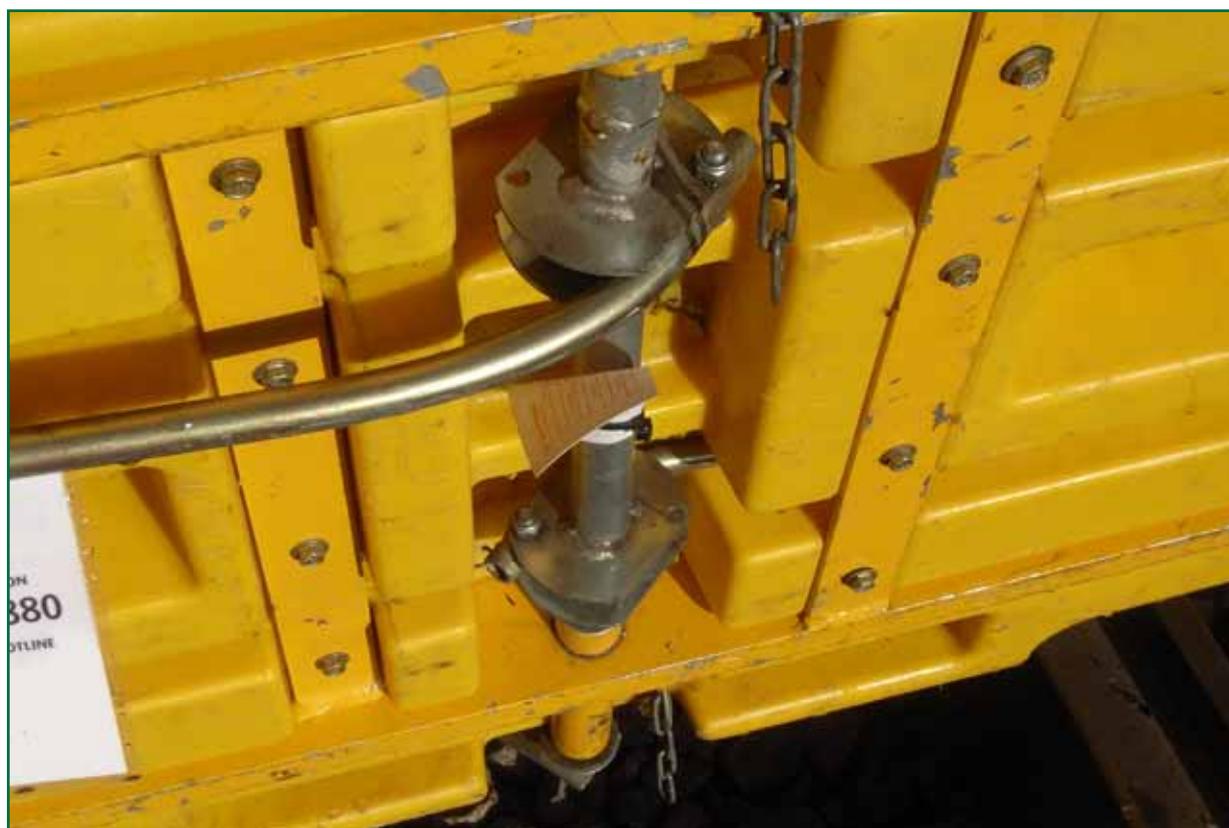
Figure D6: Brake linkage of a trolley from Havant depot, as examined after the incident

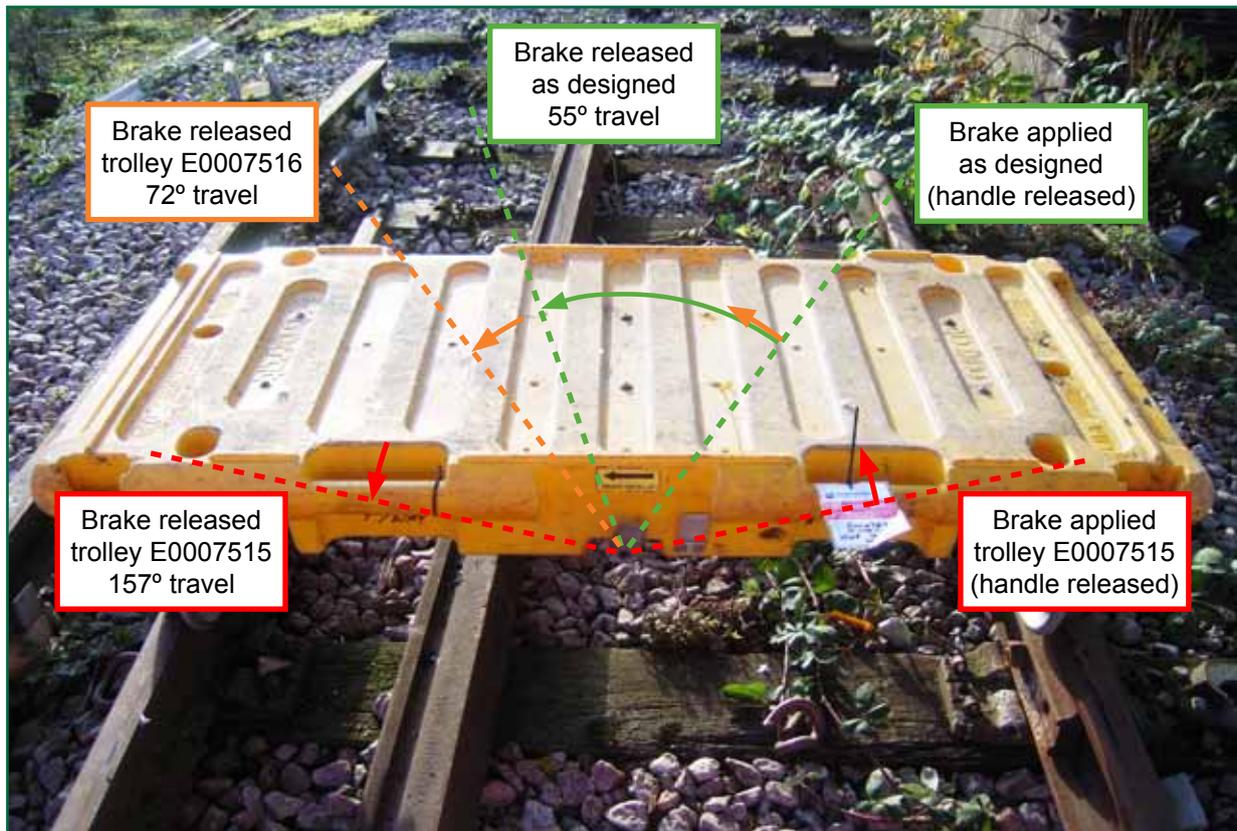
D6 As the pushrods start to bend around the camshaft, the angle through which the handle must then be turned in the correct direction to release the brakes is increased; this probably makes it harder to use the trolley. Testing by the RAIB established that the total angle through which the brake handle had to be rotated to release the brakes (figure D7), including slack in the mechanism, was approximately:

- 72° for the trolley from Reading depot; and
- 125° and 157° respectively for the two trolleys from Havant depot.

Figure D7: Rotation of brake handle required to release the brake

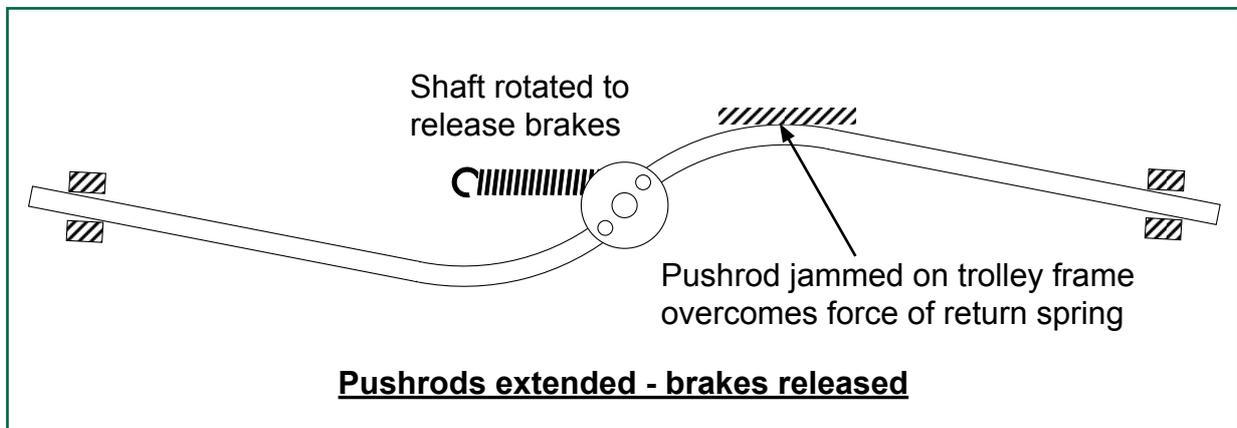
- D7 Where the bending of the pushrods has become extreme, the upper pushrod can rub on the trolley frame. During testing, the RAIB observed that the friction was sometimes sufficient to cause the pushrod to jam and prevent the brakes from applying, figures D8 & D9.
- D8 When the trolleys were examined by the RAIB and Network Rail after the incident it was also found that two of the four securing bolts were missing from one of the brake discs on trolley E0007515, and that a lubricant or release agent had been applied to the surface of the discs. Although these conditions each had the potential to prevent the brakes from applying, neither of them was sufficiently advanced to have done so at the time of the incident. The RAIB did not therefore consider them further in this investigation.

Figure D8: View of the brake linkage showing bent upper pushrod jammed on trolley frame

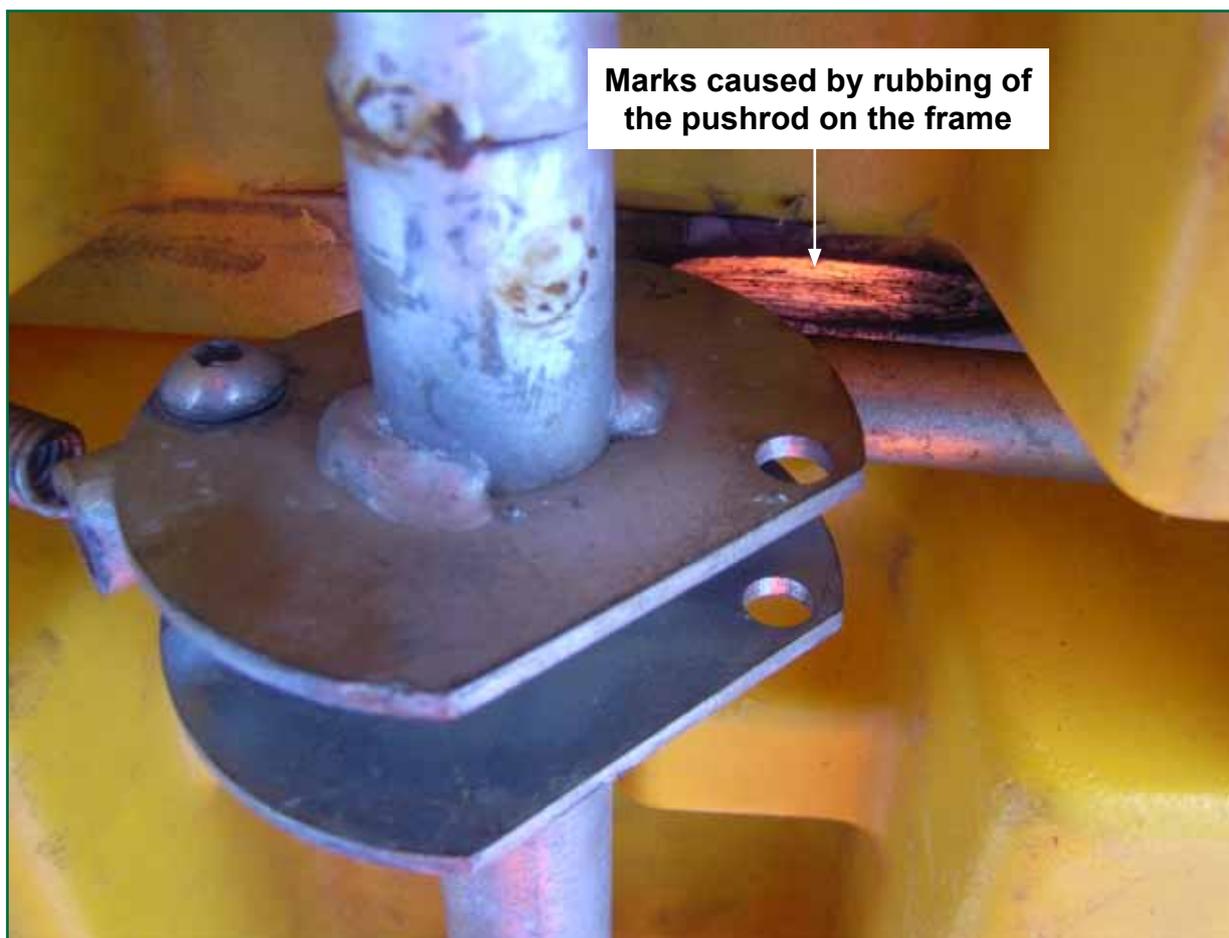
*Figure D9: Close-up of the upper brake pushrod, showing evidence of rubbing on the frame*
