Rail Accident Investigation Branch

Rail Accident Report

Near miss incident at Ufton Automatic Half Barrier Crossing, Berkshire 4 September 2011

Report 28/2012
December 2012

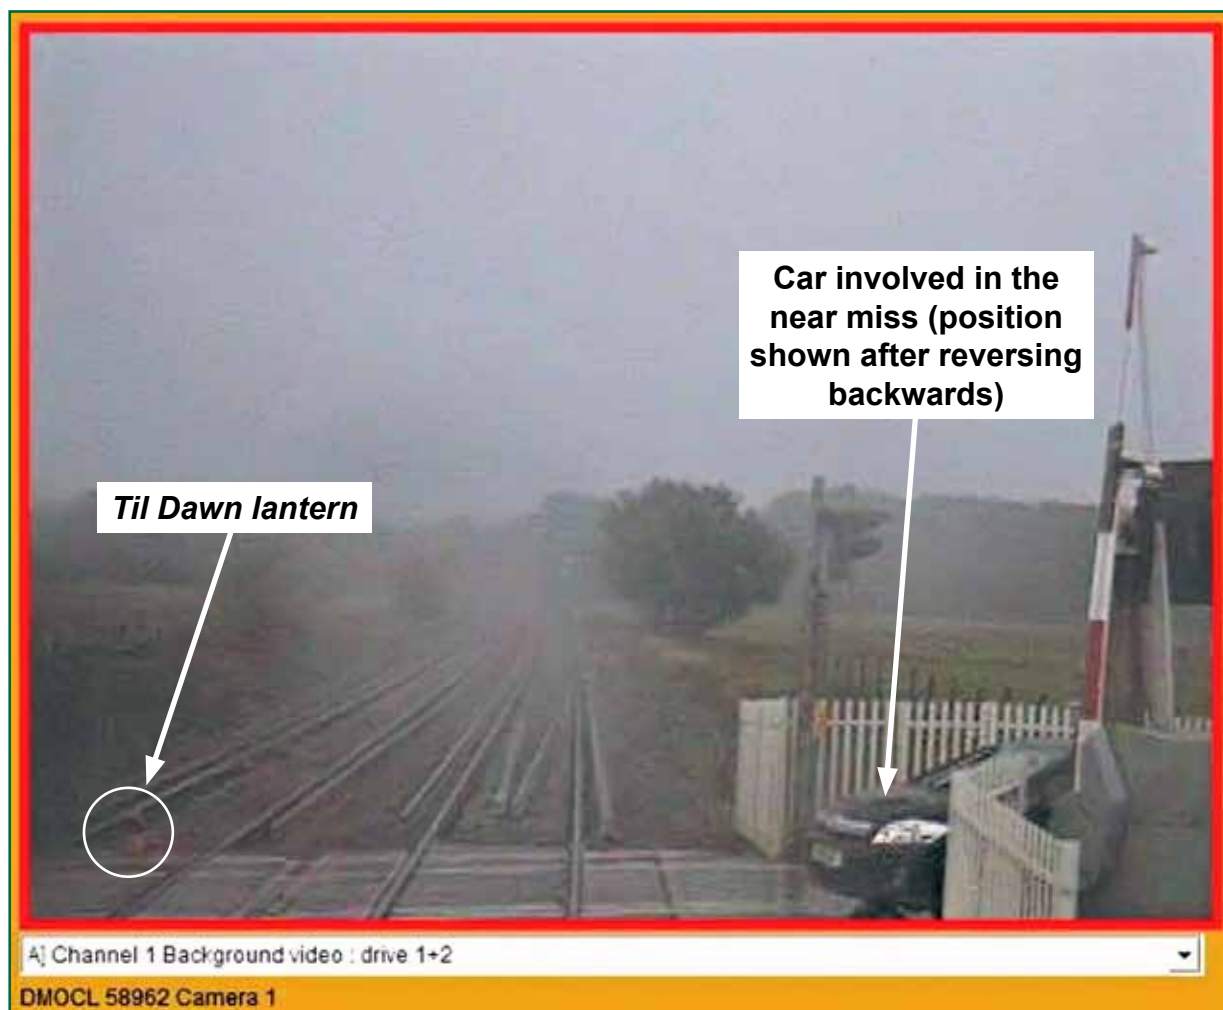
Figure 10: Rear facing CCTV image from train 1K54 showing Ufton Crossing and the car involved in the near miss

- 70 At about the same time, the car driver reversed his car to check that the road traffic signals were not illuminated. Having found that they were not illuminated, he drove over the crossing and onwards to his final destination.

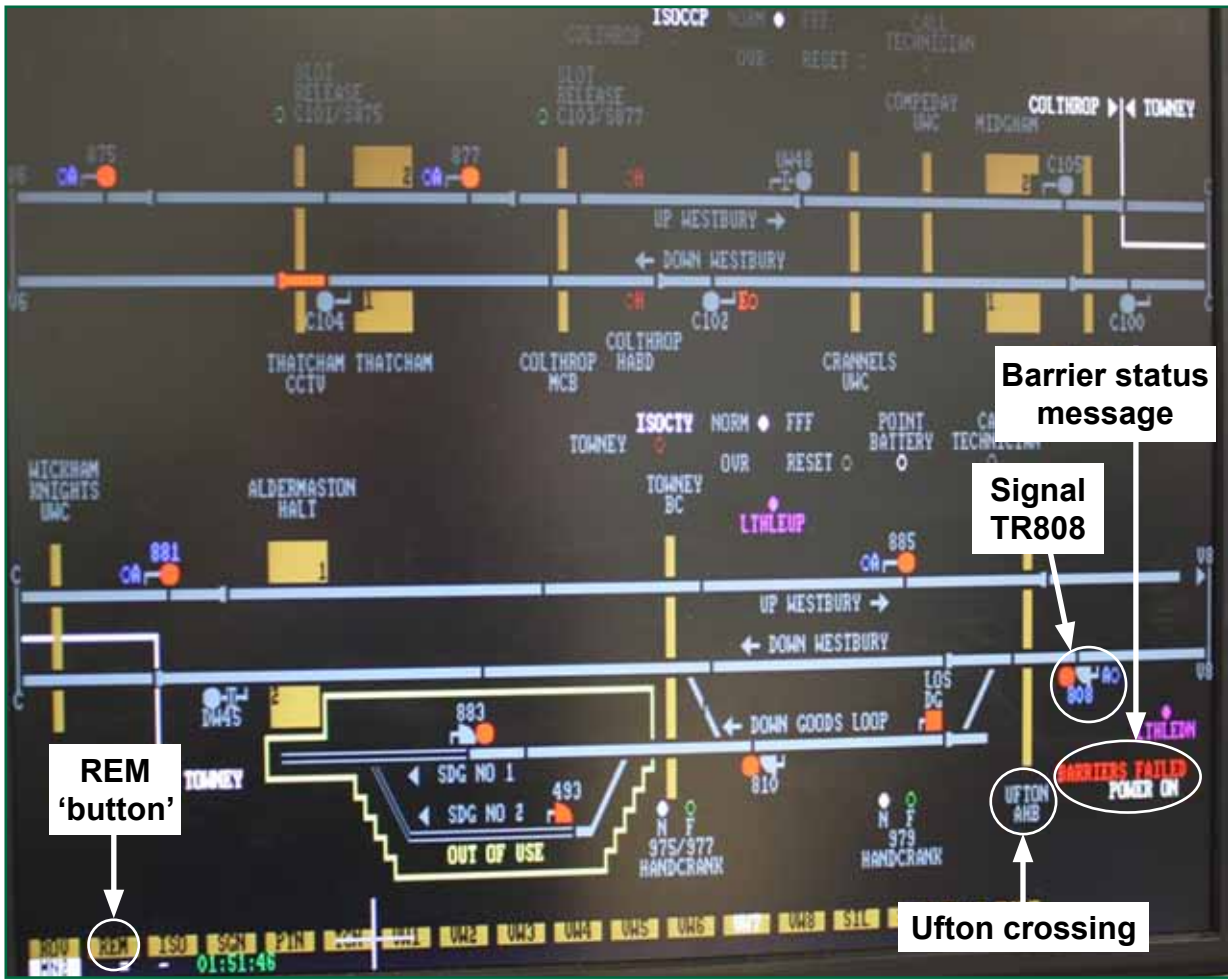
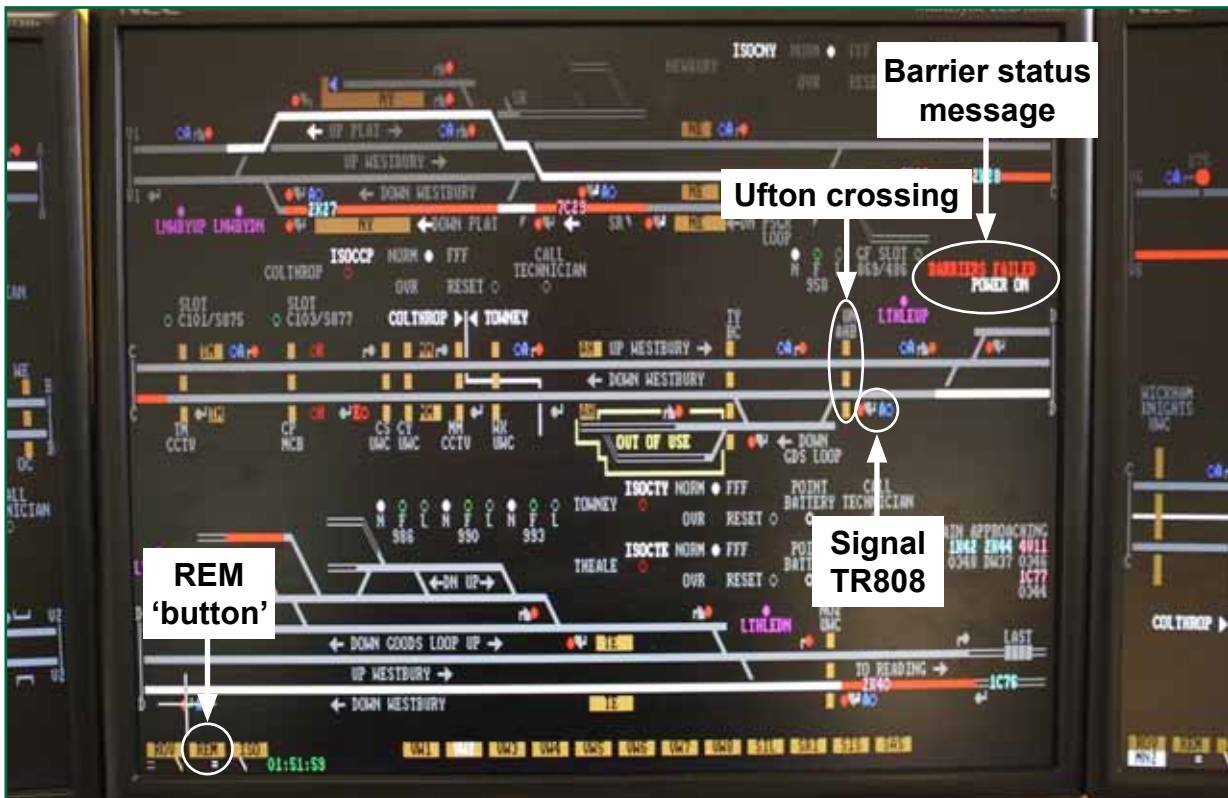
112 The status message ('barrier failed') displayed on detailed view 7 and overview 2 when Ufton crossing is under local control are shown on figures 11 and 12 although the exact display detail (train locations, signal status etc) do not exactly match what would have been displayed at the time of the incident. The barrier status message is the only indication given to the signaller that the crossing is under local control excepting a warning which is acknowledged when local control is first implemented (an event which, in this incident, took place before signaller B started his shift).

- 132 When Ufton AHB was under local control, the Newbury workstation VDUs did not show 'FAILED/ LOCAL CONTROL' as required by the operating specification. Instead, the displays read, 'BARRIERS FAILED'. The term 'local control' has the advantage of reminding the signaller of the presence of a level crossing attendant.

- 3 *The intent of this recommendation is to ensure that, when automatic half barrier level crossings are under local control, IECC displays provide conspicuous warnings compatible with Network Rail's IECC control and indication specification.*

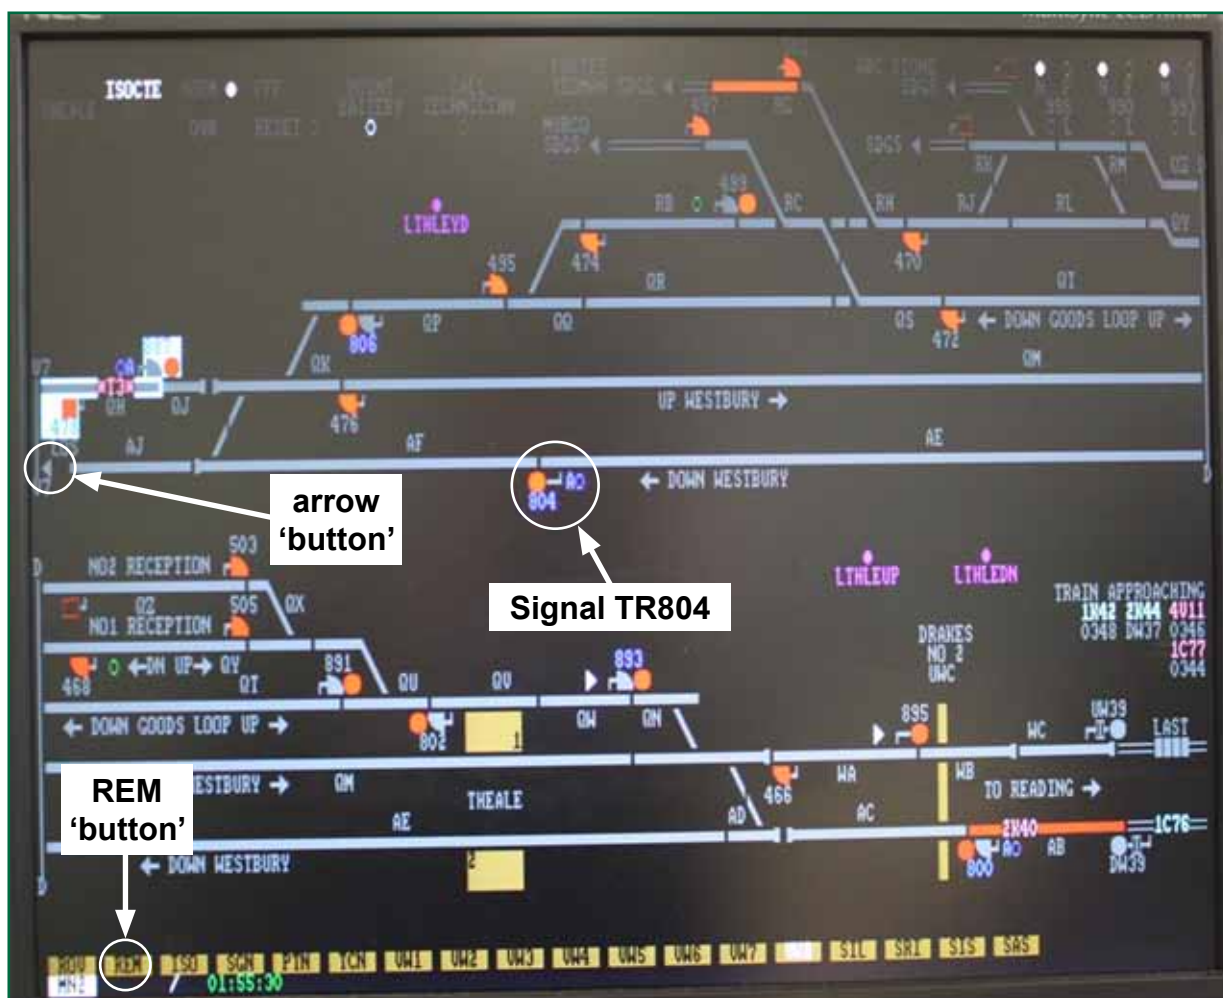
Figure 13: VDU screen 'detailed view 8'

- 108 It is possible that the signaller removed the reminder using the 'arrow' button on detailed view 8 (figure 13). Neither Ufton level crossing, nor an indication of the crossing's status (eg barriers failed) is visible when the reminder is removed using the arrow on detailed view 8. The barrier status is shown on overview 2 and (although probably not displayed when the reminder was removed) detailed view 7. Even if one of these views was displayed on an adjacent screen, the status would not be adjacent to the arrow on detailed view 8.

- 109 The ability to remove the reminder using the arrow on detailed view 8 is an error trap because the signaller could remove a safety critical reminder when the associated crossing status message was not visible.

- 1 *The intent of this recommendation is to ensure that signallers can see appropriate information on the VDU screen when considering whether to remove reminders from signals and points using controls on IECC workstation VDUs. These include reminders on signals that are used to protect an automatic crossing under local control.*

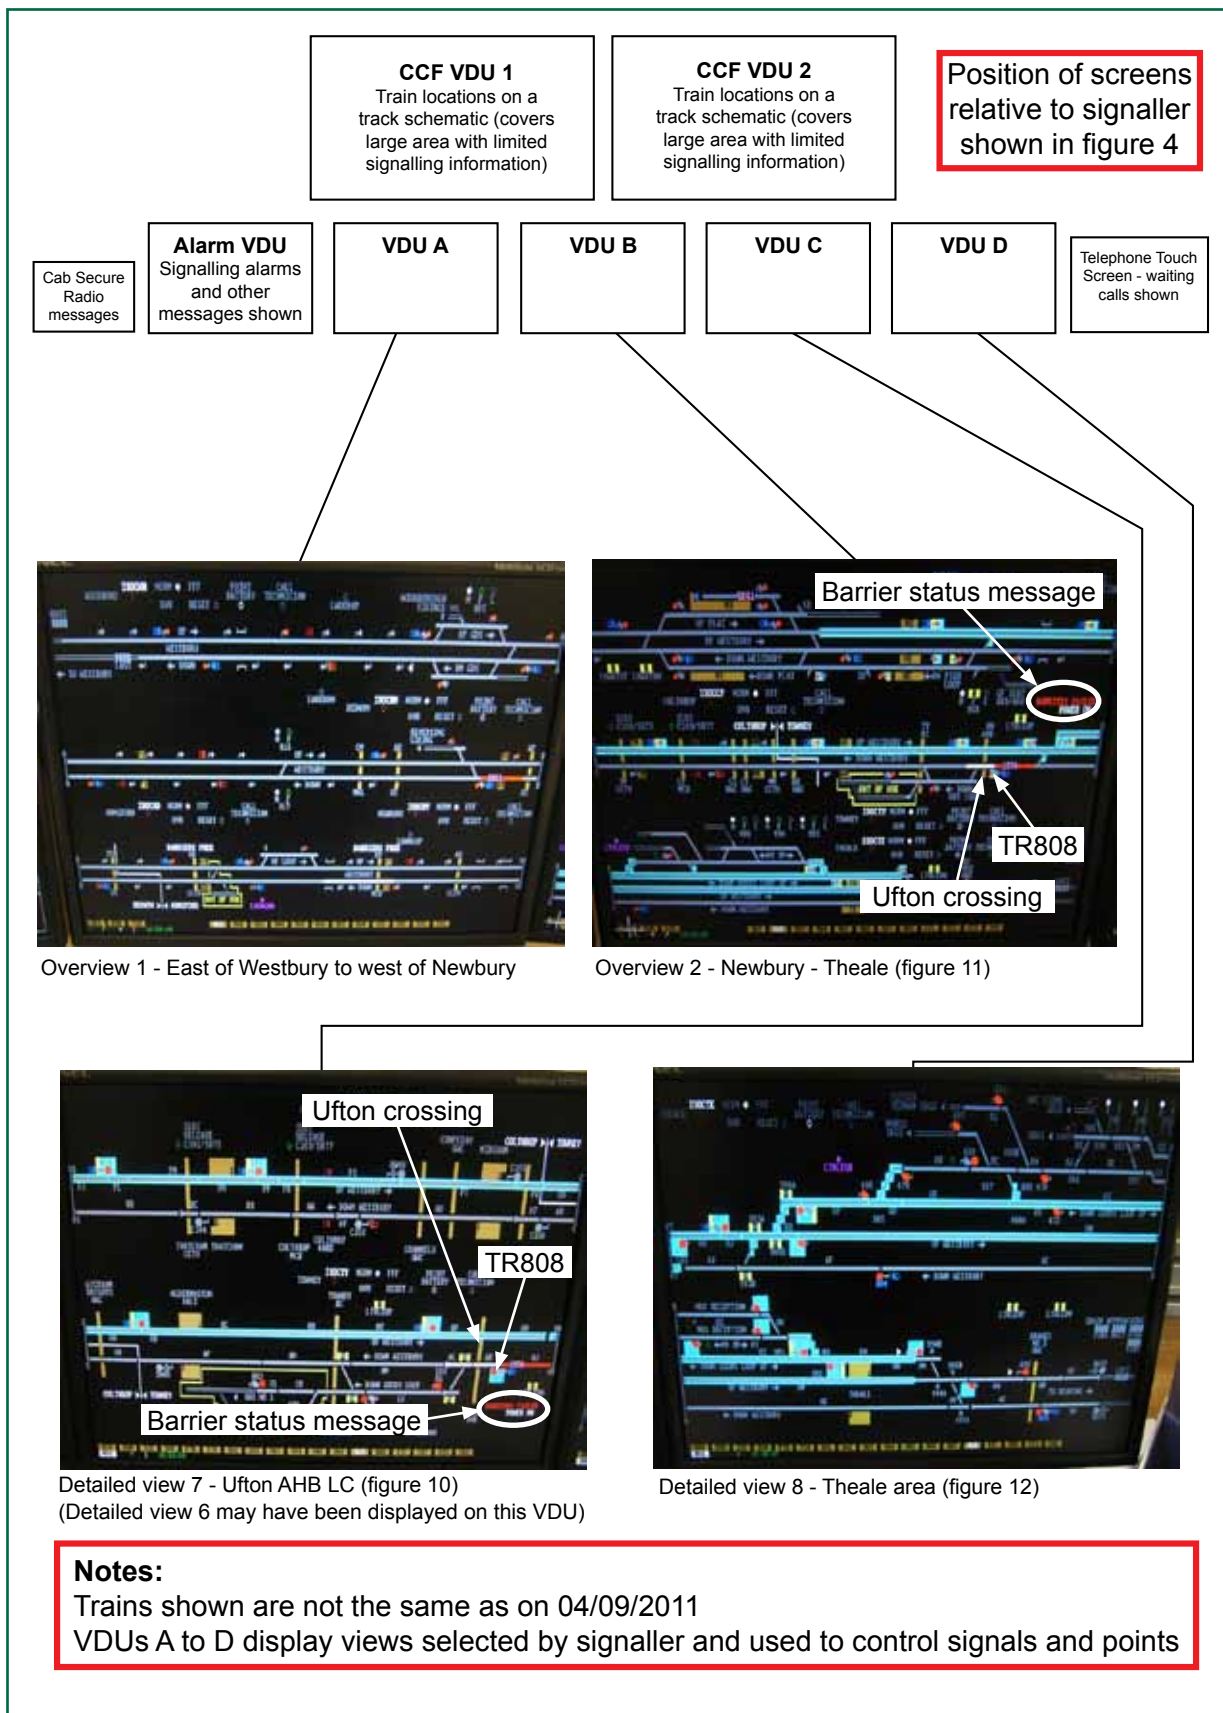
Figure 15: VDU views probably displayed when the route was set from signal TR808 and over Ufton crossing

110 The level crossing barrier status message was positioned at a location where it could be overlooked by a signaller setting a route over the crossing. This was a possible causal factor.
