Rail Accident Report

Derailment at Princes Street Gardens, Edinburgh 27 July 2011

Derailment at Princes Street Gardens, Edinburgh, 27 July 2011

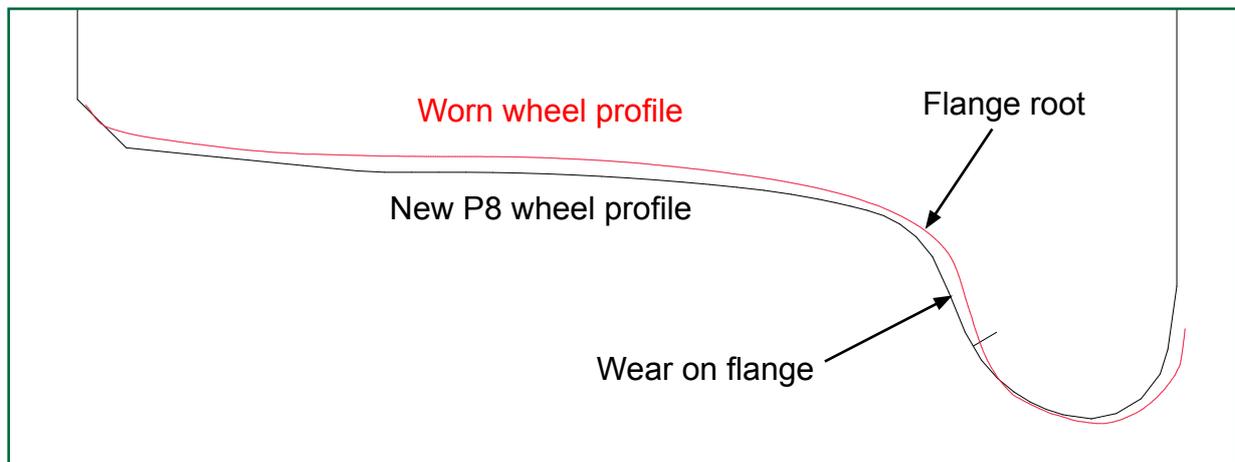
- 49 Measurements taken by Network Rail of the train's wheel dimensions showed that the first wheel to derail, the leading left-hand wheel on the leading bogie of the third coach, had around 2 mm of wear to the wheel flange thickness, with minimal wear to the wheel *tread*. All other wheels on the train showed a similar pattern of wear, although the first wheel to derail had marginally the thinnest flange. The flange thickness of this wheel was, however, well within the limits provided by the Railway Group Standard (paragraph 16) measuring 26.1 mm compared with the minimum limit of 24 mm.
- 50 The wear to the flange occurred in the flange root area (figure 6).

Figure 6: Wear to the flange thickness on first wheel to derail compared with new P8 wheel

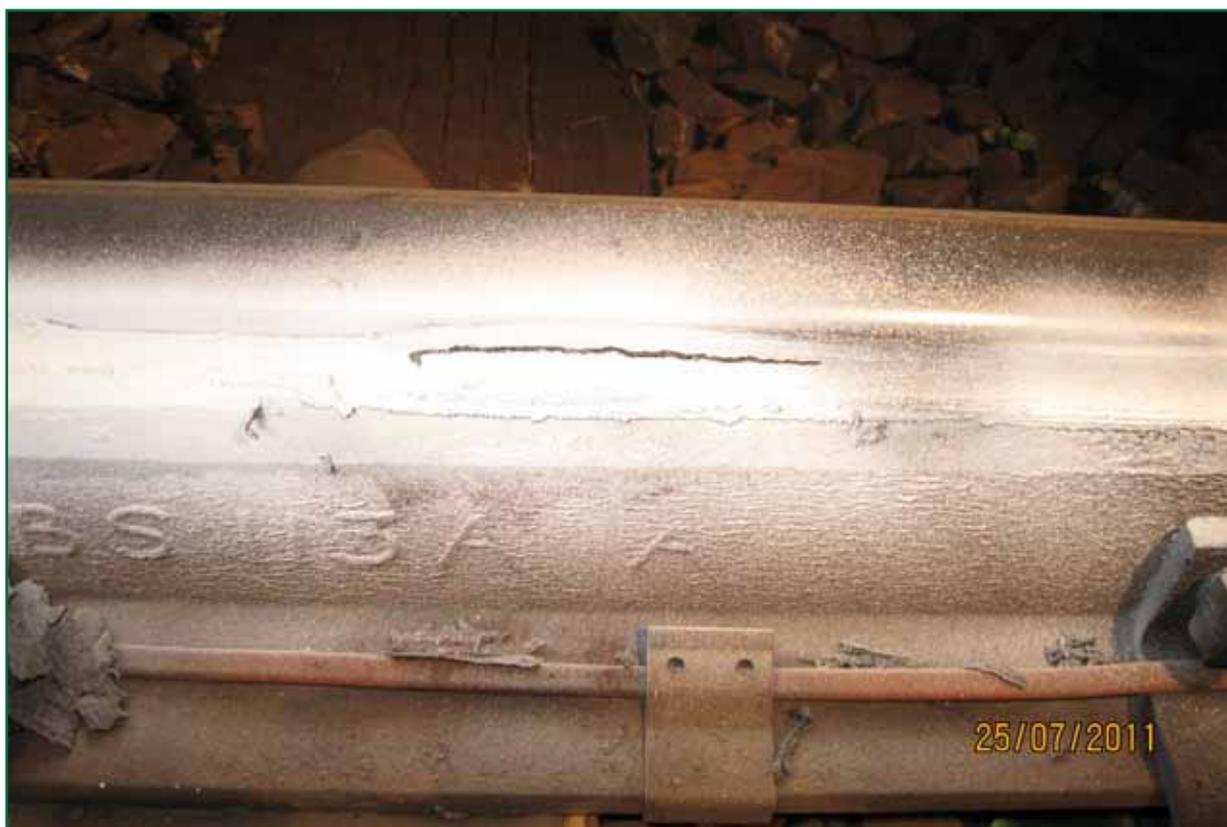
- 86 The former GSM and the grinding technician reported to the RAIB that they were shocked by the condition of the left-hand switch rail. The grinding technician described it as one of the worst switches he had seen on a main line. He noted that it was very low relative to the stock rail in the first metre but with no damage in this area. When he stripped the lubrication from the switch rail he also noticed a previously unidentified crack about 140 mm long, starting approximately 1.5 metres from the toe and running close to the top of the switch rail (figure 7). Although the grinding technician was unsure about whether the switch was repairable by grinding, work proceeded to attempt to restore a profile that would pass the TGP8 gauge and to remove the crack.

Figure 7: Crack in left-hand switch rail of points 167B at 1.5 metres from switch toe

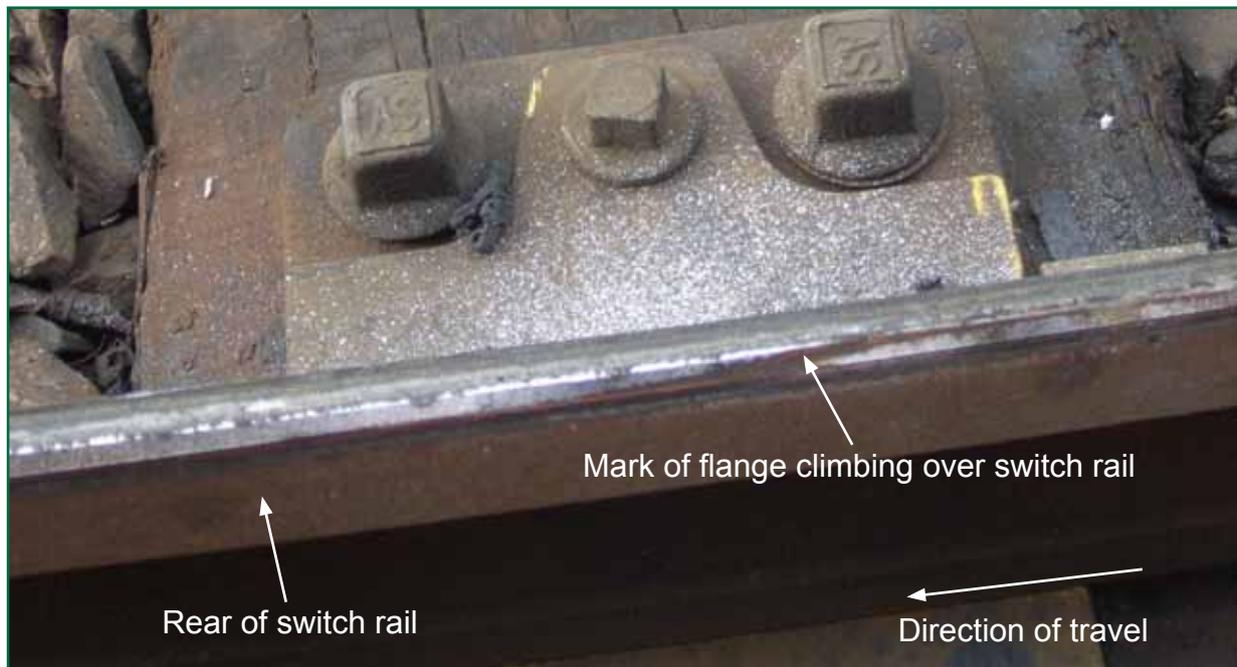
- 94 Marks on the switch rail and damage to switch components and bearers were consistent with the leading left-hand wheel of the third coach climbing over the switch rail at a point 2.8 metres from the switch toe (figure 8), deflecting the switch rail towards the four-foot and dropping down between the switch and stock rails. This pulled the corresponding right-hand wheel into contact with the open right-hand switch rail and squeezed the switch rails together, damaging the third and fourth stretcher bars. The right-hand wheel of the leading axle was subsequently pulled into derailment, dropping between the right-hand stock and switch rails, approximately 14 metres from the switch toes.

Figure 8: Witness mark of wheel flange climbing over switch rail at 2.8 metres from switch toe

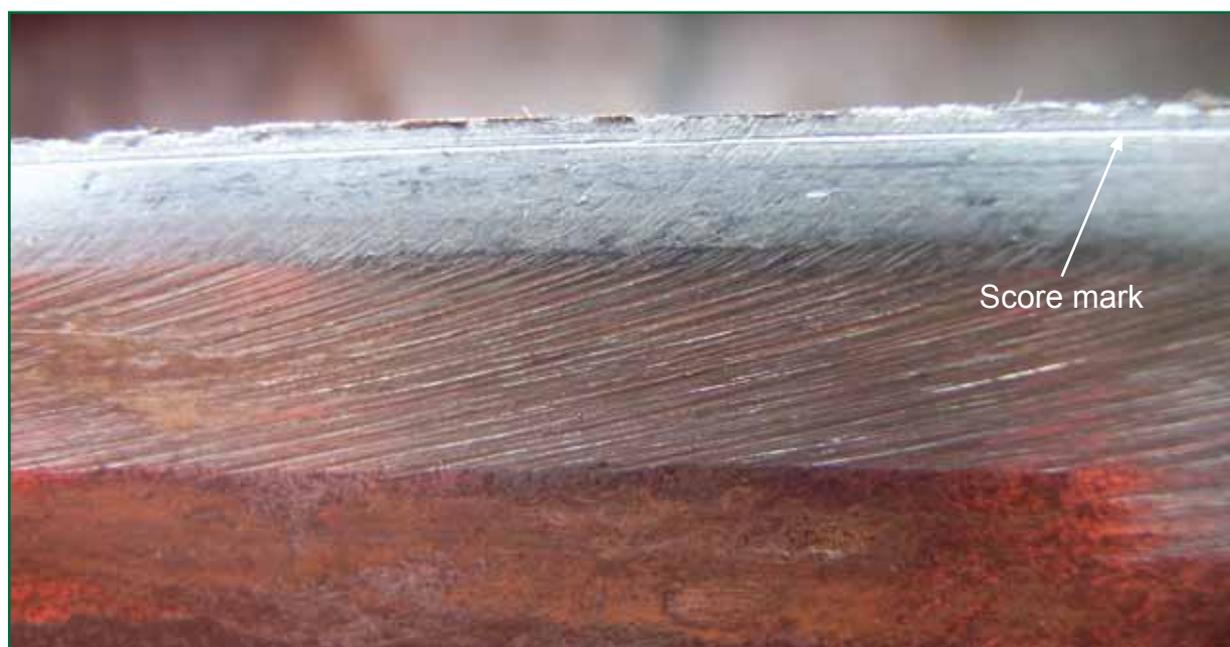
Figure 9: Score mark close to top of switch rail and marks left by grinding

- The dynamics modelling analysis predicted the occurrence of a flange climb derailment risk from a worn wheel in the area 400 mm to 800 mm from the switch toe under high friction conditions.
- The grinding repair left the switch rail with a compliant flange contact angle in the first metre of the switch (although little grinding was found to be needed in this area) and would not therefore have contributed to a flange climb derailment, except possibly to increase the friction in this area (paragraph 124).

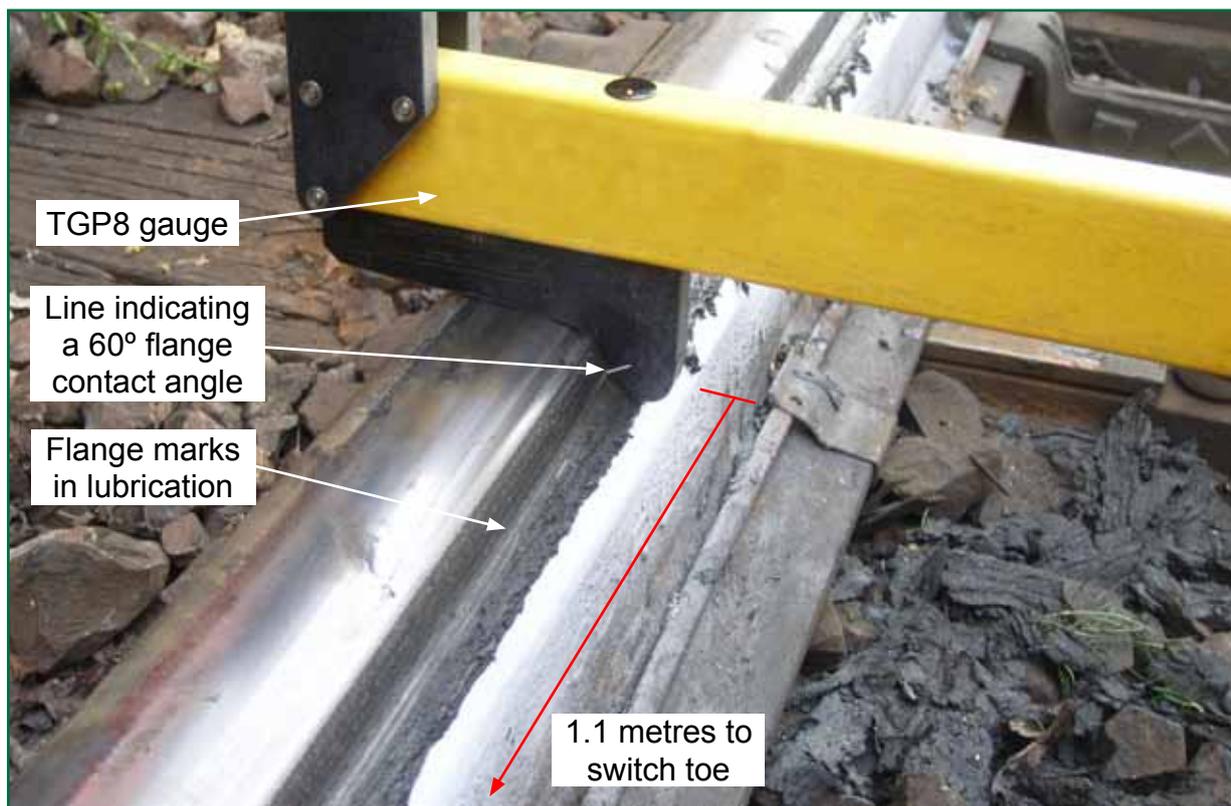
Figure 10: TGP8 gauge applied to left-hand switch rail of points 167B 1.1 metres from the switch toe

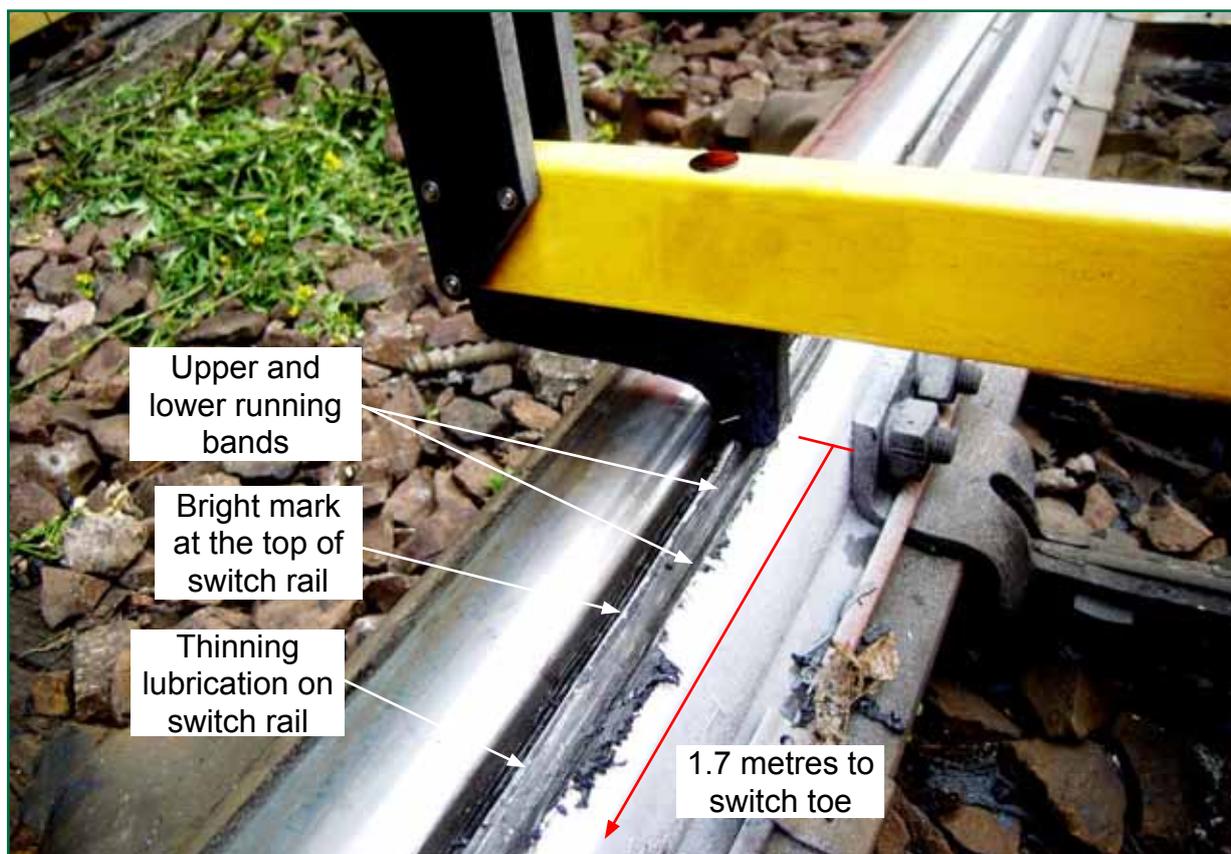
Figure 11: TGP8 gauge applied on markings on left-hand switch rail of points 167B 1.7 metres from the switch toe

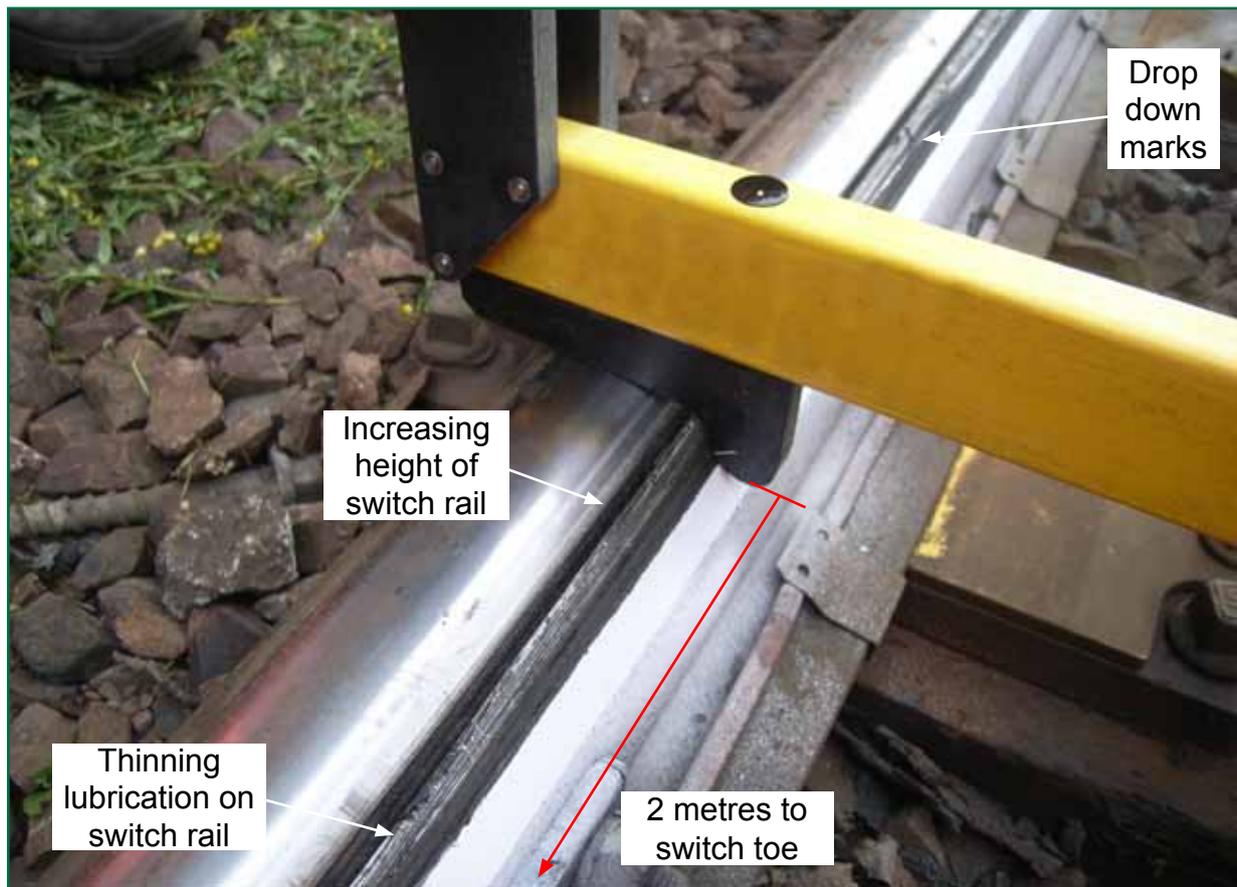
- From around 2 metres from the switch toe there was an emerging pattern of flange markings left by wheels taking a rising path on the switch rail, coincident with the increasing height of the switch rail. There were also distinct marks of flanges having dropped down the gauge face from the higher to lower running bands. At least six 'drop down' marks were observed on the switch rail, indicating that other wheels had tried to climb the switch rail (figure 12).

Figure 12: TGP8 gauge applied to left-hand switch rail of points 167B 2 metres from the switch toe

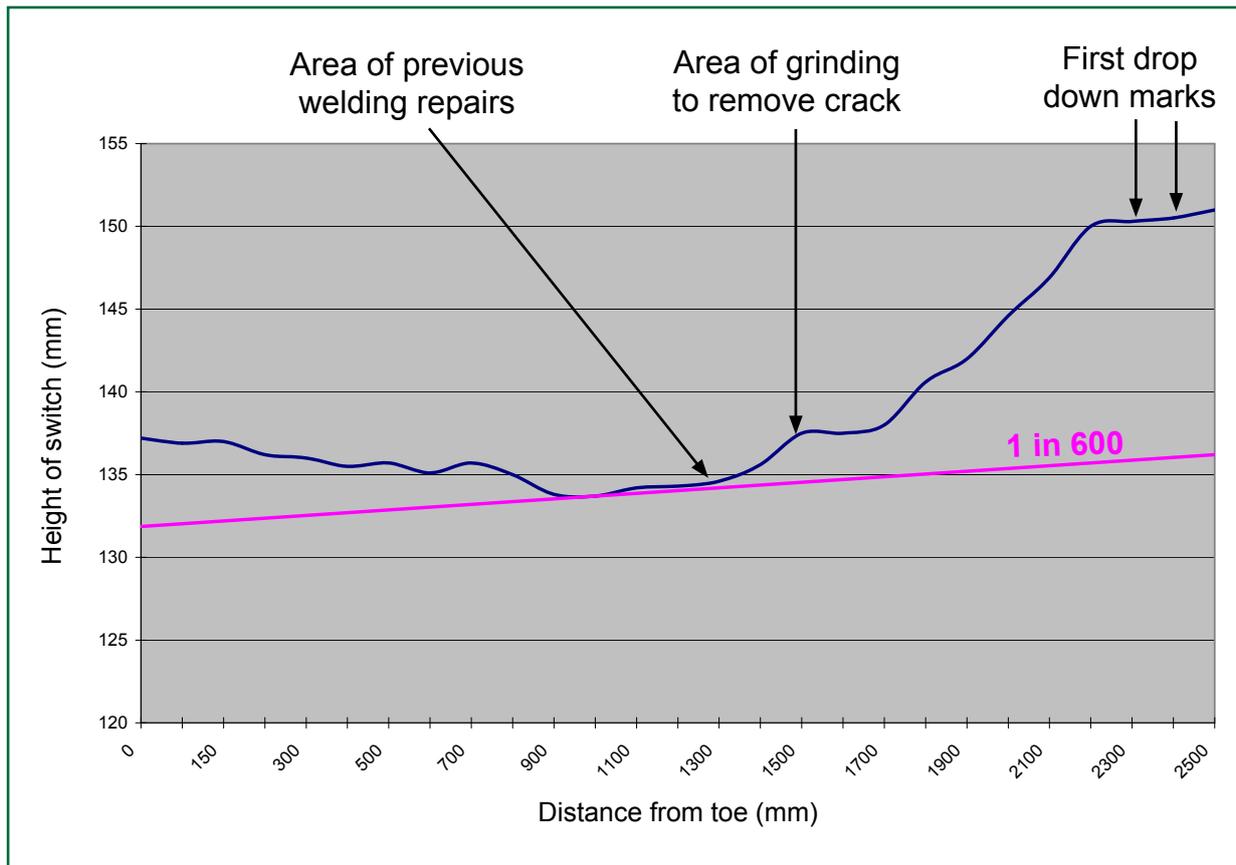
106 The decision not to impose a ban on facing moves on a switch that was beyond repair by grinding in accordance with the 053 standard was causal.

108 Grinding the toe of the left-hand rail of points 167B so that it was 2 mm below the bottom of the sidewear scar on the stock rail and blending out at a gradient of 1:600 was not, in any event, realistically achievable. Figure 13 shows the height profile of the switch rail after the derailment. The height, which was measured at 137.2 mm at the toe, dipped down to 133.7 mm at one metre from the toe. If a line representing a 1:600 gradient is drawn so that it passes through this lowest point, the switch rail would need to be reduced to a height of 131.8 mm at the toe. This would entail the removal of an unrealistic amount of metal and leave the switch rail so low that it would be unable to engage with the wheel flange to steer the train for a considerable distance from the toe.

Figure 13: Points 167B - profile of top of switch rail

109 The grinding repair to remove the crack was also not blended into the unaffected part of the switch rail at a gradient of 1:600 as required by the 053 standard (figure 13). Instead the technician used a straight edge to get a line to grind to. This was stated by the grinding technician to be partly because of the lack of time but mainly because he felt it was not practicable to blend out at the required rate without taking the switch toe too low. The switch was ground from the area of the crack towards the switch heel for as far as could be achieved in the time available.
