Rail Accident Report

**Train departed with doors open, Warren Street,
Victoria Line, London Underground
11 July 2011**

11 July 2011

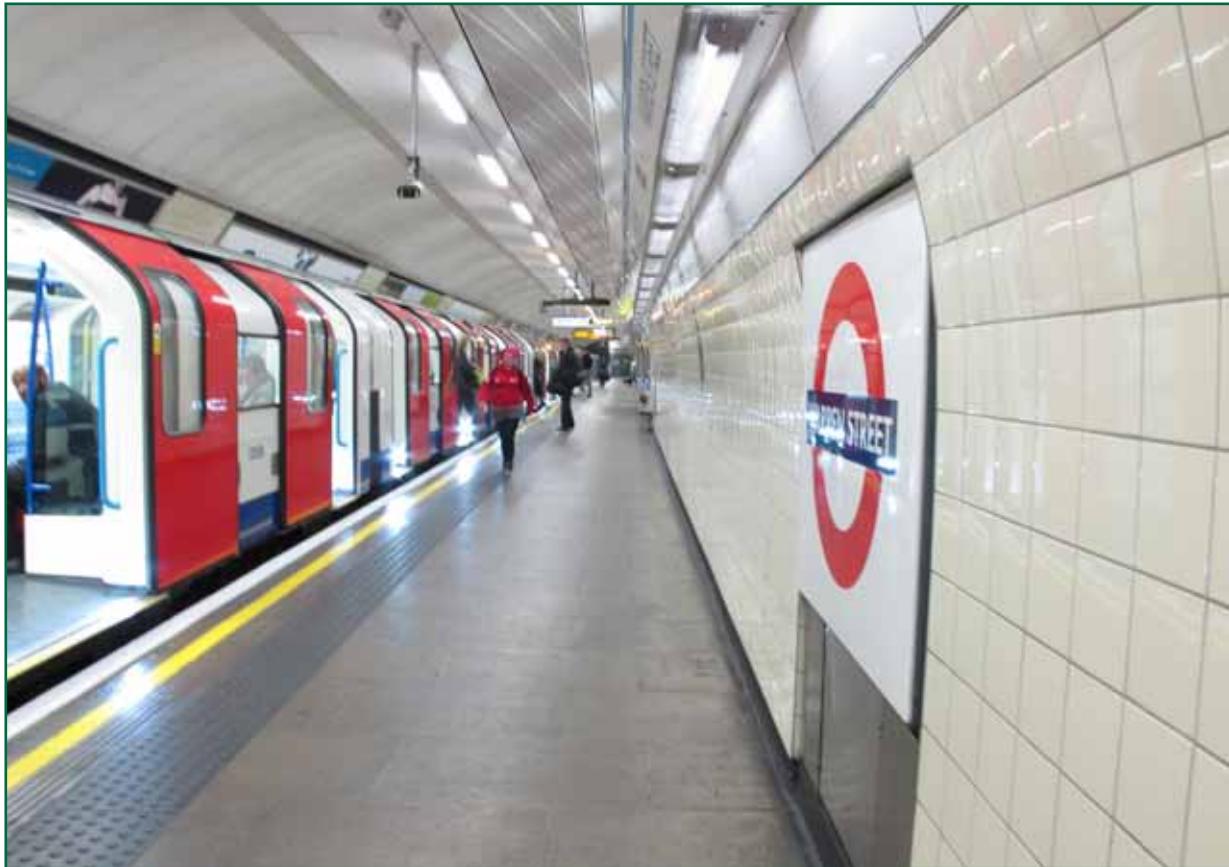
Figure 2: Northbound platform at Warren Street, Victoria Line (by courtesy of London Underground)

- 6 After the train had been moving for about three seconds, and when the train reached 8 km/h, a safety system on the train automatically closed the doors. By this time, the first car had entered the tunnel with the leading set of passenger doors open.
- 7 When the train reached 11 km/h, and on realising that something was wrong, the train operator applied the service brake and then the emergency brake to stop the train, by which time it had travelled 14 metres. Around 13 metres of the distance travelled was into the tube tunnel immediately beyond the end of the platform.
- 8 After the train stopped, station staff de-trained the passengers, and the train was taken out of service. It then ran empty to the depot at Northumberland Park for examination.
- 9 No passengers were injured in the incident.

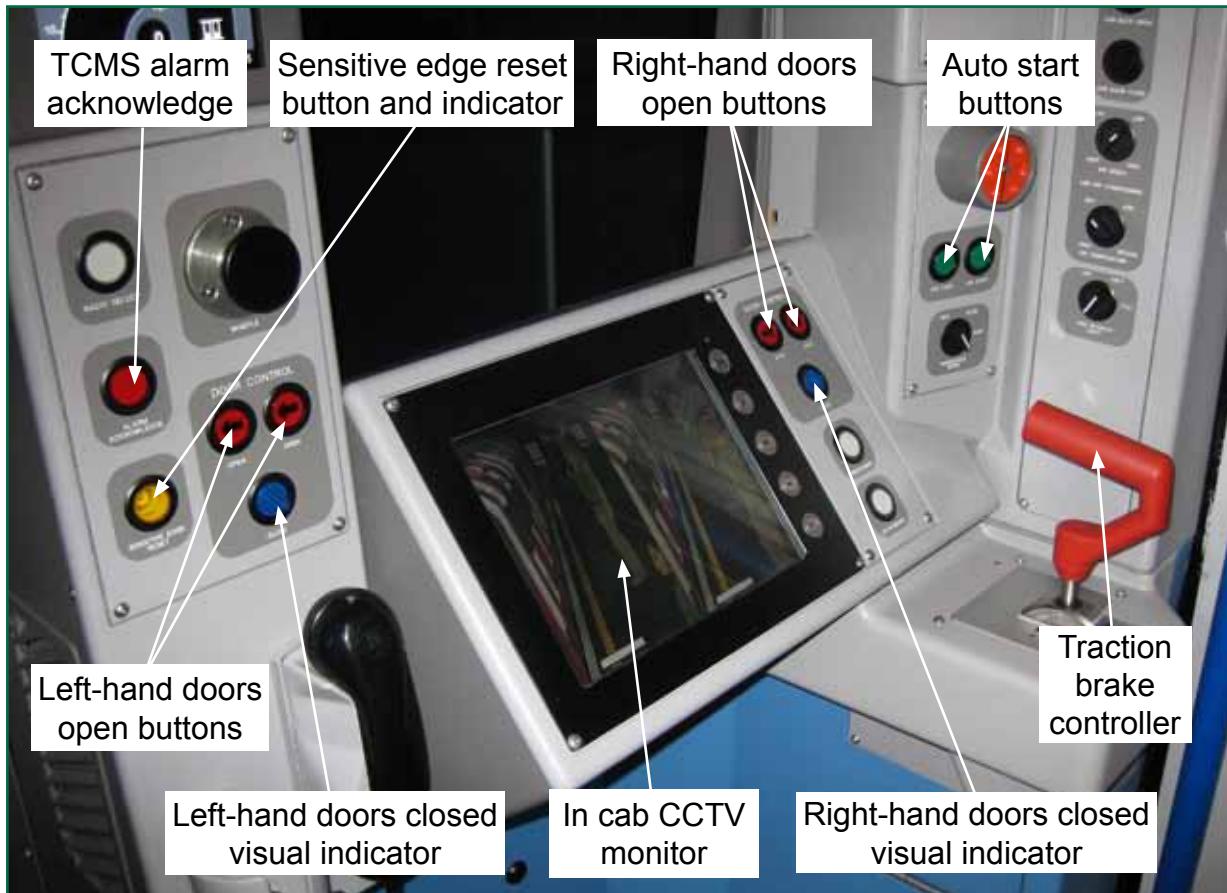
Figure 3: Layout of relevant cab controls in the driving cab of 2009 tube stock

- 17 On each car there is a set of double sliding doors at a third and two thirds of the way along each side. In addition, the cars without a driving cab have single leaf sliding doors giving access to the passenger saloon at each end; cars with a driving cab have single leaf sliding doors giving access to the saloon at the non-cab end. The layout of the doors is shown later in the report in figure 5.
- 18 The trains normally operate in *automatic mode* and only require the train operator to open the doors on arrival at a station, and then close the doors and press the *start buttons* (figure 3) if it is safe for the train to depart.

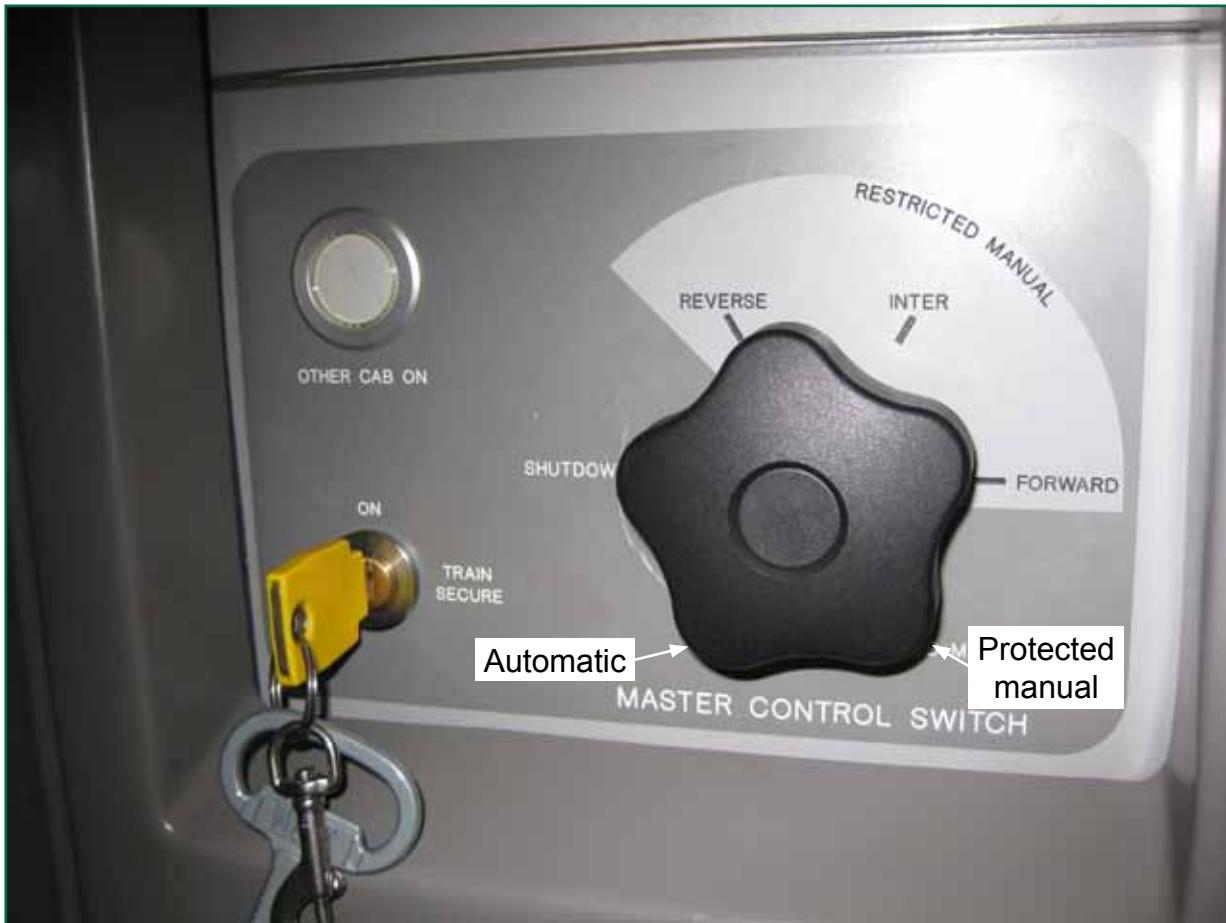
Figure 4: Master control switch 2009 tube stock

- 76 Before starting the train from Warren Street station, the train operator disabled the train door interlock using the cut out switch. This is a causal factor.

- 128 While between Oxford Circus and Warren Street, the train operator turned the master control switch to shutdown and then back to protected manual (paragraph 52). This action caused the door close relays to de-energise causing the sensitive edge override and sensitive edge cut out switches to be ineffective. Train operators had not been briefed on this and it made it more difficult for the train operator to resolve the activated sensitive edge at Warren Street.

- 136 The circuitry is to be modified so that turning the master control switch to shutdown does not de-energise the door closed relays, or cause the sensitive edge override to be no longer available. The implementation of this change has been allocated to Bombardier to carry out (paragraph 132a).

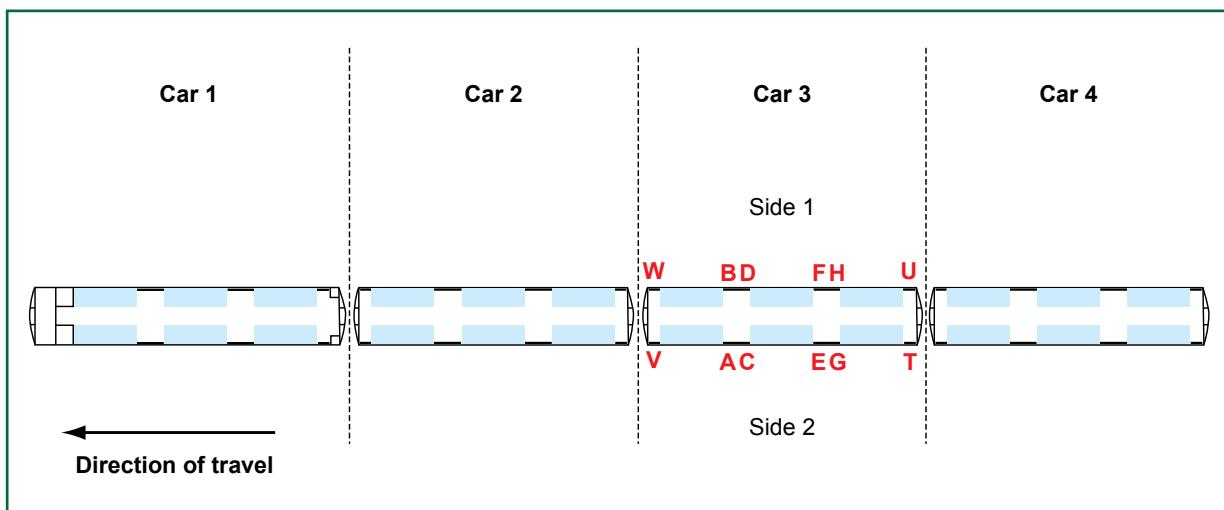
Figure 5: Layout and designation of train doors 2009 tube stock

- 47 The message displayed related to the third car of the train, car number 13066, and advised 'SE door DBW side 1'. Doors D, B and W are located as shown in figure 5. The message further advised: 'Emergency brake applied, once cause of activation is known press Sensitive Edge push button for brake release'.

- 62 London Underground found that the cause of the activation of the sensitive edge system was the strap of a passenger's bag that had caught between the doors when they closed at Oxford Circus. These were now on the non-platform side at Warren Street. The bag was released from the doors.
