Rail Accident Investigation Branch

Rail Accident Report

**Train departed with doors open, Warren Street,
Victoria Line, London Underground
11 July 2011**

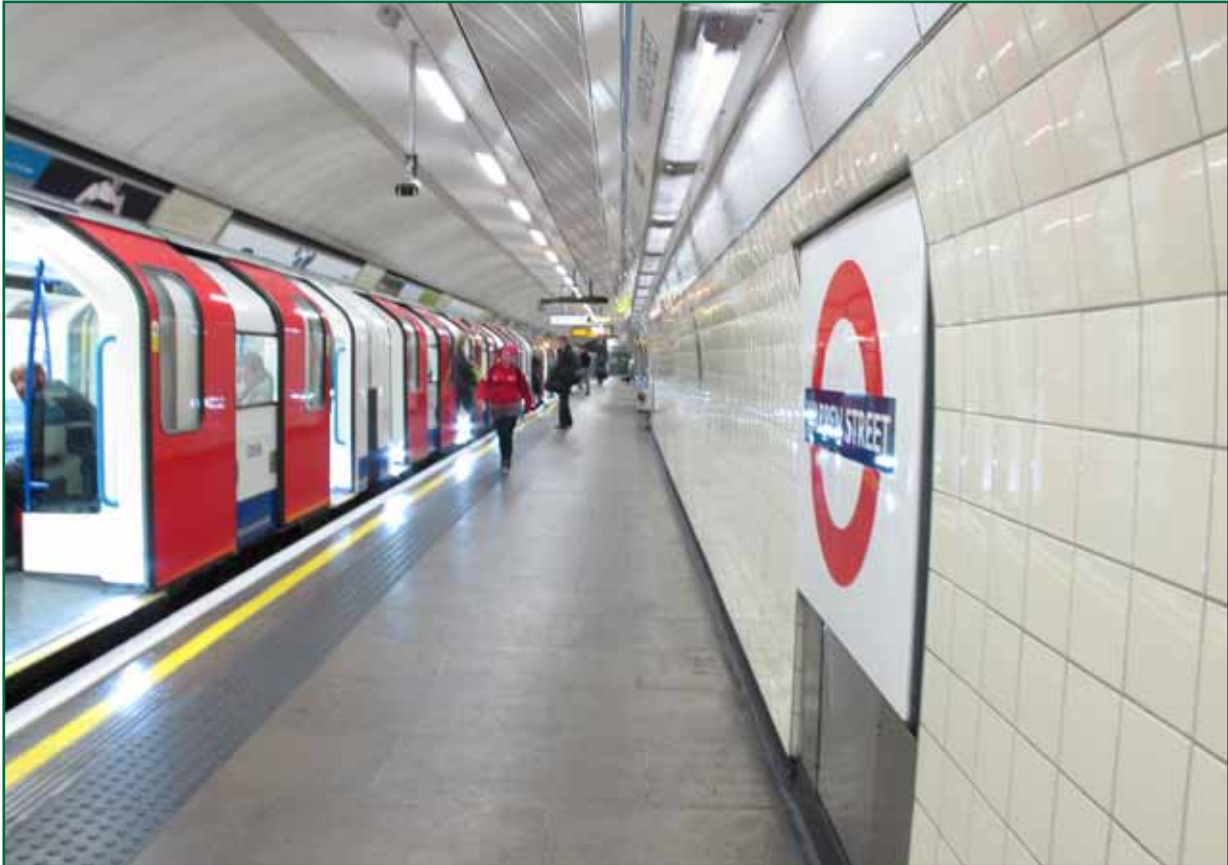
Figure 2: Northbound platform at Warren Street, Victoria Line (by courtesy of London Underground)

- 5 At 17:29 hrs on 11 July 2011, a northbound Victoria Line train departed from Warren Street underground station (figures 1 and 2) with all the saloon doors open on the platform side of the train. The train's destination was Seven Sisters and the service number was 237.

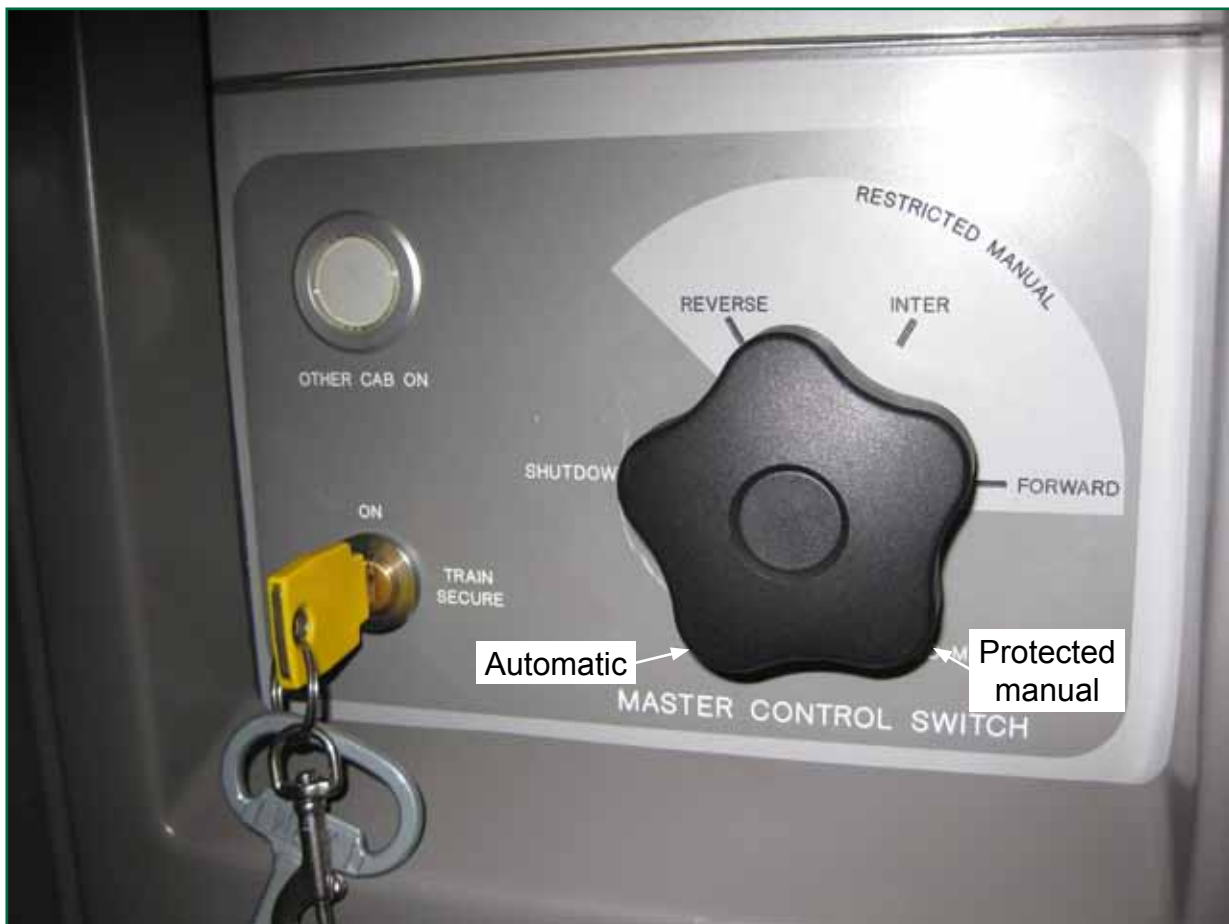
Figure 4: Master control switch 2009 tube stock

- 128 While between Oxford Circus and Warren Street, the train operator turned the master control switch to shutdown and then back to protected manual (paragraph 52). This action caused the door close relays to de-energise causing the sensitive edge override and sensitive edge cut out switches to be ineffective. Train operators had not been briefed on this and it made it more difficult for the train operator to resolve the activated sensitive edge at Warren Street.

- 136 The circuitry is to be modified so that turning the master control switch to shutdown does not de-energise the door closed relays, or cause the sensitive edge override to be no longer available. The implementation of this change has been allocated to Bombardier to carry out (paragraph 132a).

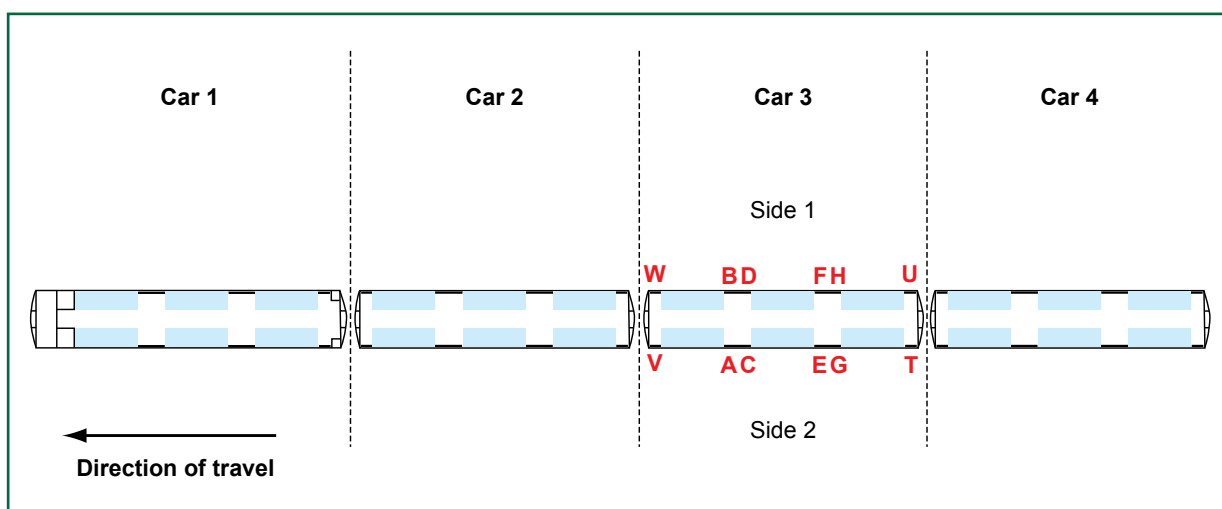
Figure 5: Layout and designation of train doors 2009 tube stock

- 47 The message displayed related to the third car of the train, car number 13066, and advised 'SE door DBW side 1'. Doors D, B and W are located as shown in figure 5. The message further advised: 'Emergency brake applied, once cause of activation is known press Sensitive Edge push button for brake release'.
